NATIONAL TRANSPORTATION SAFETY BOARD
Office of Aviation Safety
Washington, D.C. 20594

SYSTEMS GROUP CHAIRMAN FACTUAL REPORT ADDENDUM
FOR DEPOSITS ON FUEL TANK ELECTRICAL COMPONENTS

A. ACCIDENT: DCA96MA070

Airplane : Boeing 747-131, N93119
Operated as Trans World Airlines (TWA) Flight 800

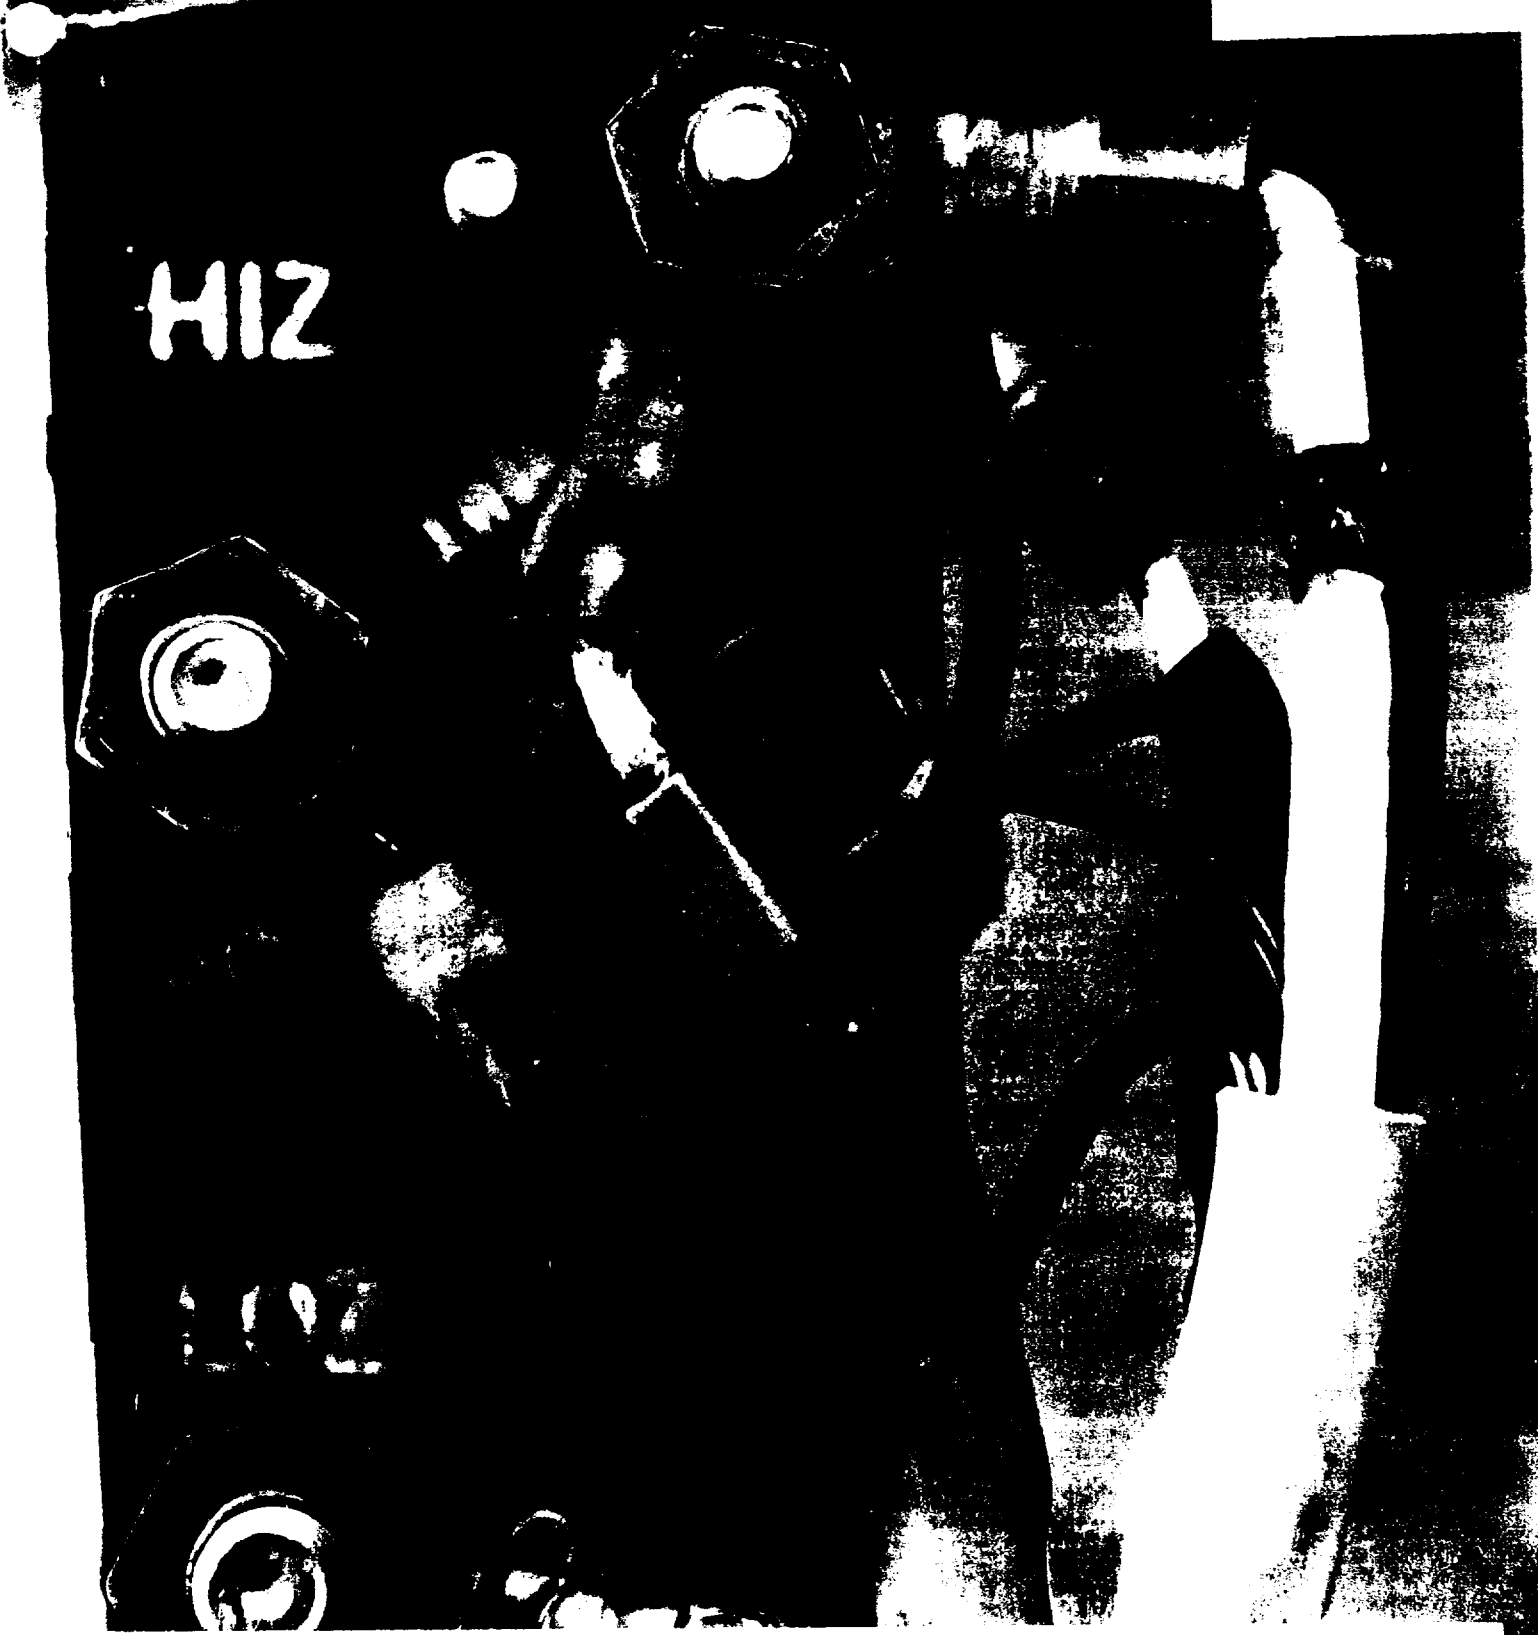
Figure 3. Terminations on compensator F59 before mechanical cleaning (4.2X).

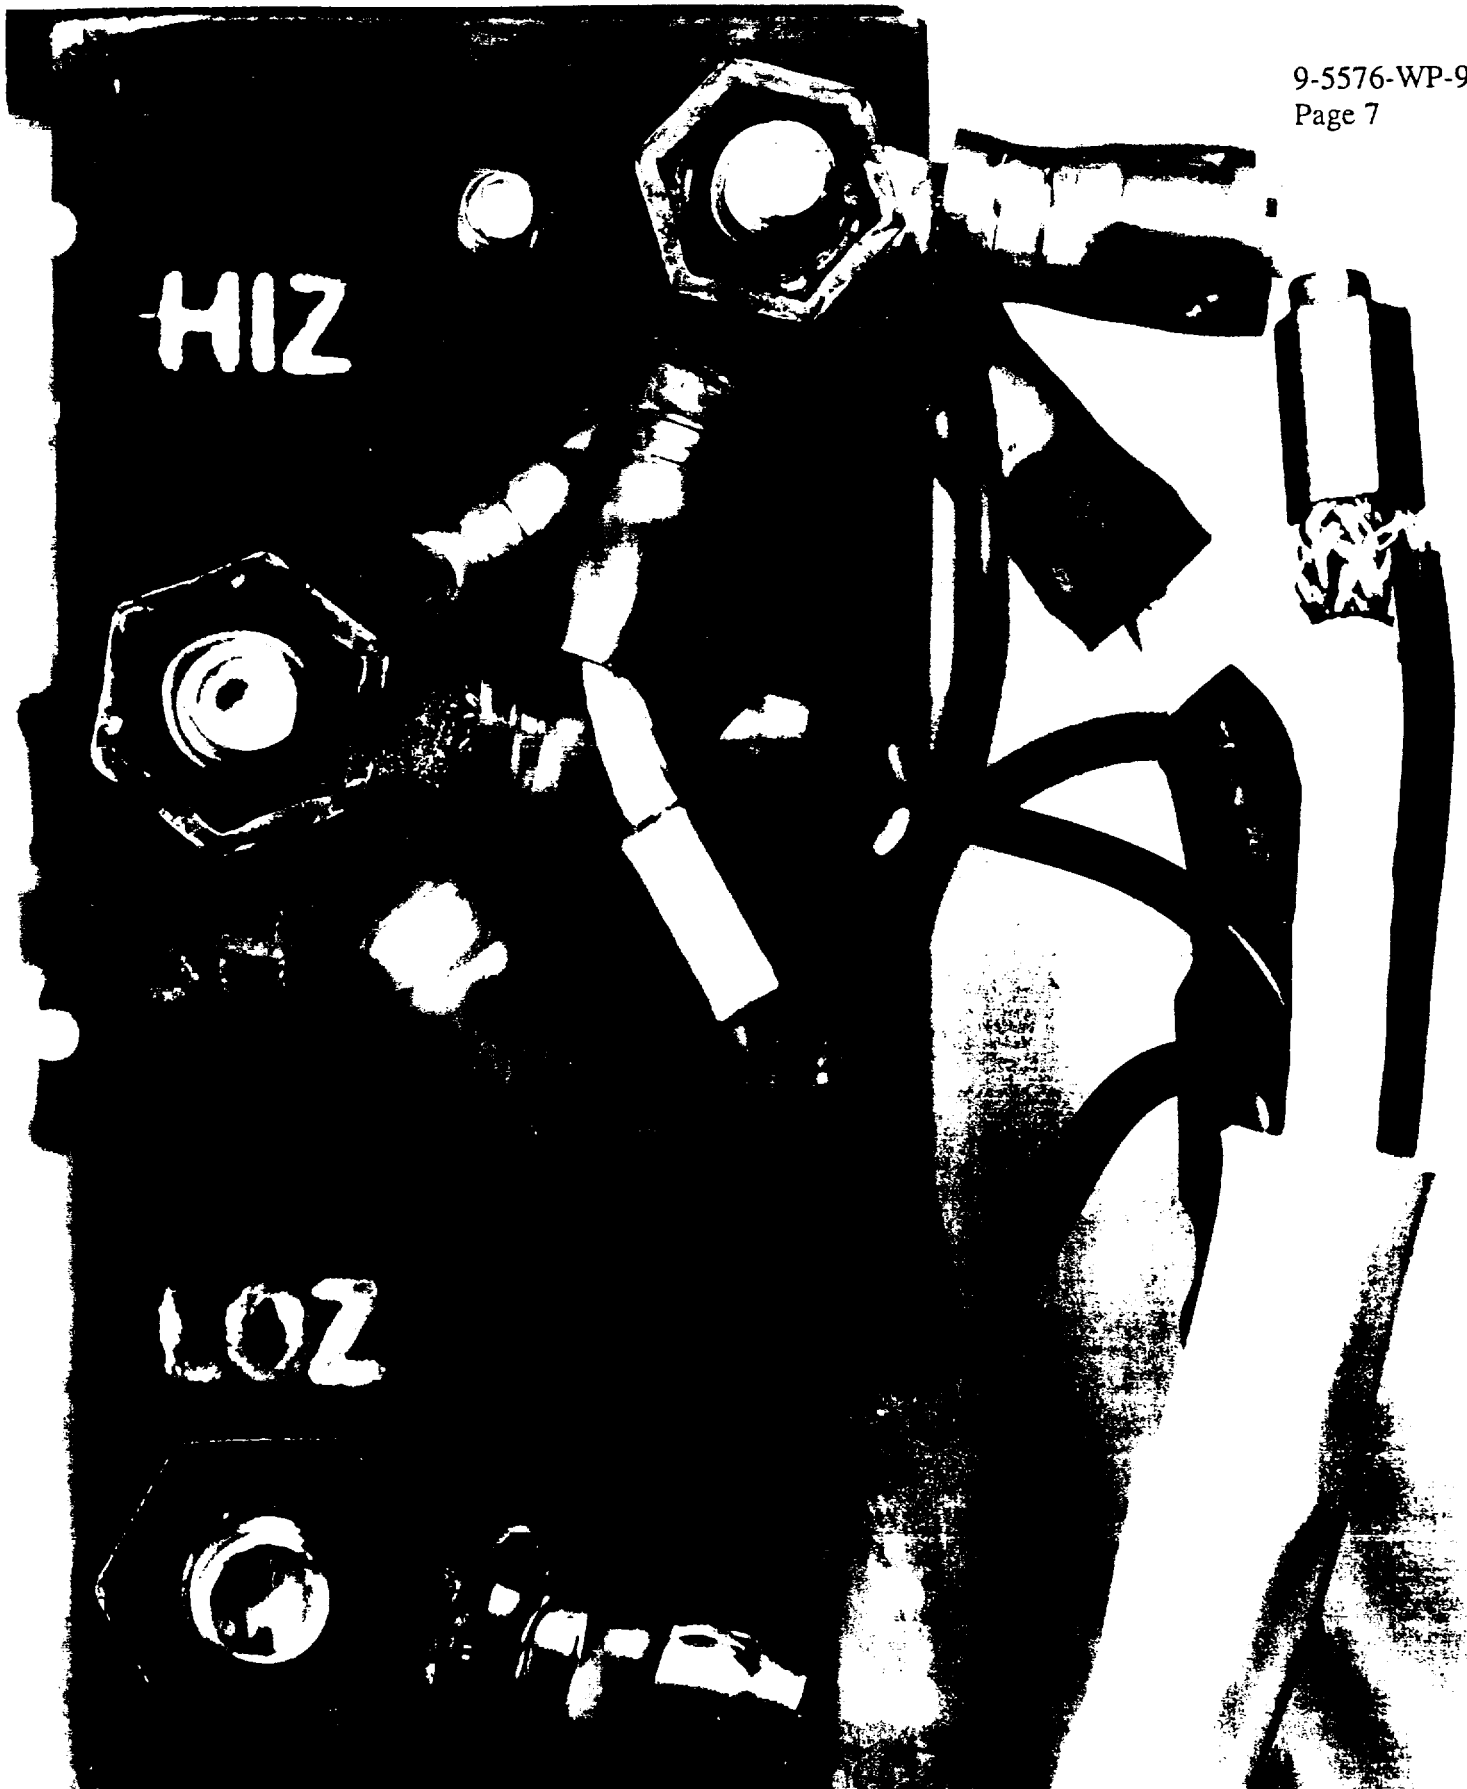
Figure 4. Terminations on compensator F59 after mechanical cleaning (4.2X).

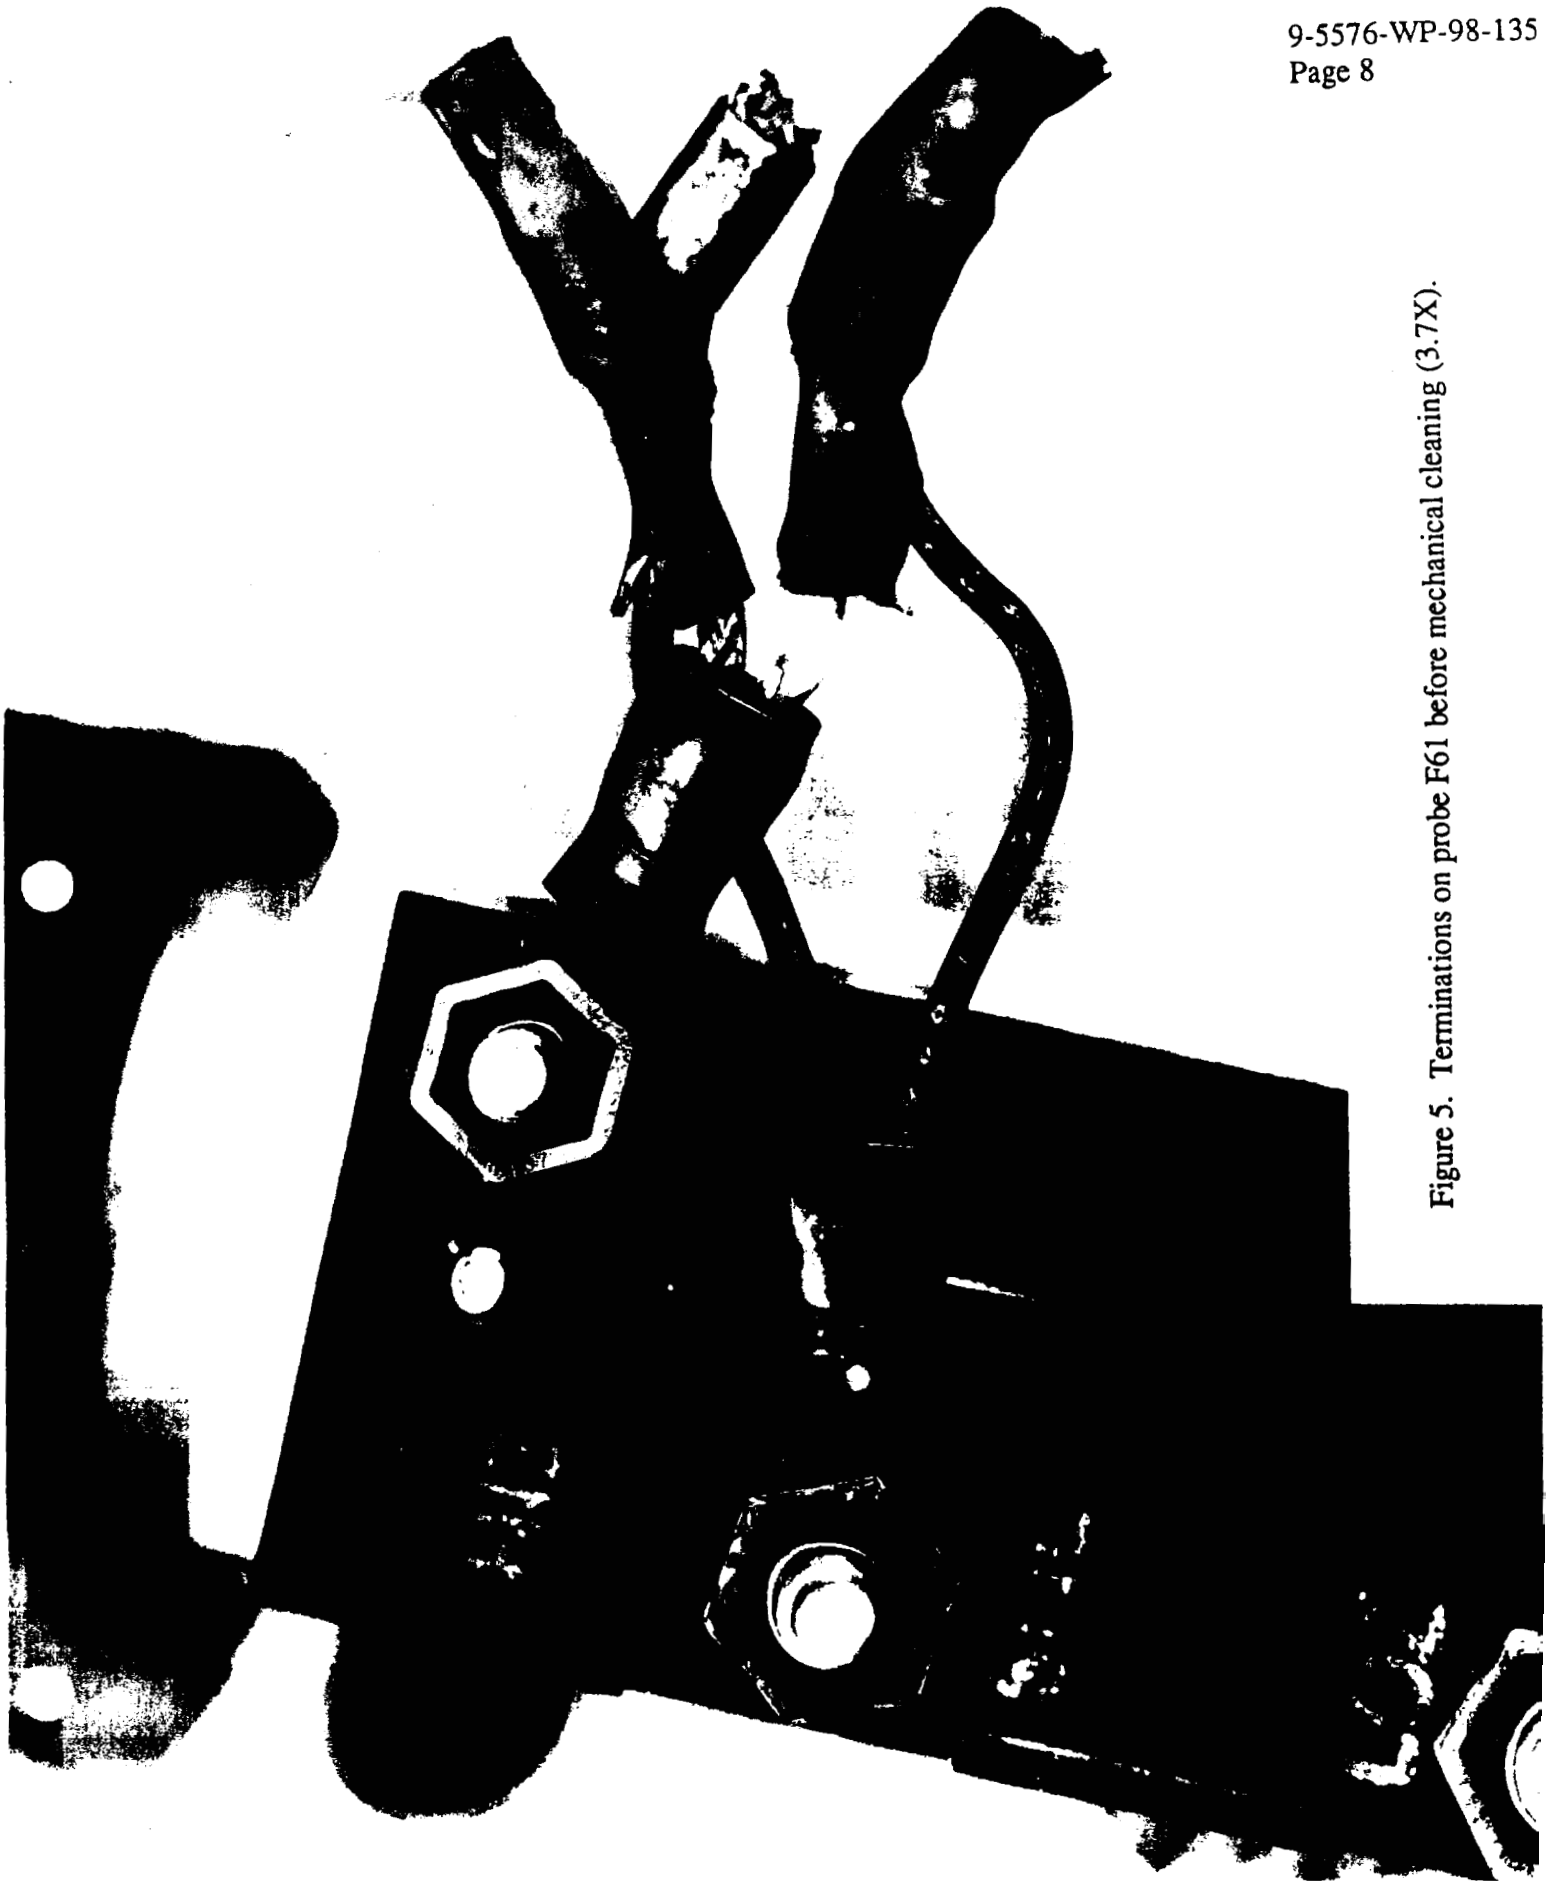
Figure 5. Terminations on probe F61 before mechanical cleaning (3.7X).

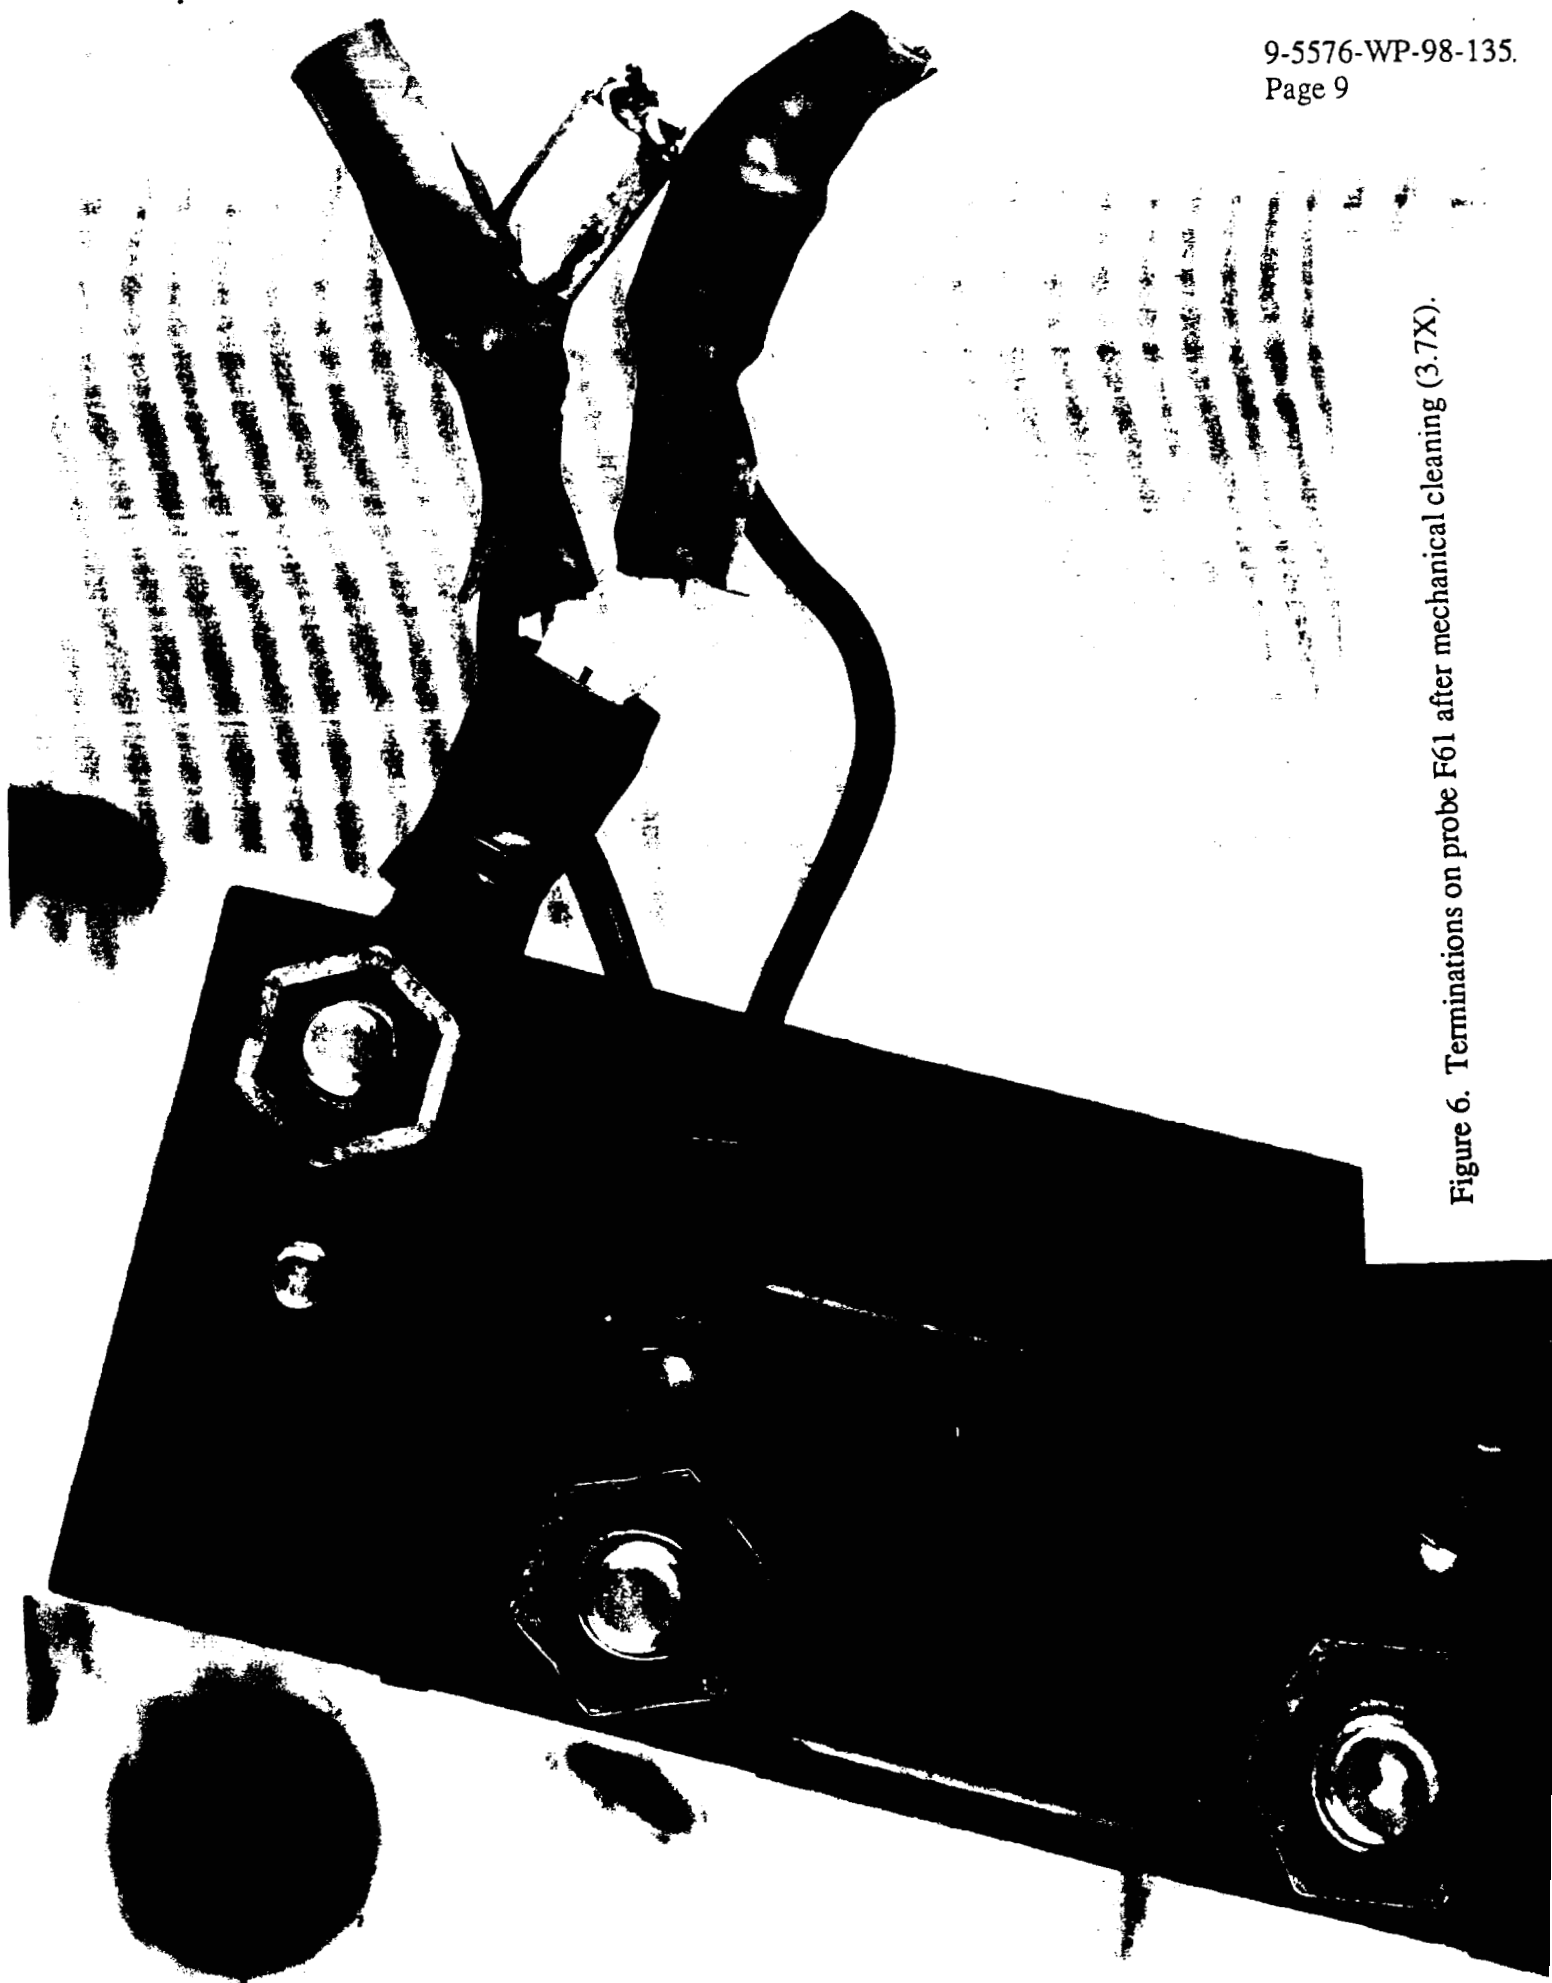
Figure 6. Terminations on probe F61 after mechanical cleaning (3.7X).

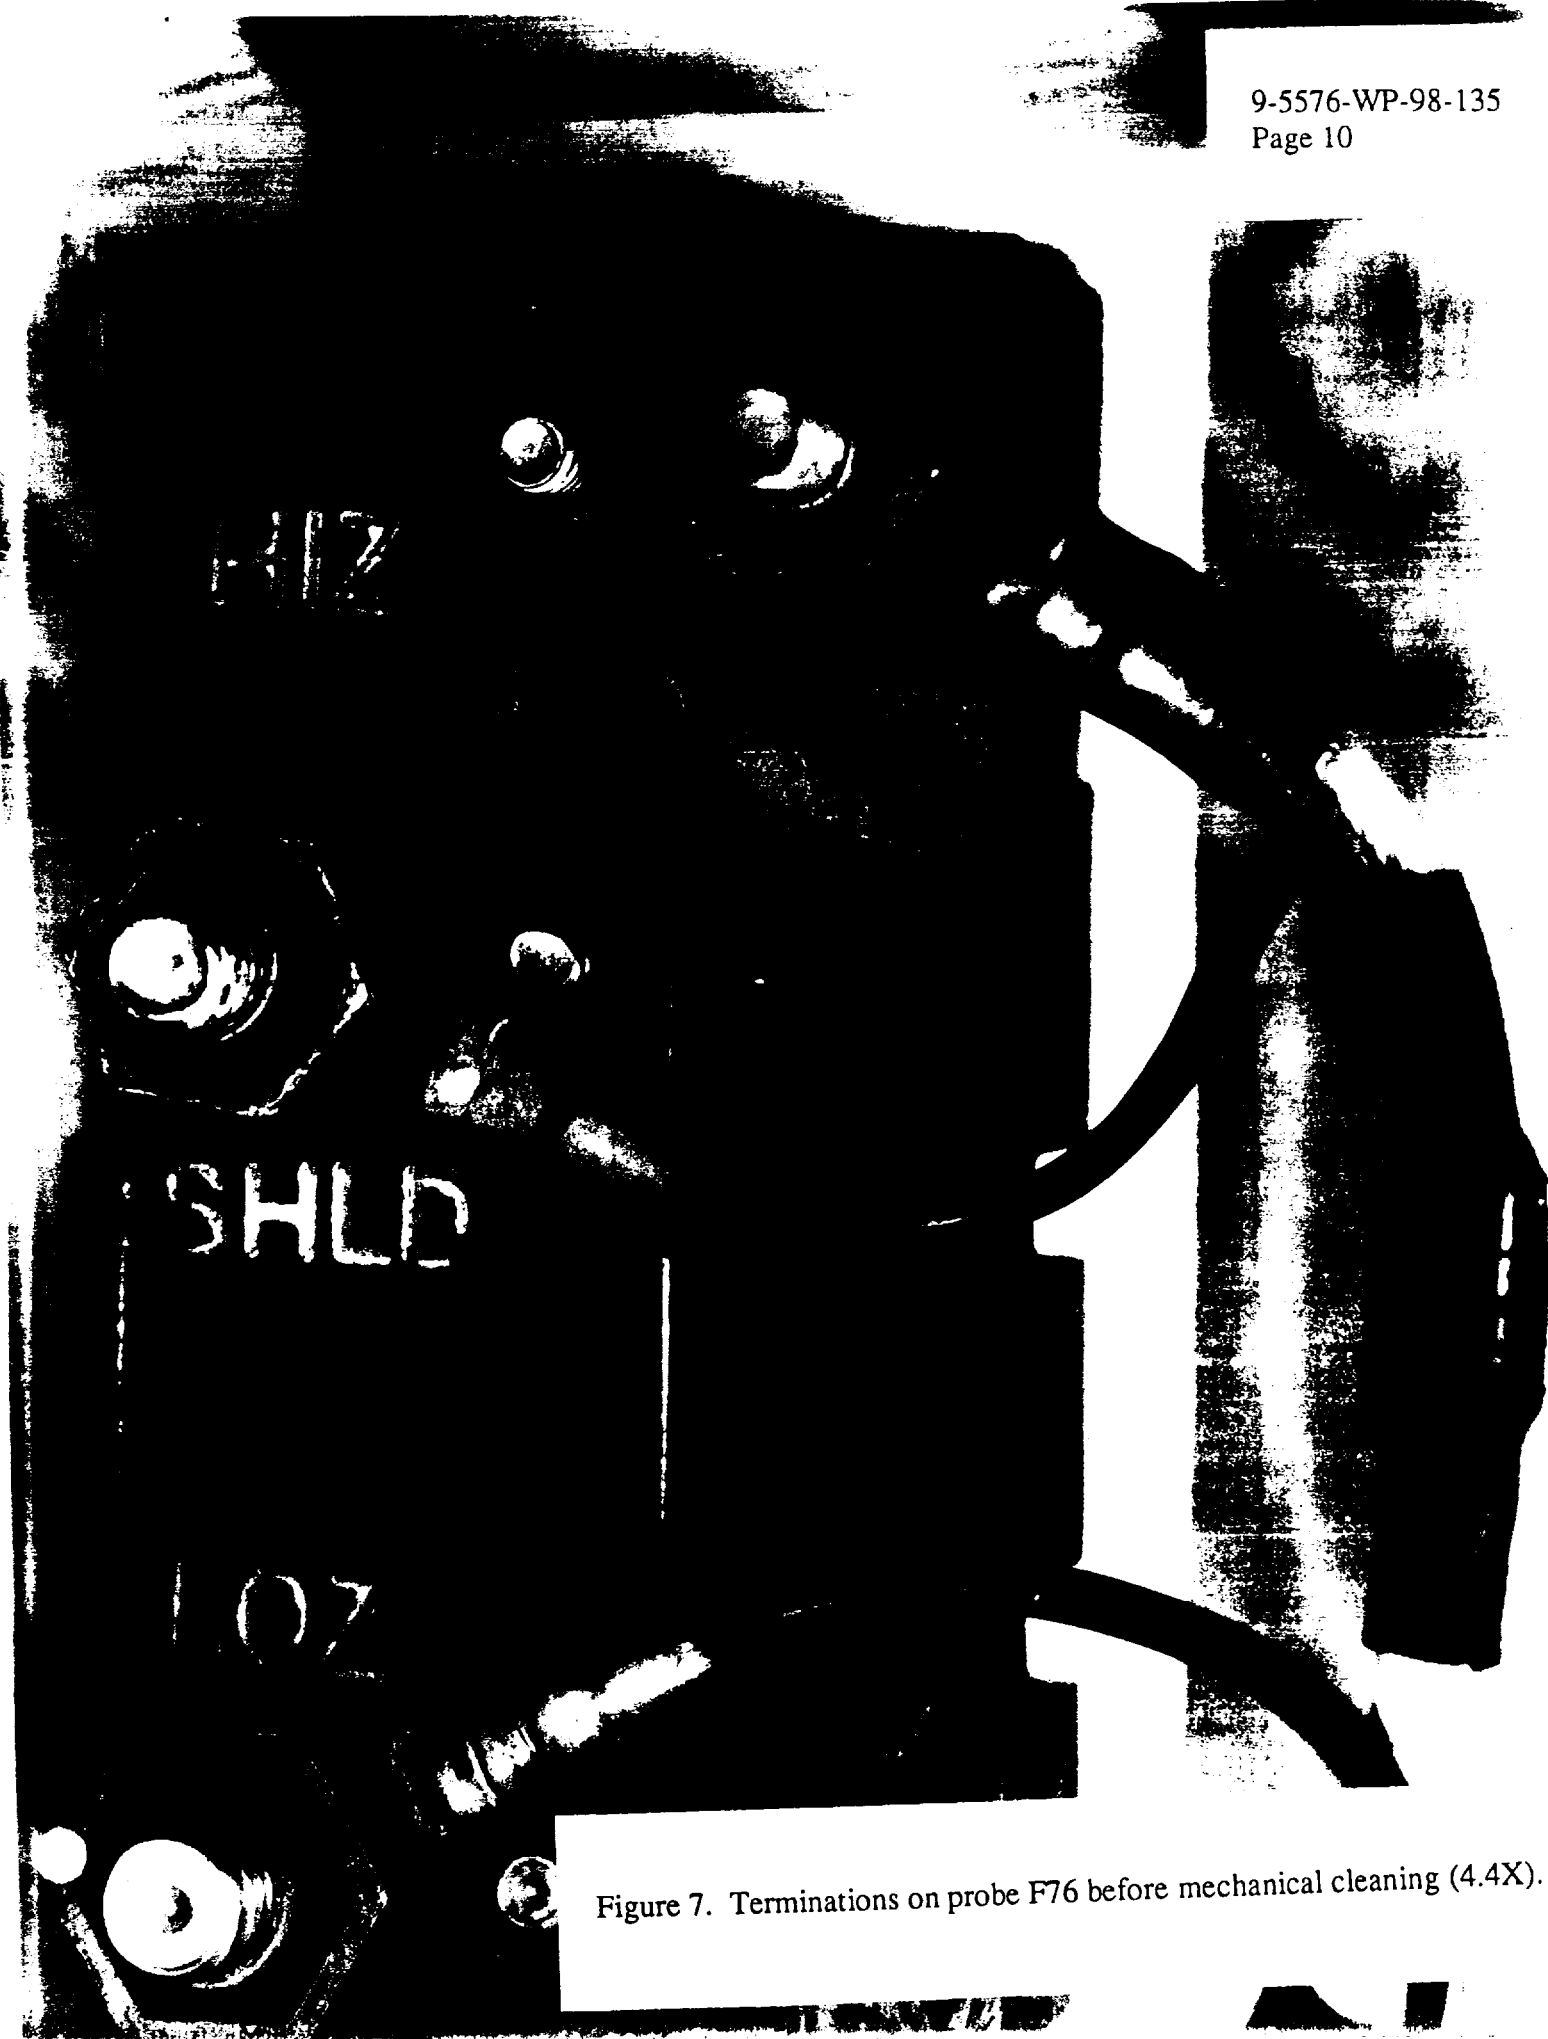
Figure 7. Terminations on probe F76 before mechanical cleaning (4.4X).

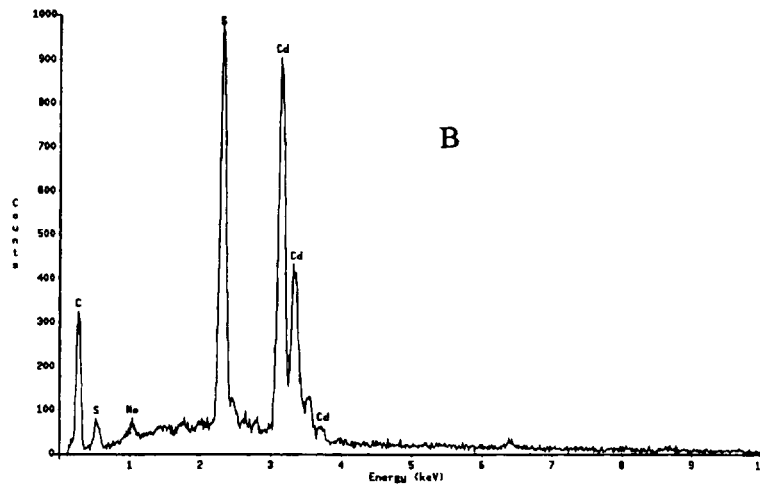
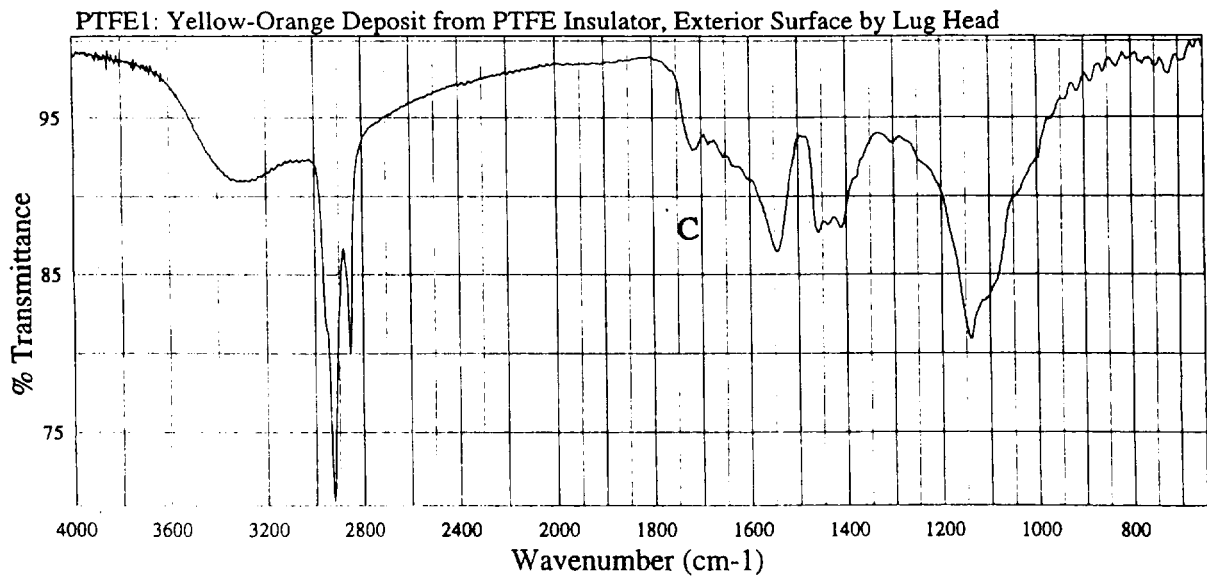
Figure 4. (A) Orange deposits on the surface of the PTFE insulator sheet that separated the terminal block assembly from the shield tube (2.3X). (B) An electron microprobe elemental survey and (C) infrared spectrum of the deposits shown in (A).

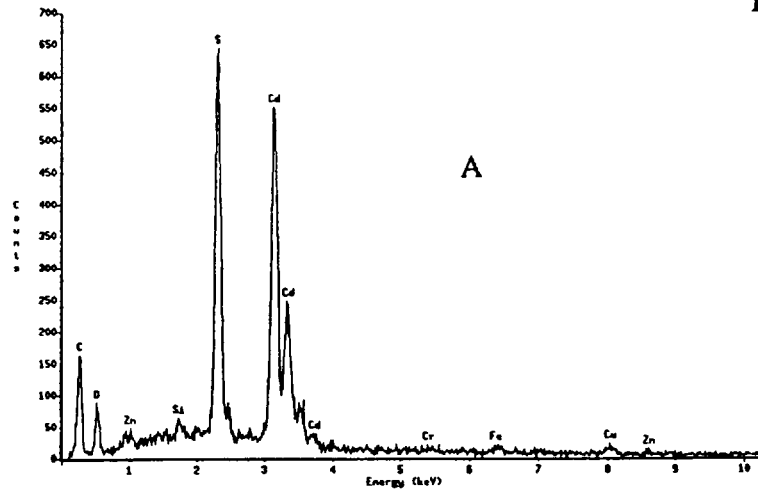
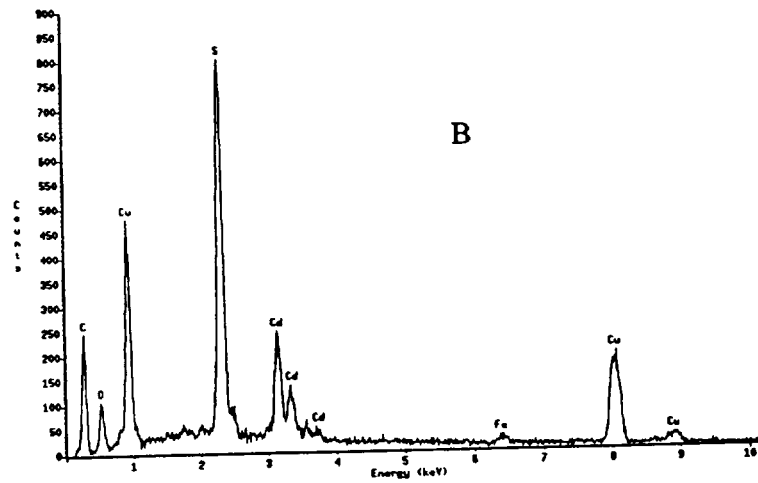
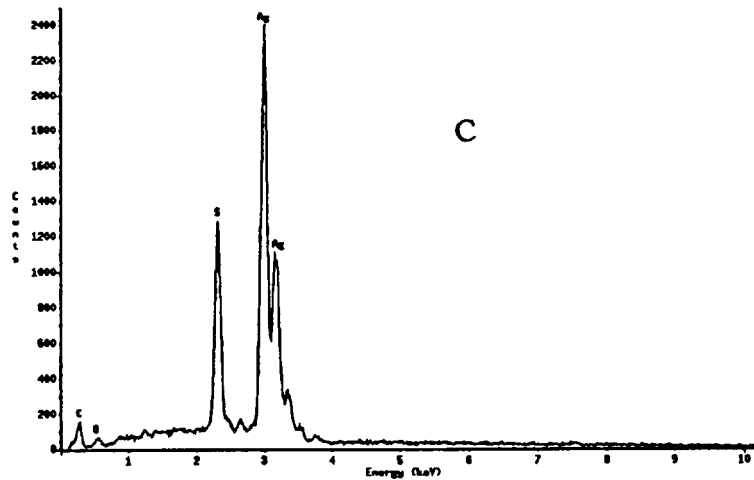
Figure 5. Electron microprobe elemental surveys of (A) orange deposits and (B) dark deposits from the shield terminal block, and (C) black material from the surface of the shield terminal hold-down nut.

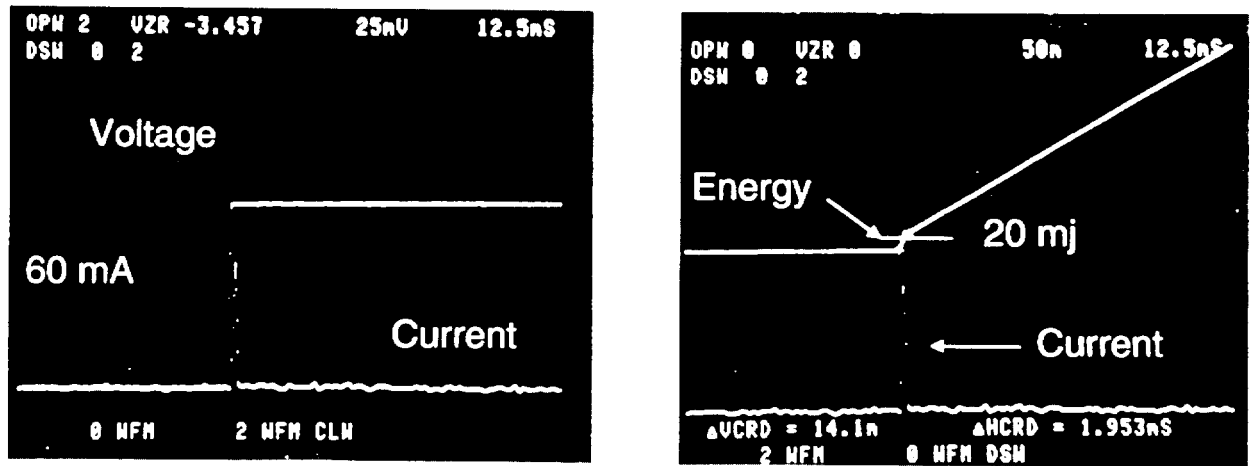
Figure 15. Barner strip discharge event 1 (table 2), terminal area 3 and 4, points 2 and 4 (figure 13).
 Initial resistance 0.4 kilohms, applied voltage: 170V.
 Arc Event: Small arc (exhibit 2).
 Current 60 mA peak for 2 milliseconds, voltage (final): 170V.
 Arc energy based on waveform calculation: 20 millijoules.

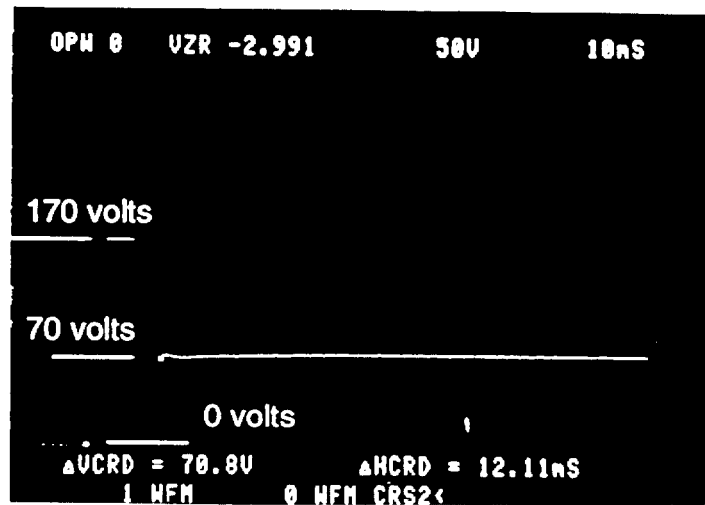
Figure 16. Event 2 (table 2) terminal area 3 and 4, points 3 and 4 (figure 13).
 Initial resistance 2.2 kilohms, applied voltage: 170V.
 Arc Event: Large arc (exhibit 2 and figure 18).
 Current event not captured.
 Arc energy: $(50 \text{ V}) \cdot (V_f) = (5(290E-6))(170 - 100) = 2.40 \text{ millijoules}$ (voltage drop of 100 volts in 10 milliseconds).

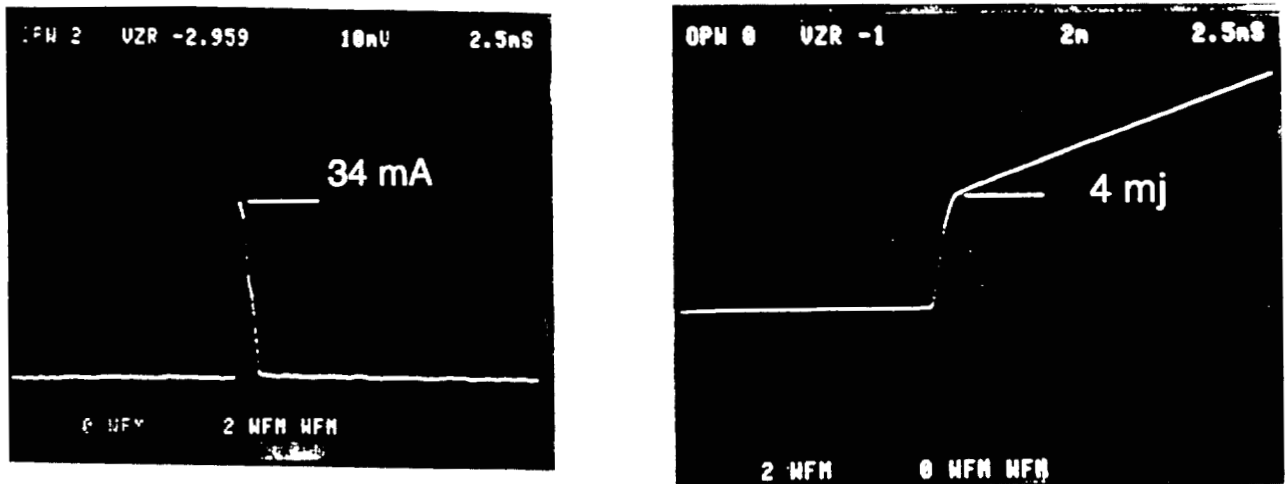
Figure 17. Event 3 (table 2) terminal area 2 and 3, points 10 and 11 (figure 14).
 Initial resistance 3.3 kilohms, applied voltage = 170V
 Arc Event - Small arc (exhibit 2)
 Arc current 34mA peak for 1 millisecond, voltage (final) = 170V
 Arc energy based on waveform calculation 4 millijoule

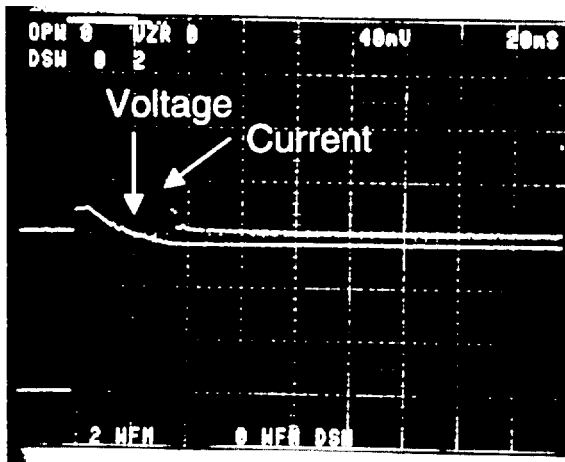
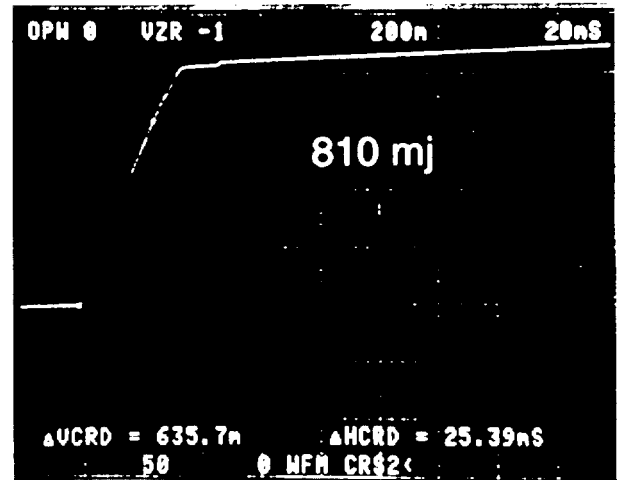
Six tests were conducted using the laboratory-prepared carbon films with resistance values between 660 ohms and 4.7 kilohms. The capacitors were charged to 170 VDC. The fuel vapors ignited in three out of six attempts. The events were recorded with a high-speed video system and oscilloscope (figures 21, 22 and 23). The videotape was digitized and ignition examples are offered in exhibit 2. A summary of test results is given in table 3. The first two tests were part of the setup process. Event 6 was the application of 250 volts to the test sample used in event 5. Although an arc was produced, the vapors did not ignite. The energy impressed onto the sample was calculated by two methods. The first method captured voltage and current waveforms on the oscilloscope. As before, the energy was calculated using the procedure in appendix C. A second method was to use the difference between the initial and final voltage remaining in the capacitors after the arc event. Testing was halted after obtaining three ignition events. Variation in energy readings was due to several factors. In event 7, the current probe amplifier was saturated, due to the selected amplifier range, and the actual current level was not captured.

Figure 21 Event 7 (table 3) Container heated to 30°C
 Initial film resistance 2.3 kilohms, applied voltage = 170V
 Five drops of lighter fluid, dwell period three minutes, arc ignited vapor
 Arc current 160 mA peak for 40 milliseconds, ending voltage 140 volts
 Arc energy = $.5C(V_i - V_f) = .5(290E-6)(170 - 140) = 1.348$ millijoules
 Oscilloscope trace energy calculation = 810 millijoules
 Actual current level not captured due to instrumentation scaling

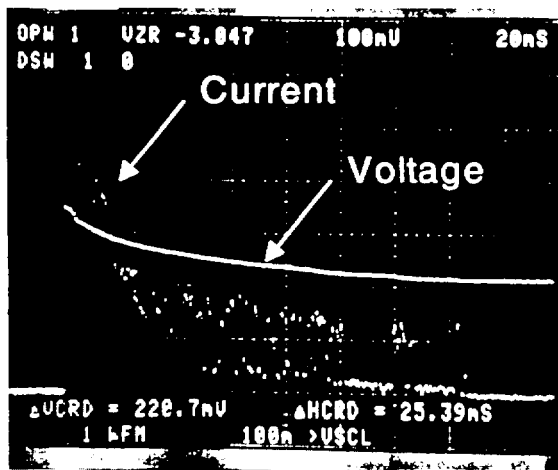
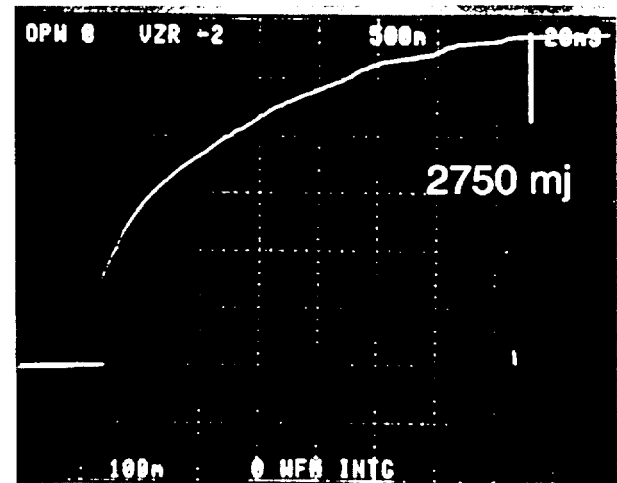
Figure 22 Event 8 (table 3) container heated to 30°C
 Initial film resistance 622 ohms, applied voltage = 170V
 Five drops of lighter fluid, dwell period three minutes, arc ignited vapor
 Arc current 500 mA peak for 150 milliseconds, ending voltage 110 volts
 Arc energy = $.5C(V_i - V_f) = .5(290E-6)(170 - 110) = 2.436$ millijoules
 Oscilloscope trace energy calculation = 2750 millijoules

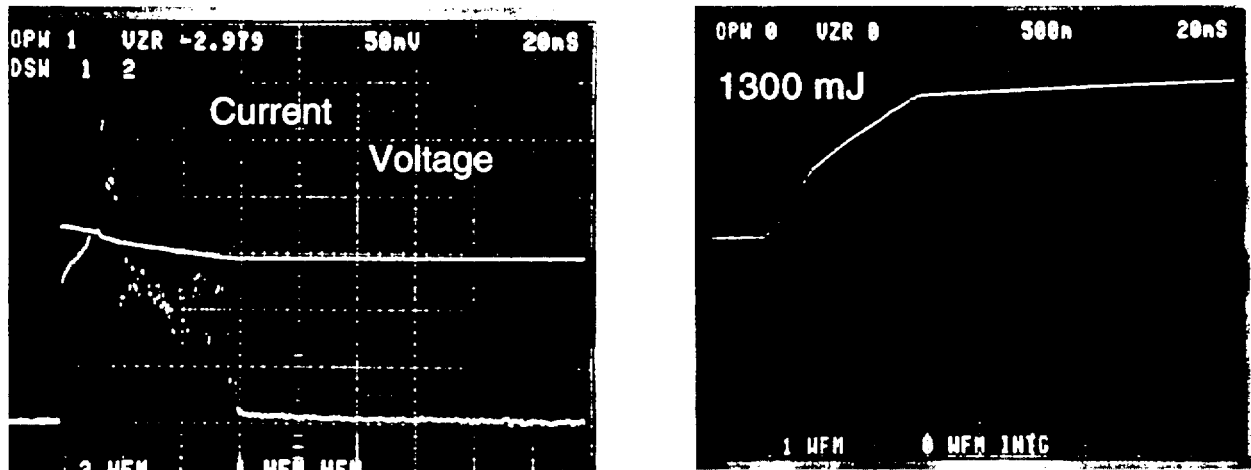
Figure 23. Event 9 (table 3) container heated to 30 C.
 Initial film resistance 2.2 kilohms, applied voltage = 170V.
 Five drops of lighter fluid, dwell period three minutes, arc ignited vapor.
 Arc current 300 mA peak for 60 milliseconds, ending voltage 145 volts.
 Arc energy = $5C(V_i - V_f)t = .5(290E-6)(170-145) = 1.142$ millijoules.
 Oscilloscope trace energy calculation = 1300 millijoules.

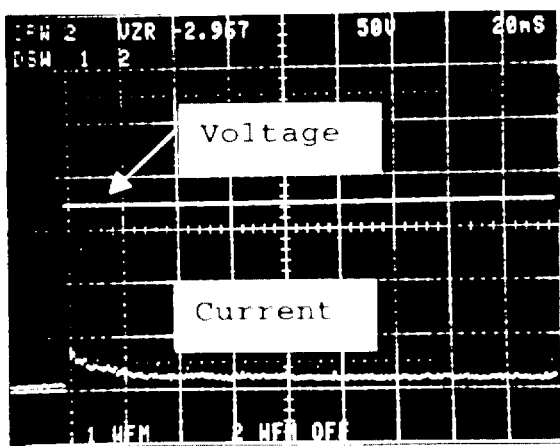
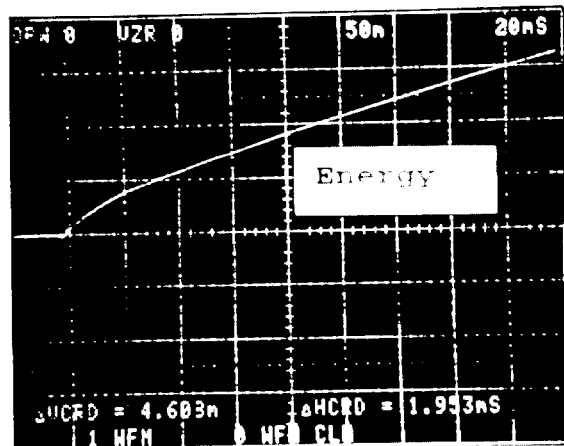
The next sets of tests were conducted on components from submitted fuel probes. Three insulated lug terminals were removed from the probes. The insulation on these terminals had a conductive black residue. Conductive silver paint stripes were applied to the residue to enhance the contact connection, and silver-plated copper wires were attached using conductive silver paint (figure 24). The initial resistance values of these films were between 725 and 3.8 kilohms. The films were tested in the same manner as the previous carbon films. There were no ignition events and the impressed energy was between 2.5 and 4.6 millijoules. Similar tests were also conducted on four terminal blocks with conductive residue. The resistance values of these films were between 0.72 and 3.1 kilohms. There were no ignition events and the impressed energy was between 1.1 and 4.2 millijoules. The results are given in table 4. A captured waveform is shown in figure 25. There were no electrical arcs captured on the videotape for events 10 through 16.

Figure 25. Event 12 from table 4, FG420A29S/N A110 was terminal residue. The peak current was 28mA over a two millisecond duration. The energy impressed across the film was 1.6 milljoules (mJ).

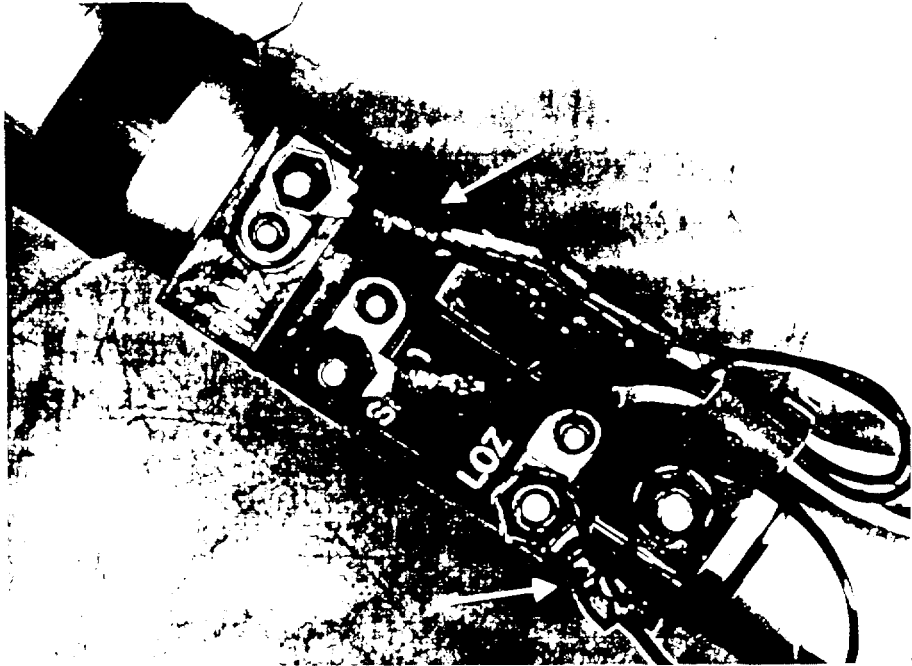
Figure 1 Fuel probe FG420A12 Z119. Note residues on the Hi-Z and Lo-Z wire terminals (arrows).
Mag: 1.1X

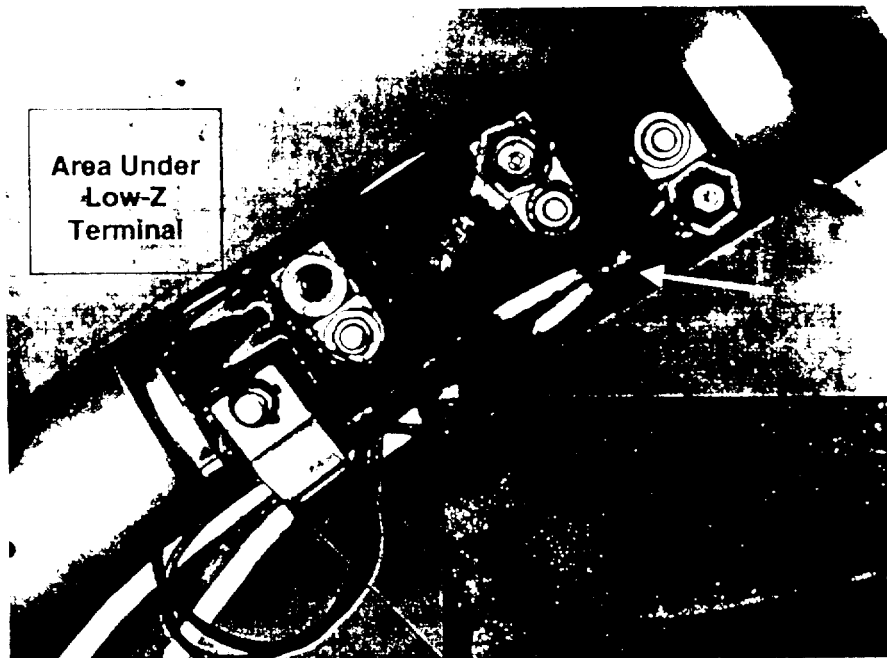
Fuel probe P/N FG420A18, S/N A-85 was selected for testing. Residues were noted on the terminal block under the Lo-Z terminal lug (main report, figure 2). The test procedure on residue films was used as before and the results are given in table 3. The residue film surface had no visible damage from the discharge events.

Figure 2 Fuel probe FG420A18, S/N A-85. Note residues on terminals (arrow) and on the terminal block (insert).
