NATIONAL TRANSPORTATION SAFETY BOARD
Office of Aviation Safety
Washington, D.C. 20594

SYSTEMS GROUP CHAIRMAN FACTUAL REPORT ADDENDUM
FOR DEPOSITS ON FUEL TANK ELECTRICAL COMPONENTS

A. ACCIDENT: DCA96MA070

Airplane : Boeing 747-131, N93119
Operated as Trans World Airlines (TWA) Flight 800

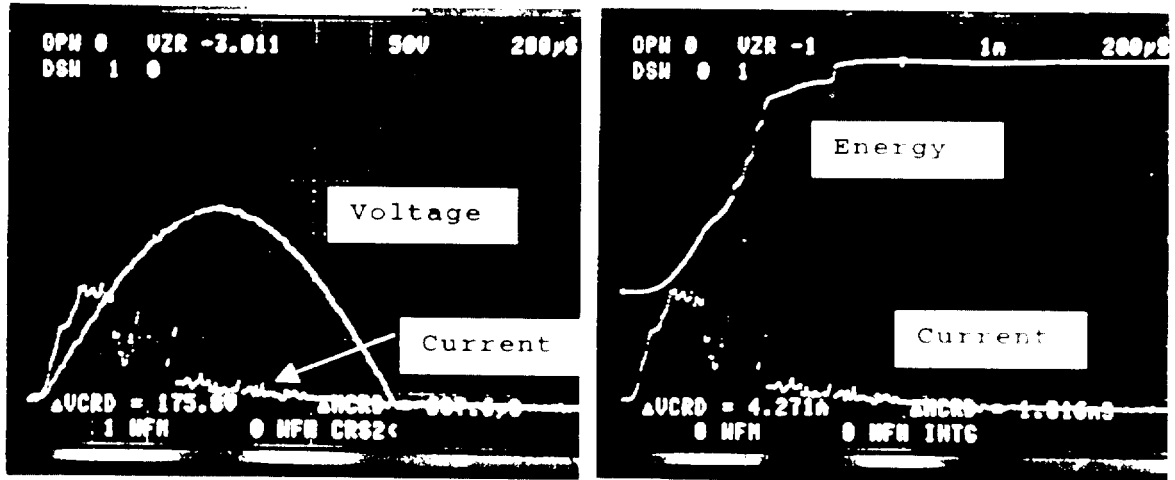
Test	Initial/Final Resistance (kilohms)	Peak Voltage/Voltage at Peak Current (volts)	Peak Current (mA)	Dynamic Resistance ² (kilohms)	Calculated Energy ³ (millijoules)	Comments
1	5.8/open ¹	175.8/160	24	17.6	0.43	Terminal block, under lug Breakdown (Figure 15)
2	3.3/open ¹	173.8/170	35	4.8	0.39	Terminal block, under lug Breakdown (Figure 16)
3	9.2/open ¹	174.3/160	13.5	11.8	0.63	Terminal block, under lug Breakdown (Figure 17)

Figure 15. Voltage breakdown on the FG420A18 A 85 terminal block underneath the Lo-Z terminal. Peak breakdown values (red arrows) were 160V and 24mA (left) and calculated energy was 0.43 mJ (right, conversion factor = 0.1X).

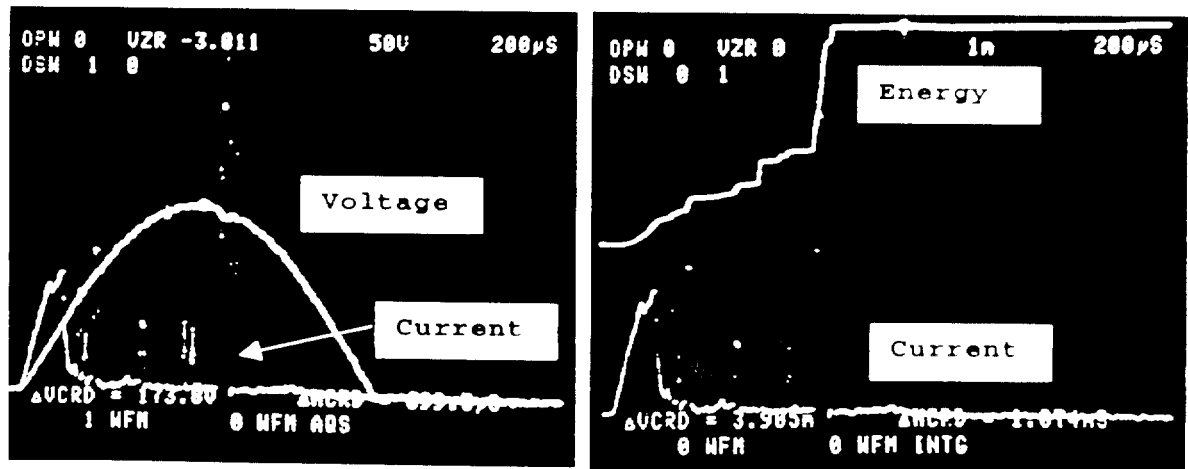
Figure 16. Voltage breakdown on the FG420A18 A 85 terminal block underneath the Lo-Z terminal. Peak breakdown values (red arrows) were 170V and 35mA (left) and calculated energy was 0.39 mJ (right, conversion factor = 0.1X).

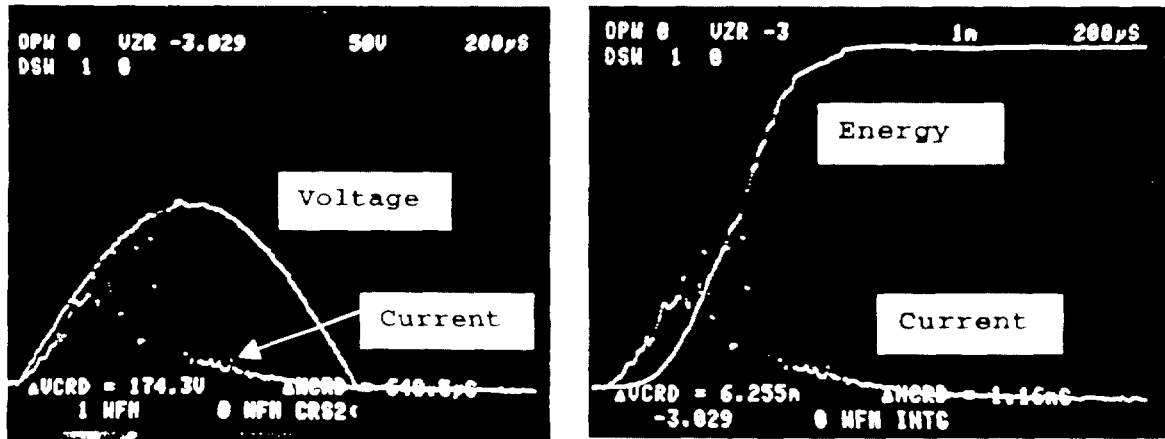
Figure 17. Voltage breakdown on the FG420A18 A 85 terminal block underneath the Lo Z terminal. Peak breakdown values (red arrows) were 160V and 13.5mA (left) and calculated energy was 0.63 mJ (right, conversion factor = 0.1X)

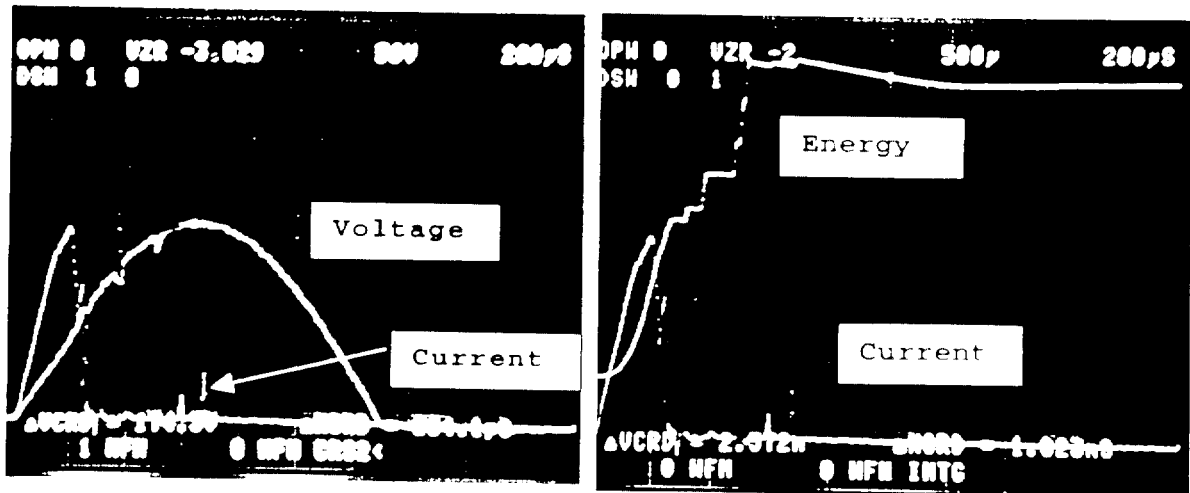
Figure 19 Voltage breakdown on the P/N FG420A23 S/N A-119 residue area under the Low-Z terminal lug on the terminal block. Peak breakdown values (red arrows) were 162V and 59.8mA (left) and calculated energy was 0.55 mJ (right, conversion factor 0.2X)

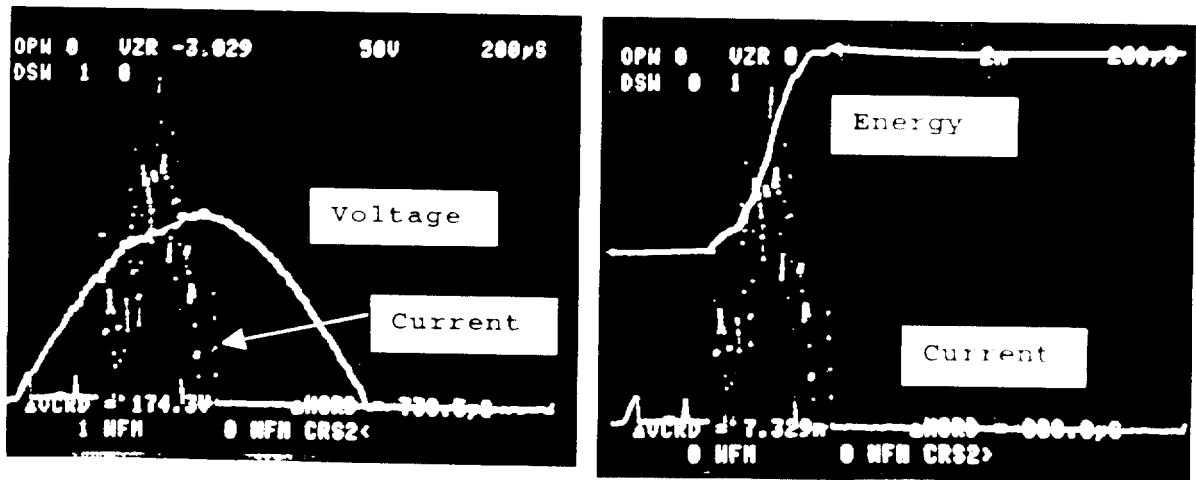
Figure 20 Voltage breakdown on the P/N FG420A23 S/N A-119 residue area under the Low-Z terminal lug on the terminal block. Peak breakdown values were 155V and 60mA (left) and calculated energy was 1.46 mJ (right, conversion factor 0.2X)

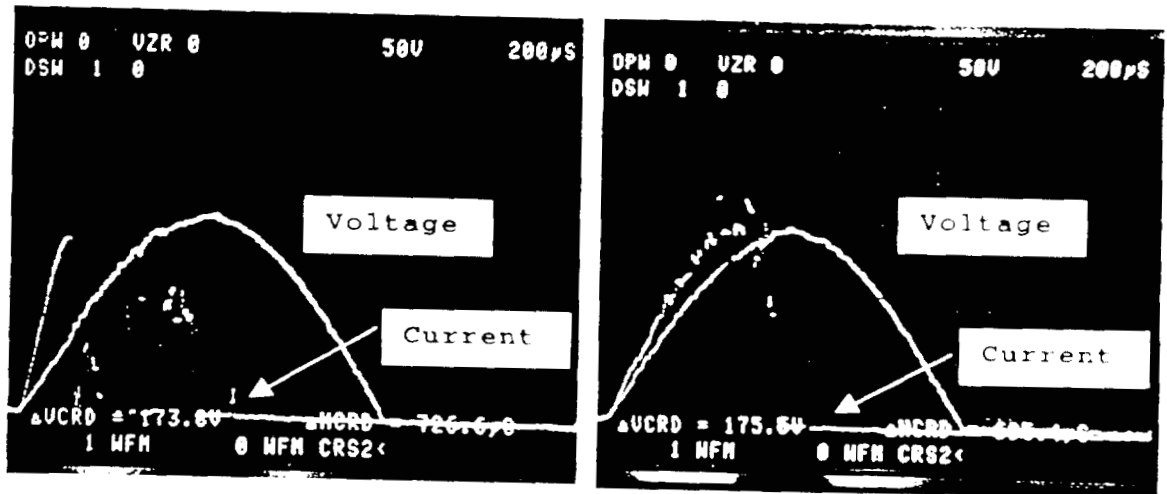
Figure 21. Voltage breakdown on fuel probe FG420A23 S/N A 119 residue area under the Low-Z terminal lug on the terminal block. Peak breakdown values for events were 60V and 30mA (left) and 145V and 42mA (right)

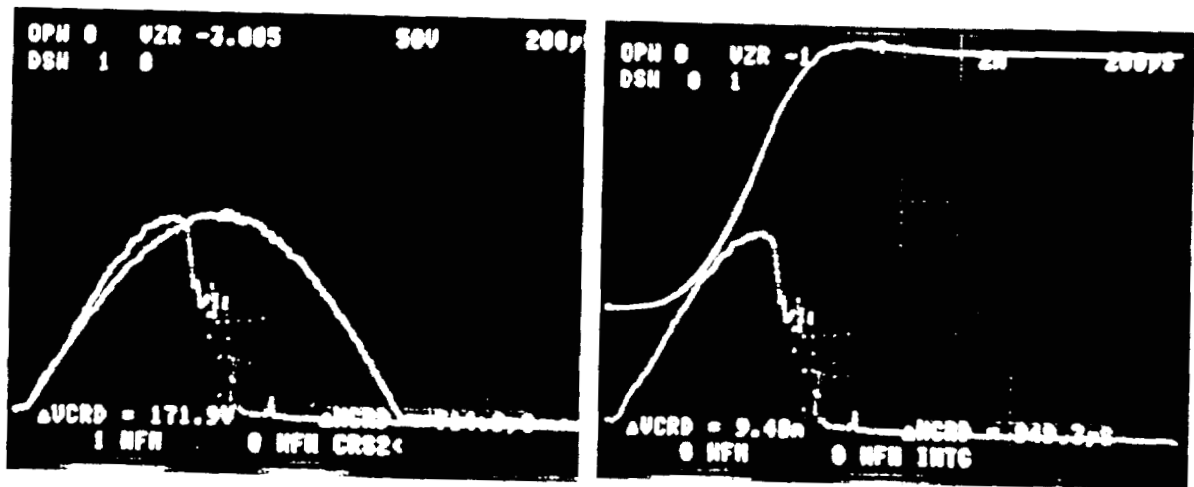
Figure 22. Voltage breakdown on the P/N FG420A23 S/N A 119 residue area under the Low-Z terminal lug on the terminal block. Peak breakdown values were 158V and 34mA (left) and calculated energy was 1.9 mJ (right, conversion factor = 0.2X)

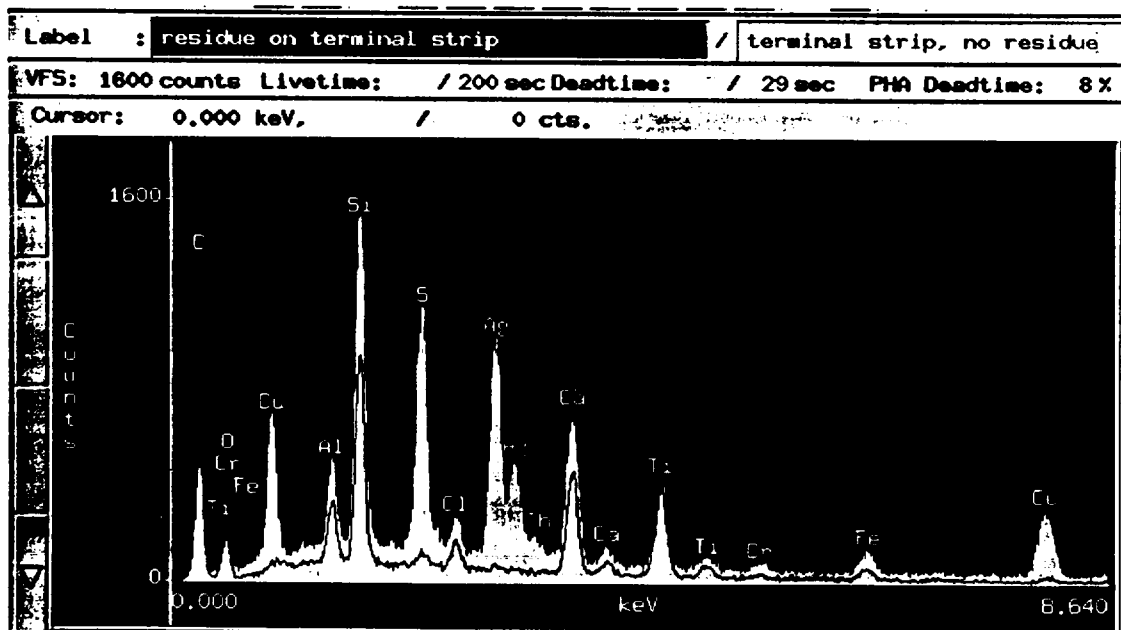
Figure 2. EDS spectra comparison between a nonresidue (red outline) and residue area (yellow area). Areas analyzed are shown in figure 8, main report. Note the absence of silver (Ag), copper (Cu), and sulfur (S) peaks in the nonresidue area.

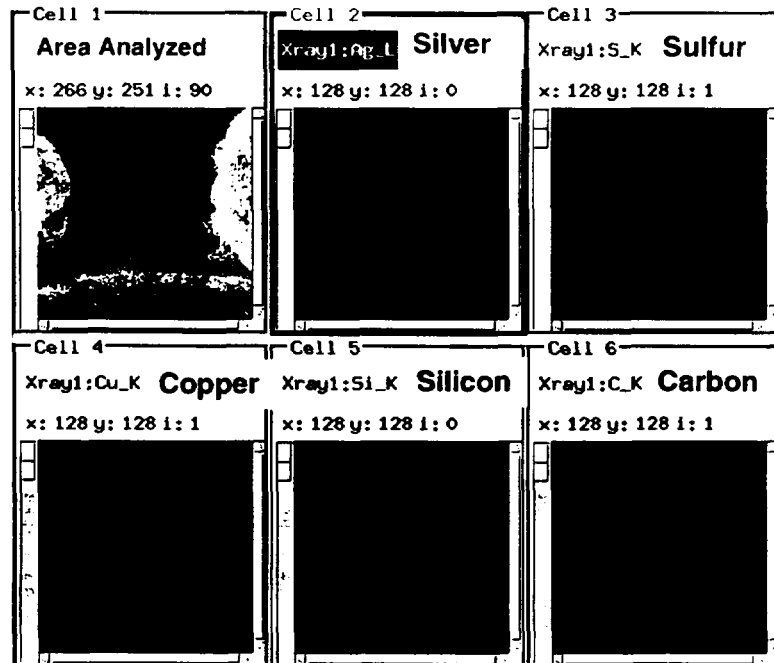
Figure 4. EDS map of a terminal strip with silver dots (see figure 18, main report). Note that silver is the primary element found in the silver dot area. Silver was also found between the silver dots but associated with copper and sulfur.

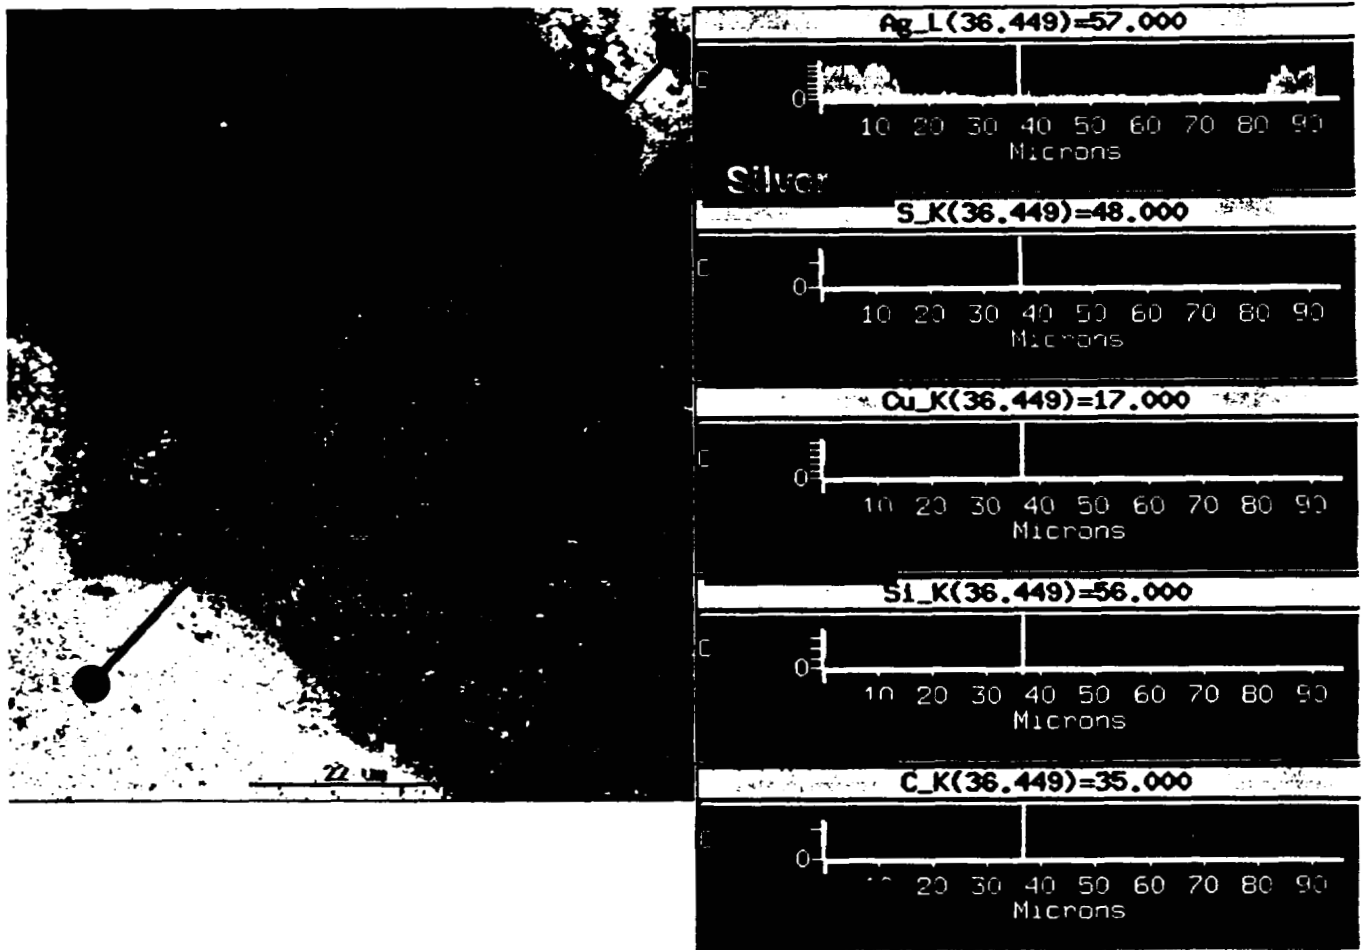
Figure 5. SEM micrograph and EDS line analysis of arc track site (see figure 13 in main report) between terminals 2 and 3 and points (silver dots) 1 and 4. The black reference line (left) was the line scanned (red line corresponds to the vertical white line in spectra).

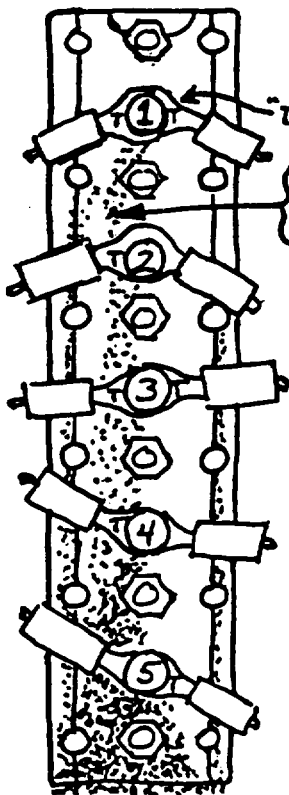
CRIMPED CONNECTORS ON THIS SIDE ARE STAINED AT TERMINAL & ON PLASTIC SLEEVES.

CRIMPED CONNECTORS & PLASTIC SLEEVES ARE CLEAN.

Dots indicate visible residue on surface of grey plastic.

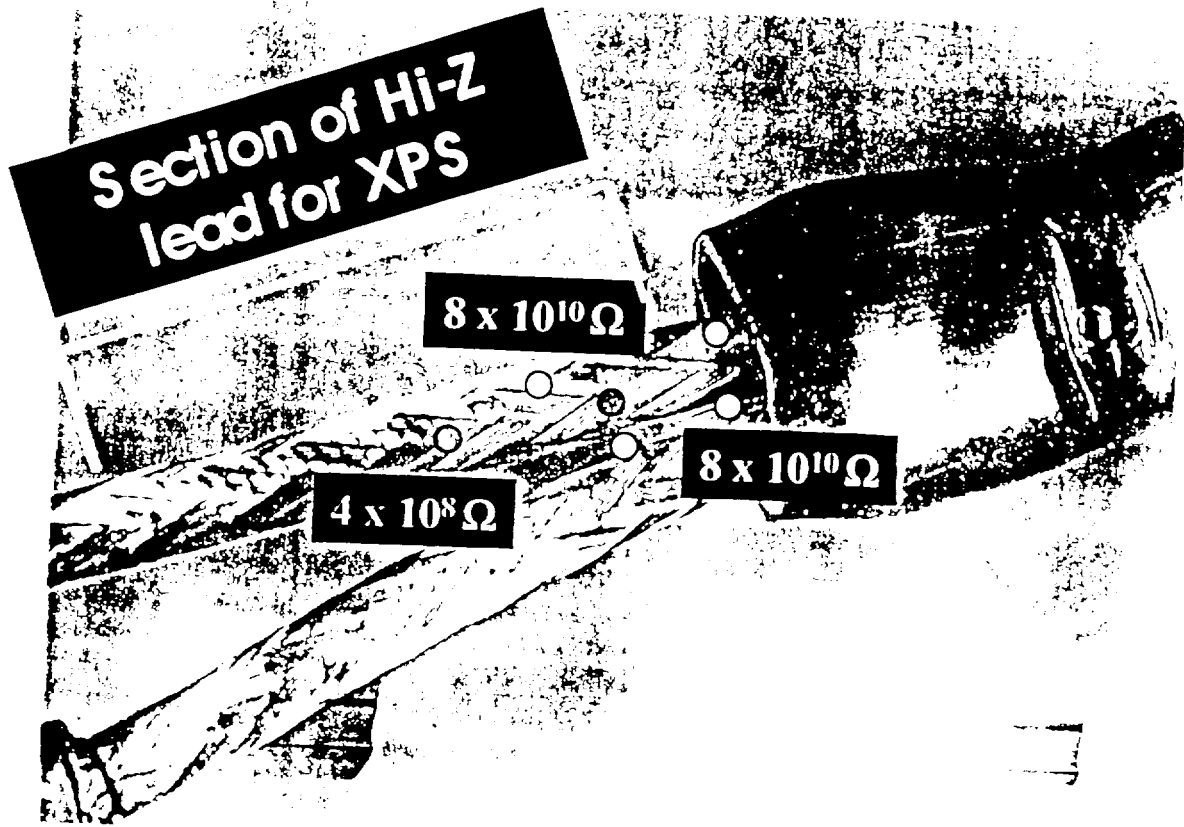
Evergreen Fuel Probe 420A14 SN Z-60
Measured surface resistance values and locations
HP 4339B High Resistance Meter
The section outlined in white was removed for XPS analysis
Figure 13

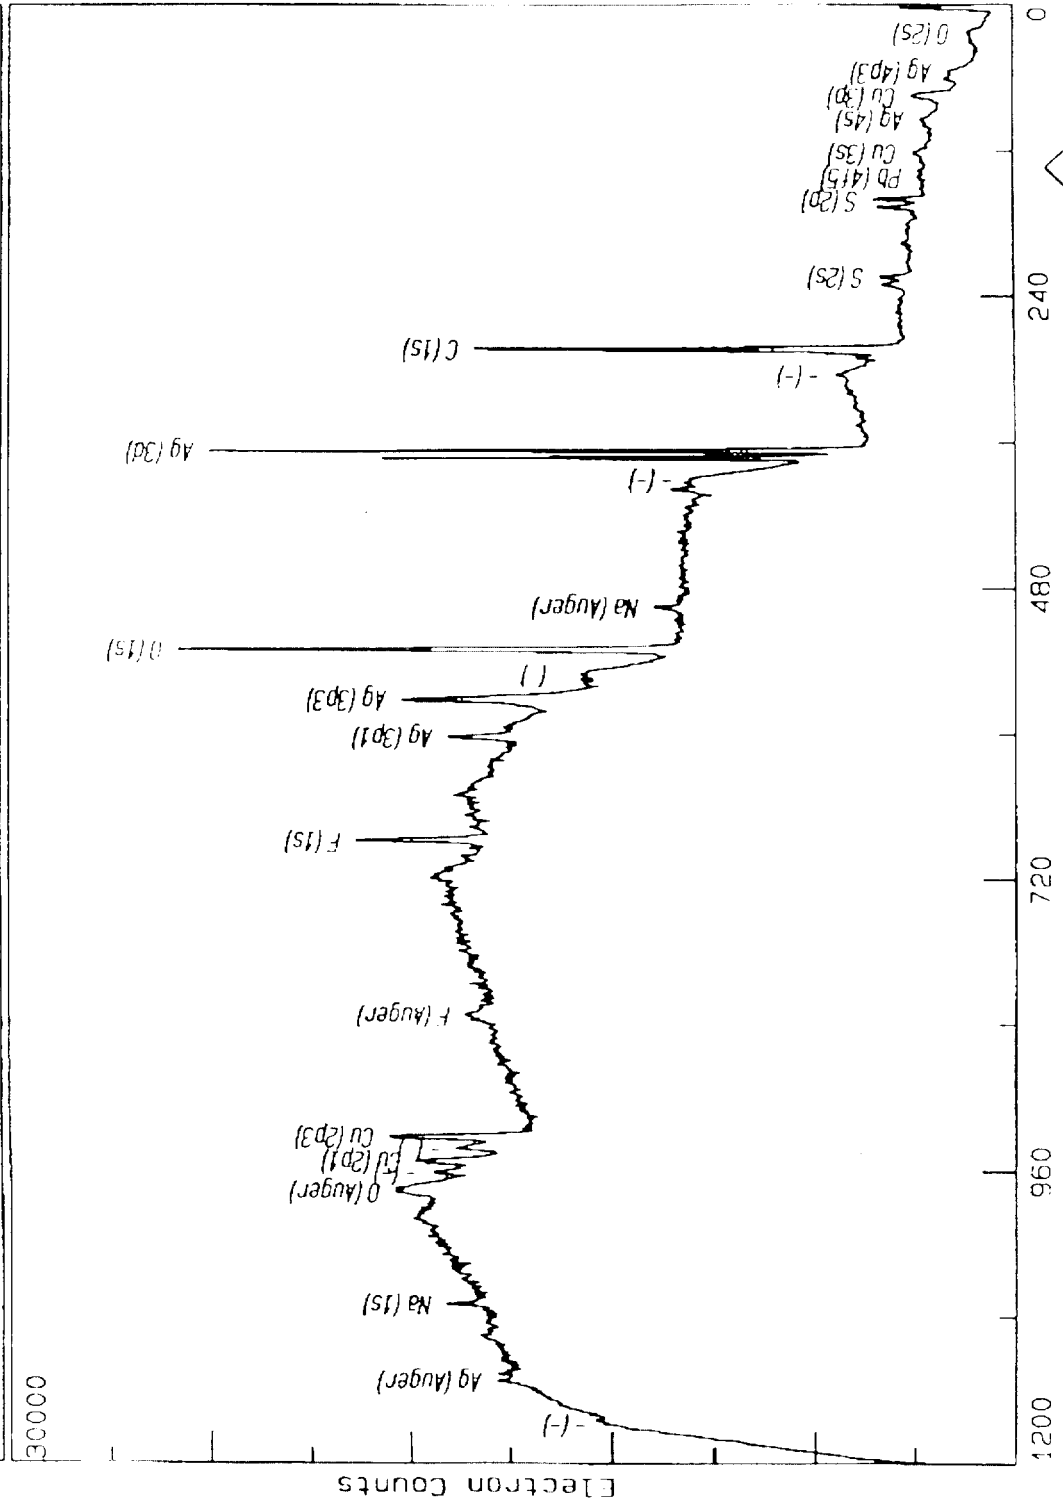
Figure 14

An XPS survey scan of the dark region is shown in Figure 14, with an expanded view of the 0 to 250 eV binding energy range in Figure 15. The calculated atomic concentrations for the elements detected are listed in Table 2. It can be seen that the dark region contains silver, copper, and sulfur with smaller concentrations of sodium, and lead. The fluorine is probably from the Teflon™ insulation on the wire.

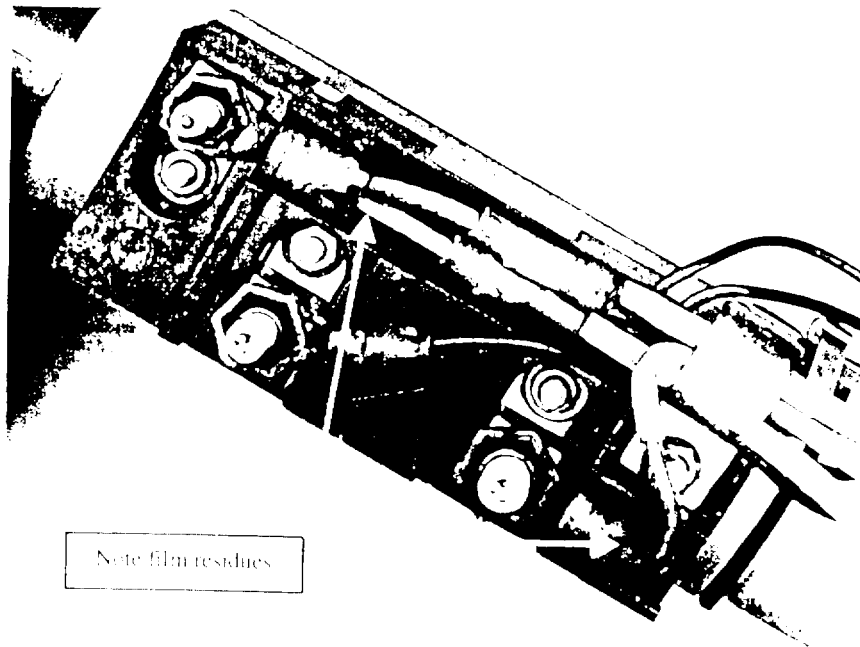
Figure 6. Typical as received condition of fuel probe terminal block from 747-200, number N1341W (FG420A24, Serial No. A 123).

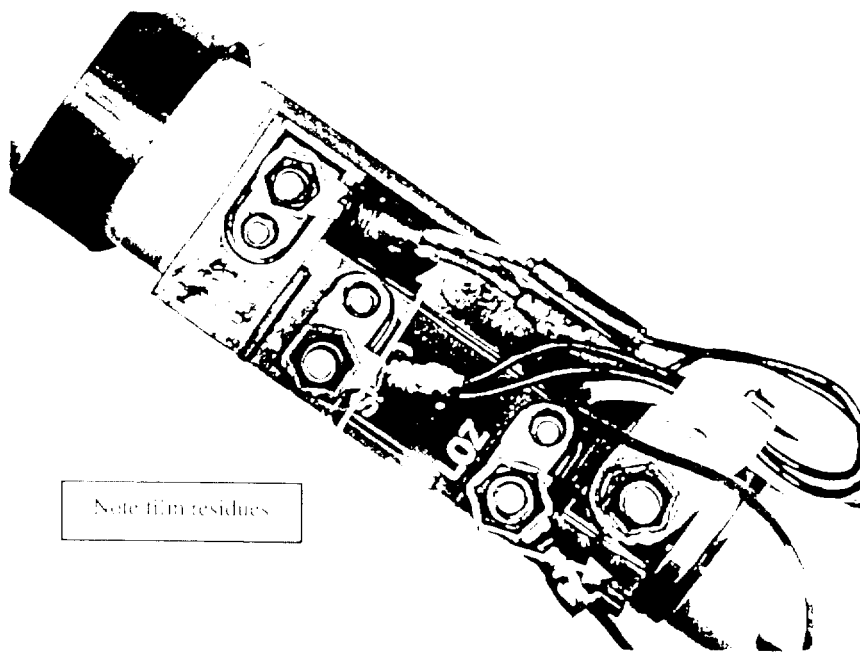
Figure 10. Typical as received condition of fuel probe terminal block from 747-256, number N1341W (FG420A12 Serial No. Z 119).

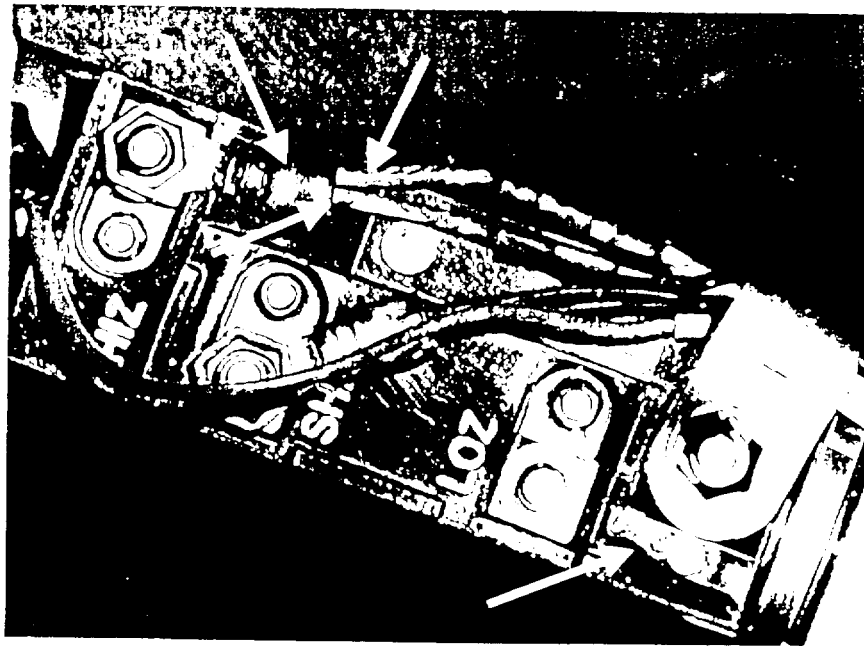
Figure 22. Fuel probe terminal block with Lo-Z (red) wire removed from terminal post. Copper/Silver/Sulphur rich film residues are visible adjacent to Lo-Z terminal and deposited on Hi-Z (white) wire insulation (model No. FG420A14 Serial No. Z-60 from aircraft N134TW).

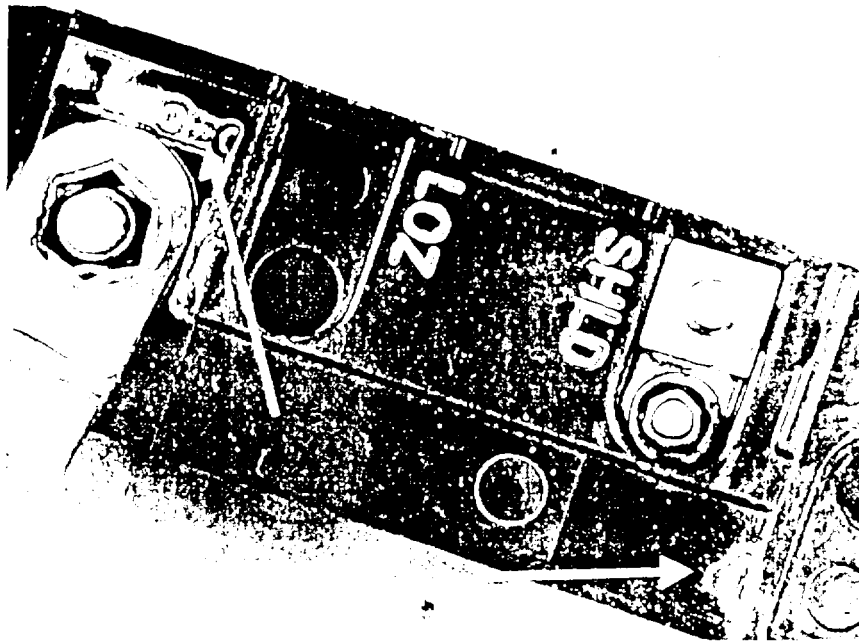
Figure 23. Fuel probe terminal block with FQIS wires removed. Copper/silver/sulphur rich film residues are present adjacent to Hi Z and Lo Z terminals (fuel probe - Model No. FG420A14 Serial No. Z-60 from aircraft N134TW)

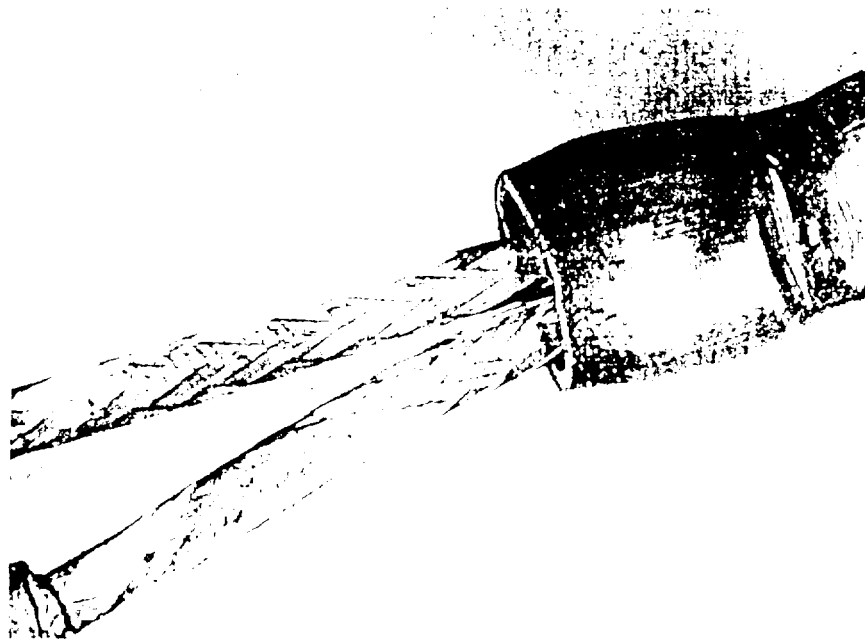
Figure 25. Closer view of copper/silver/sulfur rich film residue seen in figure 22 deposited on Hi Z wire (fuel probe: Model No. FG420A14 Serial No. Z 36) from aircraft N134TW).

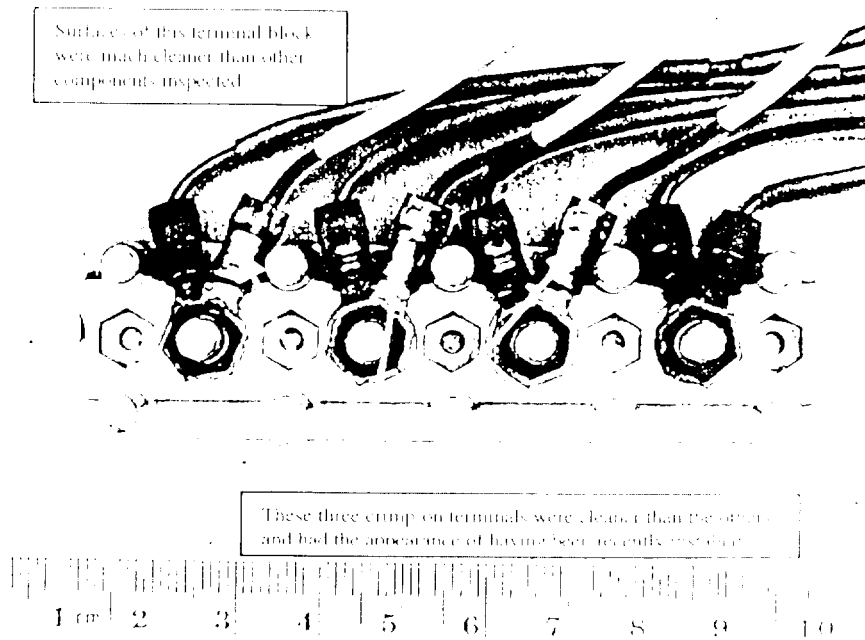
Figure 27. Closer view of an FQIS terminal block seen in figure 26. Clean surfaces and freshly terminated wires gave the appearance of a component having been recently installed (from 747-156, number N134TW).

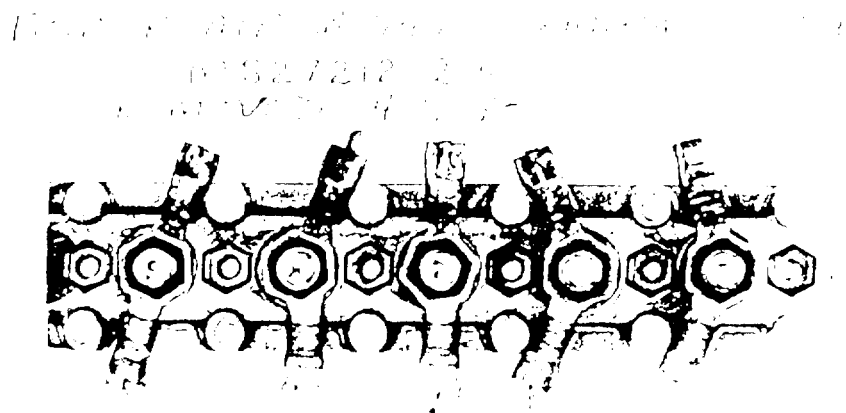
The submitted terminal strip exhibited low resistance values (10^4 ohm range) between terminals (appendix B, table 3). The terminal strip has five screw terminals to which ten wires are connected. The strip was initially received with the crimp-on terminals in place. The wires had been cut to remove the terminal strip without loosening the nuts on the terminal post. Terminal post combinations 2 to 3, 2 to 4, 2 to 5 and 3 to 5 had resistance values between 20.5 kilohm to 94 kilohm when measured at 3.5v using Hewlett Packard 4339B high resistance meter. Following terminal-to-terminal resistance measurements, the terminal strip was sent to an outside lab for a surface analysis method not available at AFRL. The crimp-on terminals were removed before time-of-flight secondary ion mass spectroscopy (TOF-SIMS) surface analysis. When the terminal strip was returned to MLSA, the terminal-to-terminal resistance measurements had increased to values between 120 kilohms and 9.5 megohms using a Hewlett Packard 4339B high resistance meter at 3 volts.

Figure 28. Boeing 747 CWT terminal strip with crimp on ring connector in place. Strip was removed by cutting FQIS wiring at ring connectors. Terminal posts are numbered one to five from right to left. Lower row of crimp on terminal and attached wire were clean and appeared to have been recently installed.

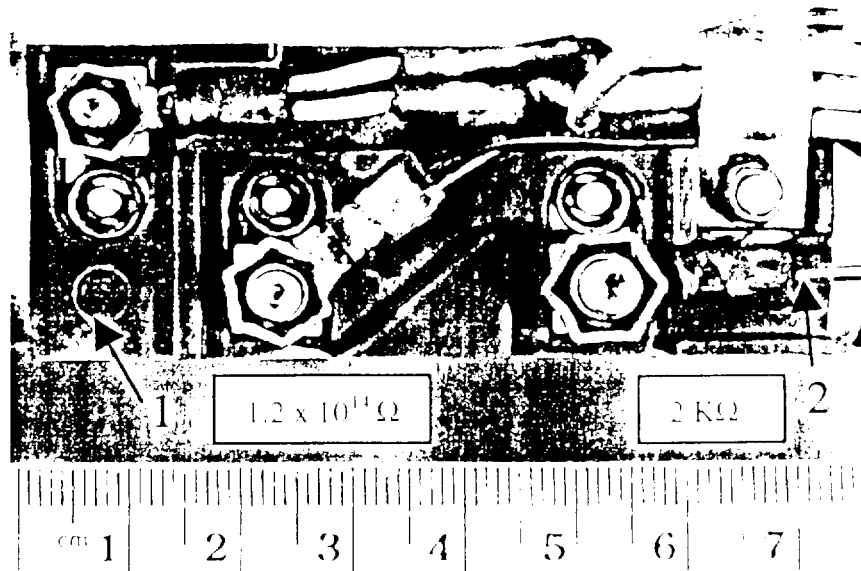
Figure 33. Fuel probe terminal block (Model No. FG420A20, Serial No. A 174). Point-to-point surface resistance measurements were taken at points 1 and 2 using fixture seen in figure 32 and HP 4329A high resistance meter with probes spaced at approximately 0.1 inch). Note the correlation between low resistance and the presence of film residue.

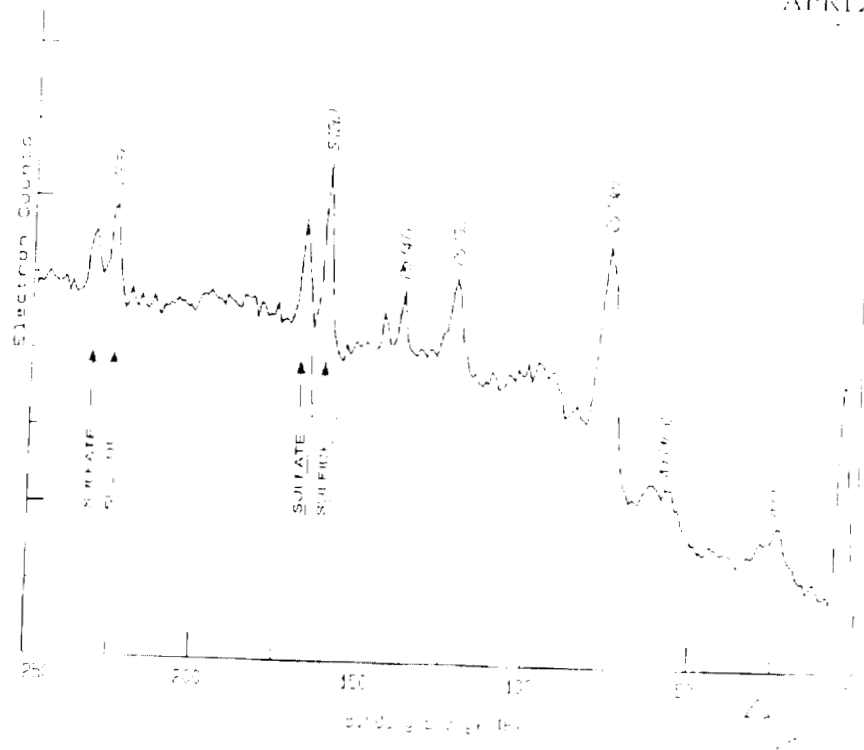
Surface analysis using X-ray Photoelectron Spectroscopy (XPF) and scanning electron microscope (SEM) Energy Dispersive Spectroscopy (EDS) identified copper, silver, and sulfur in residue regions (figures 35 through 39). Probes were segregated for follow-on voltage and energy breakdown tests based on residue build-up and surface resistance probing.

Figure 35. Photoelectron spectroscopy plot of film residue observed in region 1 (as seen in figure 34).

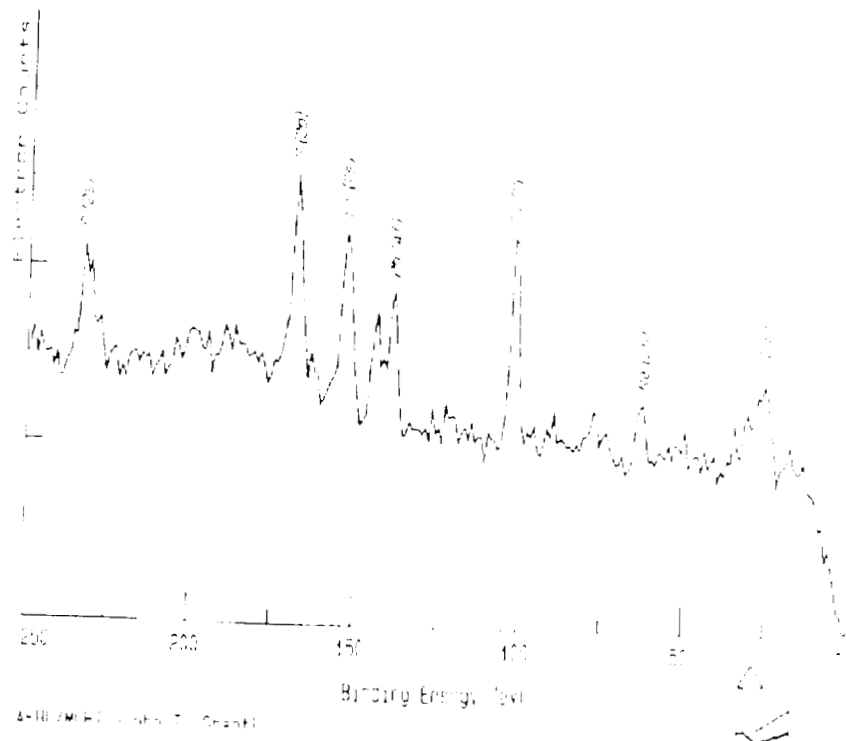
Figure 36. Photoelectron spectroscopy plot taken in region 2 (as seen in figure 34) where no evidence of film residue was observed.

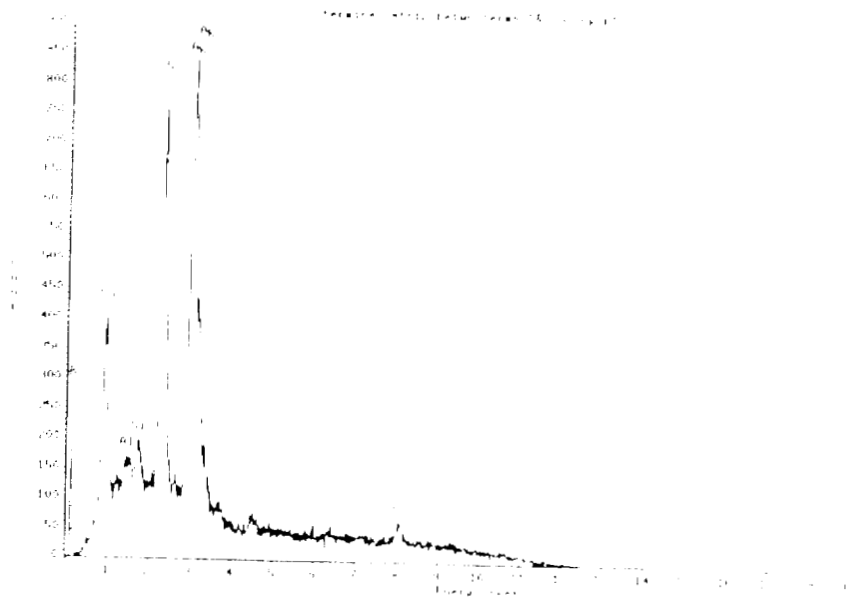
Figure 38. Energy dispersive spectroscopy analysis of surface chemistry in the circled area seen in figure 37. The terminal strip surface in the circled area was covered with a heavy black residue stain containing silver, copper and sulfur as indicated above.

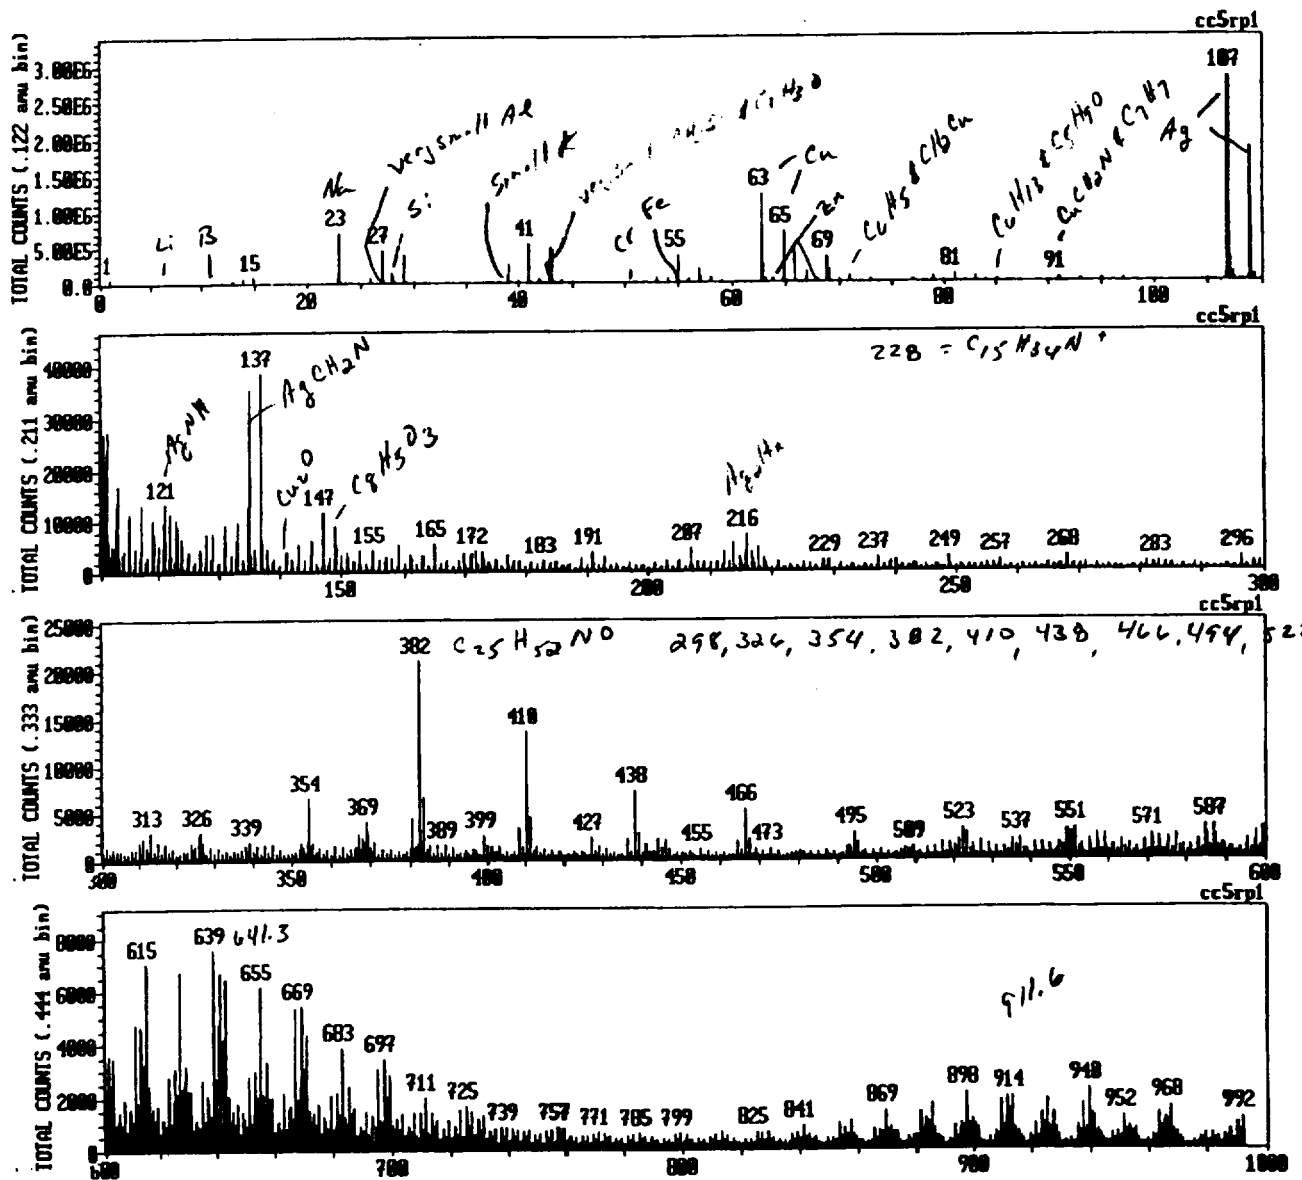
FIGURE 1

Figure	Item	Comments
1	+ spectrum	Dark area on the inside surface of plastic sleeve from crimp connector 5R
2	+ spectrum	Dark area on the terminal strip flange between 5L and 6L
3	+ spectrum	Dark area of post 5R
1	- spectrum	Dark area on the inside surface of plastic sleeve from crimp connector 5R
2	- spectrum	Dark area on the terminal strip flange between 5L and 6L
3	- spectrum	Dark area of post 5R

FILE NAME: cc5rpl DATE : 20 Apr 98 14:38 ACQUISITION TIME: 15.0 MIN. SPECTRUM INTEGRAL : 19204632
 Inside surface of plastic sleeve from crimp connect 5R; 15 kV bunched, cd0, ga3 aw4, pa8K dv1700, noes, cc10
 + IONS PRIMARY GUN: LNIG TIME RECORDER: Multi-Stop TDC X-Y SOURCE: Raster TIME PER CHANNEL: 138 ps
 DATA SET: 1 Spectra; 3 Image(s) RASTER SIZE: 121µm RASTER TYPE: 121

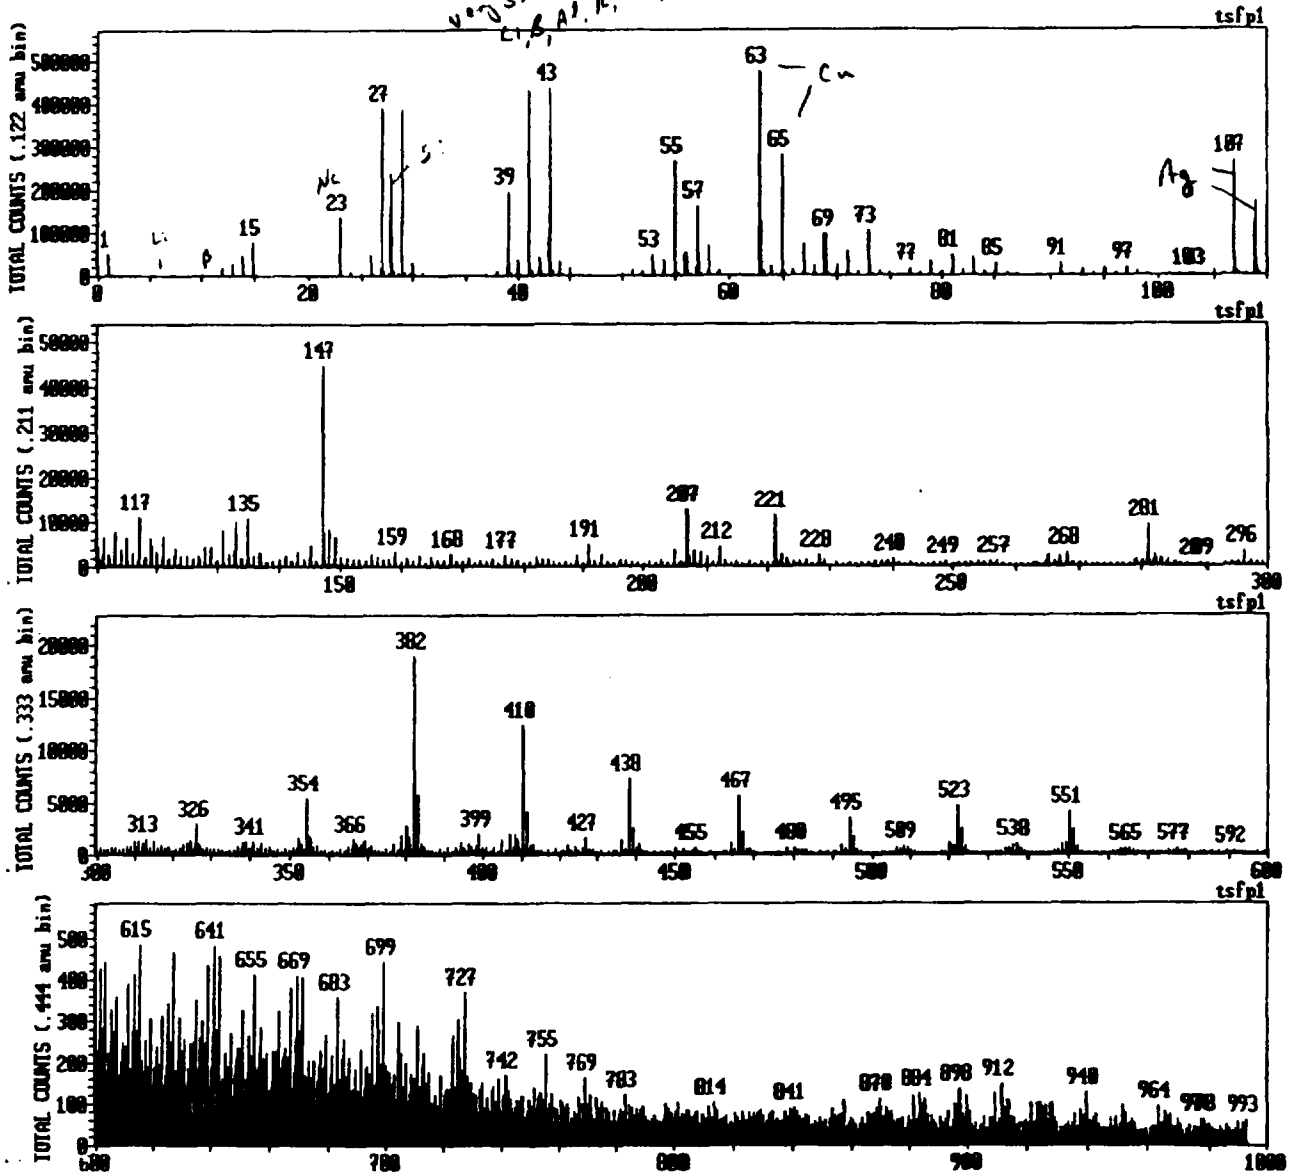
FIGURE 2

FILE NAME: tsfpl DATE: 20 Apr 98 14:15 ACQUISITION TIME: 15.0 MIN. SPECTRUM INTEGRAL: 7920953
 Terminal strip flange between 5L and 6L; 15 kV bunched, cd0, ga3 aw4, pa8K dv1700, noes, cc10
 + IONS PRIMARY GUN: LMIG TIME RECORDER: Multi-Stop TDC X-Y SOURCE: Raster TIME PER CHANNEL: 138 ps
 DATA SET: 1 Spectra; 3 Image(s) RASTER SIZE: 121µm RASTER TYPE: 121

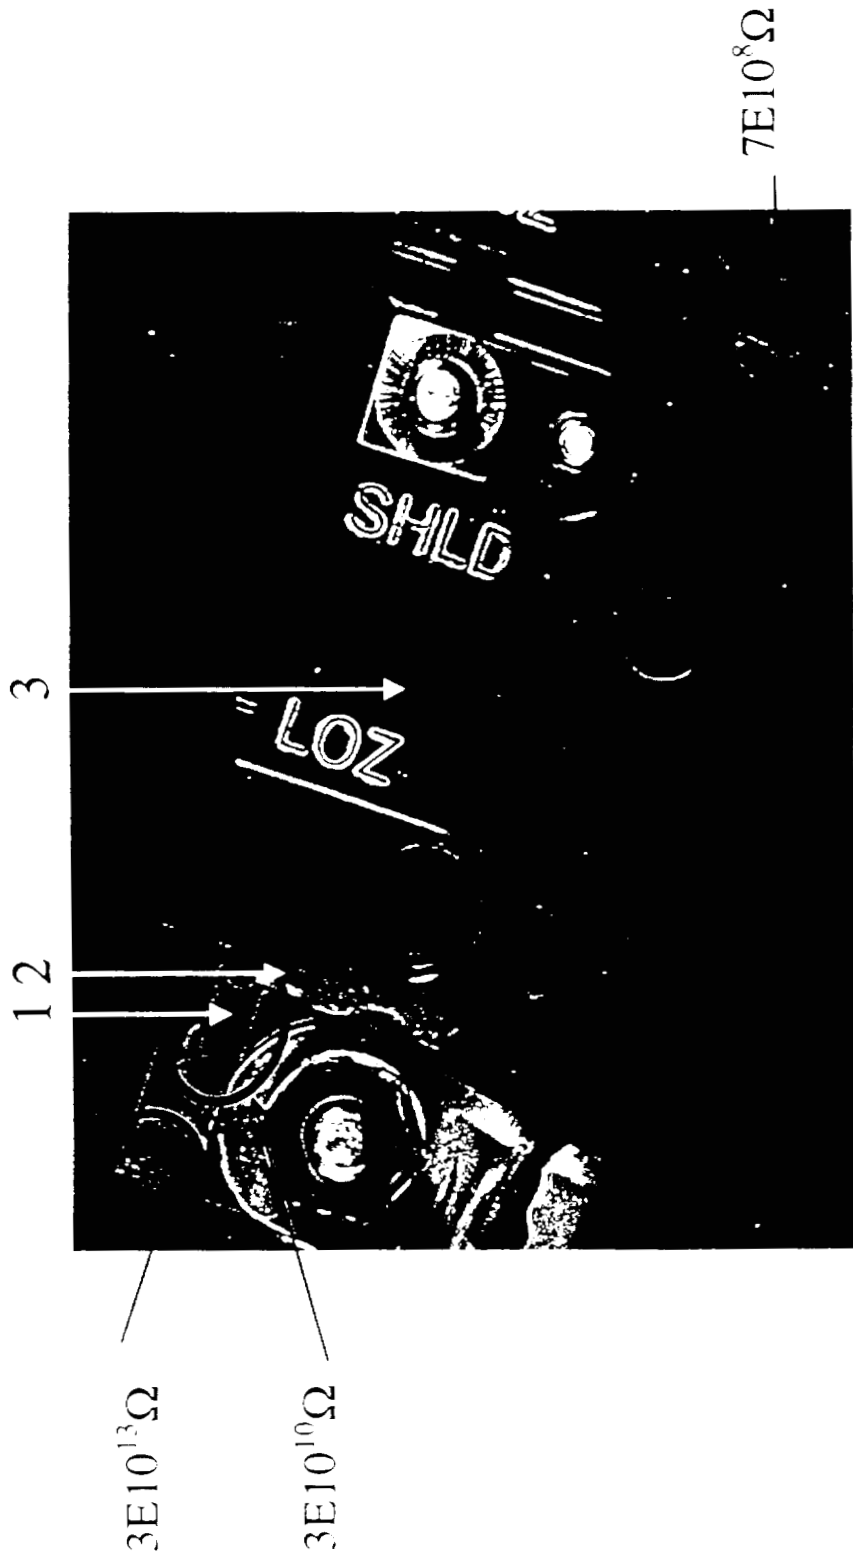
Figure 1

Evergreen Fuel Probe 420A14 SN Z-60
 Surface resistance measurements taken in circled areas
 XPS measurements were taken at points 1, 2, and 3

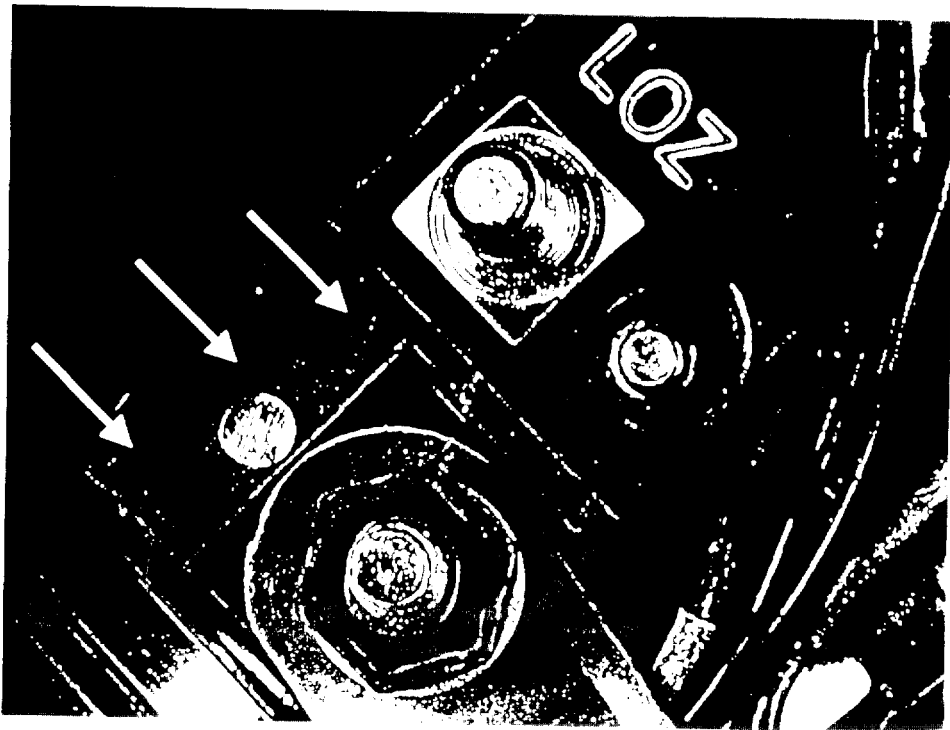
Figure 2. Close-up of fuel nozzle assembly noted near the Evergreen.
