NATIONAL TRANSPORTATION SAFETY BOARD
Office of Aviation Safety
Washington, D.C. 20594

SYSTEMS GROUP CHAIRMAN FACTUAL REPORT ADDENDUM
FOR DEPOSITS ON FUEL TANK ELECTRICAL COMPONENTS

A. ACCIDENT: DCA96MA070

Airplane : Boeing 747-131, N93119
Operated as Trans World Airlines (TWA) Flight 800

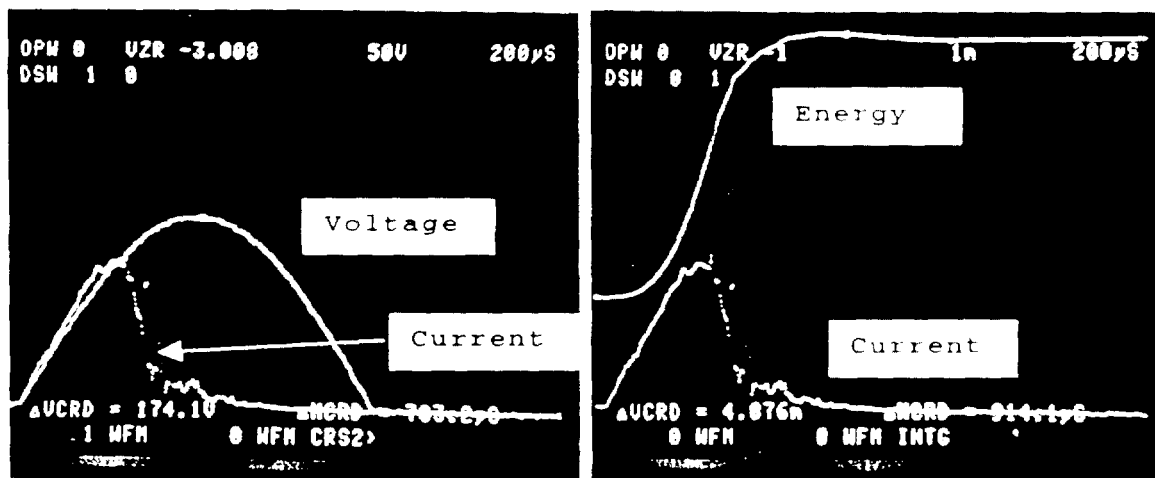
Figure 12. Voltage breakdown on terminal block under Low-Z insulated terminal lug from fuel probe 93117 F40 S/N Z-116. Peak breakdown values (red arrow) were 135V and 13.5mA (left) and calculated energy was 0.49 mJ (right, conversion factor = 0.1X).

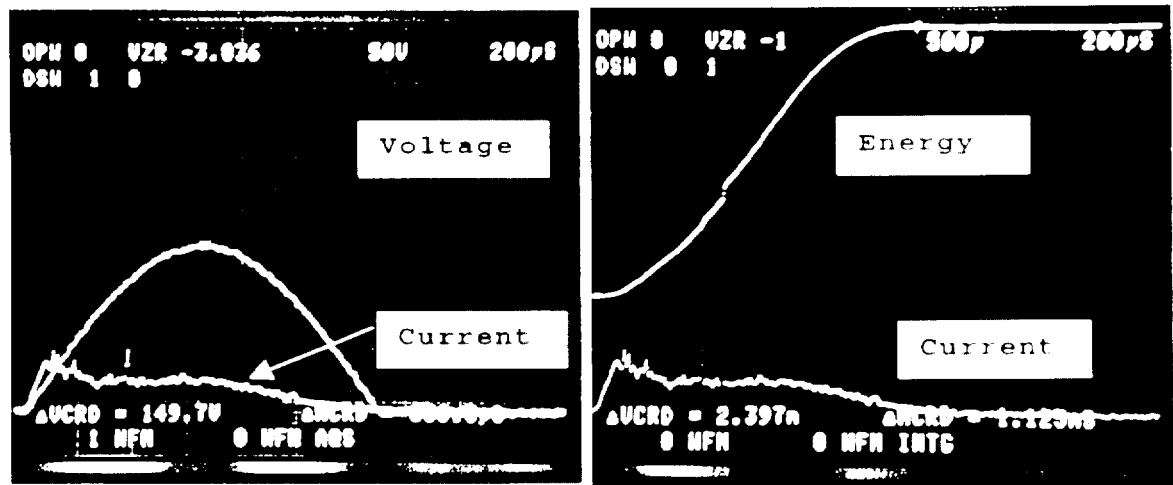
Figure 7. Voltage breakdown on Low-Z insulated terminal lug from fuel probe P/N FG420A23, S/N A 119. Peak breakdown values (red arrow) were at 140V and 5.2mA (left) and calculated energy was 0.24mJ (right, conversion factor = 0.1X).

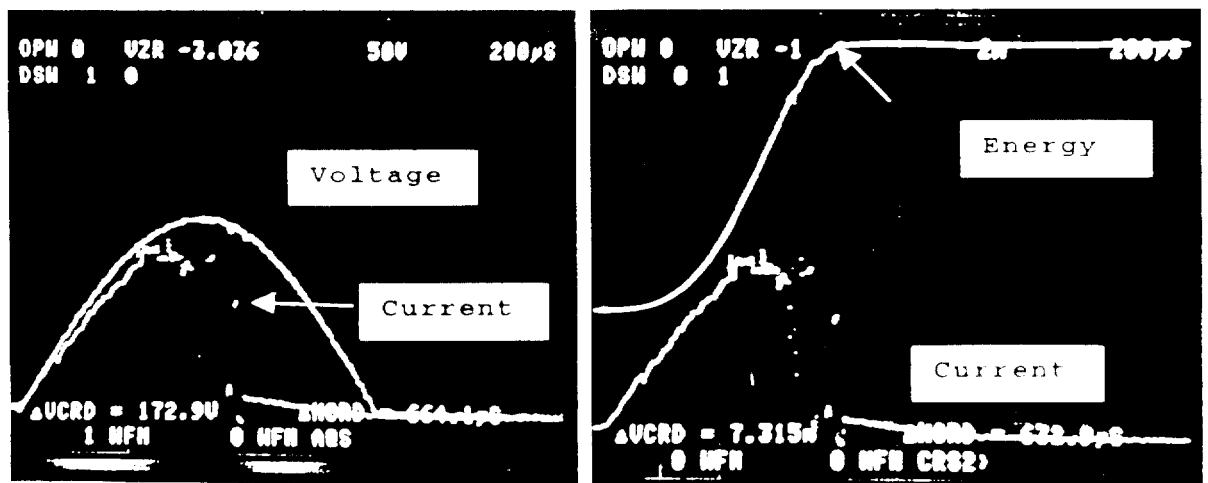
Figure 8. Voltage breakdown on Low-Z insulated terminal lug from fuel probe P/N FG420A23, S/N A 119. Peak breakdown values (red arrow) were 172.9V and 17 mA (left) and calculated energy was 1.1mJ (right, conversion factor = 0.1X).

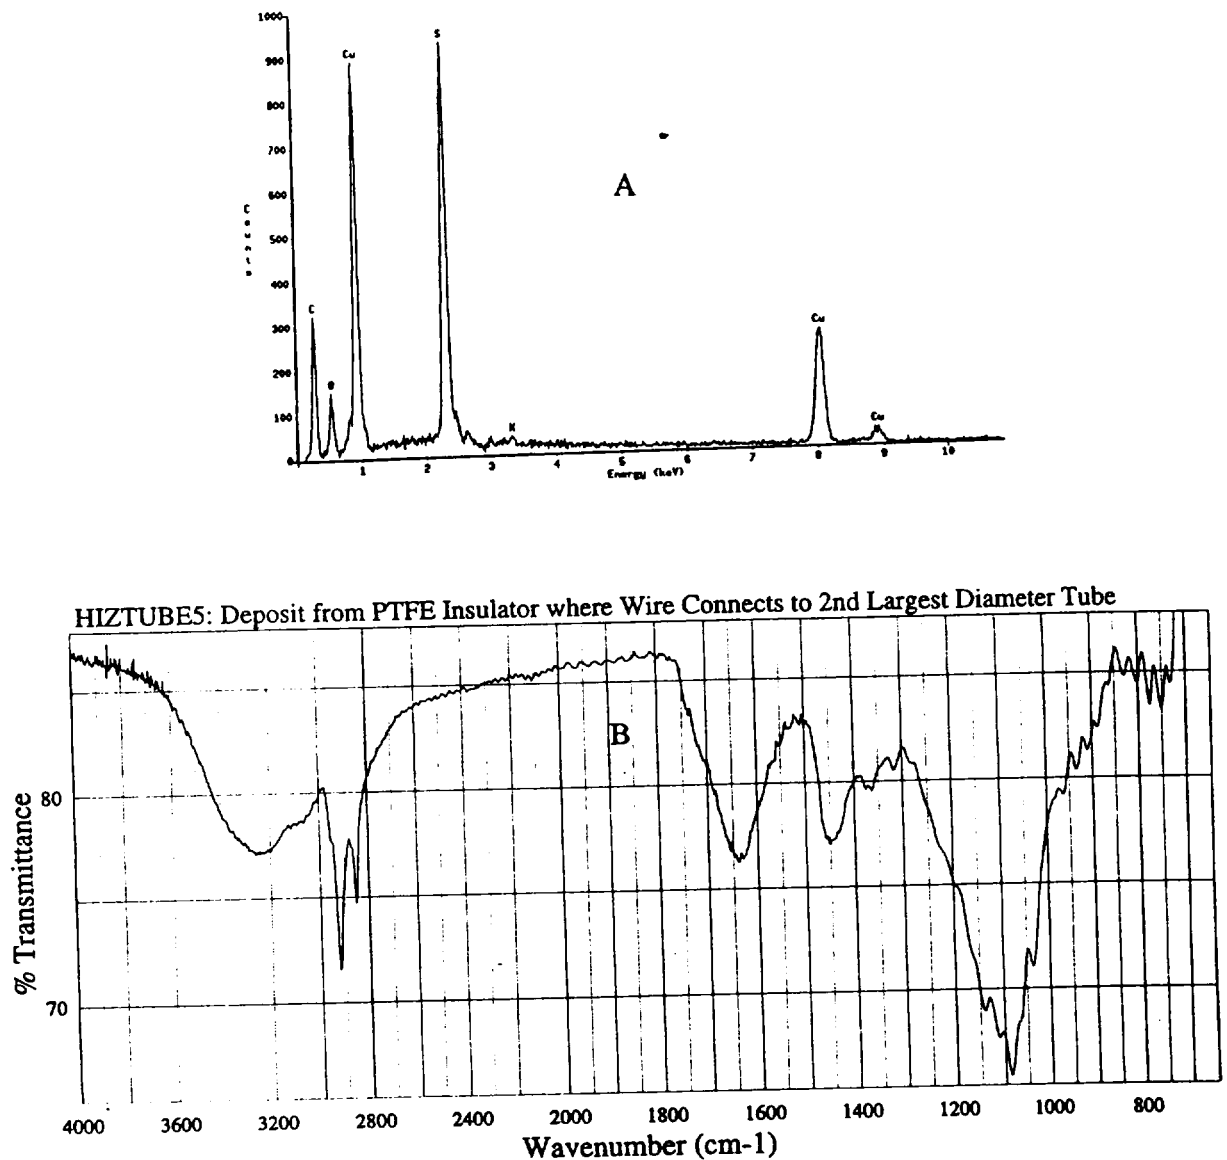
Figure 9. (A) An electron microprobe elemental survey and (B) infrared spectrum of the gray deposits shown in Figure 8. The electron microprobe survey represents deposit from the sleeve on the Hi-Z crimp terminal, while the infrared spectrum corresponds to a sampling from the PTFE insulator for the Hi-Z connection.
