APPENDIX A

APPENDIX ASummary of the N17105 Equipment Study

APPENDIX B

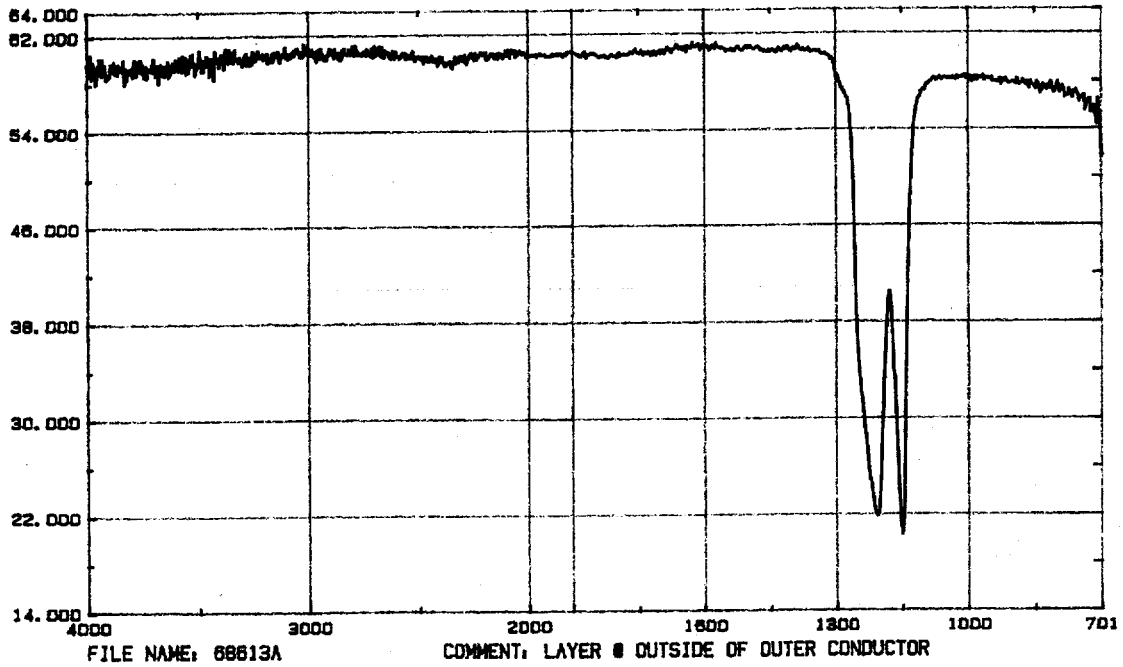
Spectrum 1. FTIR spectrum of insulation layer on the outside of the outer conductor in a coaxial wire. The spectrum matches reference spectra for polytetrafluoroethylene (PTFE) material.

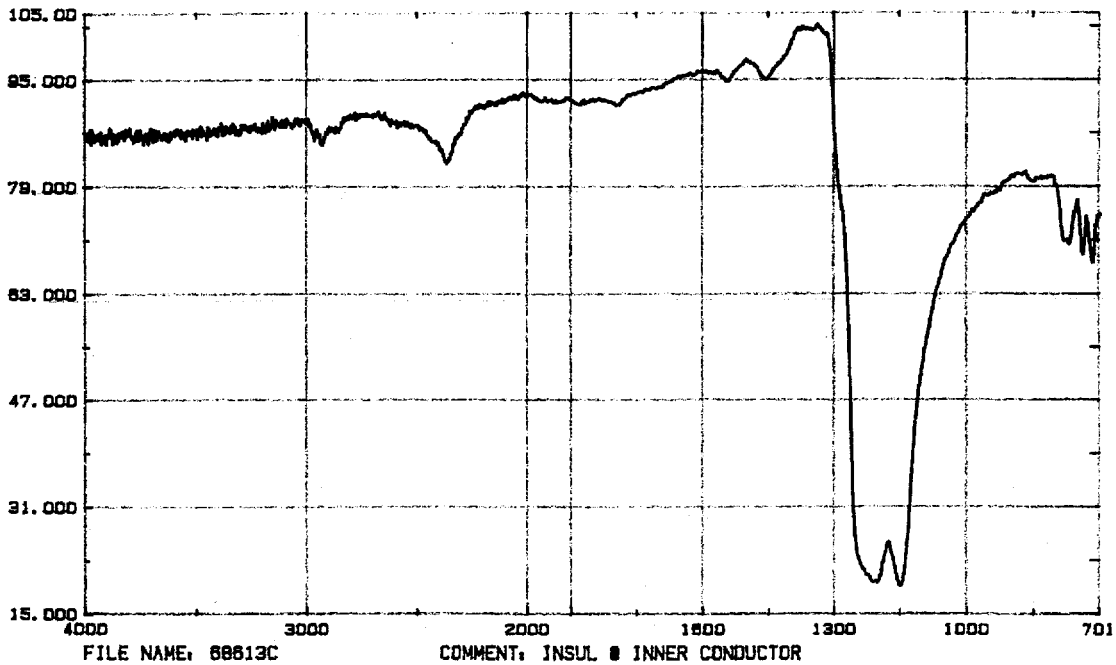
Spectrum 2. FTIR spectrum of insulation layer surrounding the inner conductor of the coaxial wire. The spectrum matches reference spectra for polytetrafluoroethylene (PTFE) material.

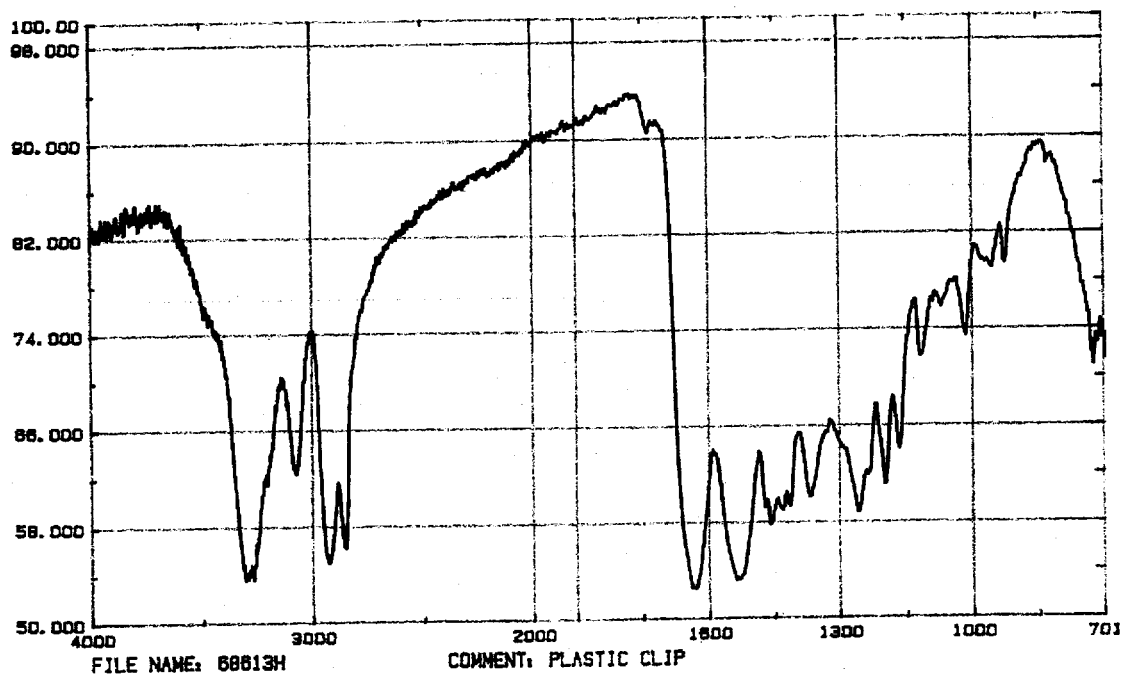
Spectrum 3. FTIR spectrum of the plastic tie down. The spectrum matches reference spectra for polyamide materials.

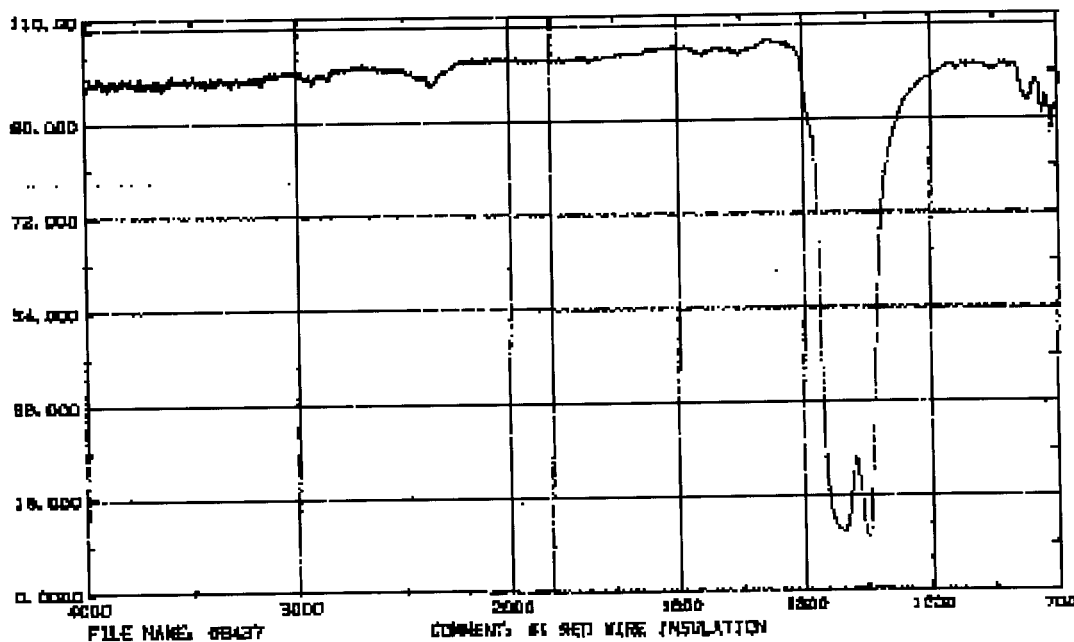
Spectrum 1. FTIR spectrum for the red-colored insulation material. The spectrum matches reference spectra for polytetrafluoroethylene (PTFE) material.

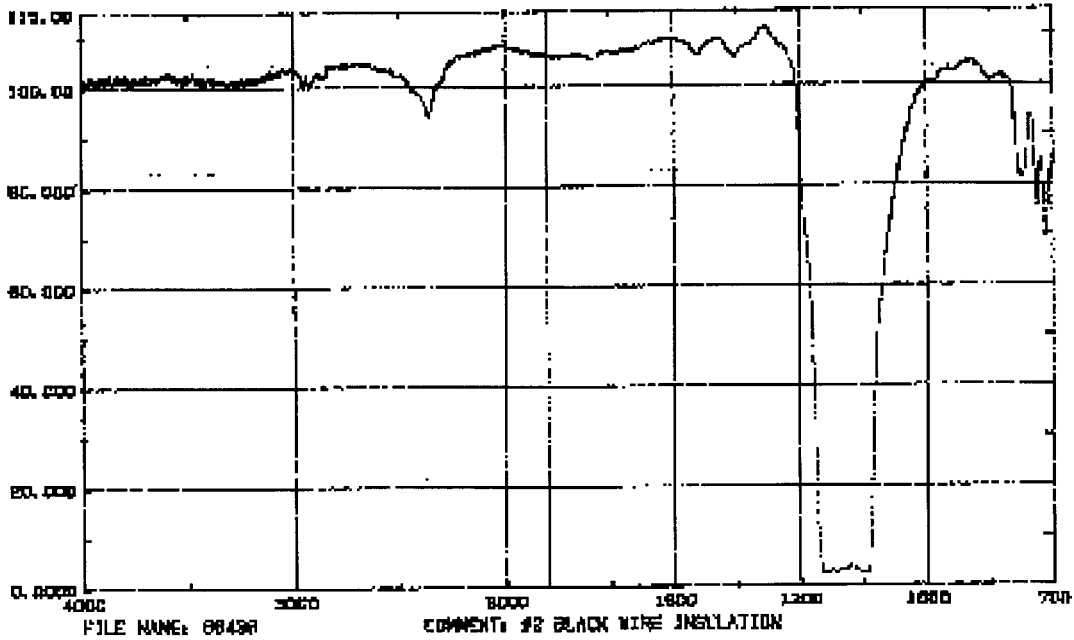
Spectrum 2. FTIR spectrum for the black-colored insulation material. The spectrum matches reference spectra for polytetrafluoroethylene (PTFE) material.

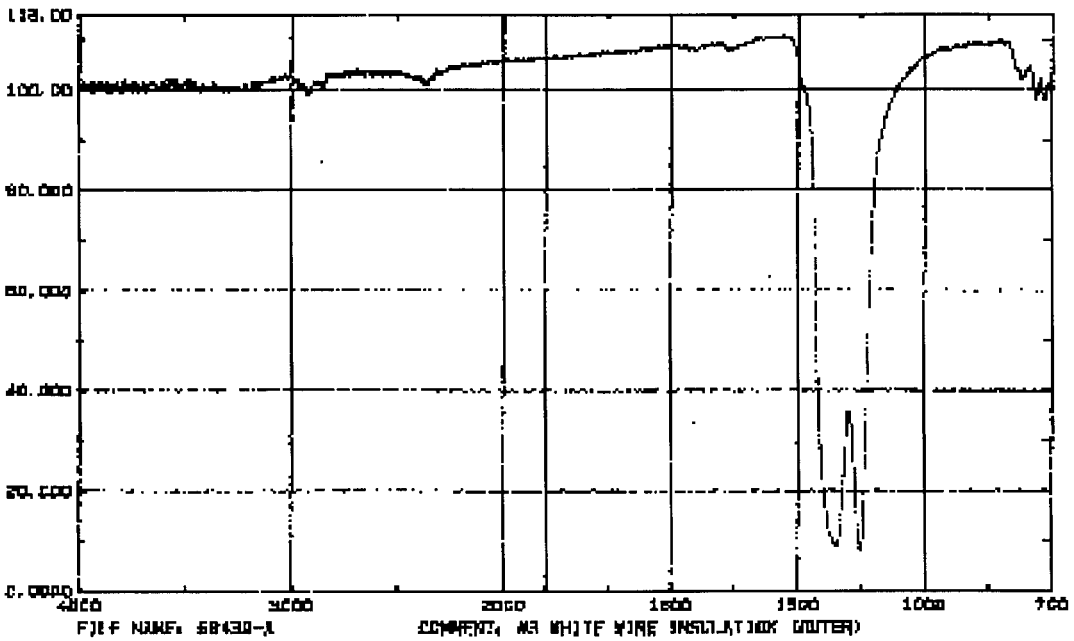
Spectrum 3. FTIR spectrum for the outer film of the white-colored insulation material. The spectrum matches reference spectra for polytetrafluoroethylene (PTFE) material.

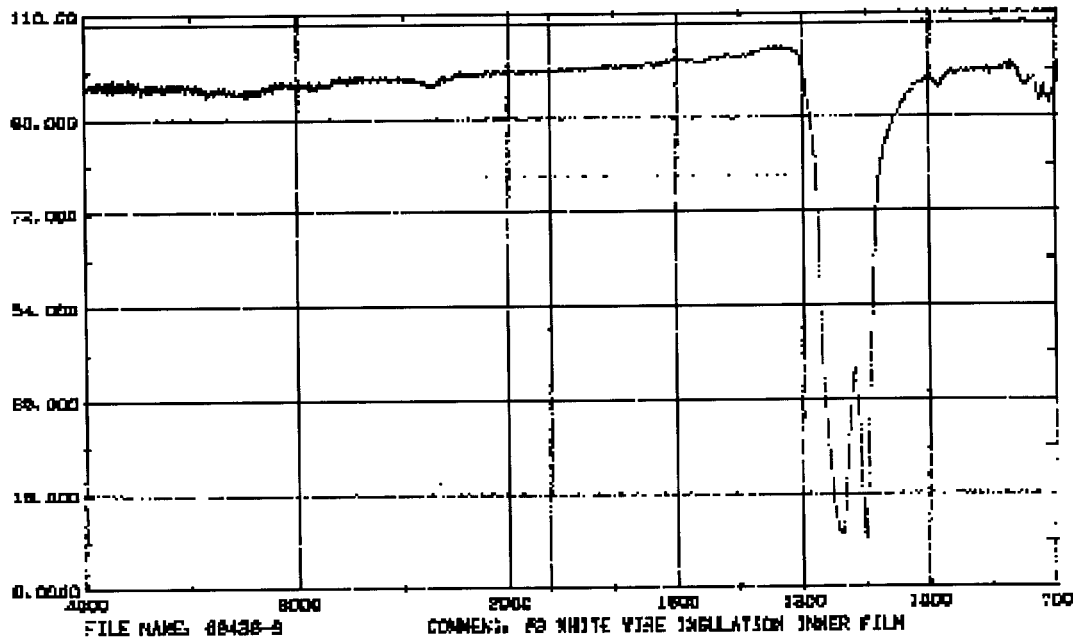
Spectrum 4. FTIR spectrum for the inner film of the white-colored insulation material. The spectrum matches reference spectra for polytetrafluoroethylene (PTFE) material.

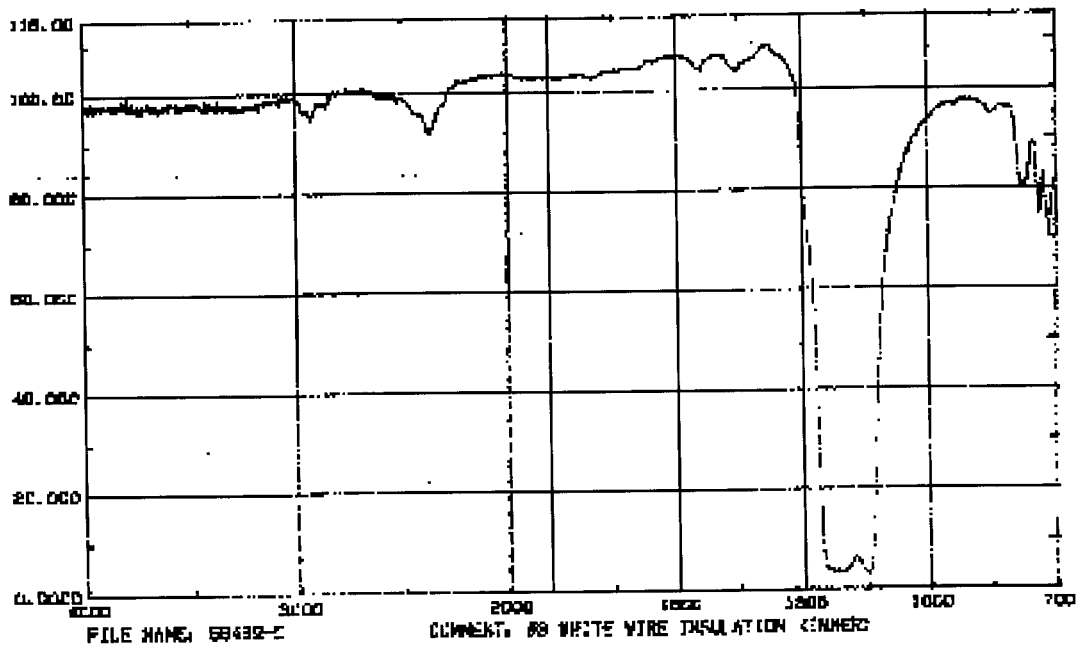
Spectrum 5. FTIR spectrum for another inner film of the white-colored insulation material. The spectrum matches reference spectra for polytetrafluoroethylene (PTFE) material.

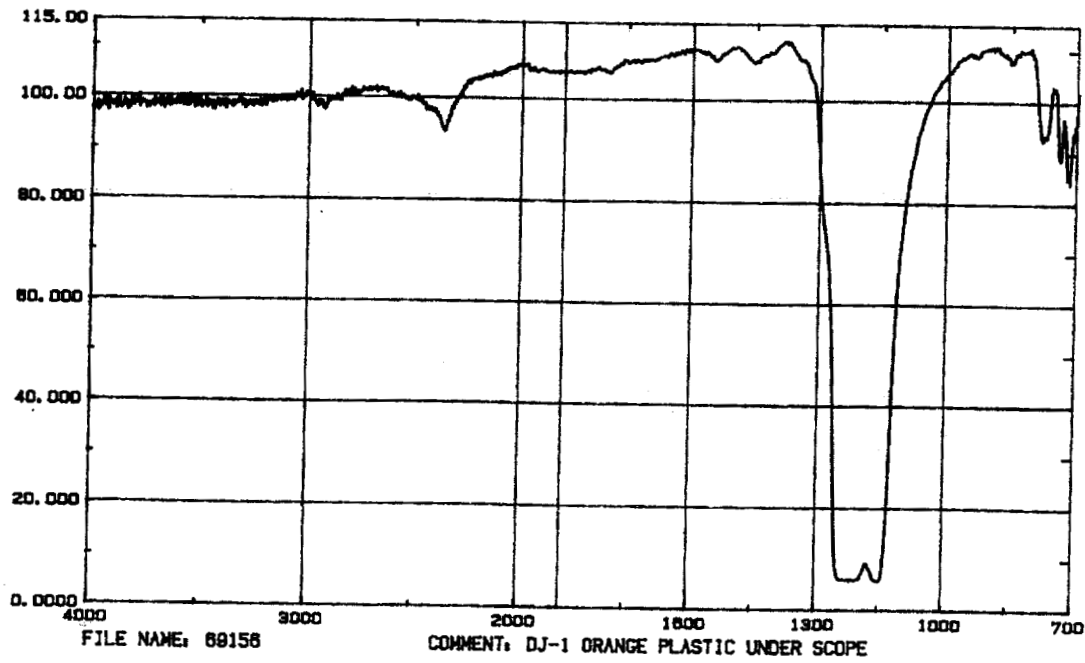
Spectrum 1. FTIR spectrum for orange-colored spacer used between the inner and outer electrode. The spectrum matches reference spectra for polytetrafluoroethylene (PTFE, Teflon).

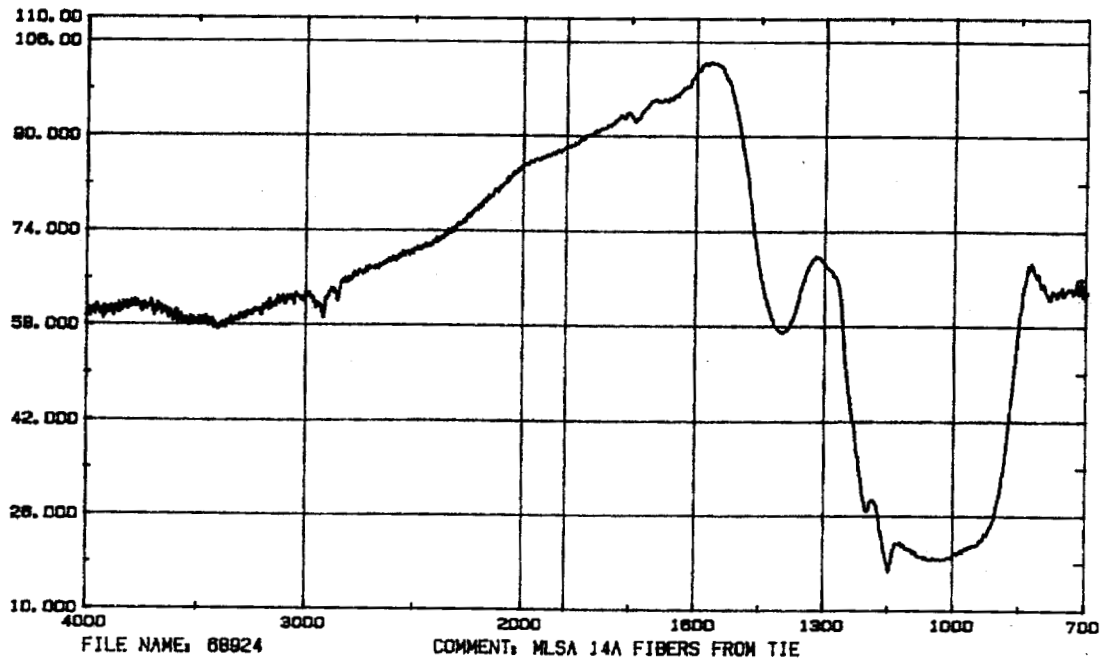
Spectrum 1. FTIR spectrum of the fibers removed from the tie. The spectrum matches reference spectra for silica glass materials.

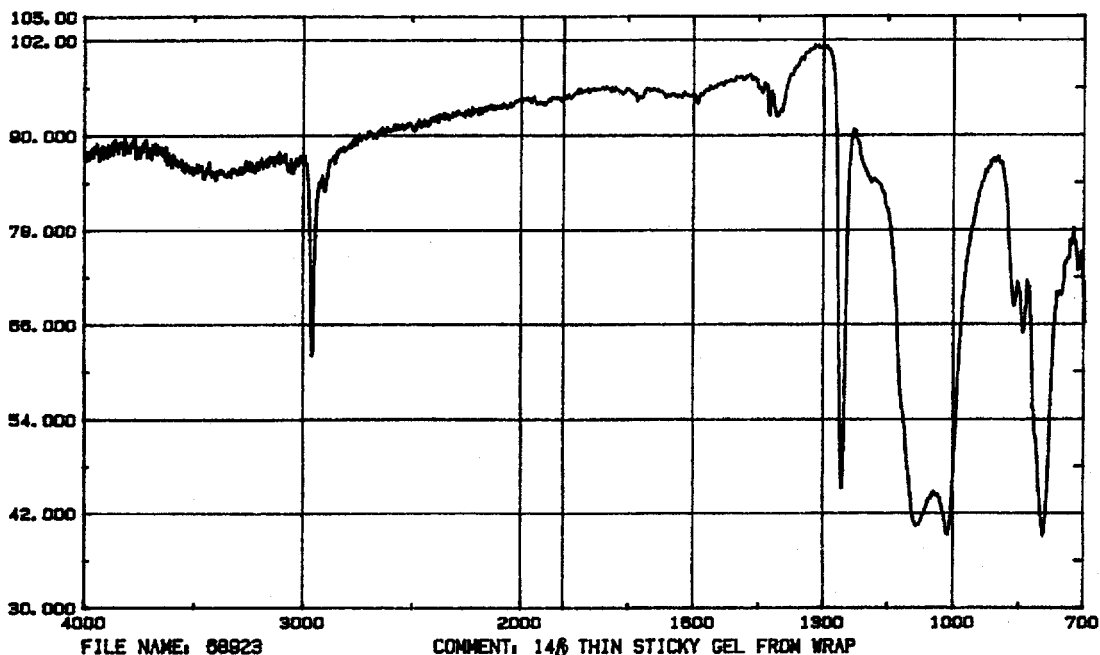
Spectrum 2. FTIR spectrum for the adhesive material on the gray-colored wrapping tape. The spectrum matches reference spectra for methyl silicone materials.

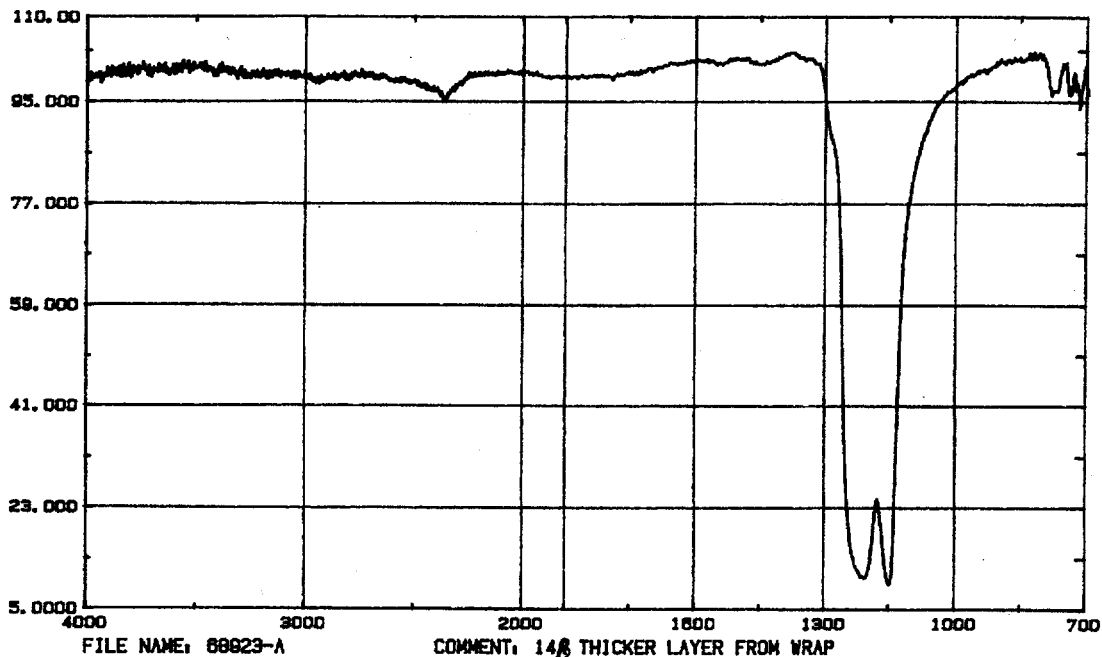
Spectrum 3. FTIR spectrum for the gray-colored wrapping tape. The spectrum matches reference spectra for polytetrafluoroethylene (PTFE, Teflon®) materials.

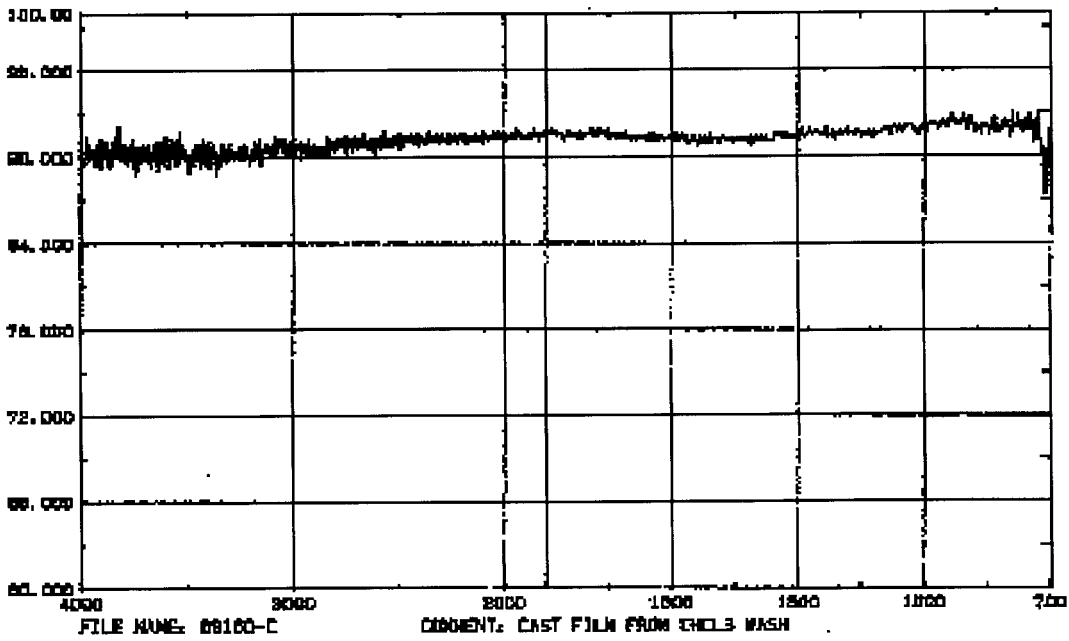
Spectrum 3. FTIR spectrum of the cast film of the chloroform washing of the black-colored residue.

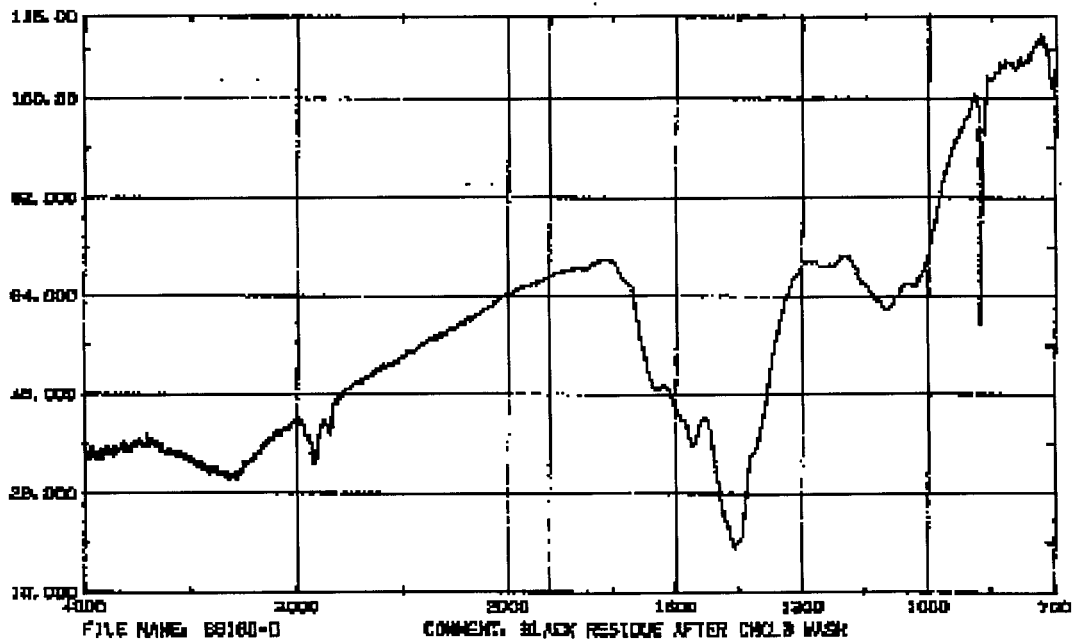
Spectrum 4. FTIR spectrum of the black-colored residue after chloroform washing.

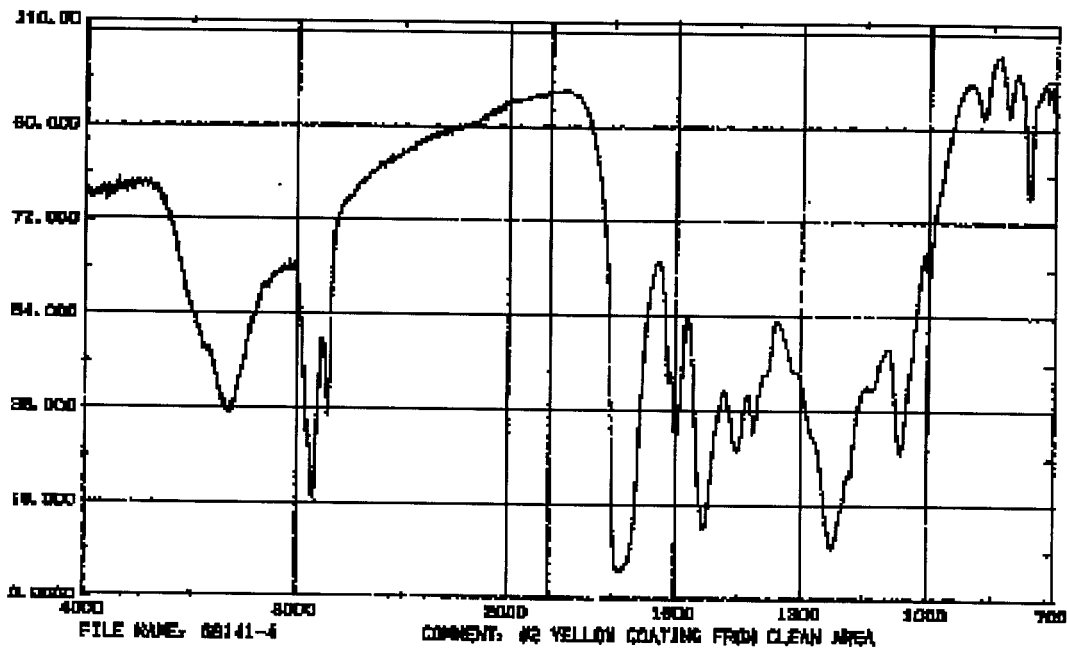
Spectrum 6. FTIR spectrum for a clean undamaged portion of the yellow coating on the tube. The spectrum most closely matched references for polyurethane materials.

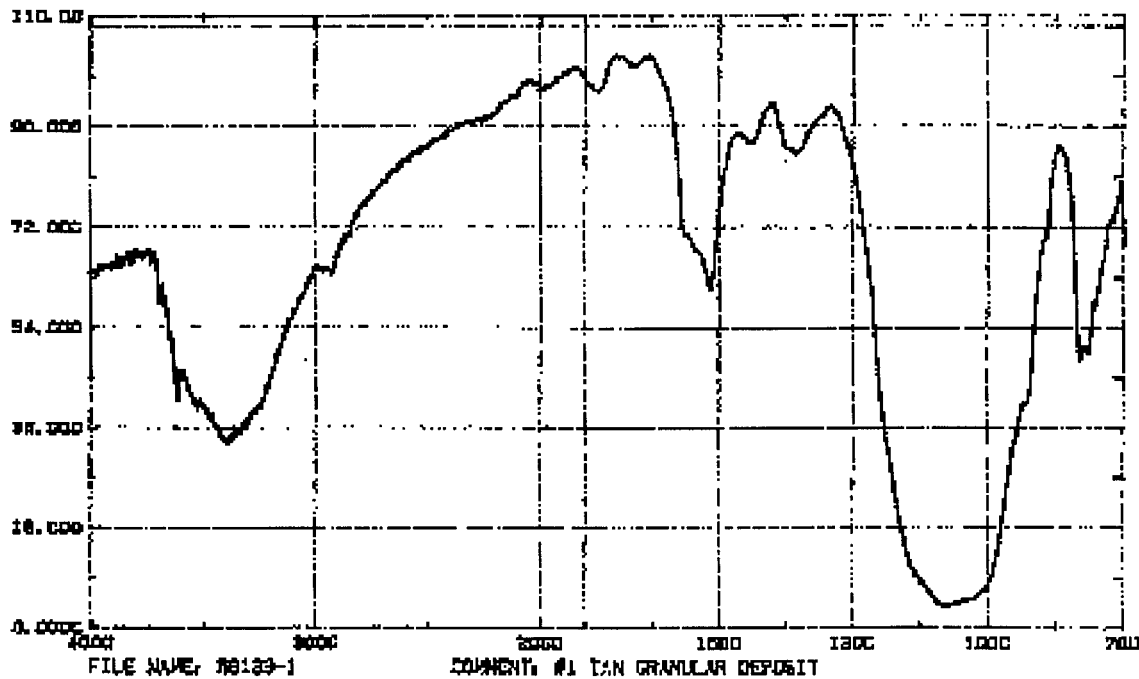
Spectrum 1. FTIR spectrum obtained for the gray-tan colored granular deposit on the metal plate. The spectrum was most similar to references for silicate type minerals.

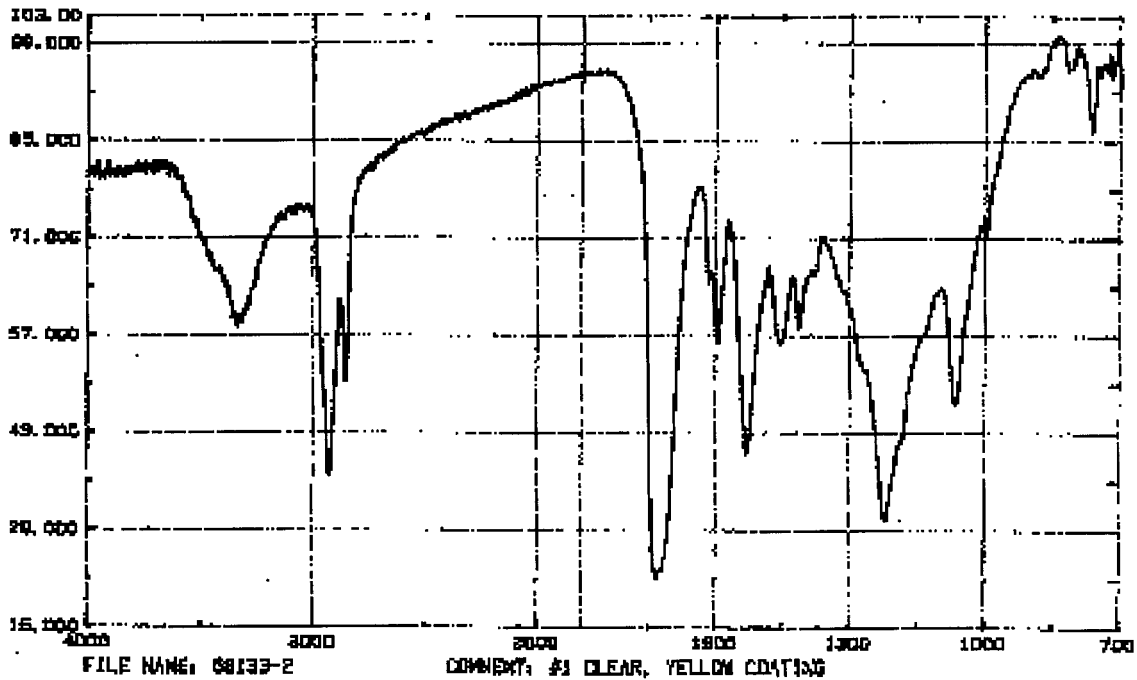
Spectrum 2. Micro FTIR spectrum obtained for the yellow coating material on the metal plate. The spectrum obtained most closely matched references for polyurethane materials.

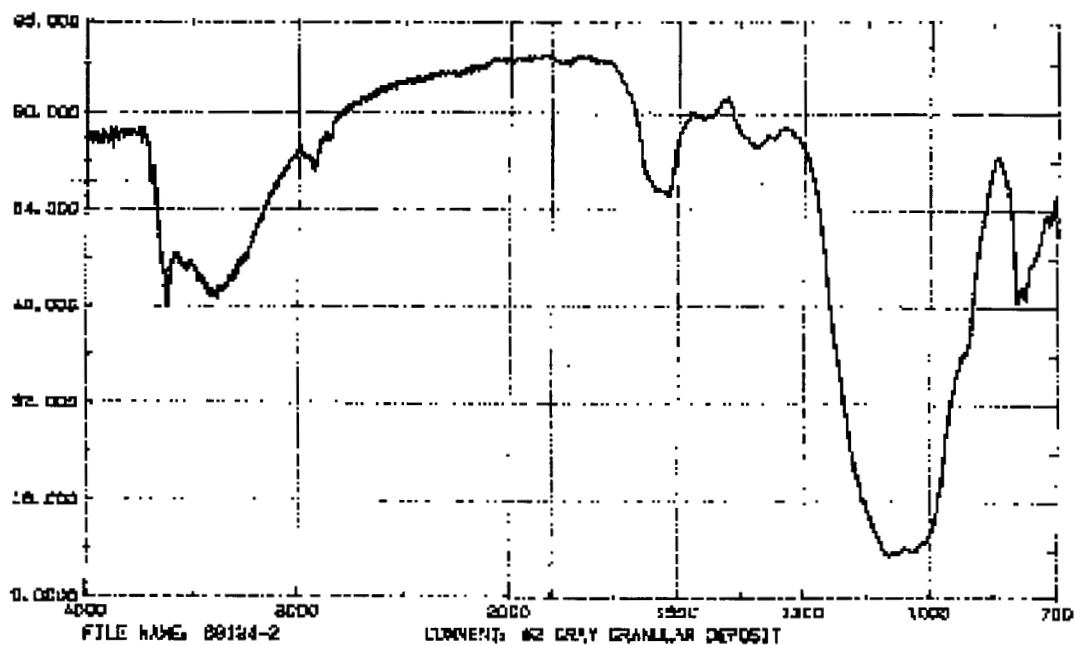
Spectrum 5. FTIR spectrum obtained for the gray granular deposits. The spectrum suggested the presence of silicate type minerals.

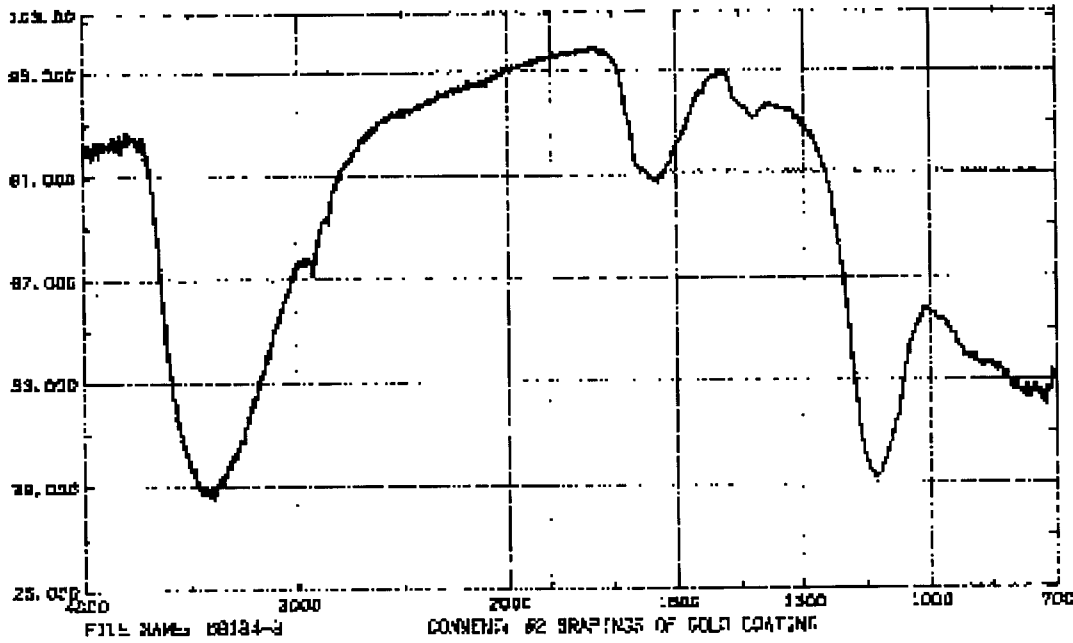
Spectrum 6. FTIR spectrum for the scrapings from the gold-colored area of the sample surface. The spectrum suggested the presence of inorganic oxides and possibly silicate materials. The general appearance of the gold-colored surface, as well as the spectral data, were consistent with those characteristics for anodized aluminum alloys.

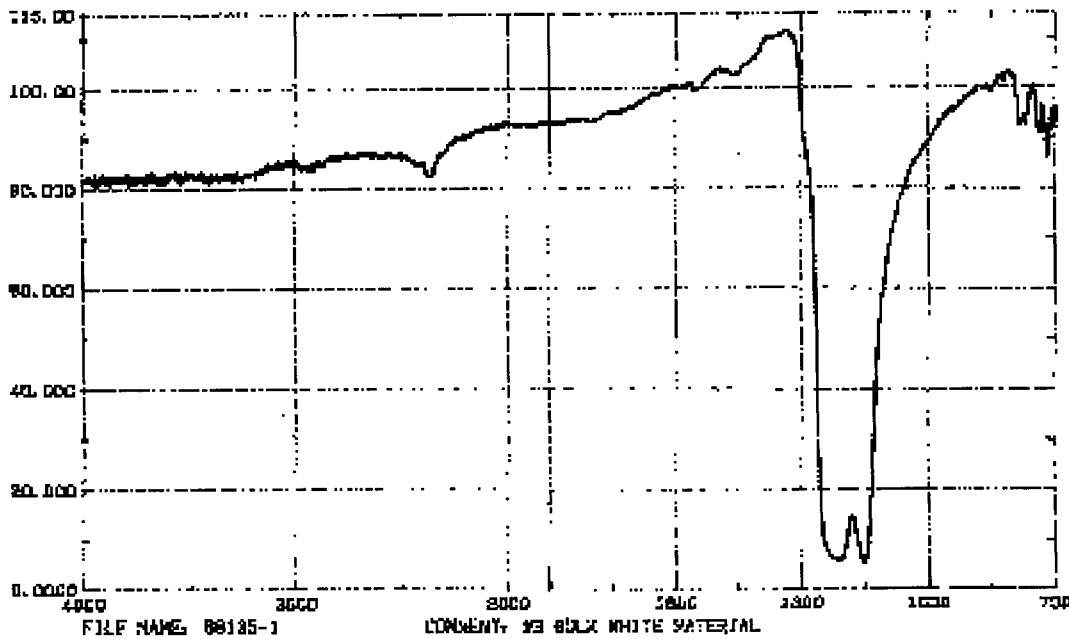
Spectrum 7. FTIR spectrum for the bulk white plastic material. The spectrum most closely matched references for polytetrafluoroethylene (PTFE) materials.

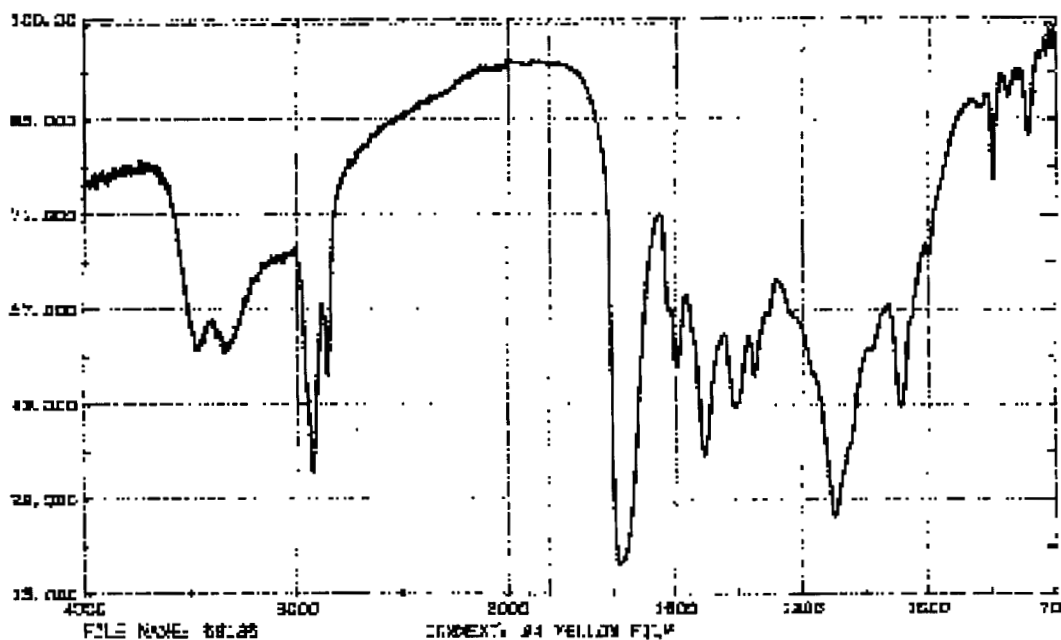
Spectrum 9. FTIR spectrum for the clear yellow film. The spectrum obtained most closely matched references for some polyurethane materials.

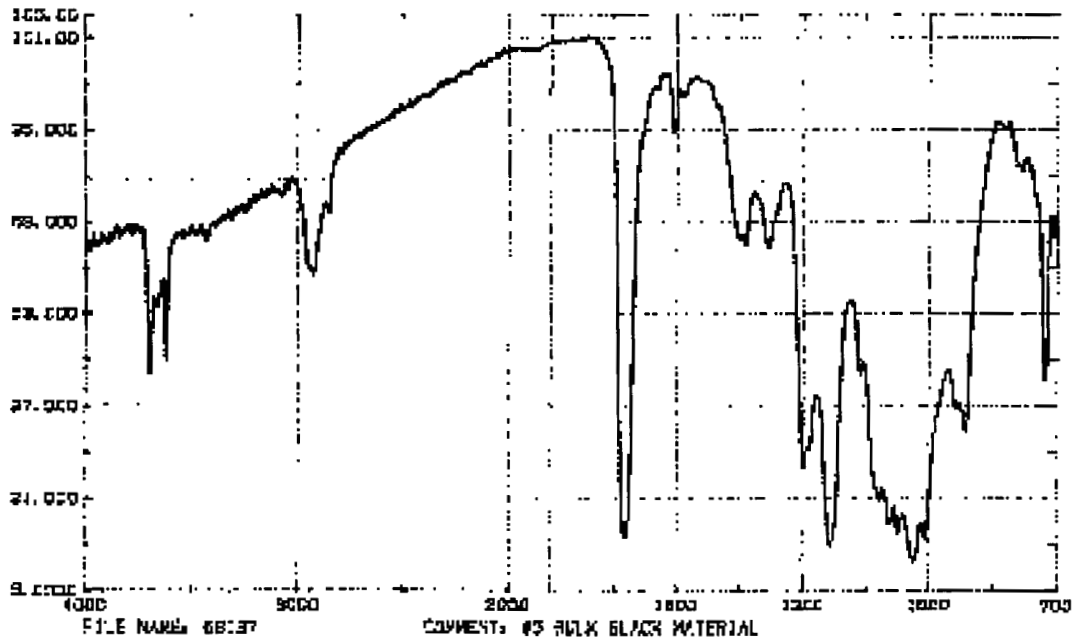
Spectrum 10. FTIR spectrum for the black plastic material. The spectrum most closely matched references which indicated the sample was composed of an isophthalic acid based polyester with a kaolinite type silicate filler.
