DOCKET NO. **SA- 516**

EXHIBIT NO. **9C**

**NATIONAL TRANSPORTATION SAFETY BOARD
WASHINGTON, D.C**

**ATTACHMENTS TO THE
SYSTEMS GROUP CHAIRMAN'S FACTUAL
REPORT OF INVESTIGATION**

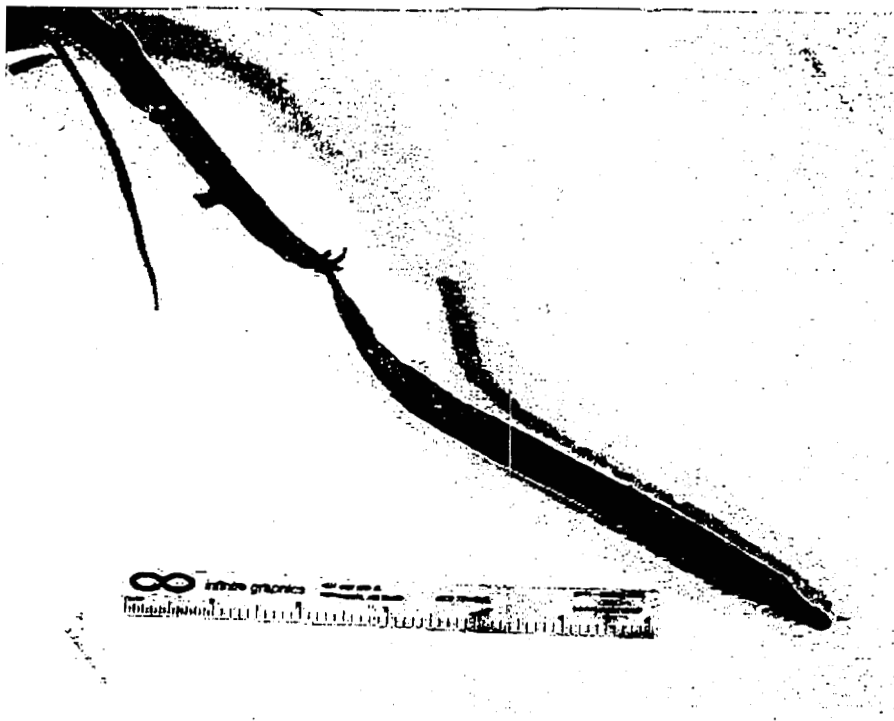
Figure 6. This is a close-up of the wiring in 5 Figure. The two melt areas on the copper wiring (middle and bottom) contained aluminum and confirmed that electrical arcing had taken place.

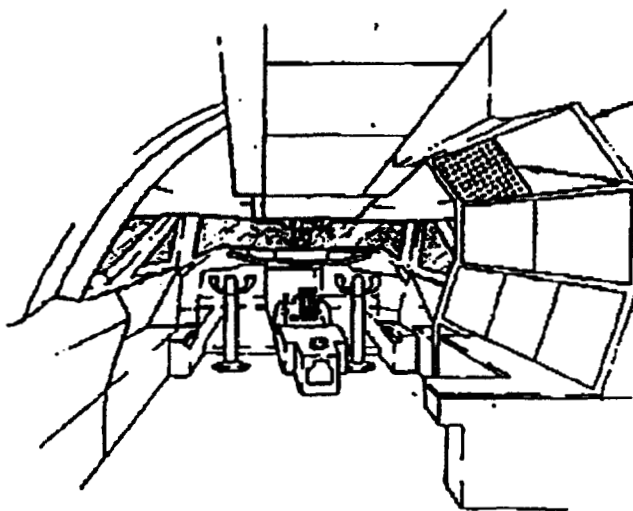
FLIGHT ENGINEER'S
P4 PANEL

REMOVE APU CONTROL
MODULE AND APU POWER
MODULE. INSPECT WIRE
BUNDLES W052, W184,
W188, W190 AND W2038
AFT OF STA 340 FOR
CHAFING. WRAP WIRE
BUNDLES WITH TEFLON
SLEEVING, AND REROUTE
WIRE BUNDLES.

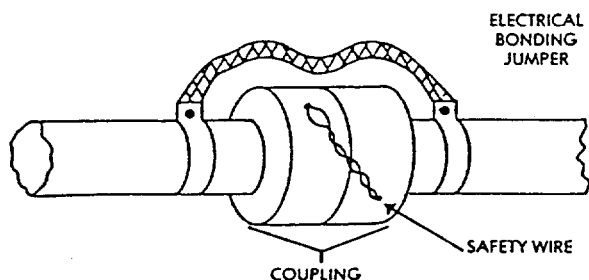
Fig. 7.27 Electrical bonding jumper across insulated coupling.

Bond straps: Electrical bond straps or jumpers are sometimes installed across poorly conducting pipe couplings, as shown in Fig. 7.27. These bond straps should not be relied upon to prevent sparking from lightning currents. Current is apt to divide in proportion to resistance which may be the result of a small contact area in the coupling. Some current in the coupling could lead to sparking even with the bond strap in place.

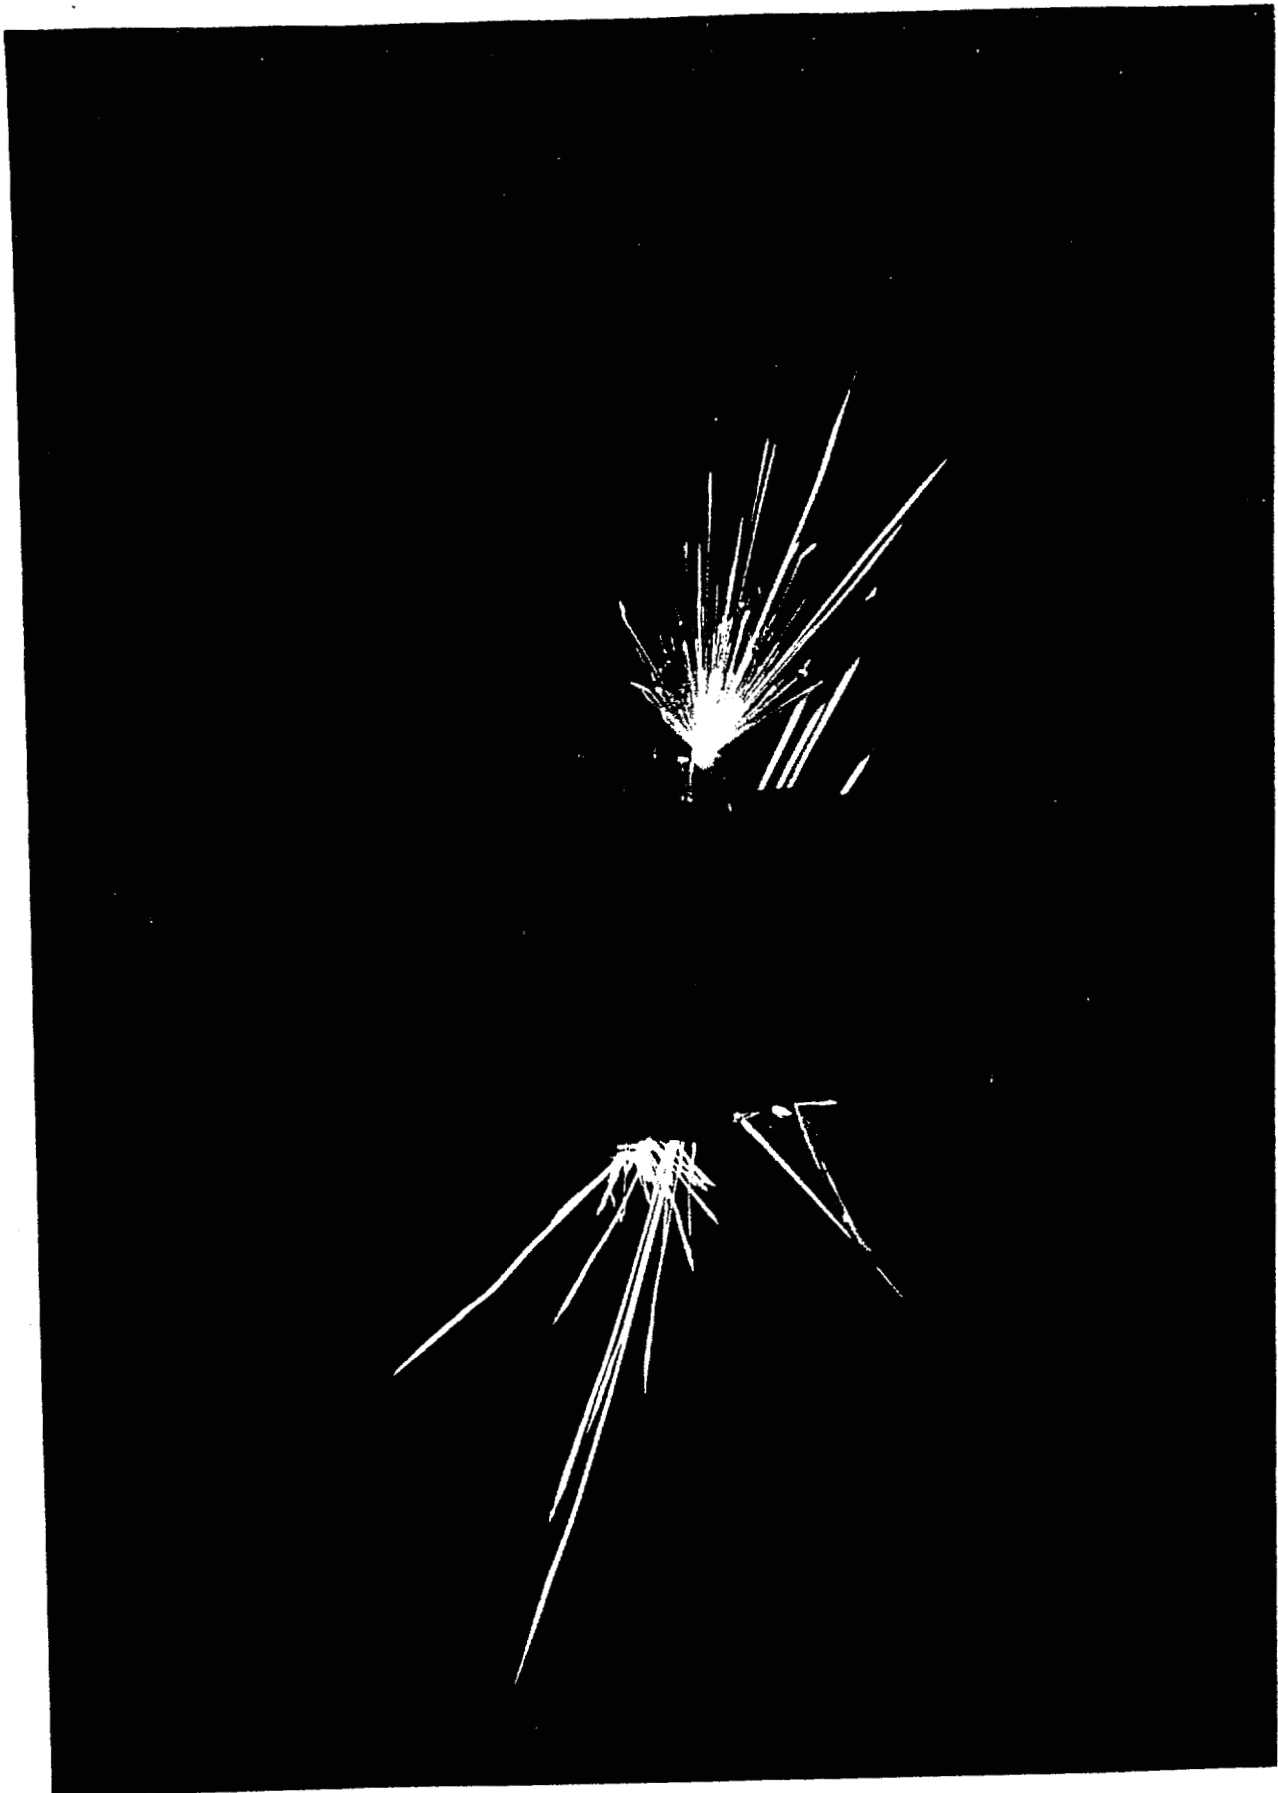
Fig 6 Pipe Joint Sparks

Whether the sparking seen would ignite aircraft fuels such as JP4 and JP8 under suitable conditions is not proven. It would however not meet the requirements of MIL STD 1757A. It is therefore hoped to extend this work to verify the ignition requirements for fuels with thermal sparks.

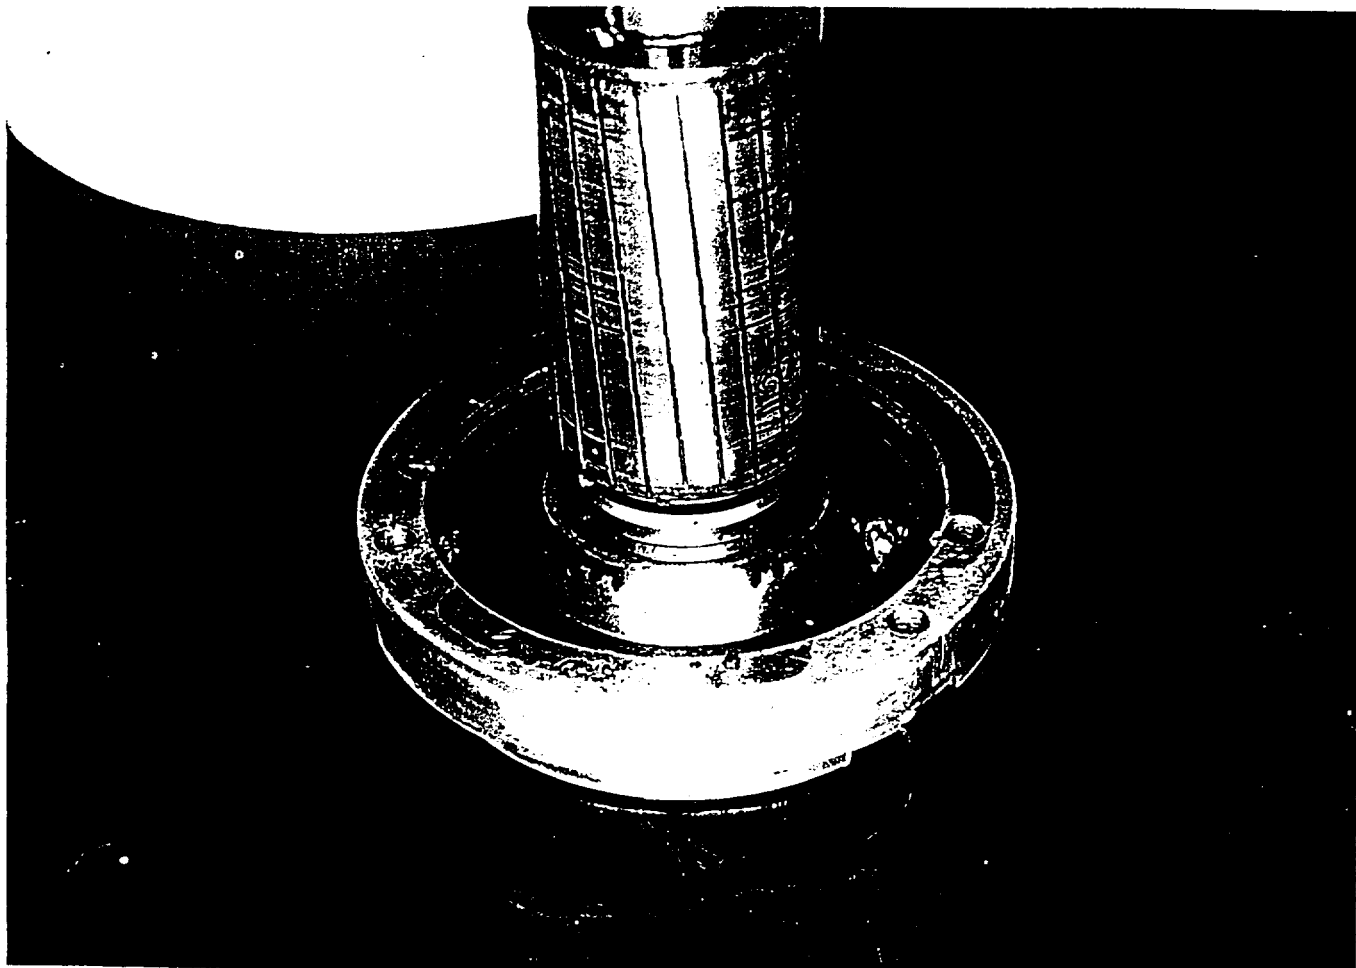
EQUIPMENT QUALITY ANALYSIS
EQA NUMBER: 1659T
PIOTO NUMBER: 9

Reference paragraph 5.8, Examination of the AC motor stator assembly [P/N RG21865] revealed several pieces of red rubber through out the assembly.

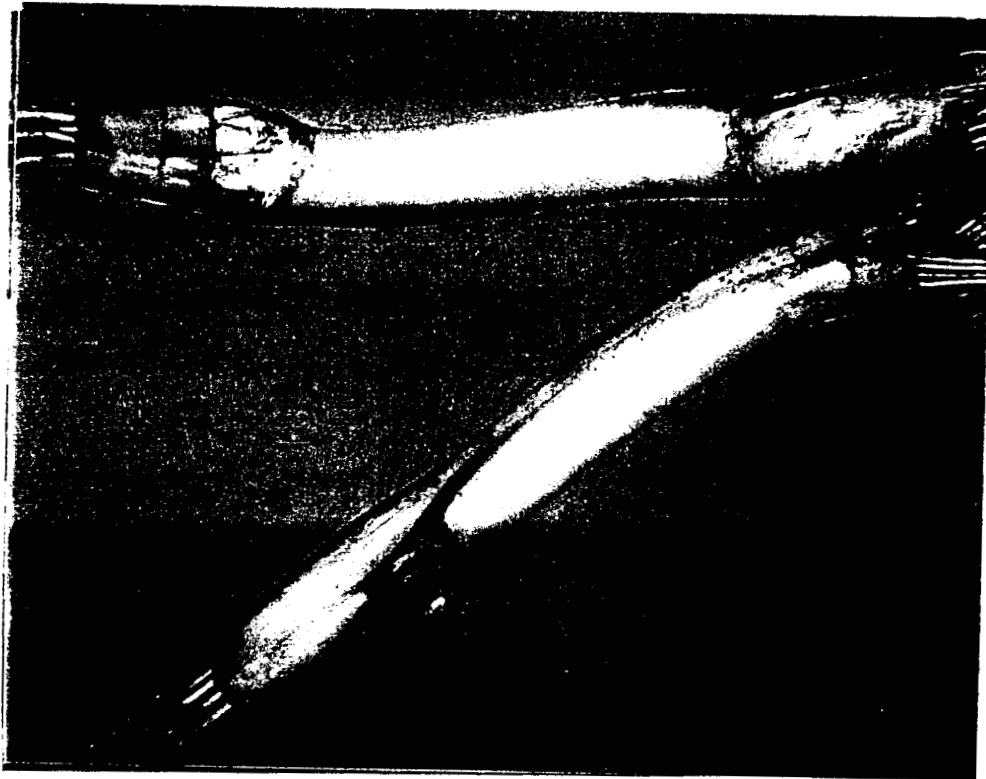
Figure 6. Sample one with high-Z wires separated. Note brown-black residues on the insulation. The residue forms a conductive path between the shield and signal wiring.

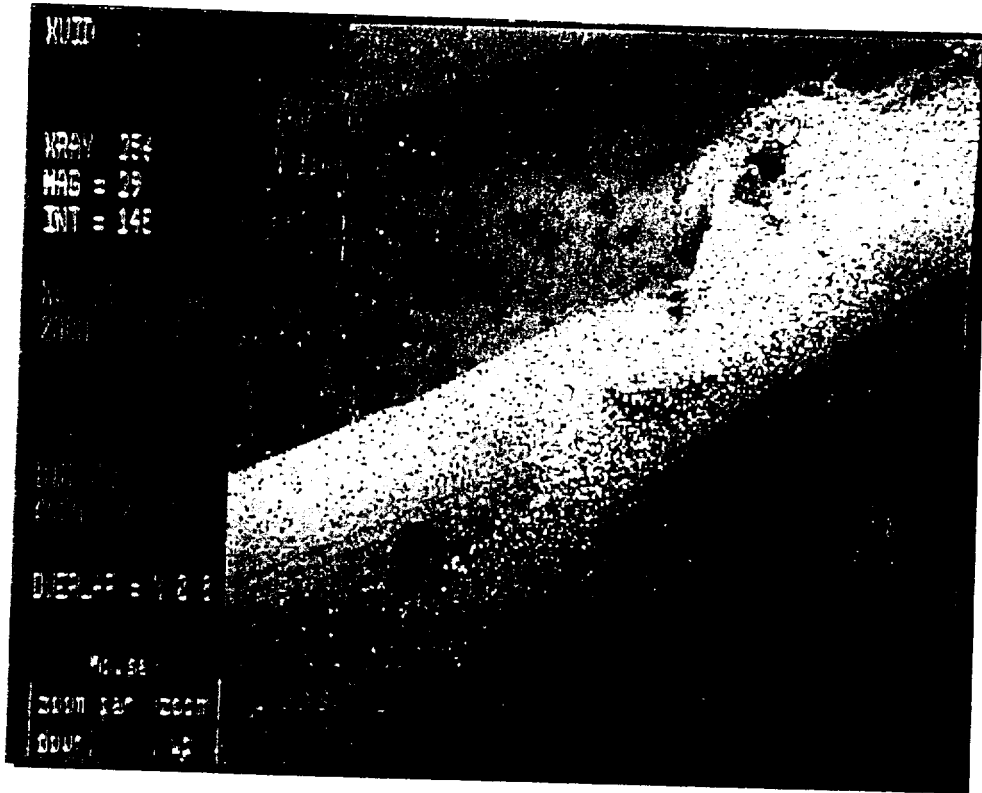
Figure 9. SEM back-scatter micrograph of the residue streak on the wiring showing the elemental distribution of copper (red) and sulfur (yellow). Note that the highest levels of the copper and sulfur coincide with the residue streak.

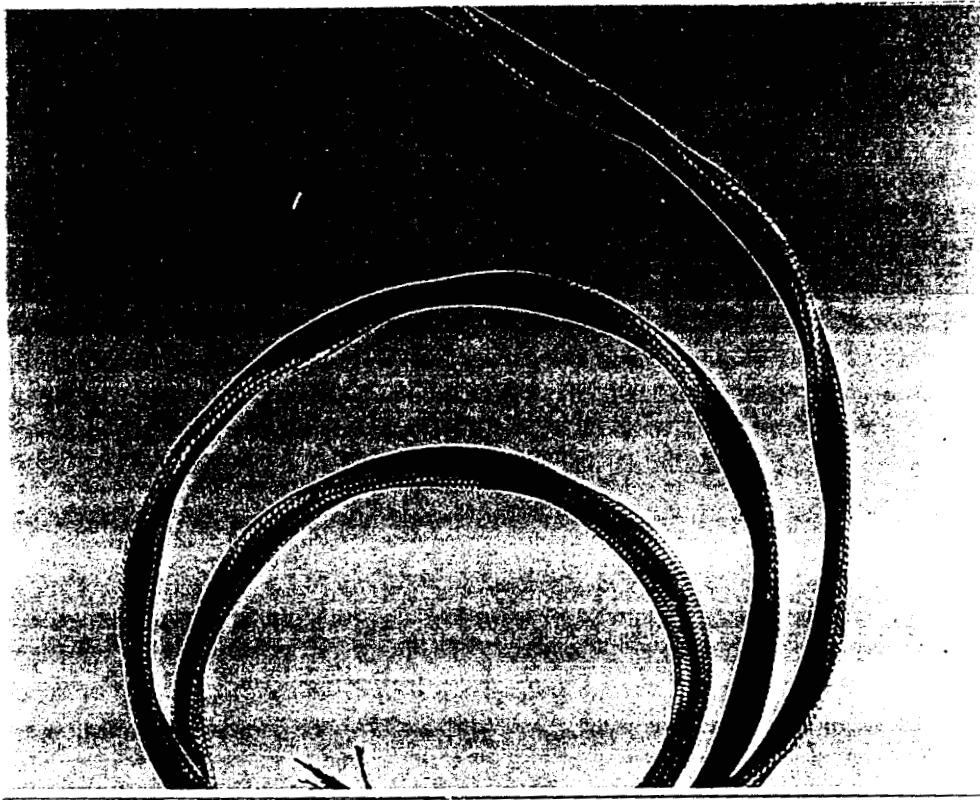
FIGURE 9. Fuel sensor cable blackening, K-329. Note that the black area corresponds to the shielded wiring only. Mag: 0.8X

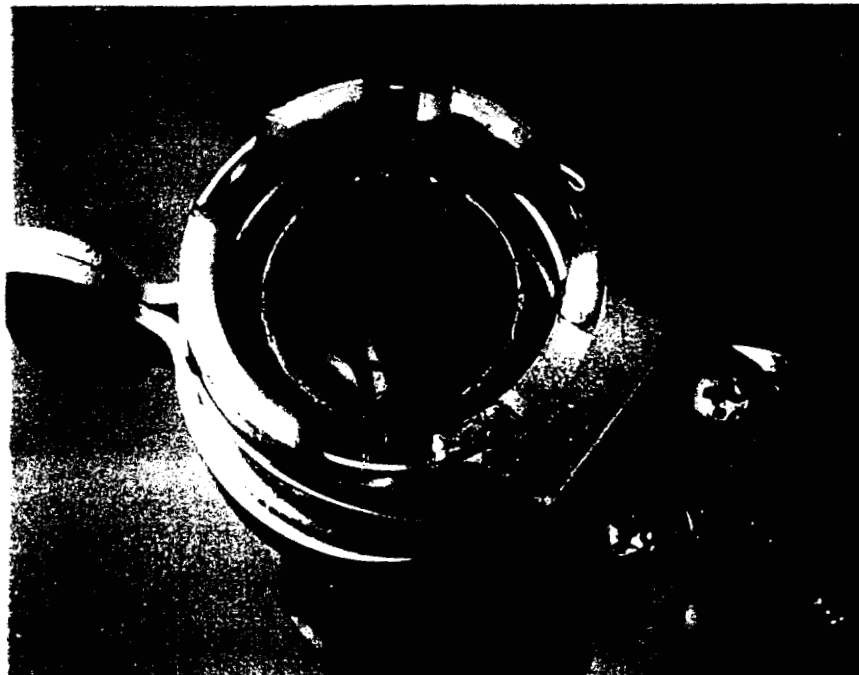
FIGURE 10. Fuel sensor top clamp exhibiting blackened area, L-78. Mag: 1.4X

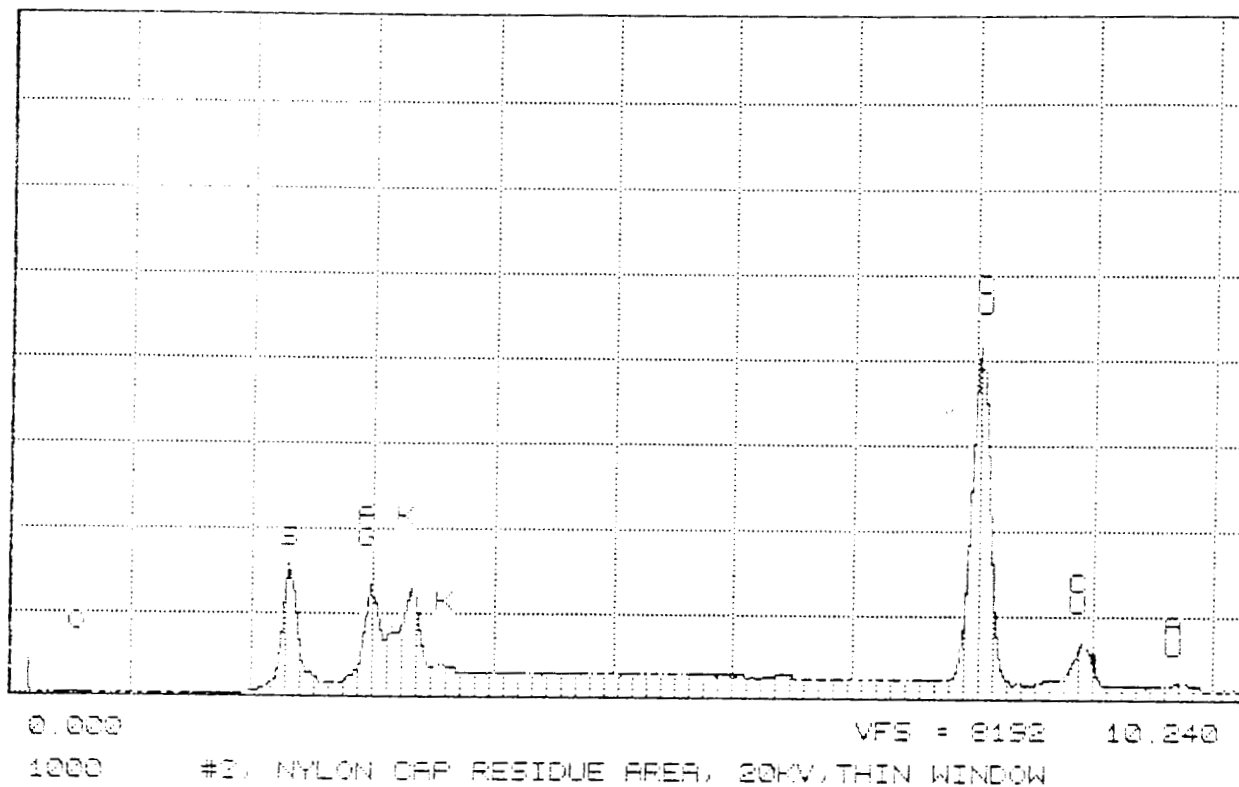
Figure 15. EDXS spectrum of residues on the nylon cap. Note presence of sulfur, silver, and copper. Areas outside of the residues did not contain these elements.
