**NATIONAL TRANSPORTATION SAFETY BOARD
OFFICE OF AVIATION SAFETY
WASHINGTON, D.C. 20594**

SYSTEMS GROUP CHAIRMAN'S FACTUAL REPORT

NTSB ID No.: DCA11IA015

Location: Jackson Hole Airport (JAC), Jackson Hole, Wyoming
Date: December 29, 2010
Time: About 1138 Mountain Standard Time (MST)
Aircraft: Boeing 757-200
Registration Number: N668AA
Serial Number: 25333

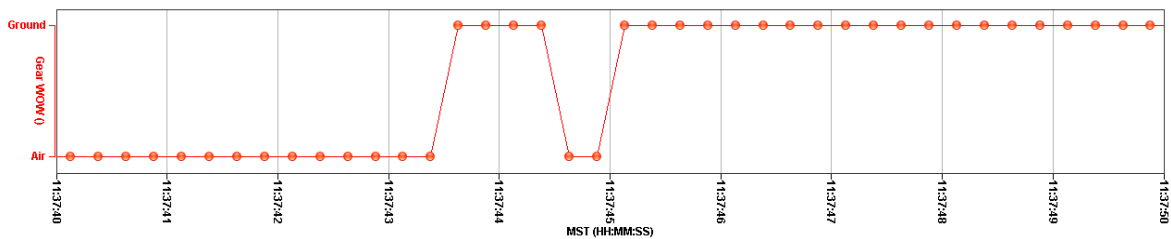
Figure 1 Weight-On-Wheels data from the December 31, 2010 landing

A review of FDR data revealed that upon touchdown in Jackson Hole, Wyoming, the air/ground discrete “Gear weight-On-Wheels (WOW)” transitioned from “Air” to “Ground” and remained on “Ground” for about one second. The air/ground discrete briefly transitioned back to “Air” for about 0.5 seconds and then back to “Ground” for the remainder of the landing. Figure 1 provides a graph showing the air/ground data from the event landing.

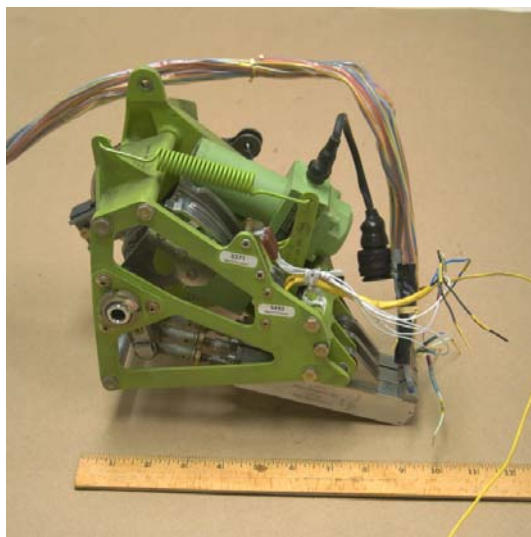
Figure 9 Speedbrake mechanism

On April 2, 2011, (after the event on March 31, 2011) American Airlines removed and replaced the speedbrake mechanism (structural assembly containing the auto speedbrake actuator, no-back clutch, switches and wiring) to address the failure of the speedbrake lever to deploy upon landing in San Francisco. Refer to Figure 9. American Airlines sent the speedbrake mechanism (P/N 254N1053-5) to the FAA to be held for further investigation. A representative from the FAA hand carried the Mechanism to the Boeing EQA Laboratory located in Seattle, Washington for examination.

A general visual inspection found that, other than a slight amount of dust and/or oil on the speedbrake mechanism arming detent cam, all mechanisms appeared in good condition. No flat spots were noted on the detent lever roller and it rotated freely. There was no visual or cosmetic damage or excessive wear noted on the exterior of the entire no back assembly.

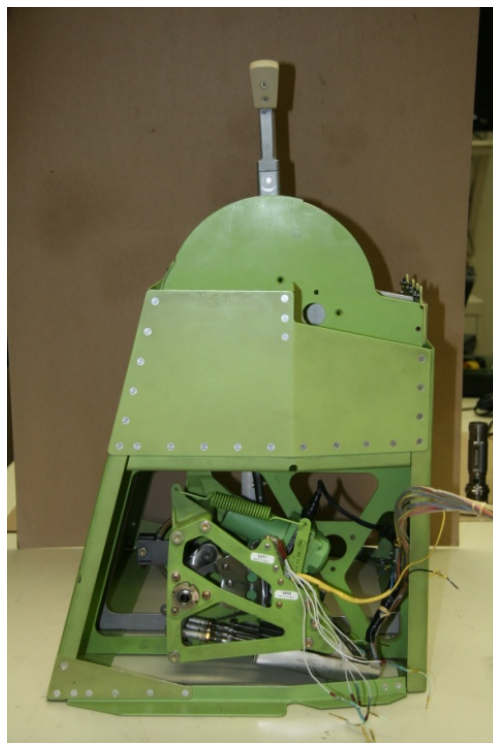
Figure 10 Speedbrake mechanism installed in test stand

The speedbrake mechanism was installed into a control stand fixture that replicates a 757 center console assembly including a speedbrake lever and its associated linkage. The test stand was provided by Adams Rite Aerospace. Refer to Figure 10.

Using a hand held force gauge, the force required to move the speedbrake lever was checked. Prior to checking the force, the speedbrake lever was moved from its down detent to a vertical position just aft of “armed”. A hand held force gauge was then positioned against the lever. The breakout force required to move the lever⁸ forward was measured three times and found to be 5.35 pounds on average. The breakout force required to move the lever aft from its vertical position was measured two times and found to be 5.5 pounds on average. The running force to move the lever from its full aft position to its “armed” detent was ranged from 4.5 pounds to 4.0 pounds. The running force to move the lever aft from a position just aft of “armed” detent to full aft ranged from 4.6 pounds to 4.0 pounds. The measured force to move speedbrake

lever out of armed detent going aft was measured three times and found to be 13.5 pounds on average.

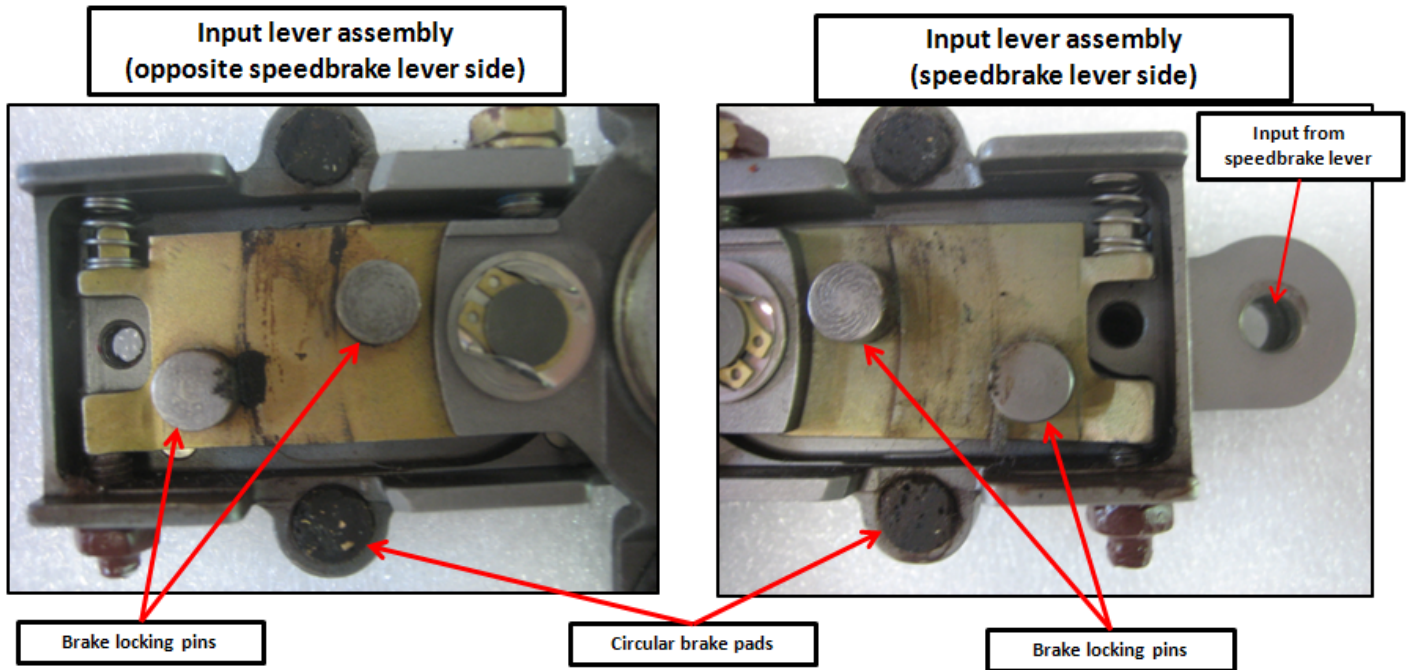
Figure 14 Input lever assembly

Radial burnishing was noted on the semi-circular brake pads, with a light oil-like film present on all friction surfaces. Refer to figure 13 for a view of the brake pads. Removal of the input lever assembly revealed the four circular brake pads, which displayed similar burnish markings as the brake pads on the brake plate and shoe assembly. Refer to figure 14 for a view of the brake pads.
