**NATIONAL TRANSPORTATION SAFETY BOARD
OFFICE OF AVIATION SAFETY
WASHINGTON, D.C. 20594**

SYSTEMS GROUP CHAIRMAN'S FACTUAL REPORT

NTSB ID No.: DCA09MA021

Location: Denver International Airport
Date: December 20, 2008
Time: About 18:18 PM Mountain Standard Time (MST)
Aircraft: Boeing 737-500

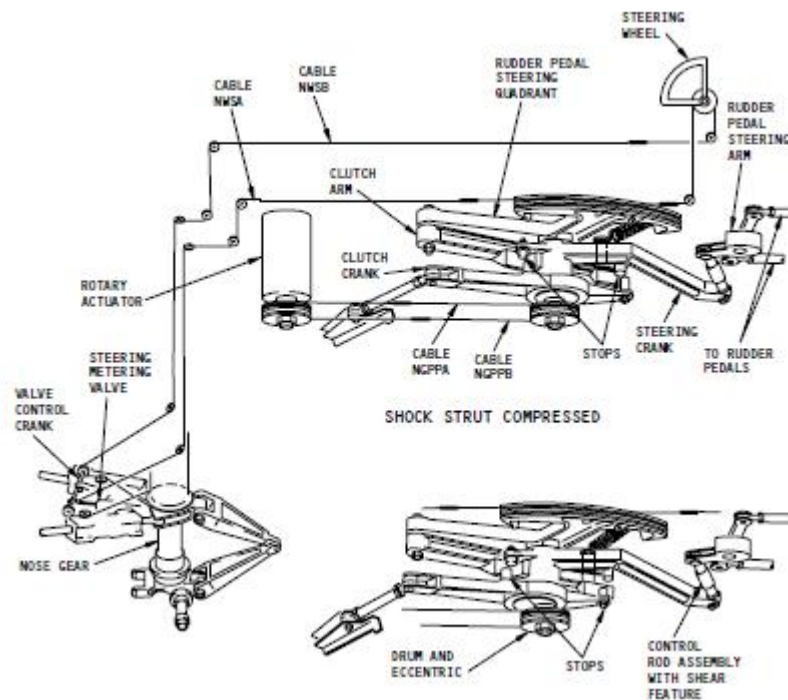
Figure 5 Figure of the nose wheel steering system

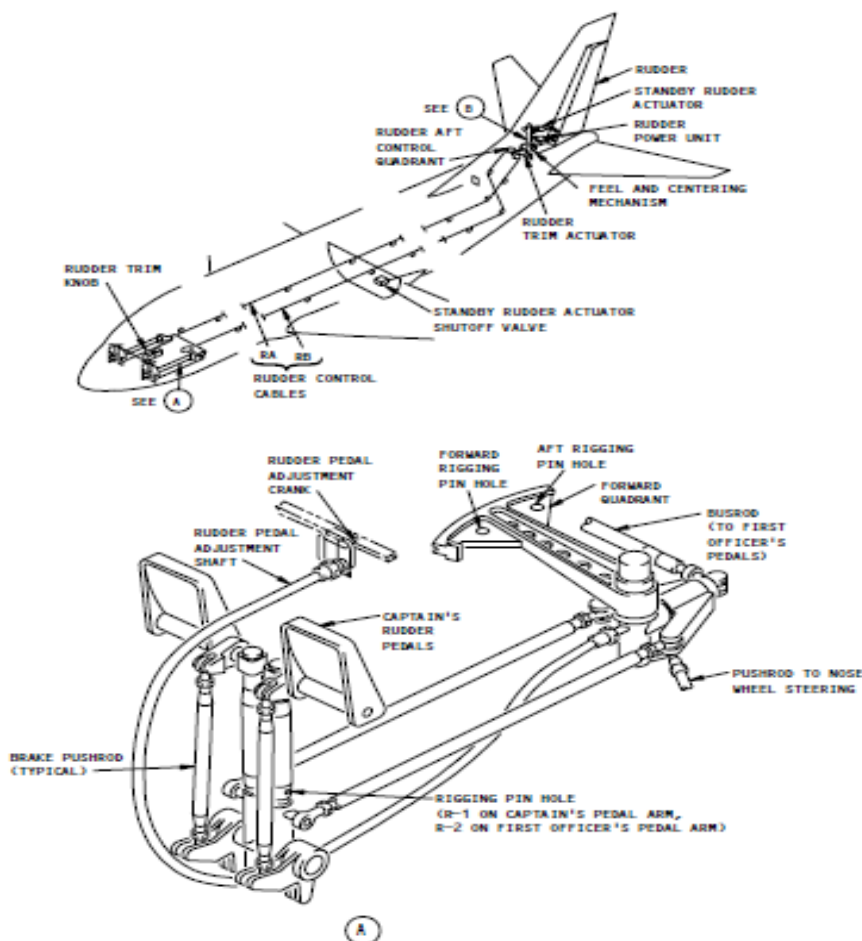
Figure 7 Schematic of the Rudder Control System

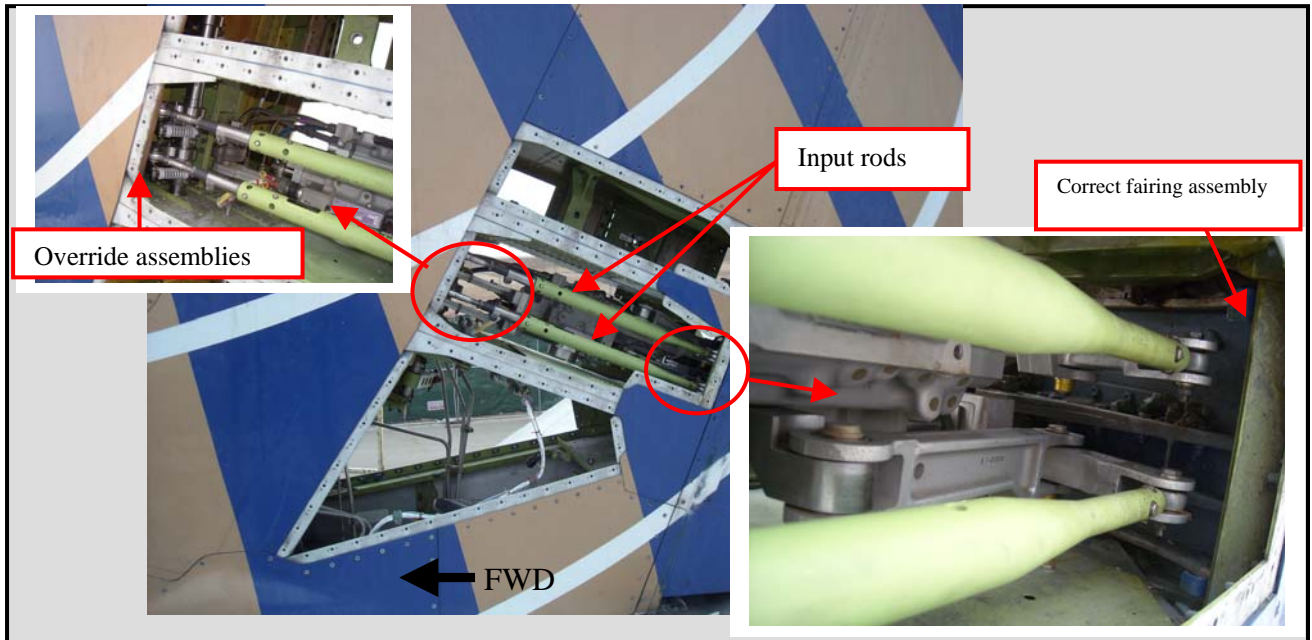
An on-scene visual inspection of the rudder main PCU ([Figure 9](#)) and its associated components (input linkages, external summing linkage, input rods, and override assemblies) revealed that all components were intact, undamaged and remained connected to their respective parts via attachment hardware.

Figure 9- View of the left side of the vertical stabilizer showing the location of the rudder PCUs

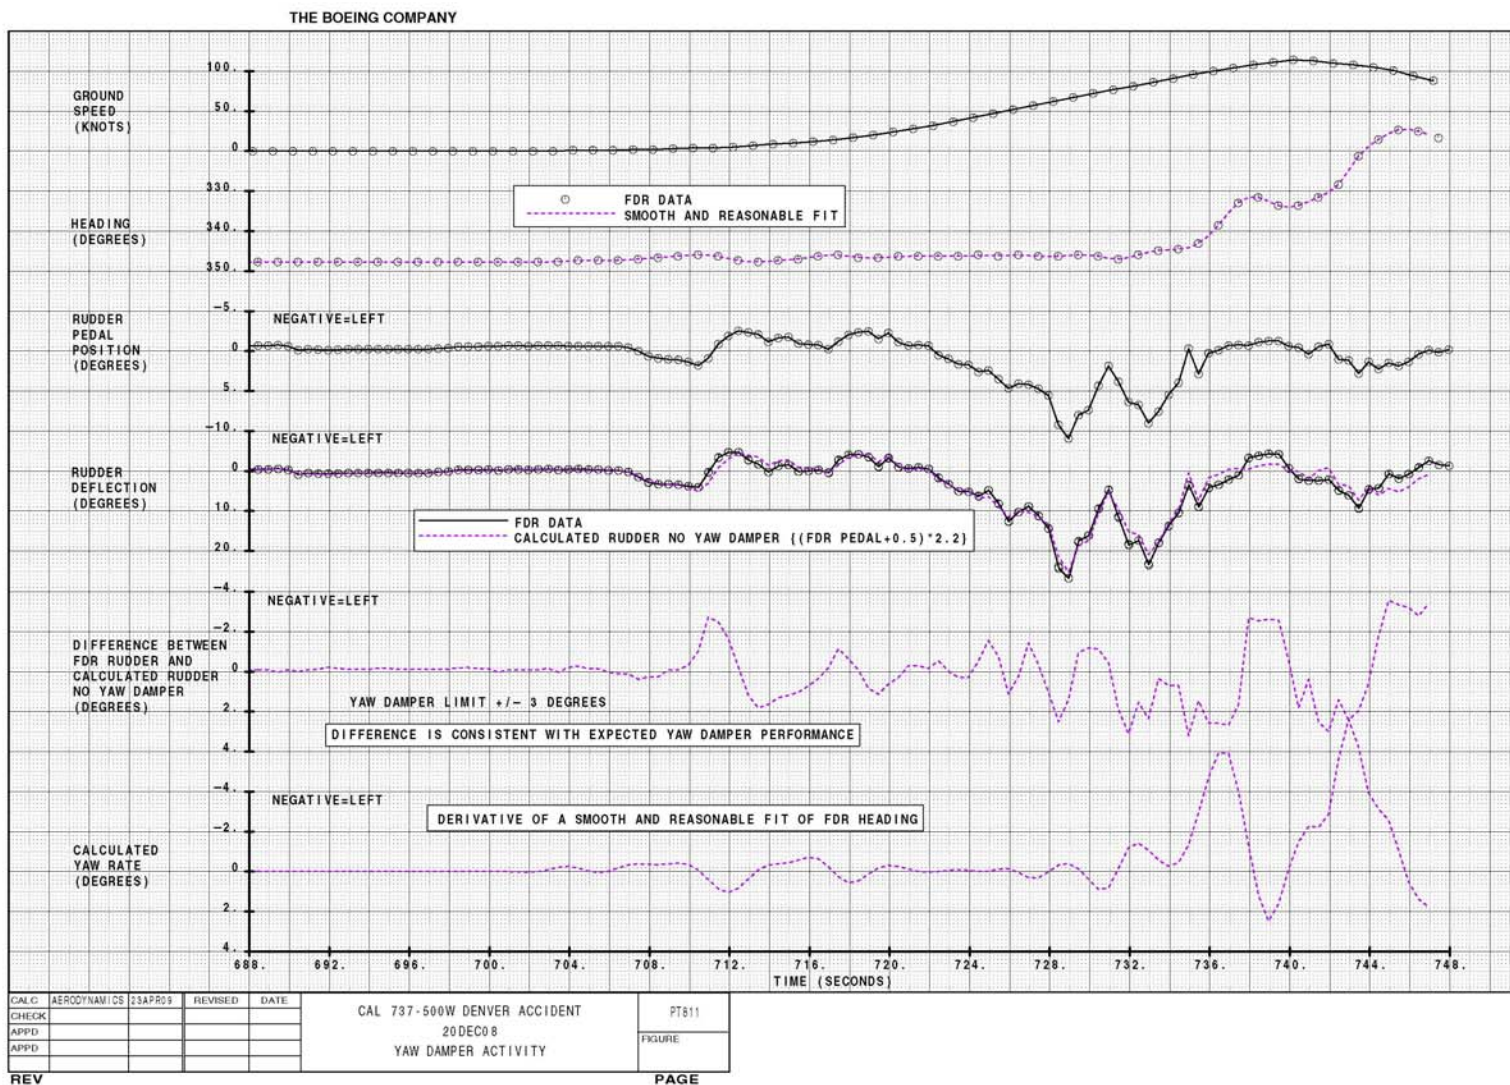
The NTSB requested Boeing to perform parametric studies of the FDR data for the rudder control system to determine if the actual rudder deflections match the expected rudder deflections for the accident takeoff. Boeing used the FDR heading, rudder pedal, and rudder deflection to perform their studies and to understand the expected yaw damper performance versus the actual yaw damper performance. The yaw damper on the 737-500 is a yaw-rate yaw damper with a rudder authority limit of +/- 3.0 degrees. An optimal control curve fit was used to calculate a smooth and reasonable curve through the recorded heading data. This curve fit was then differentiated to calculate yaw rate ([Figure 11](#)).

The FDR rudder pedal data was used to calculate a rudder deflection with no-yaw-damper by using a simplified gearing relationship. First, 0.5 was added to the FDR pedal data to center it about zero. Then the pedal position was multiplied by a factor of 2.2 (pedal-to-rudder gearing) to calculate the no-yaw-damper rudder. An estimation of the yaw damper input was calculated by taking the difference between the FDR rudder deflection data and the calculated rudder. A yaw-rate yaw damper input is expected to oppose yaw rate. The characteristics of the calculated rudder difference (estimated yaw damper input) are consistent with the characteristics of the expected behavior of the yaw damper. The FDR data of the rudder positions and the rudder pedal positions were consistent with, and matched, parametric studies of the rudder system.

Figure 11 Boeing Rudder System Analysis
