NATIONAL TRANSPORTATION SAFETY BOARD  
Office of Aviation Safety  
Washington, D.C. 20594

Systems Group Chairman's Factual Report

MIA-01-FA-029

Operator: American Airlines  
Location: Miami, Florida  
Date: November 20, 2000  
Time: Approximately 12:00 PM EST  
Airplane: Airbus A300-600, N14056

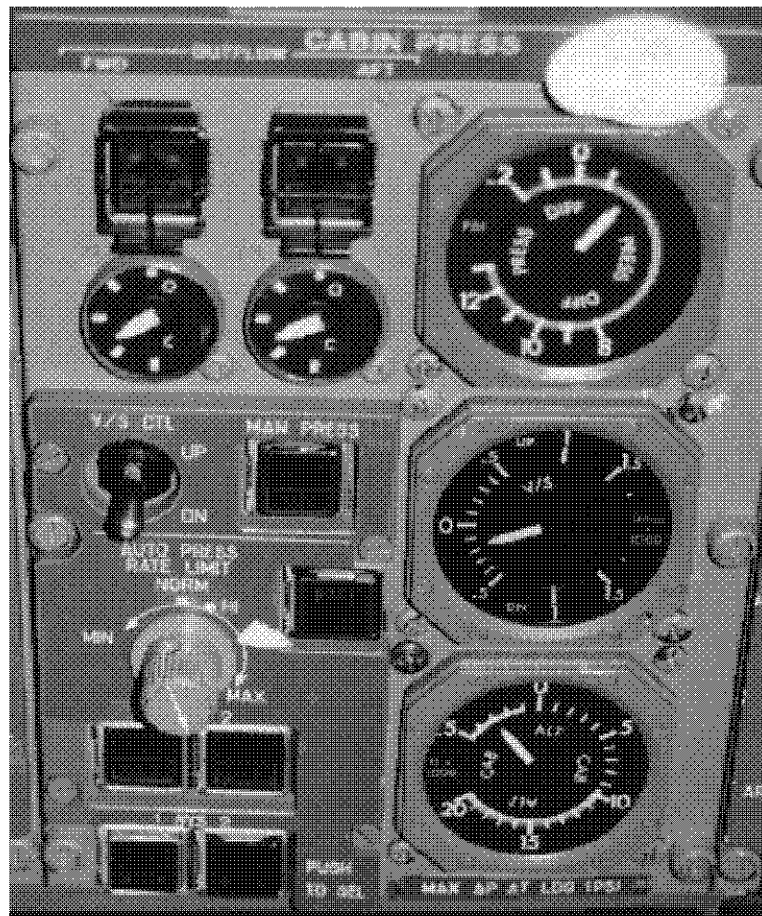
Figure 2 – Cabin Pressurization Indicators and Controls on the Flight Compartment Overhead Panel

When manual pressurization control mode is selected, the ECAM pressurization system indications for cabin differential pressure, cabin altitude rate of change, and cabin altitude no longer function. Pressurization system status monitoring is performed by referencing the cabin differential pressure indicator, the cabin altitude rate of change indicator, and the cabin altimeter. These indicators are located in the overhead panel of the flight compartment (see figure 2).

Testing of the cabin altimeter indicated that the cabin altimeter consistently read between 1000 and 1350 ft lower than the calibrated test equipment. These values were outside of the allowed tolerance bands for the component. The cabin altimeter was exposed to increased pressure to determine at what value of increased pressure the indicator would read 20,000 ft. This value was found to be 1351.9 mb (40.03 in. Hg or 19.61 psia). Disassembly of the unit did not reveal any evidence of mechanical stops that would stop the pointer at the ends of the marked ranges on the dial.

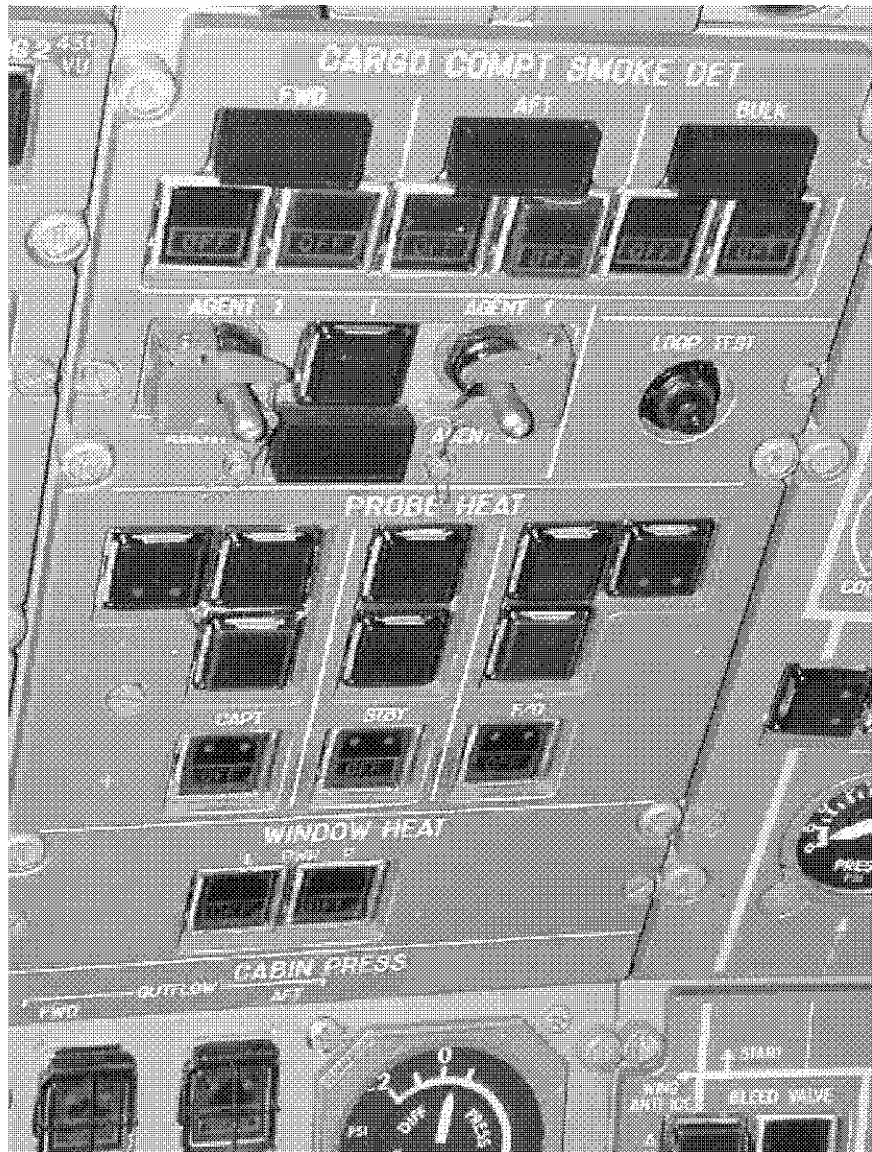
Figure 19 – Cargo Compartment Smoke Detection Control Layout (Note proximity to Cabin Pressure Indicators at bottom of figure)

The cargo compartment smoke detection system for the A300 aft cargo compartment consists of four smoke detectors (manufactured by Cerberus Guinard, part number CG7PO) arranged in pairs with one pair located in the forward part of the compartment and one pair in the aft part of the compartment. In each cargo compartment, the association of one forward and one aft smoke detector composes a loop (A or B). On the flight compartment overhead panel, there are three red SMOKE warning lights, six LOOP/OFF pushbutton switches (one pushbutton switch for each of two loops in each of three cargo compartments), and a loop test pushbutton switch (see figure 19).

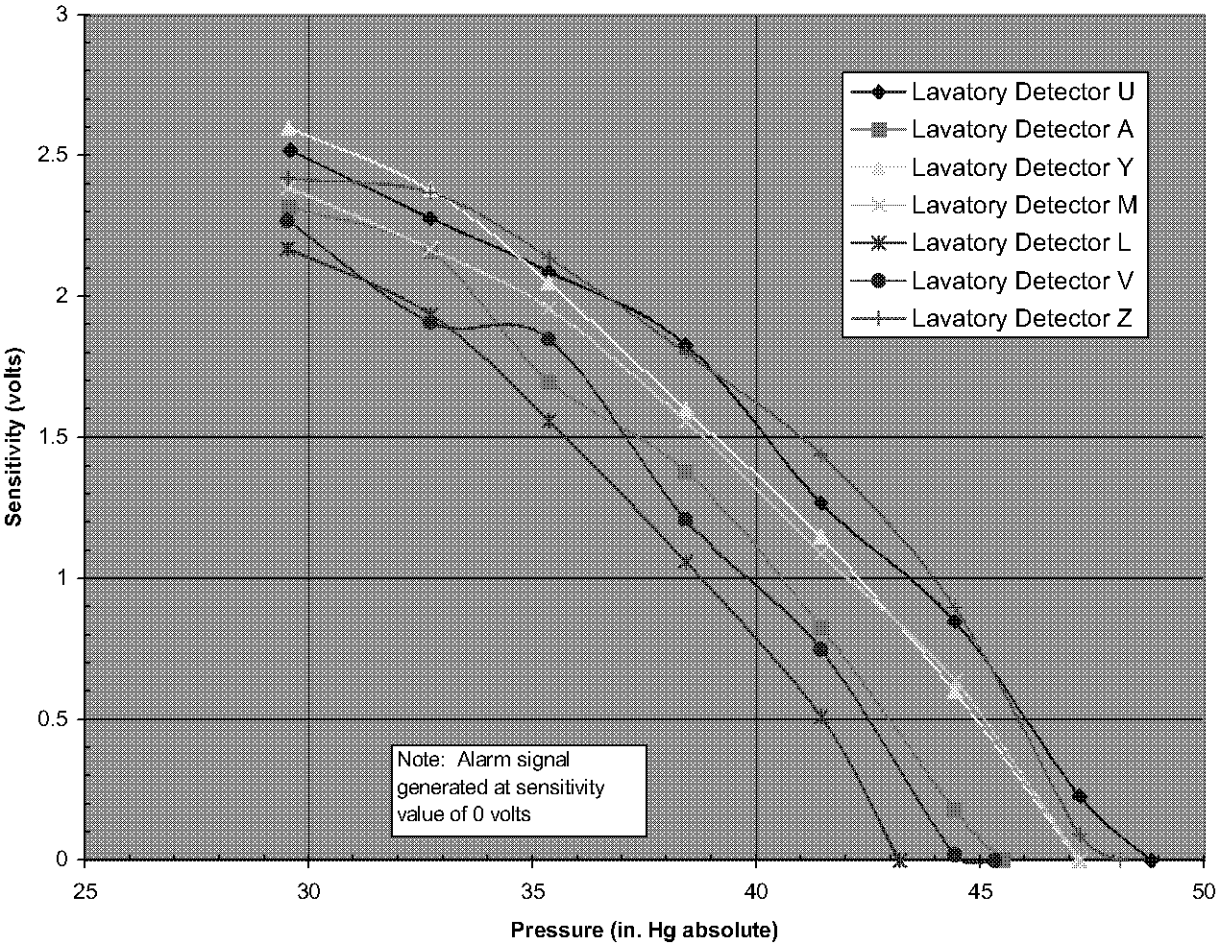
AA 1291 Lavatory Smoke Detector Pressure Test Results

### Lavatory Smoke Detector Sensitivity Test Results – Elevated Pressures

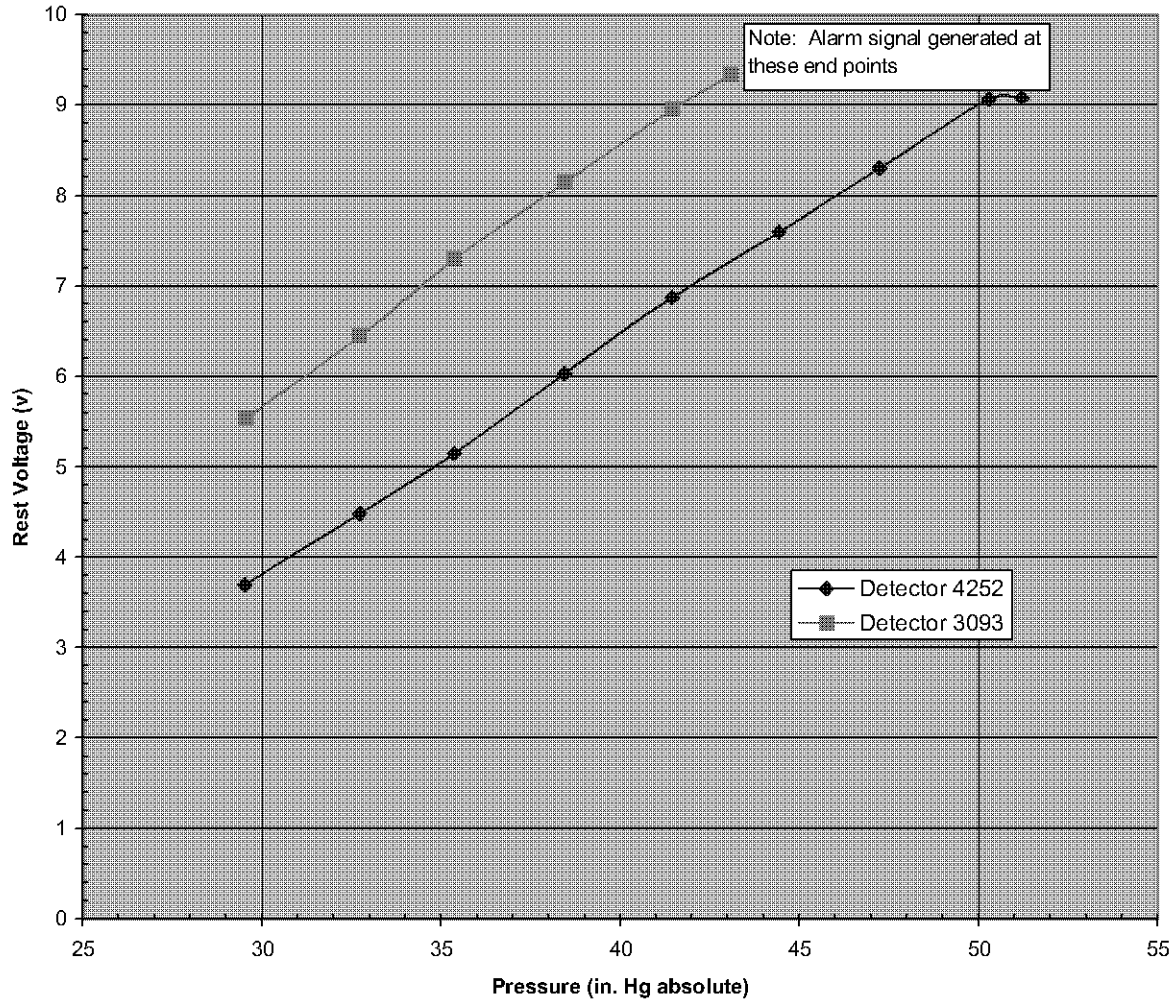
### AA 1291 Cargo Smoke Detector Pressure Test Results

Aft Cargo Compartment Loop 'B' Smoke Detector Sensitivity Test Results – Elevated Pressures
