**NATIONAL TRANSPORTATION SAFETY BOARD
OFFICE OF AVIATION SAFETY
WASHINGTON, D.C. 20594**

SYSTEMS GROUP CHAIRMAN'S FACTUAL REPORT OF INVESTIGATION

DCA06MA010

Operator: Flying Boat, Inc. DBA, Chalk's Ocean Airways
Aircraft: Grumman Mallard G-73T, N2969
Location: Miami, FL
Date: December 19, 2005
Time: 1439 Eastern Standard Time

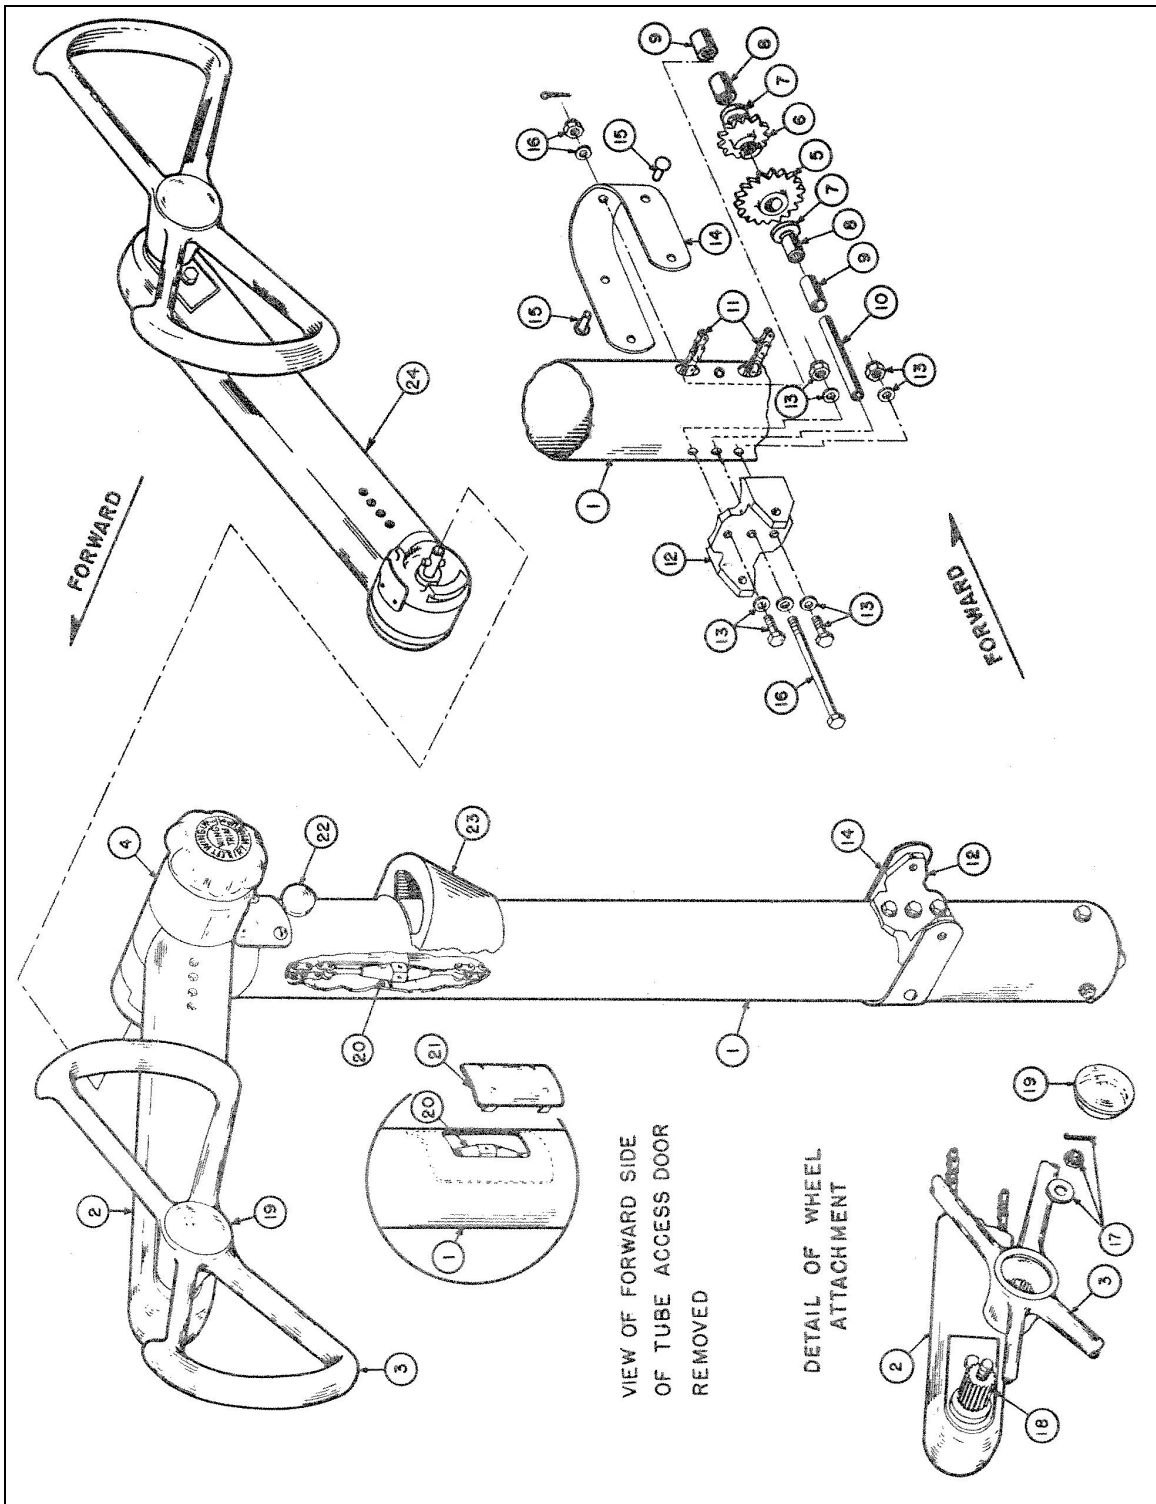
Figure 1. Control Wheel and Column

The ailerons are controlled by a throw-over wheel, which is mounted on the single control column (See Figure 1). The wheel is connected to the base of the column through two chain loops. The second chain loop is attached to two control cables. The cable run is illustrated in Figure 2. The cables terminate at a bellcrank on each wing. Motion of the bellcrank is transmitted to the aileron through a pushrod.

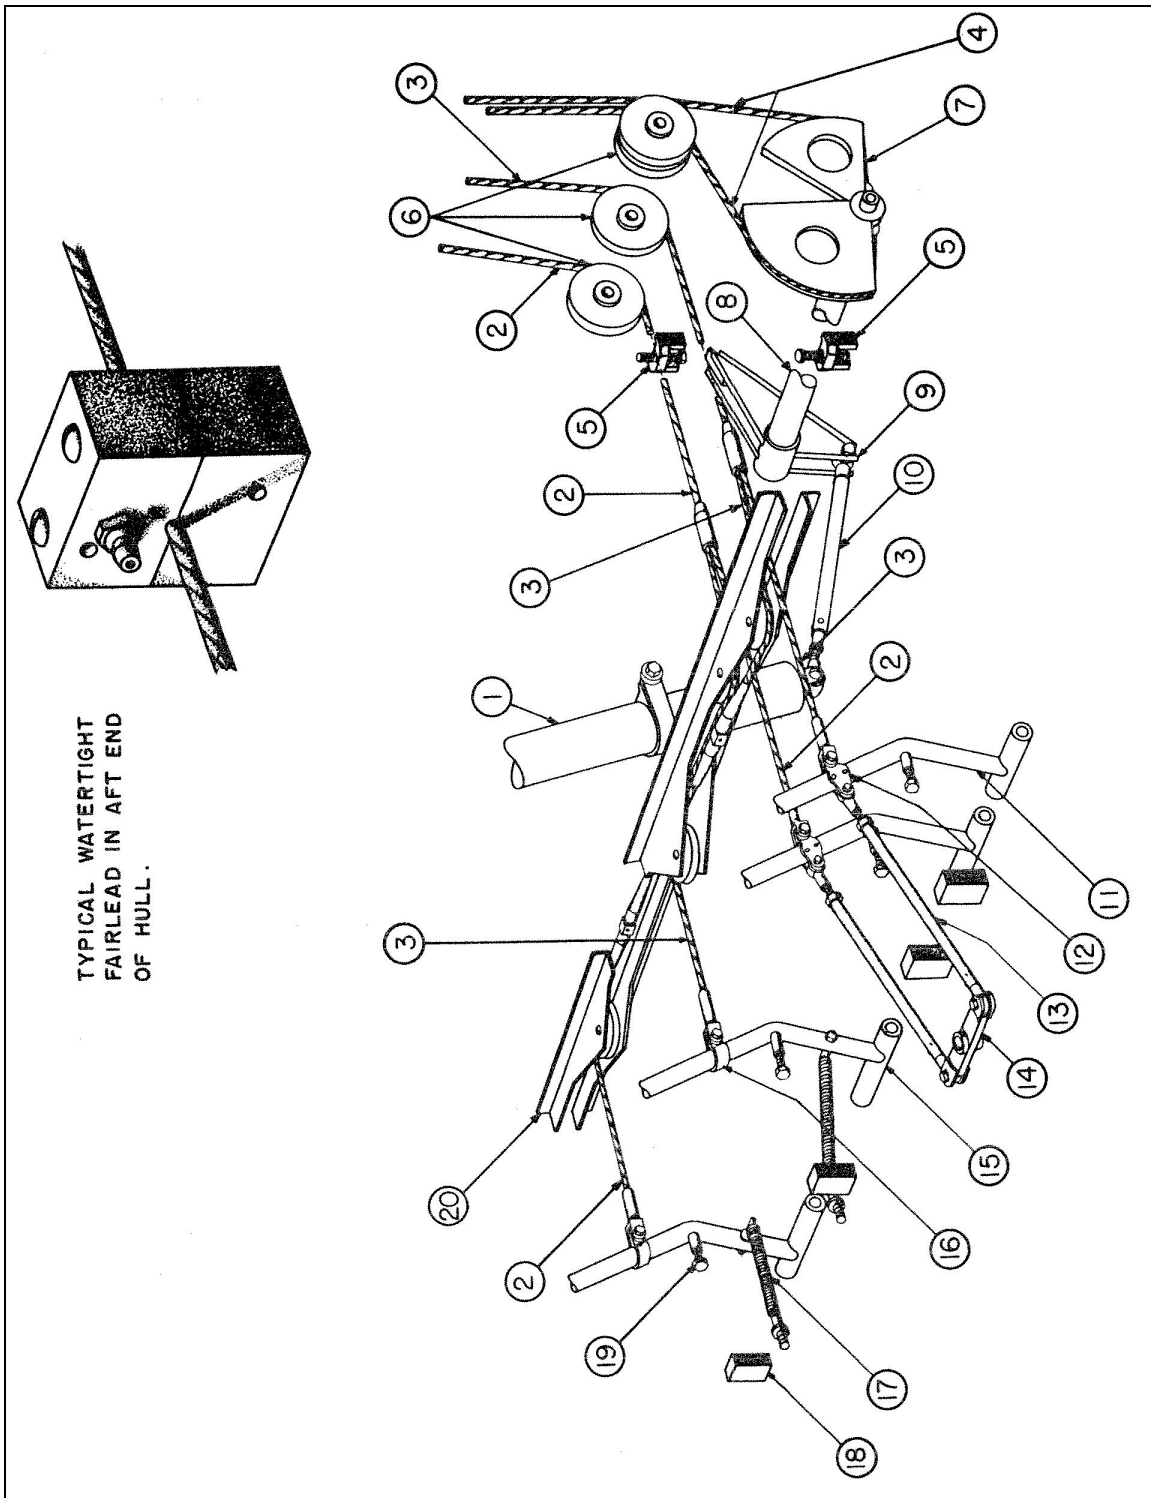
Figure5. Elevator and Rudder Controls.

The elevators are controlled through the column, mounted on the centerline of the airplane. The column is connected at its' base to a pushrod (Figure 5, item 10), which is connected to a bellcrank (item 9) mounted on one end of a torque tube (item 8). At the other end of the torque tube is a cable quadrant (item 7). The cables are routed as shown in Figure 6. The cables terminate at a quadrant between the two elevators. The quadrant is connected to torque tubes which extends to each elevator. The two torque tubes are rigidly linked at the quadrant so that they are only able to move in the same direction.

The elevator torque tube (Figure 5, item 8) was located in the wreckage (Figure 7). One of the control cables was detached from the quadrant, but one was still attached to a portion of the quadrant. It could be determined how the quadrant segment was attached to the damaged torque tube. The torque tube, bellcrank, and pushrod were damaged but still connected. The pushrod was fractured and separated from the base of the control column. The control cables were intact from the front cable quadrant to the aft quadrant. The elevators were found to be attached to the aft torque tubes and cable quadrant. Correct orientation of the control cables was confirmed.

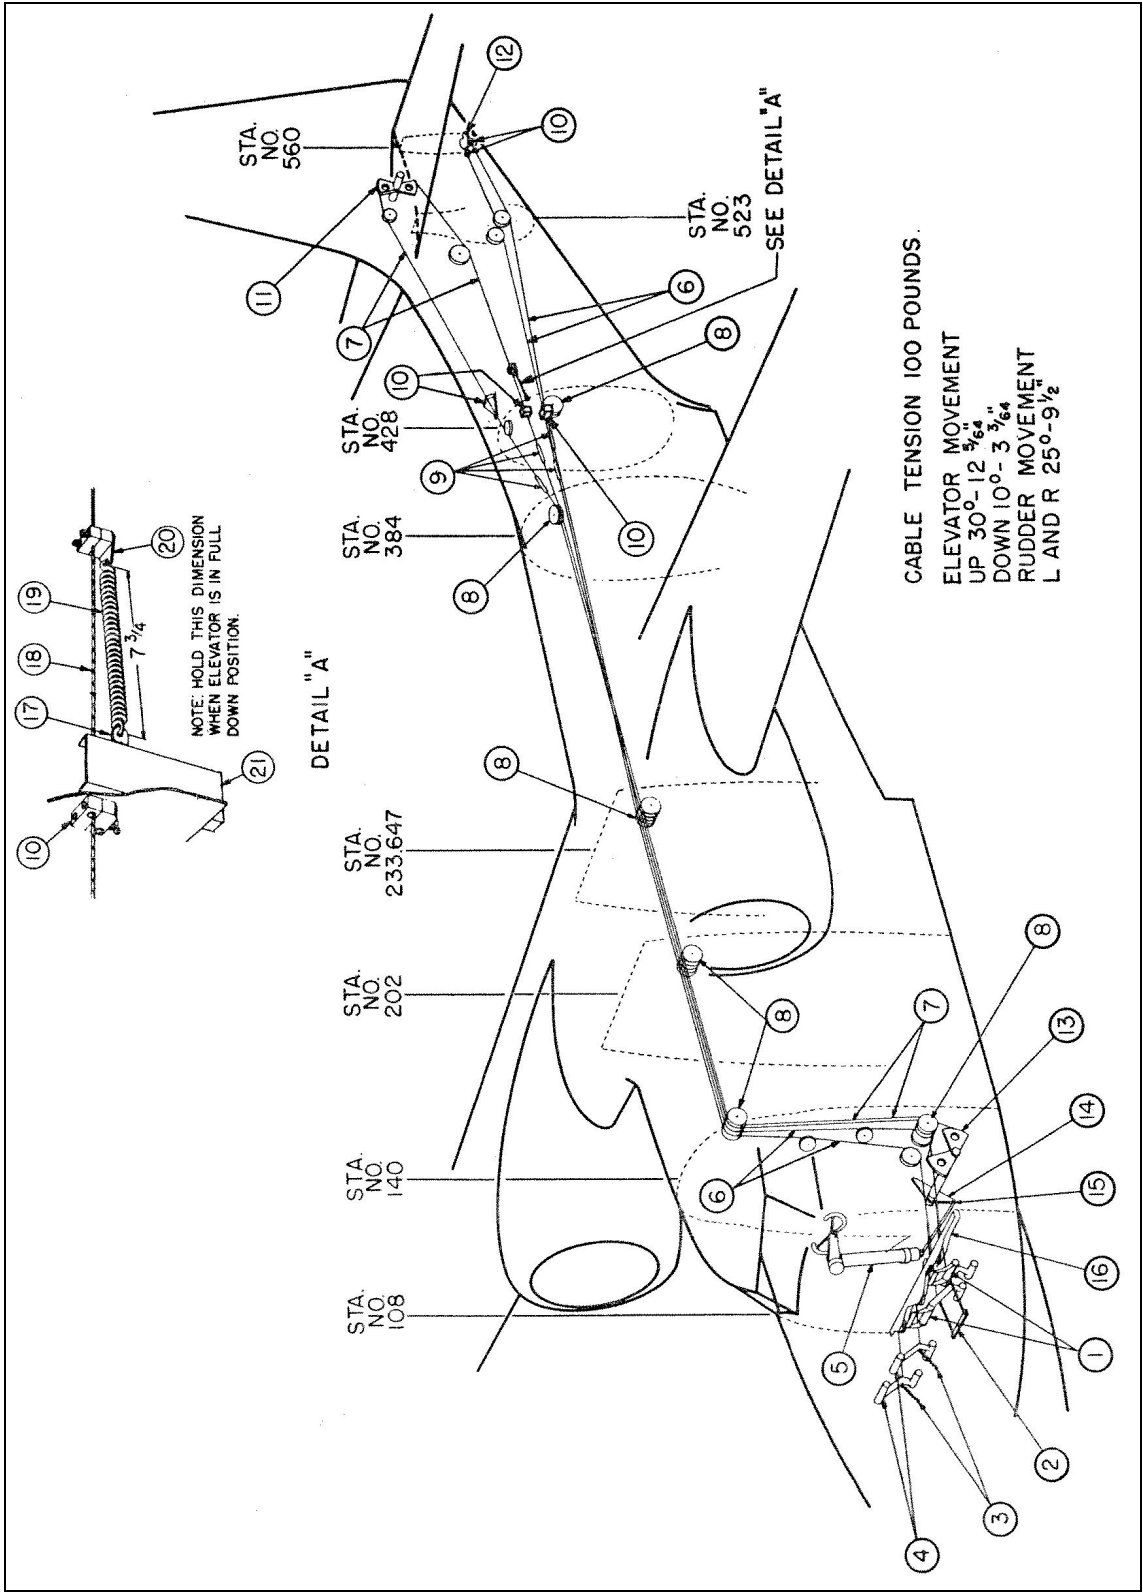
Figure 6. Elevator and Rudder Cable Routing

The rudder is controlled by a set of conventional pedals (Figure 8), which are connected through cables (Figure 5 and 6) to the rudder sector. An auxiliary set of pedals is installed for the co-pilot, and cables from these pedals are swaged to the cables from the captain's pedals.

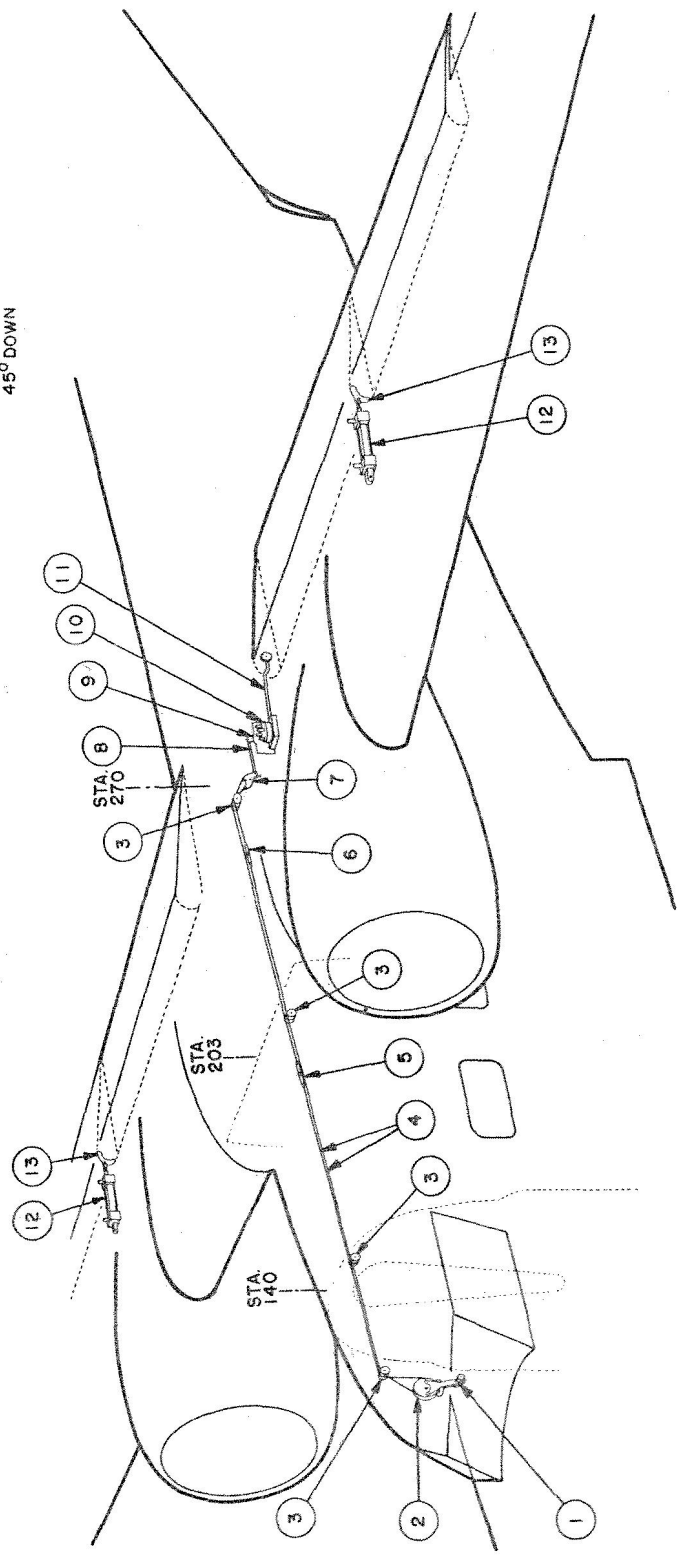
Figure 12. Wing Flap Control System.

The flaps are operated by a handle in the cockpit, which is connected through cables to a flap control mechanism and hydraulic selector valve mounted in the center section between the two flaps (Figure 12). The flaps are actuated by a hydraulic actuator on each flap. The position is fed back to the selector valve through a follow up rod.

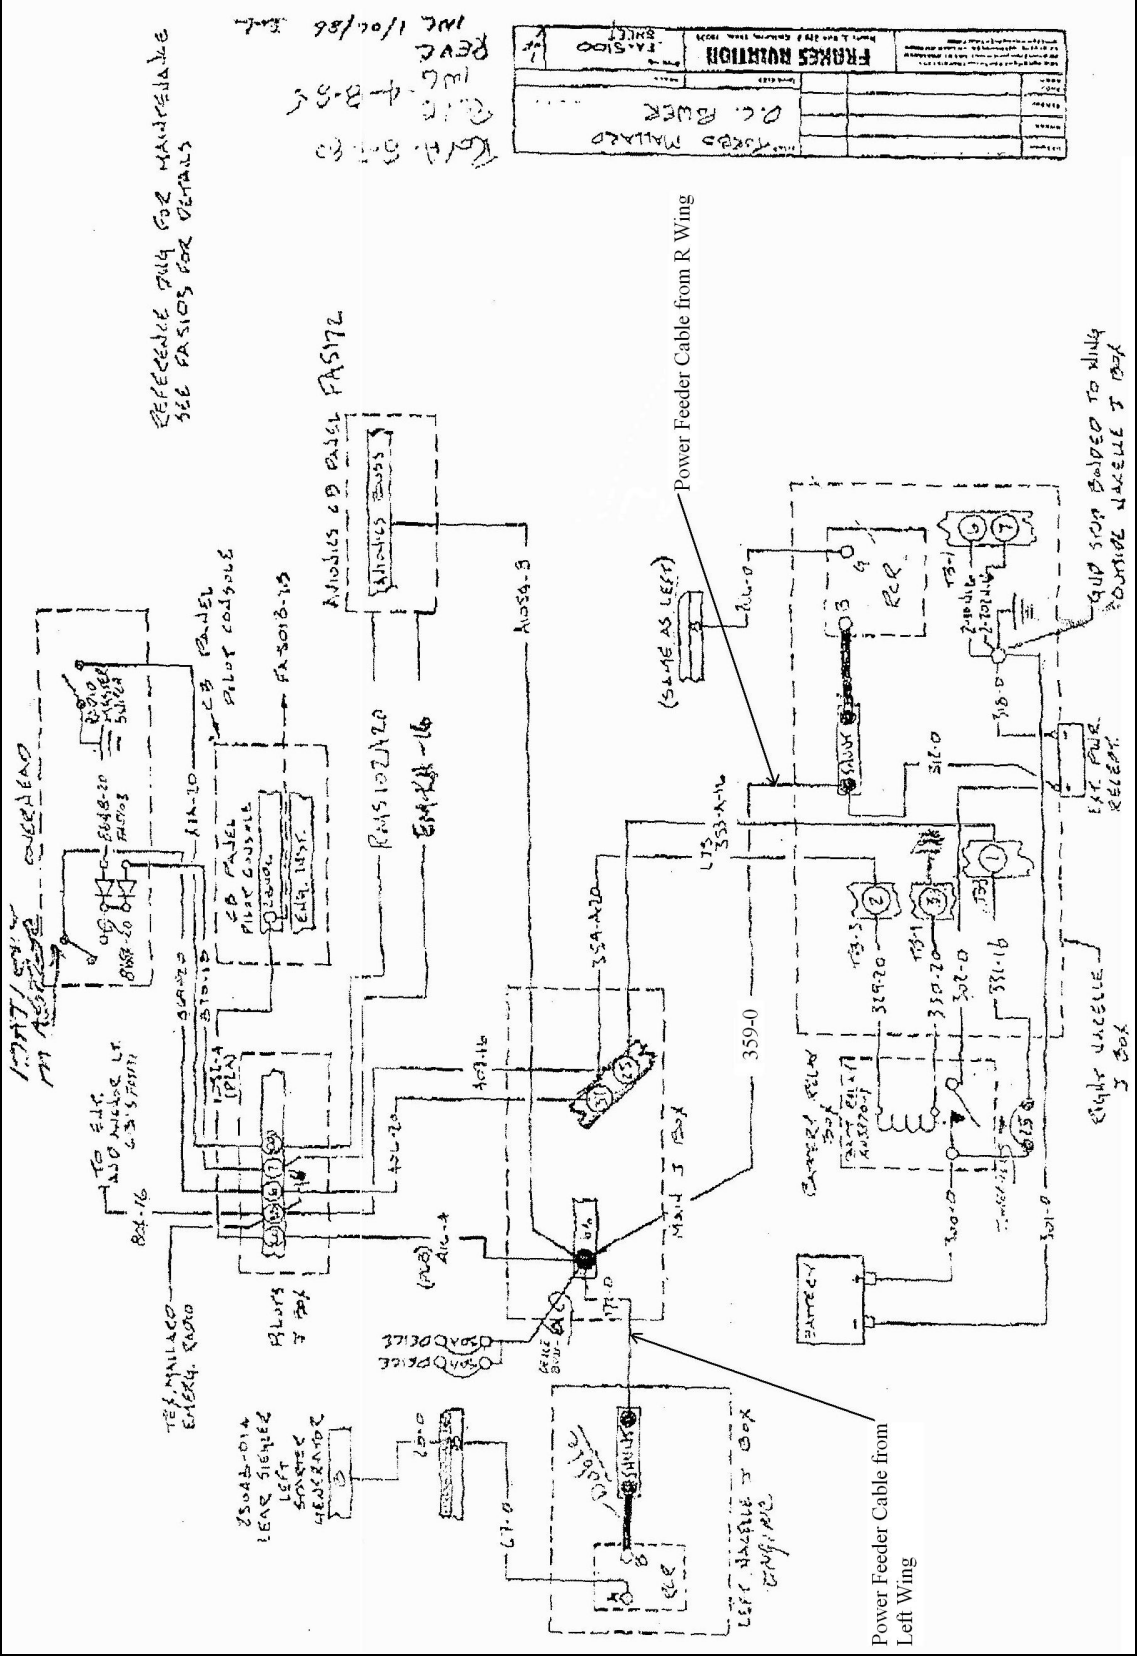
Figure 14. Electrical Power Schematic.

The Electrical system is a 28 volt DC system, powered by two generators (one on each engine) or a 24 volt, 34 amp battery when the engines are not operating. The wiring is shown in Frakes Aviation diagram FA-5100 (Figure 14). There is a single power feeder cable, which provides power from a junction box on each wing, through the wing box, to a stud in the main junction box in the fuselage.
