**NATIONAL TRANSPORTATION SAFETY BOARD
OFFICE OF AVIATION SAFETY
WASHINGTON, D.C. 20594**

SYSTEMS GROUP CHAIRMAN'S FACTUAL REPORT

NTSB ID No.: CEN11IA379

Location: General Mitchell Airport (MKE), Milwaukee, Wisconsin
Date: June 6, 2011
Time: About 2132 Central Daylight Time (CDT)
Aircraft: Bombardier CL600-2B19
Registration: N866AS
Serial Number: 7517
Operator: SkyWest Airlines

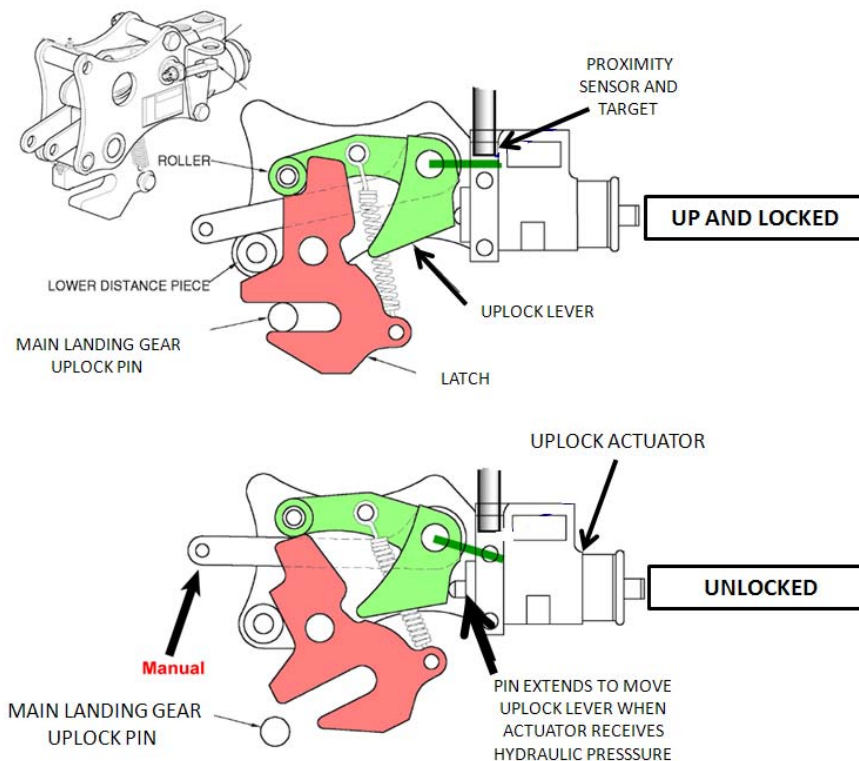
Figure 12 Schematic of the Uplock Assembly

Both MLG are equipped with an uplock assembly (Figure 12) that locks each MLG in the up and locked position. The uplock assembly consists of a latch, an uplock lever, an actuator, and a manual release lever all installed between two side plates. The uplock lever assembly incorporates a roller that engages the upper shoulder of the latch to secure the gear assembly in the up and locked position. A proximity sensor is installed on the exterior surface of the uplock assembly and detects when the gear is up and locked.

Through a manual gear extension system, there is a provision to unlock the MLG uplock assembly for emergency gear extension. This application enables the uplock to disengage from the mechanical uplock position and allow the MLG to extend by free fall method.
