**NATIONAL TRANSPORTATION SAFETY BOARD  
OFFICE OF AVIATION SAFETY  
WASHINGTON, D.C. 20594**

**Systems Group Chairman's Factual Report of Investigation**

Operator: UPS  
Aircraft: A300-600F, MSN 841  
Location: Birmingham, AL  
Date: August 14, 2013  
Time: 4:47 AM Local Time

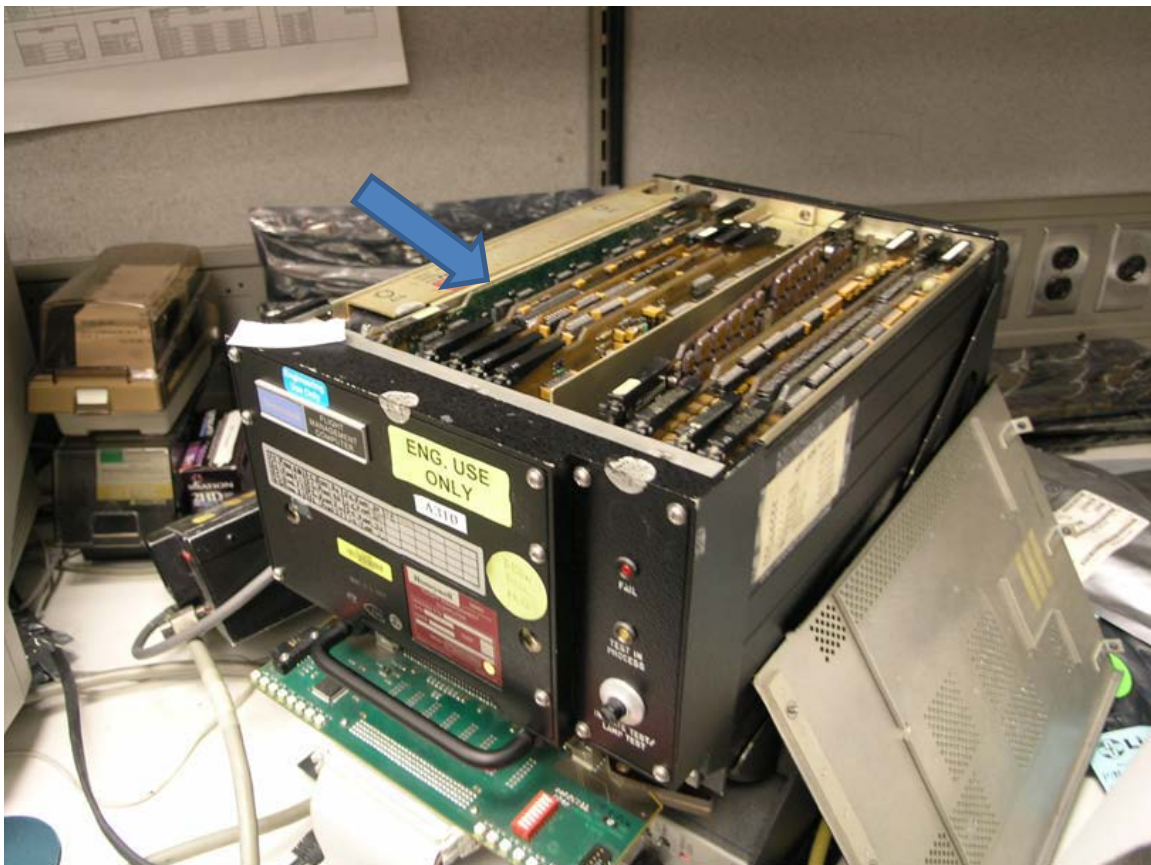
Figure 8 Known Good FMC with Accident MMC Installed

On Sept 13, 2013 NTSB representative Albert Nixon, picked the package up from the Sky Harbor facility (with both MMCs inside the package together) and hand carried it to the Honeywell, Deer Valley facility in Phoenix, AZ. Then the NTSB and Honeywell personnel convened to download the information from the MMCs. MMC SN 1789290 was cleaned of dirt and debris and inserted into a working FMC (part number 4052510-983) so that the test equipment could access the MMC data (Figure 8). The data was successfully downloaded. MMC SN 61697077 was cleaned of debris and inserted into the FMC. The test bench was able to communicate with the MMC to download the data, but the data appeared to be corrupted. However, the FMCs dual design would have assured, under normal conditions, that the flight plans were the same on both FMCs. Honeywell did confirm in the data that the FMC mode was not independent and was in fact in dual operation mode, so the one MMC card provided all the necessary data for analysis.
