**NATIONAL TRANSPORTATION SAFETY BOARD**  
Office of Aviation Safety  
Washington, D.C. 20594

**SYSTEMS GROUP CHAIRMAN FACTUAL REPORT ADDENDUM FOR  
ELECTRICAL WIRING INFORMATION**

**A. ACCIDENT: DCA96MA070**

**Airplane :** Boeing 747-131, N93119  
Operated as Trans World Airlines (TWA) Flight 800

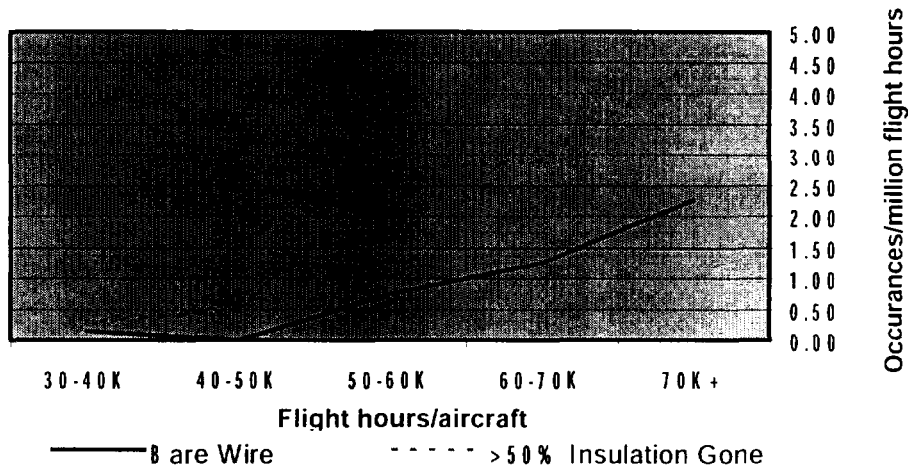
Figure 1: Age-Related Wire Failure

include both wire degradation (e.g., cracking, embrittlement) and nonwire-related aircraft aging. Aging factors independent of wire degradation may include an increased frequency of collateral wire damage associated with nonwire-related maintenance actions.

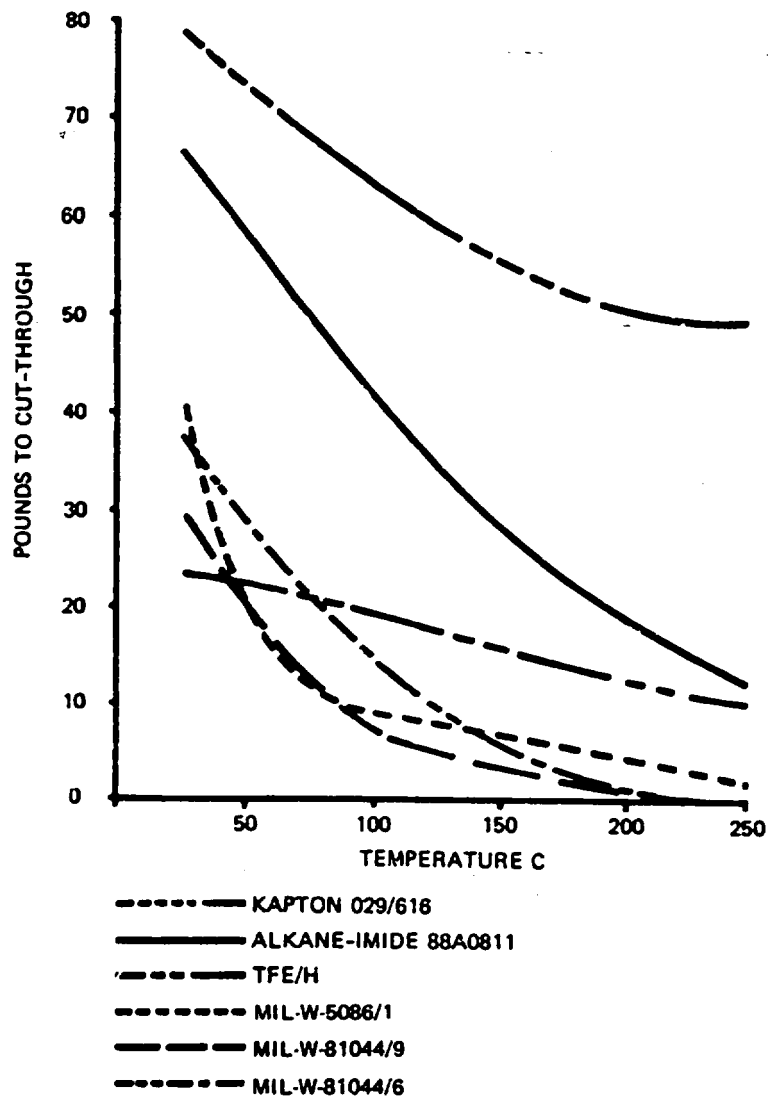
FIGURE 15. DYNAMIC CUT-THROUGH CLASS 1 WIRES

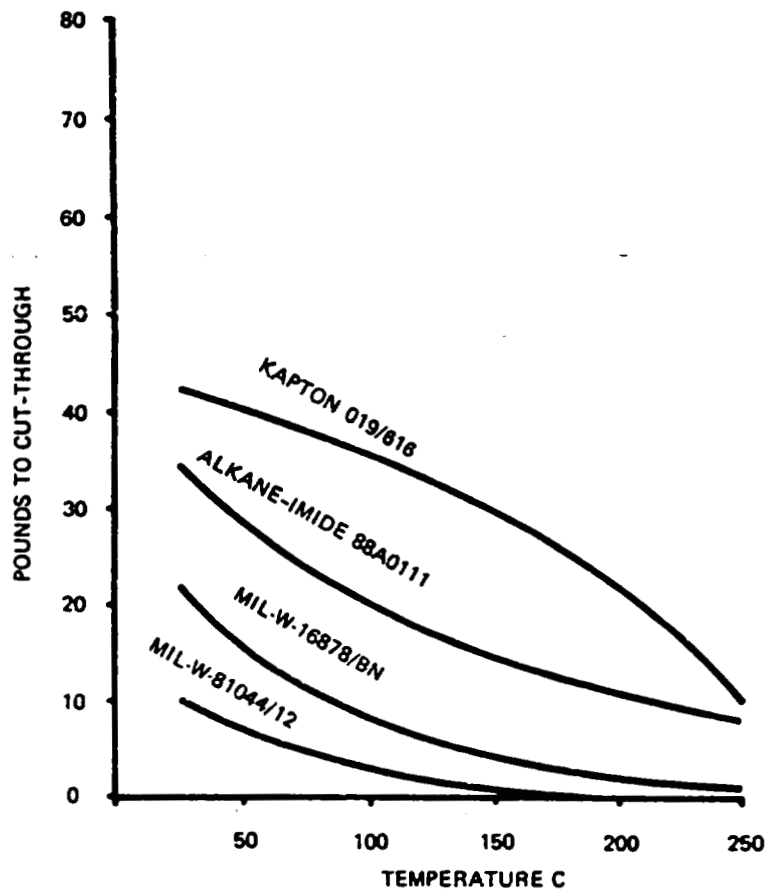
FIGURE 16. DYNAMIC CUT-THROUGH CLASS 2 WIRES

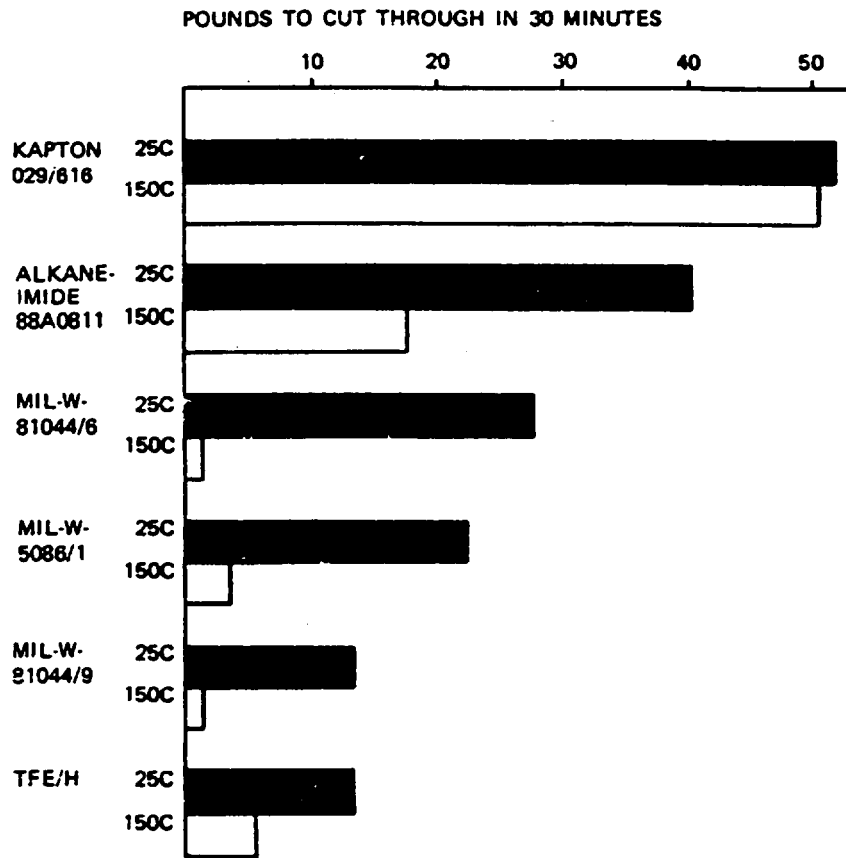
FIGURE 18. STATIC CUT-THROUGH OF CLASS 1 WIRES

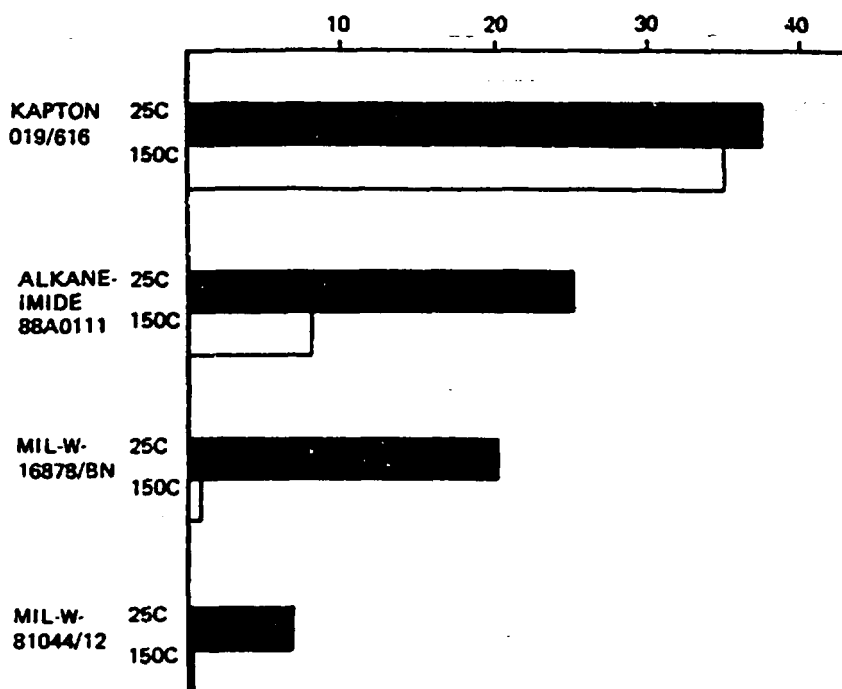
FIGURE 19. STATIC CUT-THROUGH OF CLASS 2 WIRES

In the dynamic cut-through test the very high modulus Kapton wires have the highest cut-through values. The alkane-imide 88 type wires have very significantly higher cut-through values than any of the other wires tested. Indeed, even at temperatures well in excess of its rated temperature, the alkane-imide 88 type wire has cut-through values higher than the values obtained for all other non-imide wires at their rated temperatures.

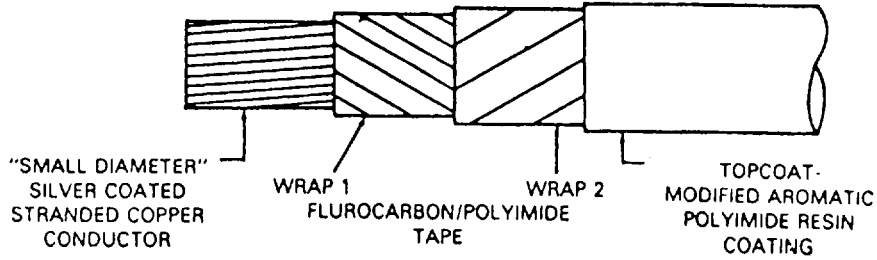
Figure 4 Structure of MIL-W-81381/11 aromatic polyimide film bonded with FEP-Teflon™

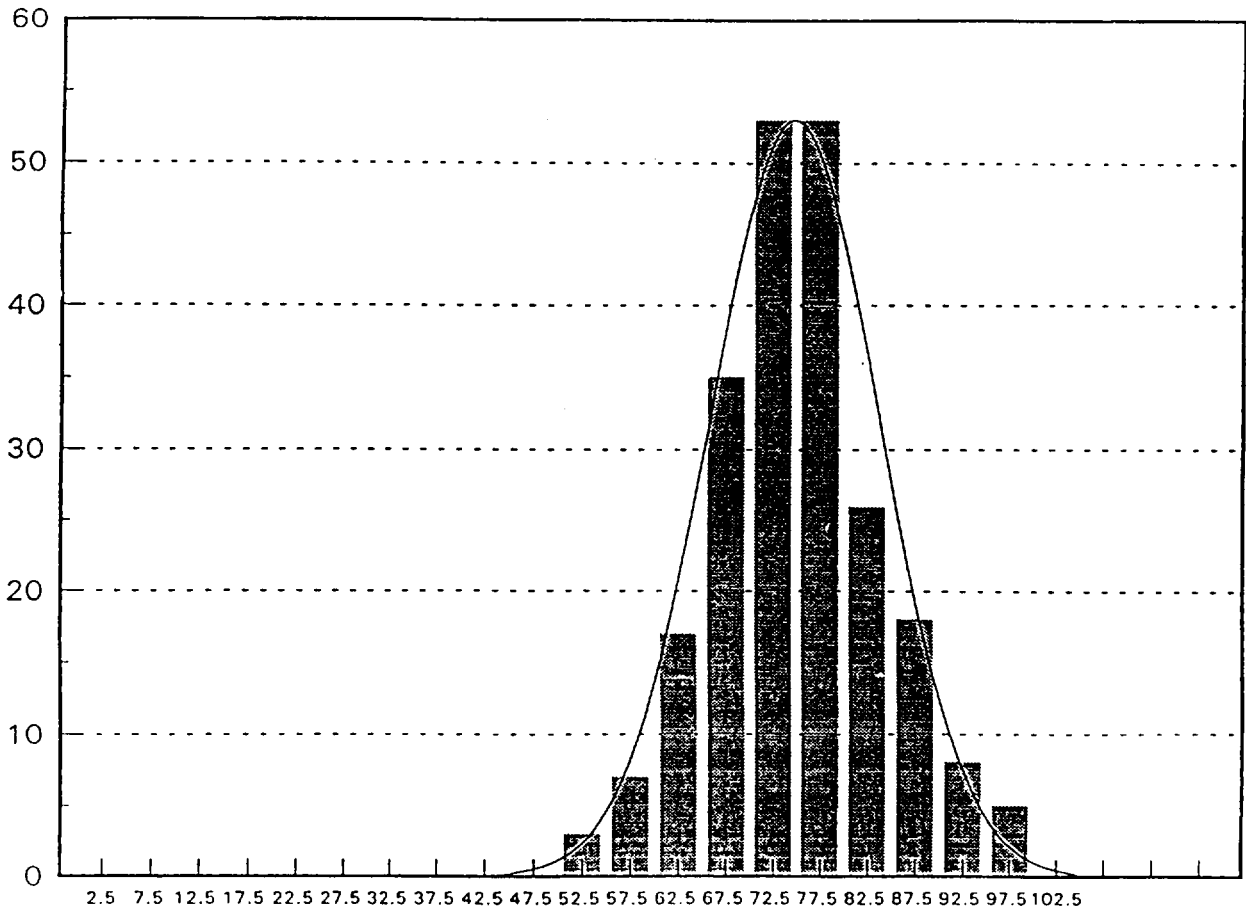
Figure 6 Failure rate curve for 256 contiguous specimens of MIL-W-81381. Abscissa shows the average test time in hours of the interval test time to indicate crack in the insulation structure progressing to the inside conductor. Ordinate is number of specimen failures per test time interval.

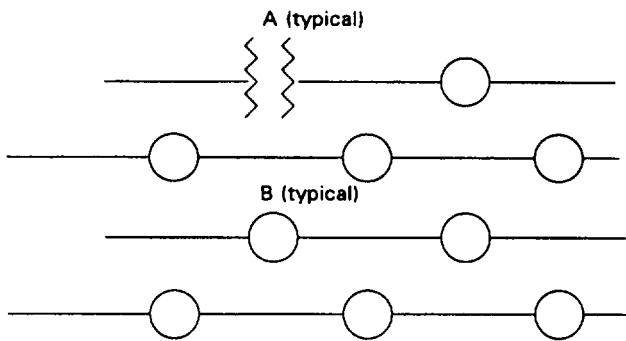
Figure 7 Schematic of repeat units (lines), polymerization points (B), and incomplete polymerization or scission points (A).

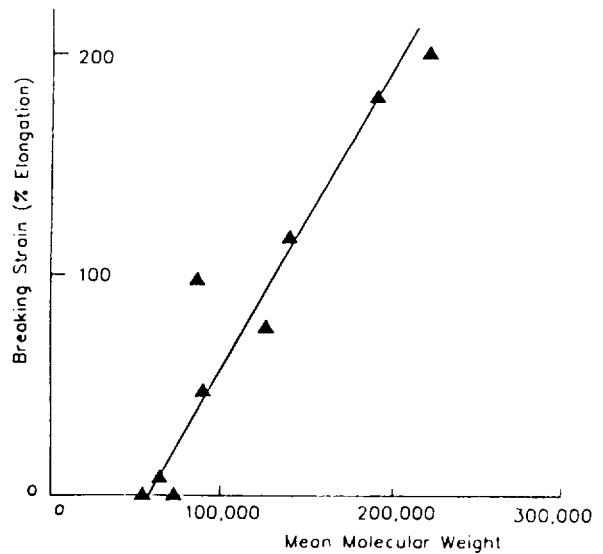
Since one can calculate the rate at which the polymer shortens for any combination of moisture, temperature, and aging strain, and the failure strain is defined by Figure 8, one can calculate the “life” of the insulation.

Figure 8 Breaking strain elongation vs. mean molecular weight (MMW) of Polymer.

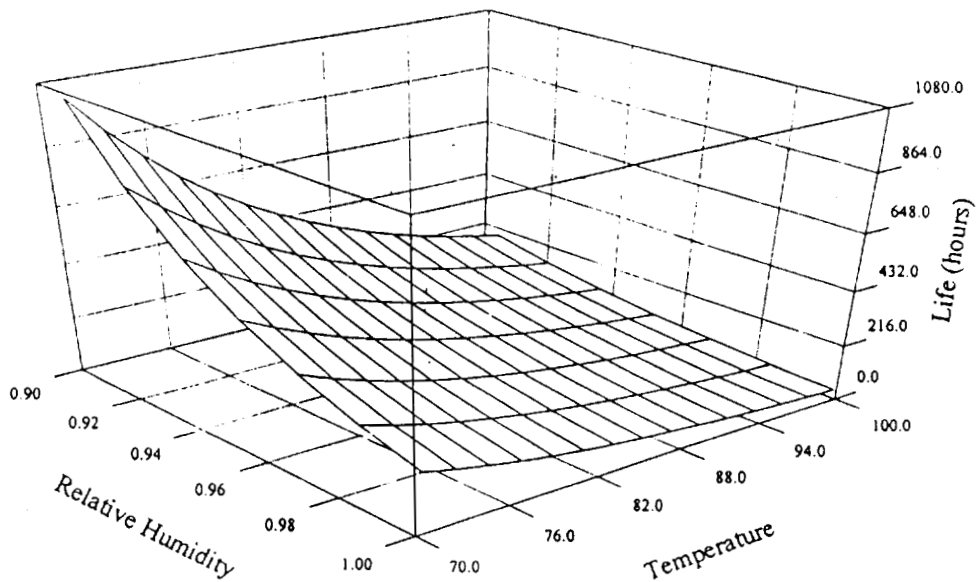
Figure 9

Figure 9, second page following, indicates the typical variation in age to fail at a ½ inch diameter wire bend as a function of temperature and humidity. Of course, if we are concerned about an “excessive trauma” such as a mechanical blow, chafing, etc. the polymer may reach the failure point with less shortening of the polymer chain. This can be analyzed on paper, measured in the laboratory and field, and results observed on “hard usage” aircraft. Figure 10, three pages following, is one such example. Much of some organizations' effort is aimed at this excessive trauma situation. Of course as aircraft wiring ages, amelioration of this effect becomes increasingly expensive and difficult. In addition efforts have been made to protect aircraft with polyimide insulation from moisture, as examination of the fundamental relations of the reference development reveal that the life of aromatic polyimide is very long if the material is protected from water. Practical implementation of protection from water is yet to be demonstrated, as far as we know.

Variation of life in hours of one group of MIL-W-81381 as a function of the temperature ( $^{\circ}\text{C}$ ) and relative humidity (%). All specimens aged with a continuous  $\frac{1}{2}$  inch bend. Confidence limit 1% probability of any failure before time indicated. Similar curves exist for other aging bend diameters and failure stresses.

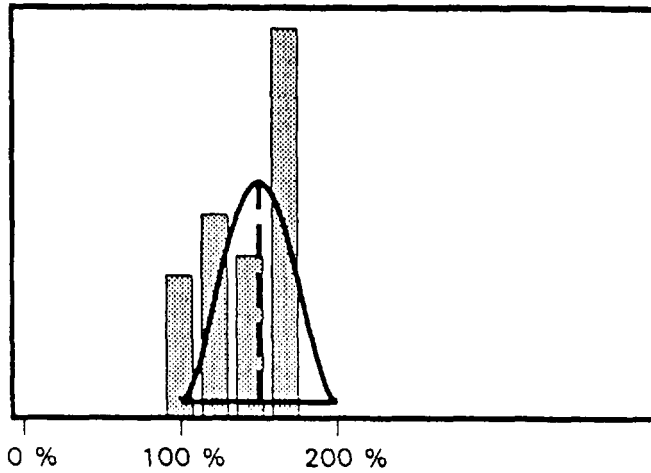
Note a second type of failure, distinct from normal aging failure is common in some aircraft types we have examined. This "excessive" trauma can be identified by measuring existing failures vs age of the wiring. This process can be observed in Figure 12 and Figure 13.

Figure 12 Age measurement of a batch of new polyimide wire. Abscissa is percent of life remaining as a percent of the shortest life expectancy of new specimens. Ordinate is the failure rate.

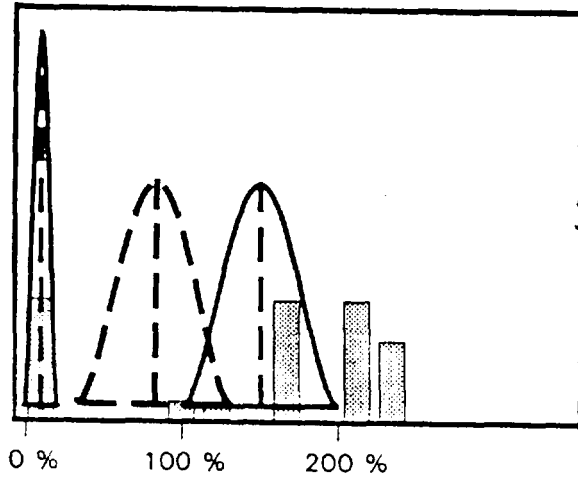
Figure 13 Measurement of the same wire from an active aircraft in maritime service since 1981. The left hand bell are the number of specimens which had already failed at the time specimens were removed. Note the bell is shown for clarity but all specimens were failed at time zero. The right hand bell is the normal aging distribution, in this case indicating essentially no aging since 1981 for this group. The dashed bell is the expected distribution of aging in more severe environmental locations. Note associated with this partially aged group is a lower resistance to trauma.

This composite report of Figures 12 and 13 provide the basis for predicting the improvement in aircraft reliability to be expected from remedial work. Partial rewiring, standard repair, and training programs will help for the two solid bell curves of Figure 13. Those actions will not cure the problem revealed by the solid left-dotted center bell, nor the dotted bell with no left bell curve.

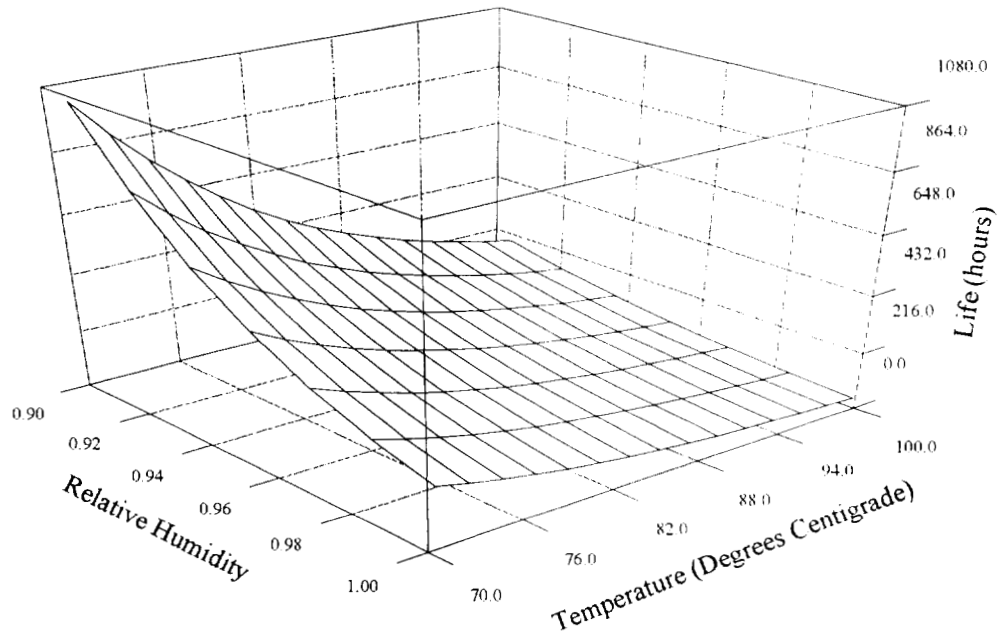
Figure 13. Time to first insulation fracture of aromatic polyimide for a one half inch diameter bend as a function of temperature and humidity.

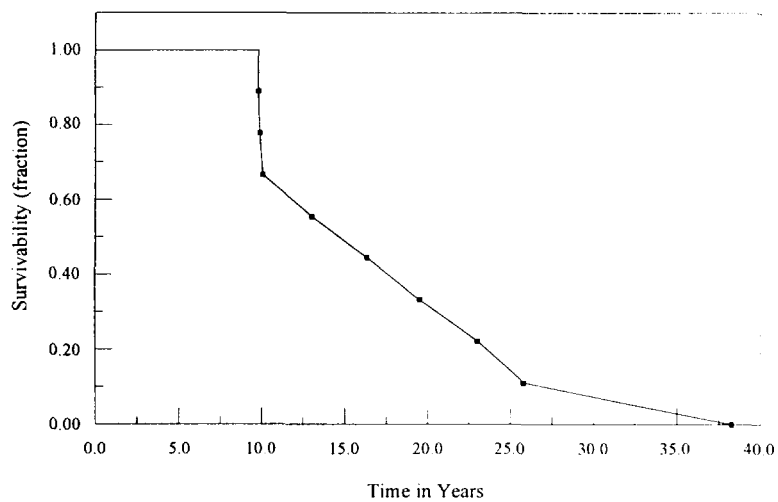
Figure 14. Insulation breaching probability in a specific aircraft zone (zone 32) of a fighter, based upon sampling tests of active aircraft wire (thirty feet of removed wire from 100,000 feet in an active aircraft). Similar projections have been verified by field follow up of projections initiated in 1990 on other A/C.

**Zone 32 Survivability Curve (Independent of Date)**
