DOCKET NO. SA 509

EXHIBIT NO. 9B

ANALYSIS OF USAir FLIGHT 1016

**SUBMITTED TO THE NATIONAL TRANSPORTATION SAFETY BOARD
31 AUGUST 1994**

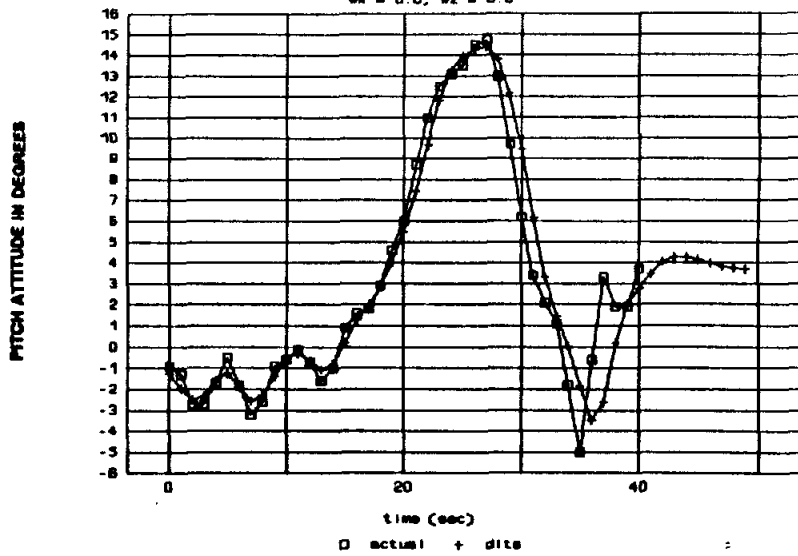
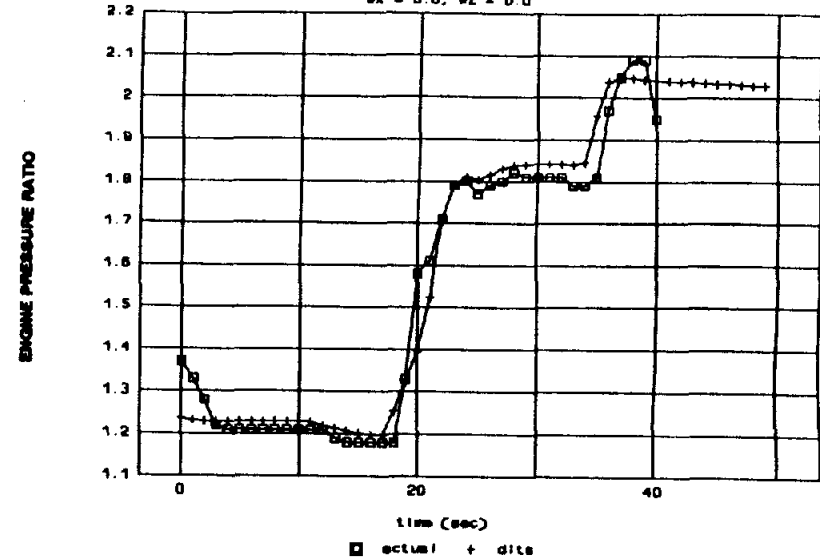
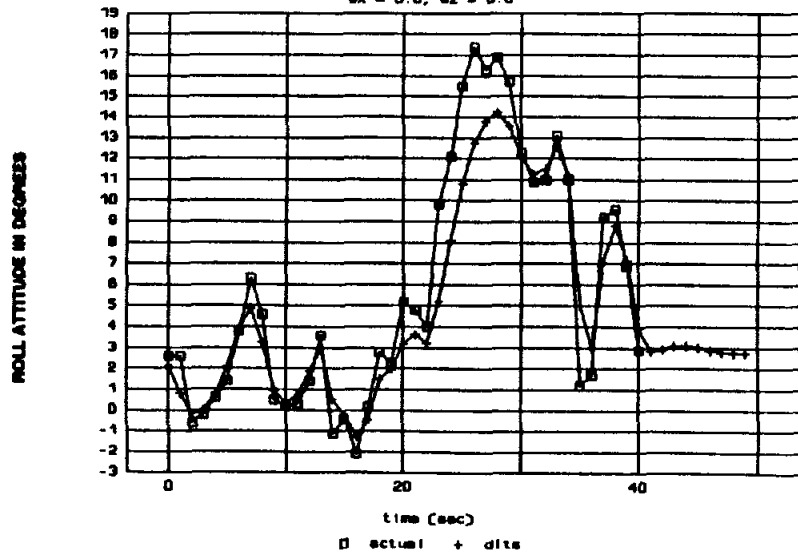
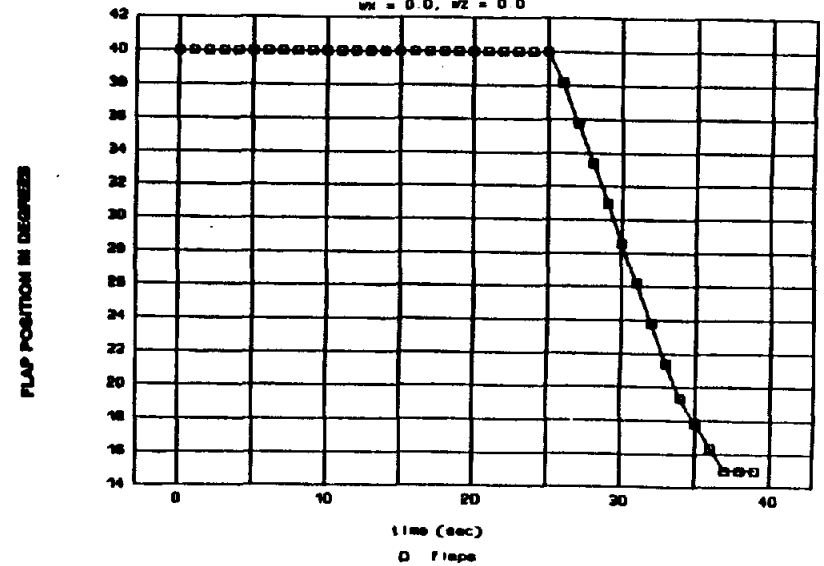
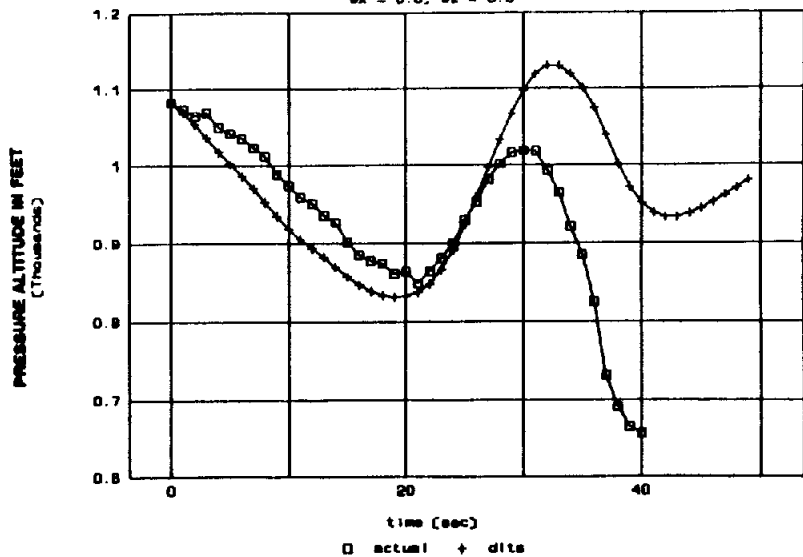
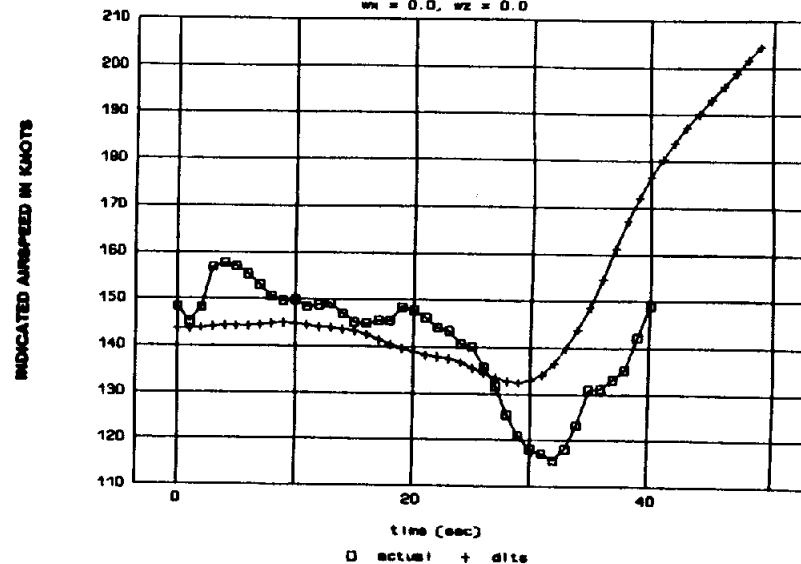
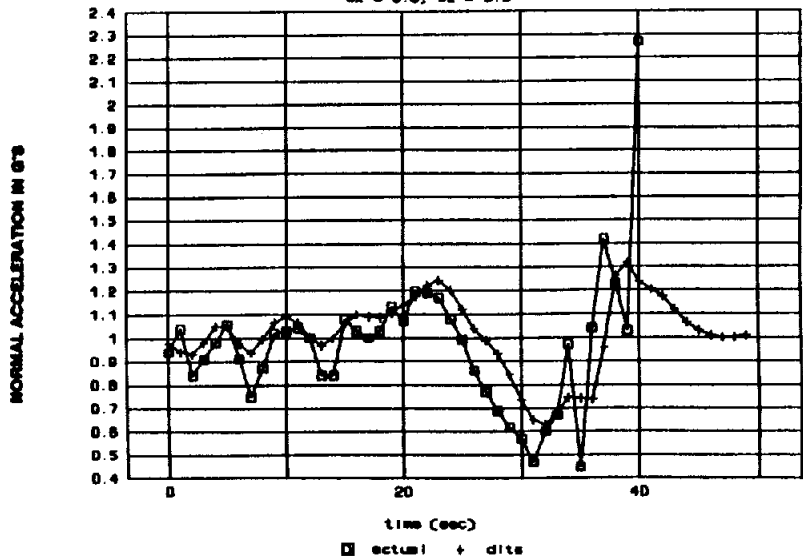
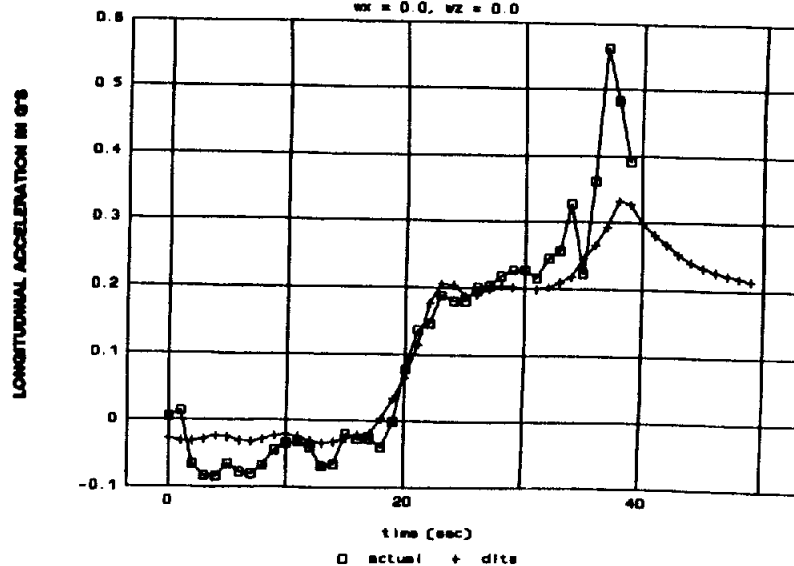
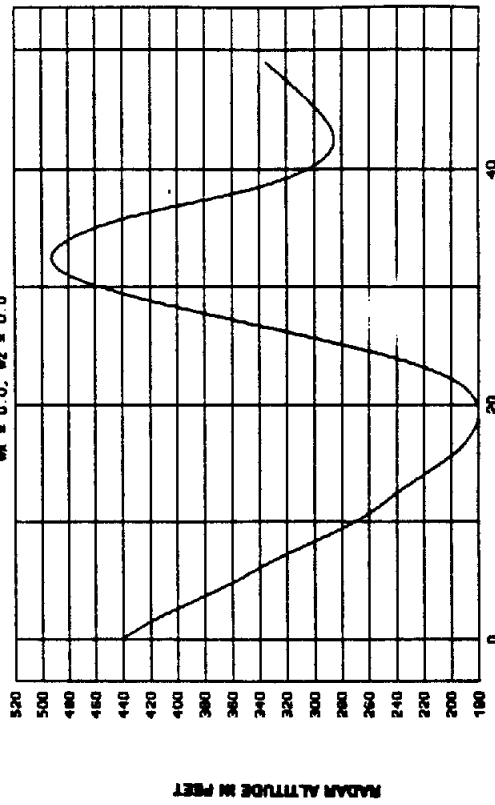
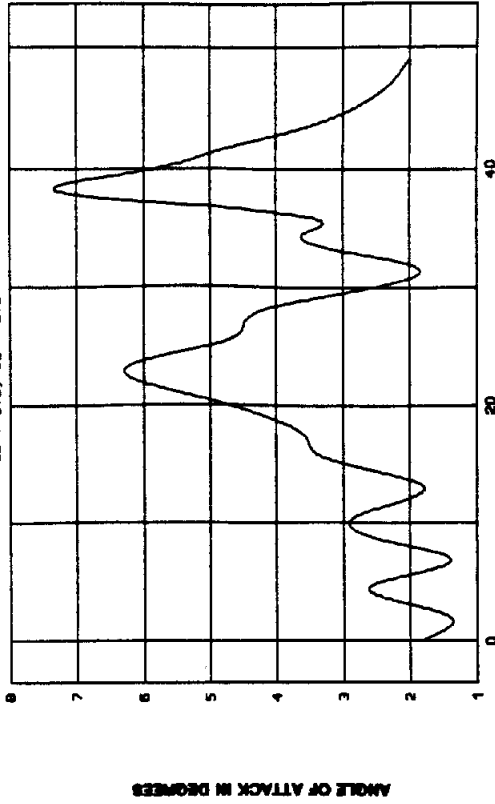
simulated aircraft's pressure altitude never decreased below 900 feet, and indicated airspeed continuously increased after execution of the go-around maneuver. Since vertical and longitudinal windshear directly affects these two parameters, these results were not unexpected. Data from this run are shown on Figures 1 to 10 inclusive.

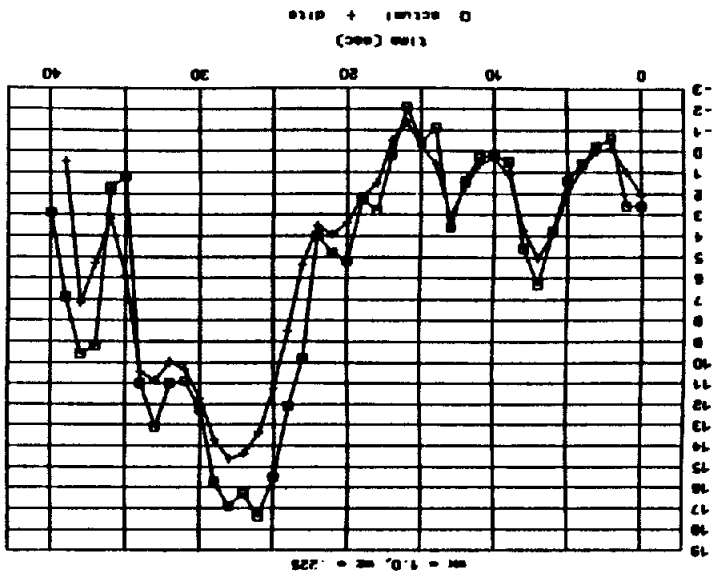
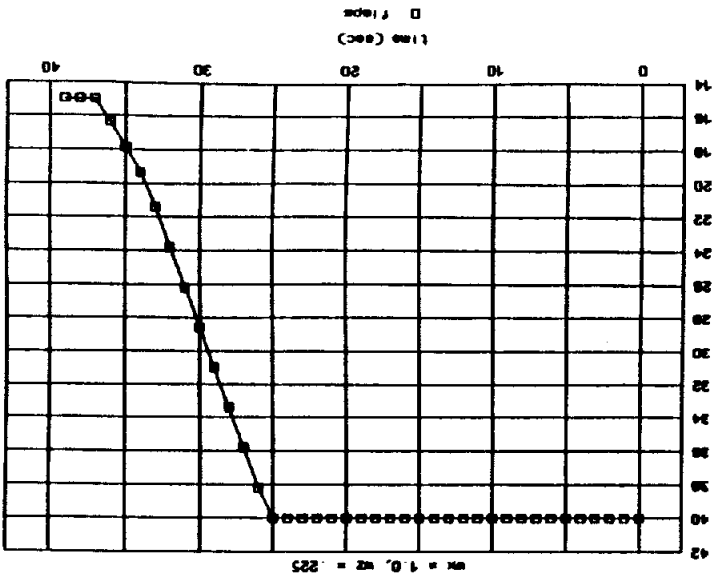
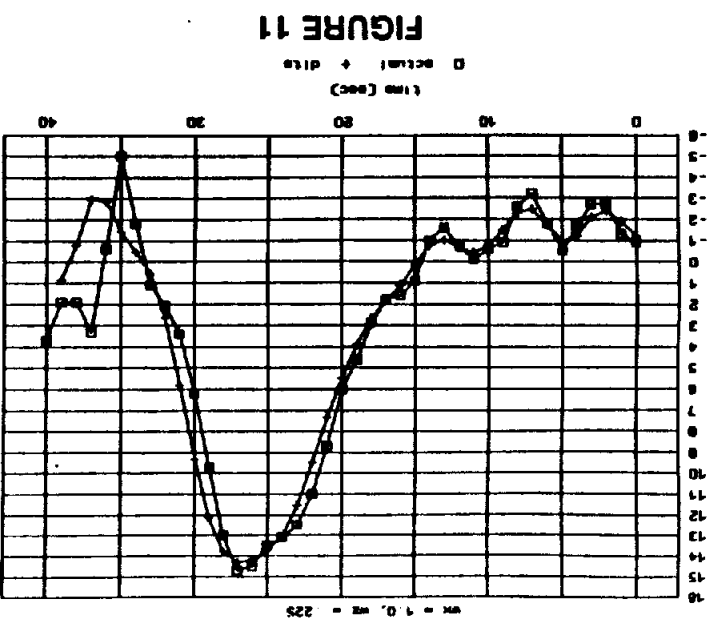
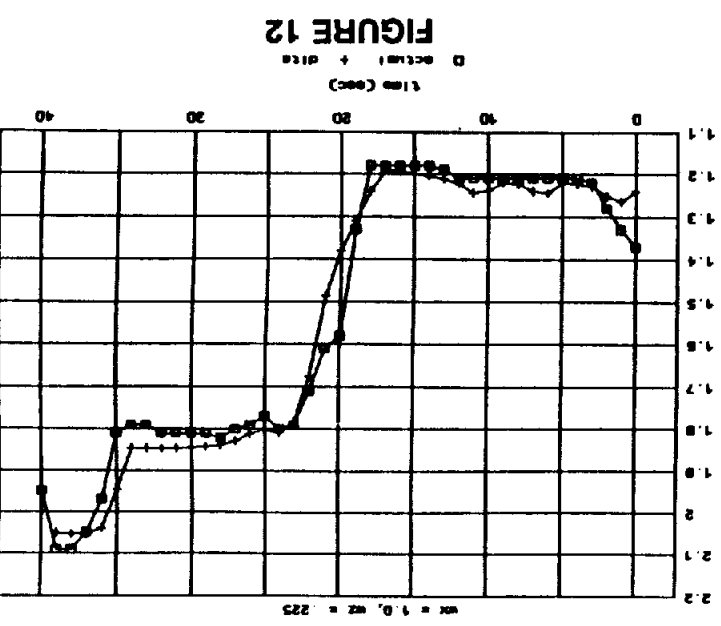
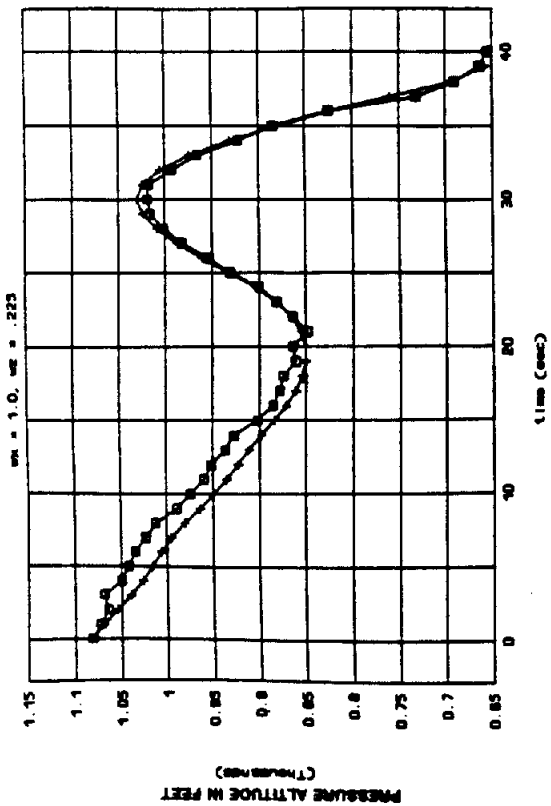
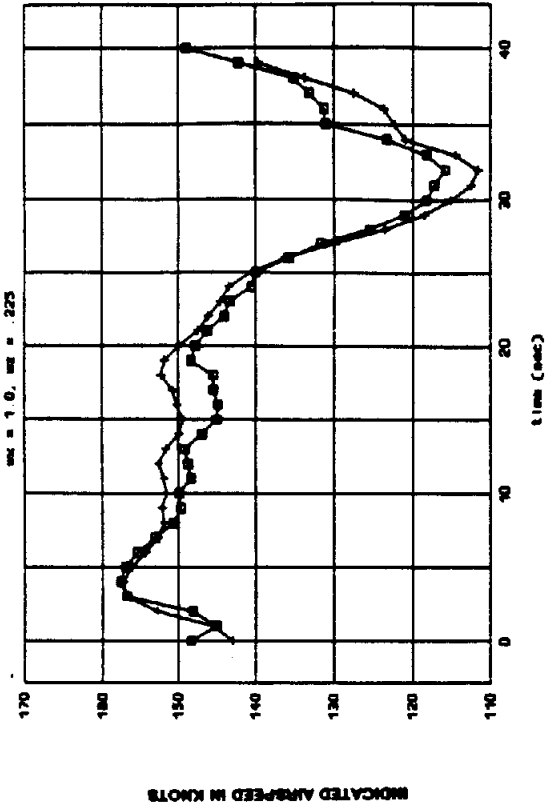
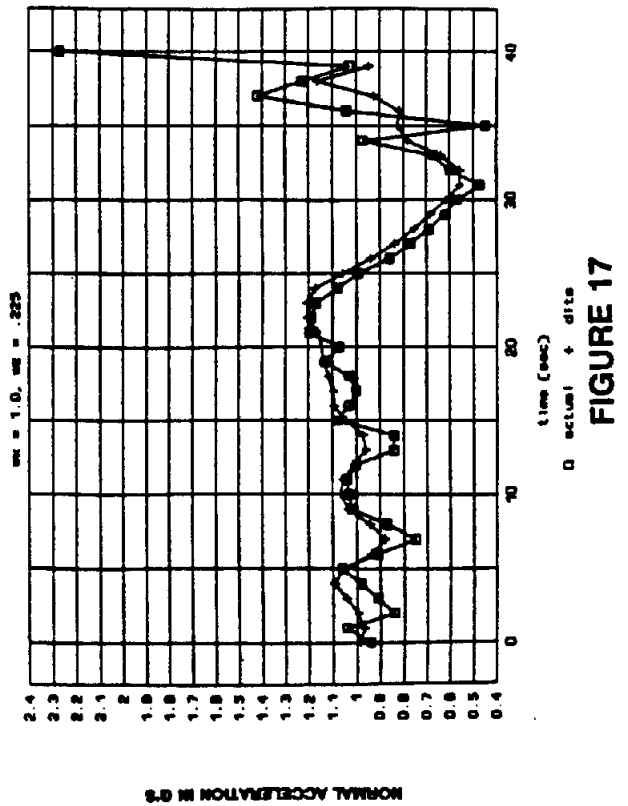
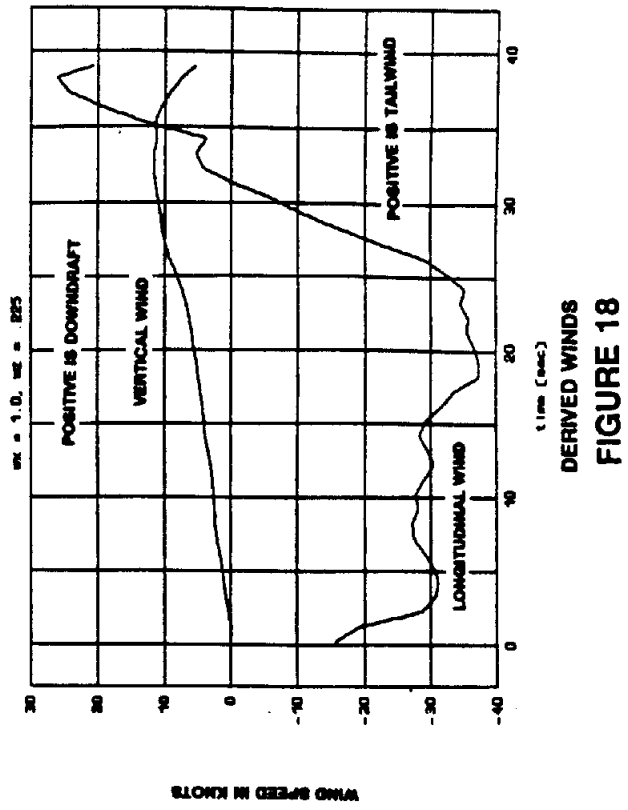
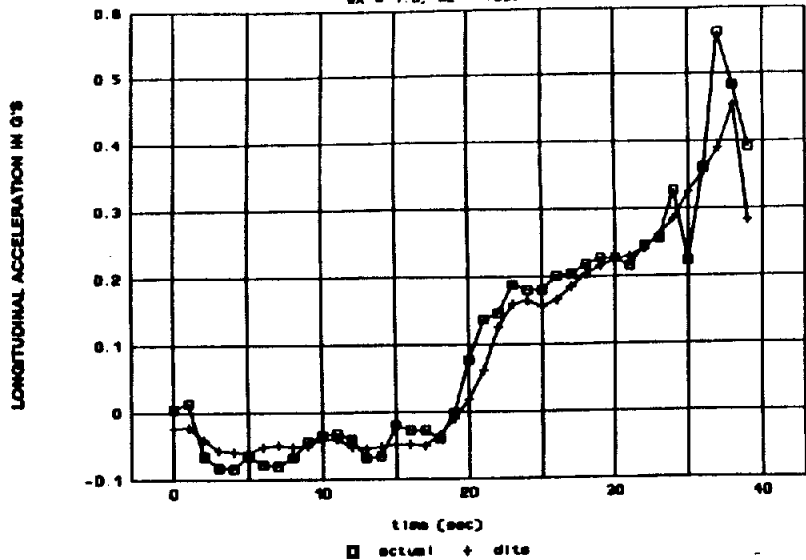
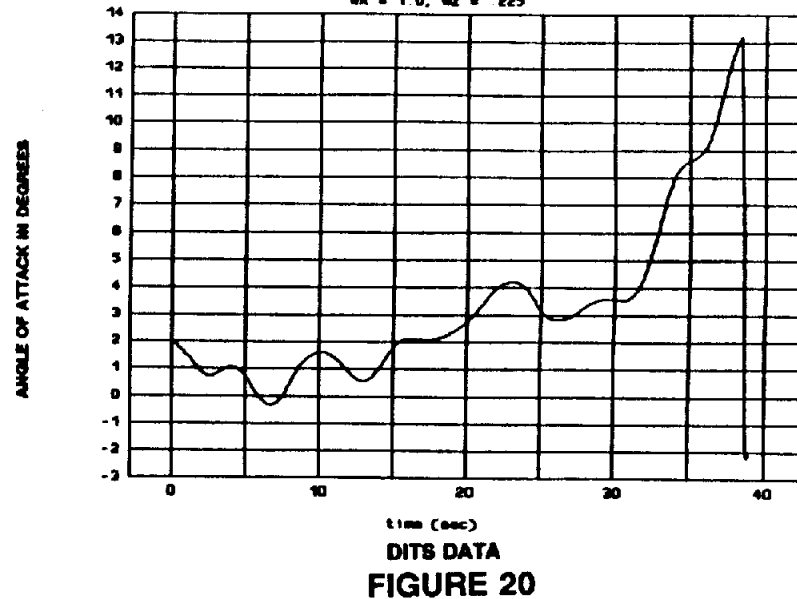
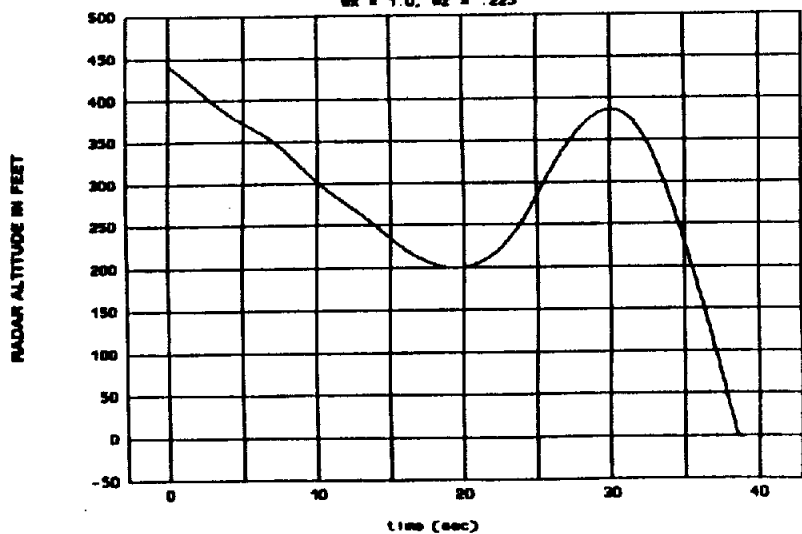
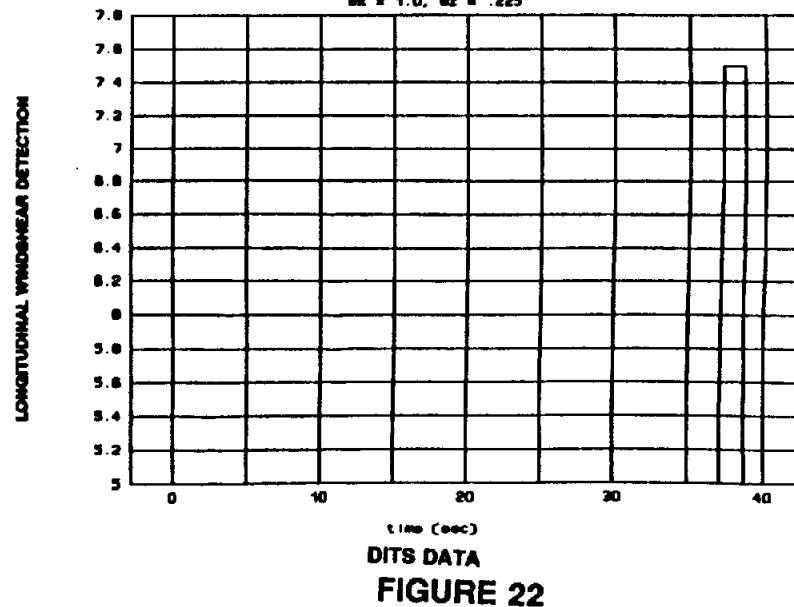
Data for the run with derived winds are shown on figures 11 to 22 inclusive.

One difference noted during the simulator tests was that stick shaker was not activated during the entire run. Data supplied by the NTSB showed stick shaker activation during the final seconds of the flight. The peak angle of attack seen in the derived winds case was 13.3 degrees (relative to the fuselage reference line, FRL). Assuming the flaps had retracted to 15 degrees at this time (simulator data shows that to be the case), the stick shaker angle of attack should have been 18.6 degrees. Even accounting for the angle of attack rate term that is used in the stick shaker activation system which has the potential to reduce the angle of attack for activation by approximately 2.5 degrees (effective stick shaker angle of 16.1 deg.), no stick shaker activation would have occurred. However, it should be noted that the DITS simulator does not include a simulation of the effects of very heavy rain, which to date are not well understood, and it is conceivable that this may have played a factor.

It should be noted that the longitudinal shear did not occur until after the execution of the go-around maneuver. It began approximately when the engine pressure ratios had achieved 1.8. The pitch attitude was about 13.5 degrees and the roll attitude was 15.5 degrees. The flaps were in the process of retracting from 40 to 15 degrees.
