Boeing Stabilizer Trim Mechanism Examination Report

**TO:** Air Safety Investigations (ASI) **EQA NUMBER:** AS12067  
**DATE:** July 14, 2014  
**MODEL NUMBER:** 747-400BCF  
**AIRPLANE NUMBER:** RT075

**SUBJECT:** *Examination of Stabilizer Trim Drive Mechanism Assembly*

**FRACTURE ANALYSIS REPORT****Engineering Report No: MS 22997****Date: 3/21/2014****Lab WR Number: 031-2014-01-20-00034****Part Information:**

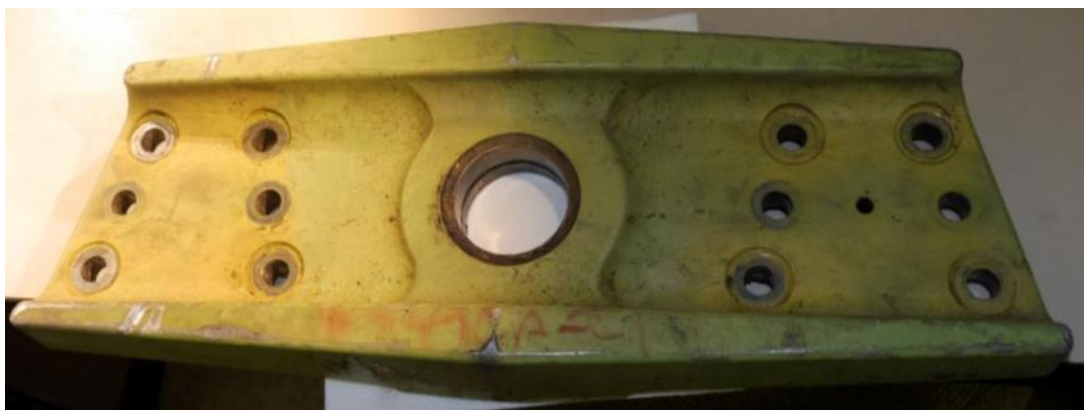
Figure 12: Upper gimble, forward yoke assembly

When un-strapping the forward upper gimble assembly it was noticed that the ball screw rotated freely within the ballnut.

The forward yoke assembly, P/N 65880708-2, was removed from the upper gimble assembly; see Figure 12.

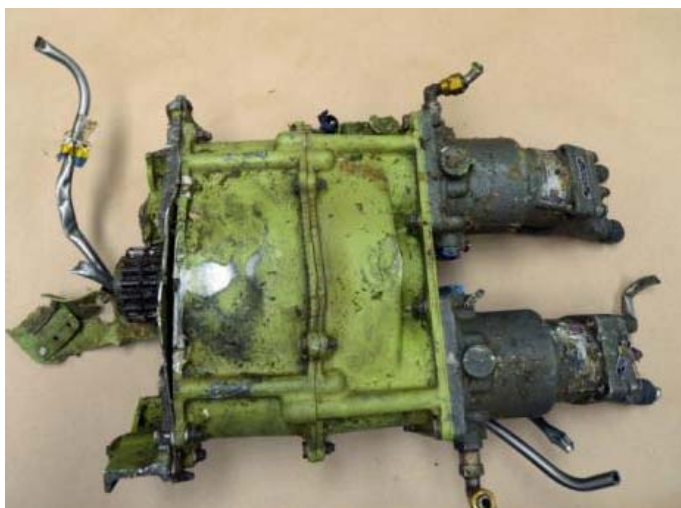
**Figure 15:** Differential assembly, aft surface

The differential assembly, P/N 65B80552, had broken free of the actuator assembly and was received separately in the shipping container. It was removed from under the actuator assembly and photographed; see Figure 15 and Figure 16. Note that both hydraulic motor assemblies, P/N 342381, were still attached to the differential assembly. The hydraulic brake assemblies were not received.

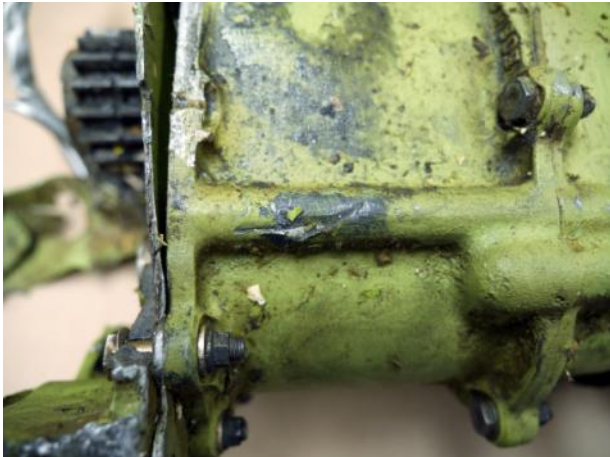
**Figure 19:** Differential assembly, forward surface

The differential assembly had extensive damage on the forward side; see Figure 17 through Figure 19.

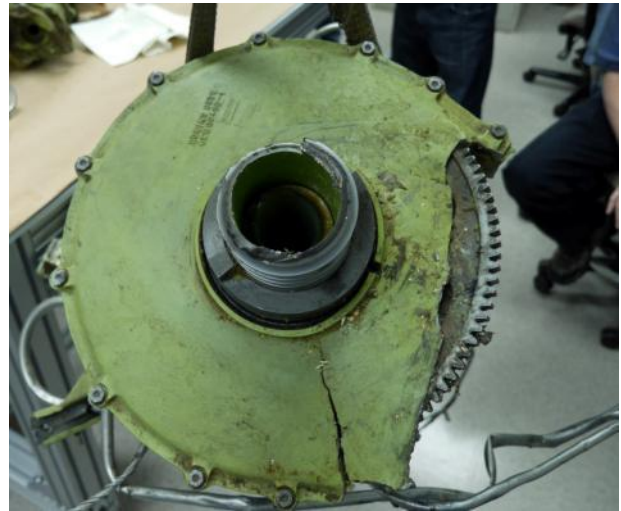
**Figure 22:** Actuator assembly, top view

A side view of the actuator assembly is shown in Figure 21. Figure 22 shows a view of the upper end of the actuator assembly, as installed on the airplane, and an end view of the fractured ballscrew that remained in the actuator assembly.

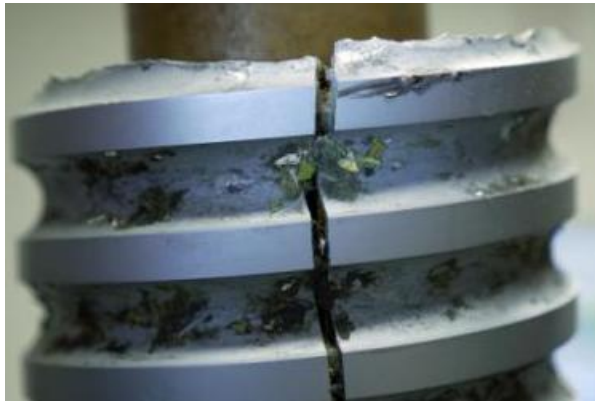
**Figure 35:** Fractured ballscrew

Several views of the fractured ballscrew are shown in Figure 35 through Figure 38.

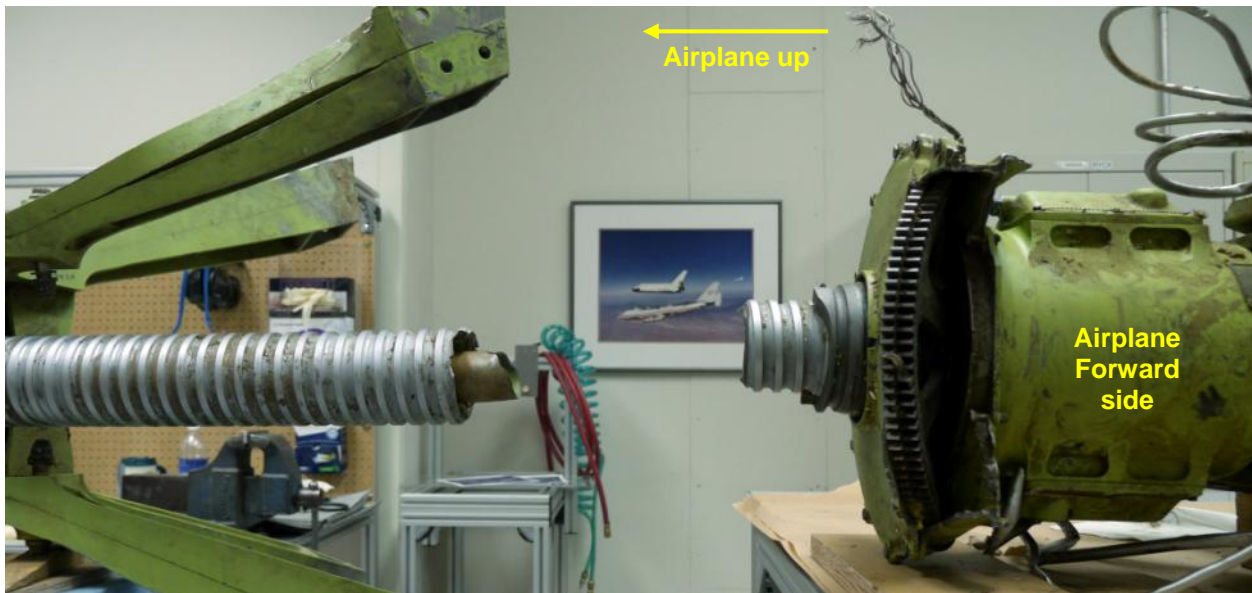
**Figure 40:** Ballscrew sections aligned

The upper gimble support structure and ballscrew were suspended with a hoist and aligned with the actuator assembly containing the remainder of the fractured ballscrew; see Figure 40 and Figure 41. The longitudinal crack shown earlier in the report is on the opposite side of the screw, as shown in Figure 40. The horizontal stabilizer trim mechanism assembly is oriented vertically when installed in the airplane.

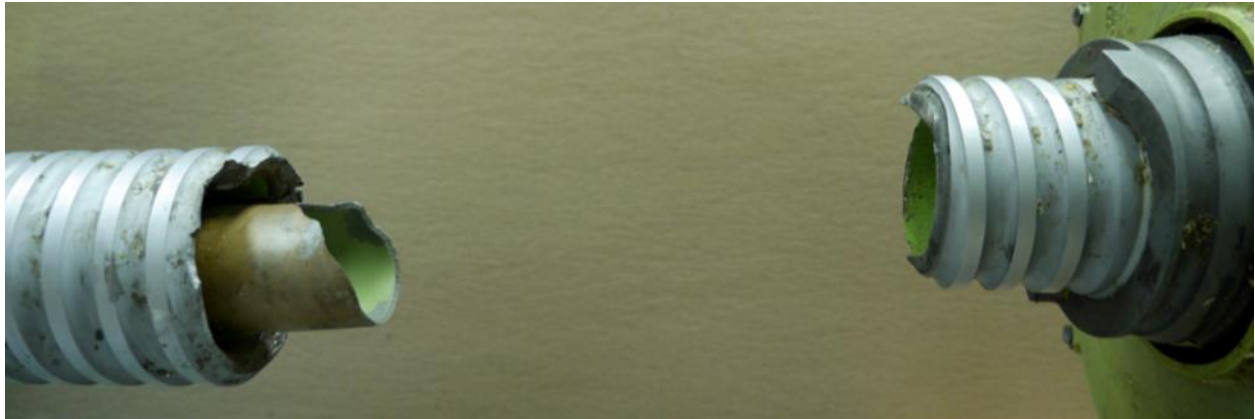
**Figure 41:** Ballscrew sections aligned

Figure 41 is a closer view of the fracture surfaces of the ballscrew shown in Figure 40. The longitudinal crack in the ballscrew is on the opposite side of the screw shown in Figure 41.

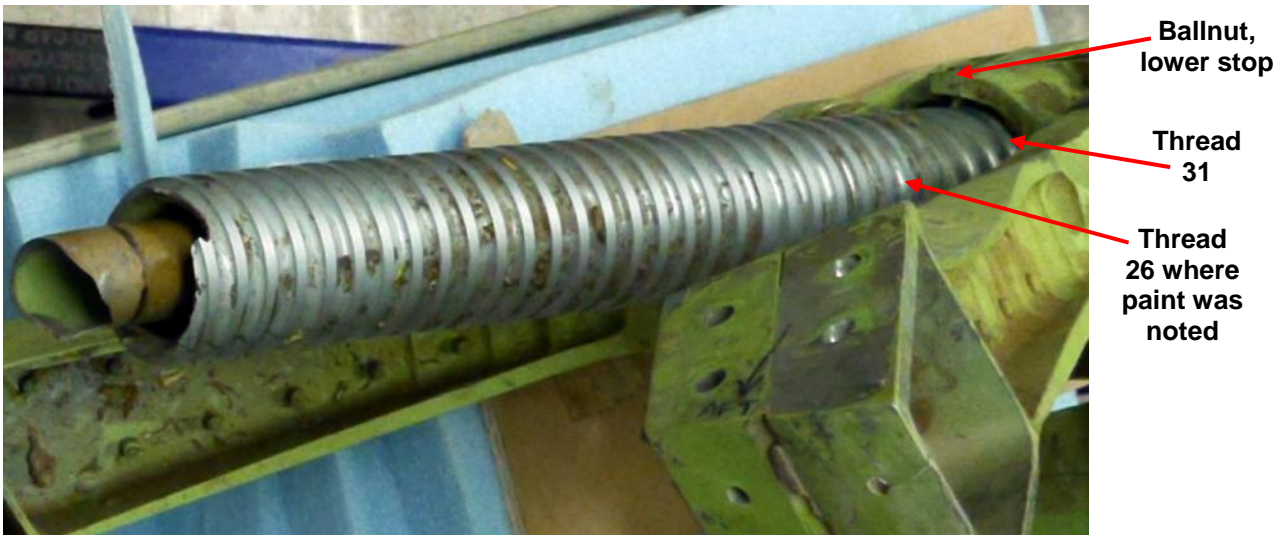
Figure 52 is included to show the location of the paint mark relative to the ballnut's lower stop after the ballscrew was oriented to match its position as found on site. There were approximately 31 threads between the ballnut lower stop and the fractured end of the ballscrew.

**Figure 51:** Location of paint mark on ballscrew

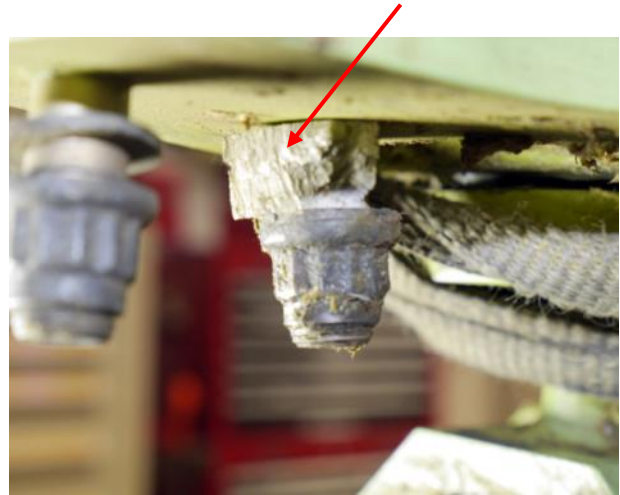
A piece of mettalic material remained trapped by an attachment bolt on one of the legs of the gimble support structure; see red arrow in Figure 57. The structural member of the gimble support that the small piece had fractured from was missing. Figure 58 shows a close-up image of the piece of structure material, prior to removal.

**Figure 58:** Piece of structure material

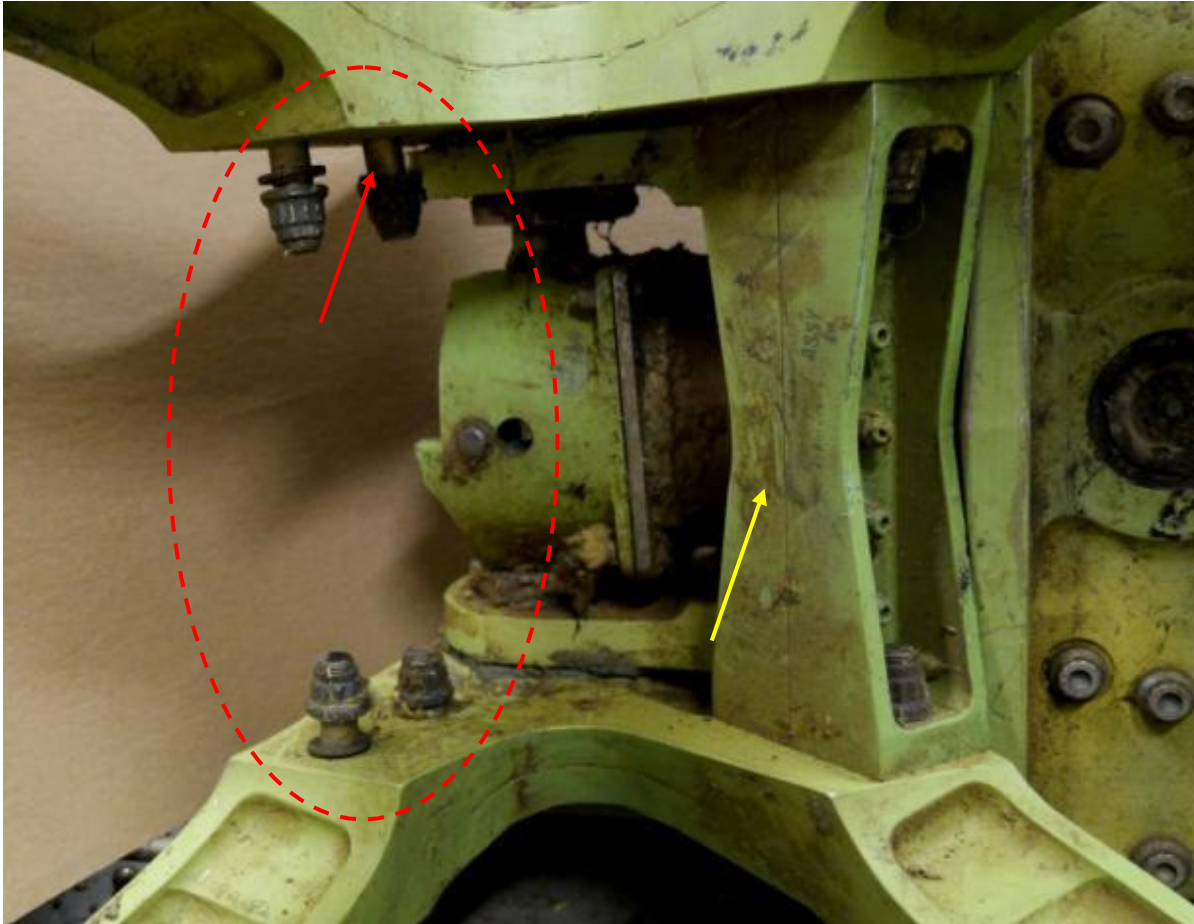
The red arrow in Figure 61 points to the location the piece of material was removed from. The red dashed oval shows where the missing piece of structure would have been located. The yellow arrow points to an intact structural member similar to the missing member, to show how the missing piece would have been installed. Both structural members are held to the upper gimble support structure by four attachment bolts.

**Figure 61:** Location of the piece of structure that the material was removed from

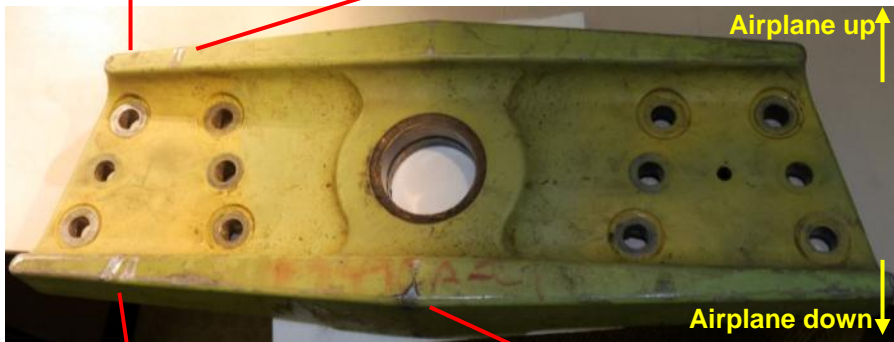
Figure 64: Upper gimble, forward yoke

The forward yoke was examined and several witness marks were identified; see Figure 62 through Figure 66.

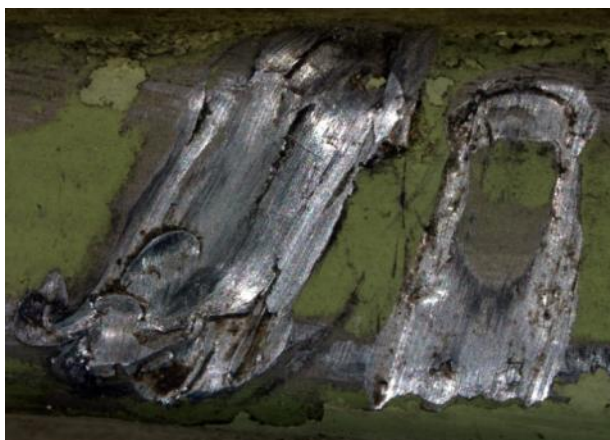
Figure 65: Forward yoke witness marks

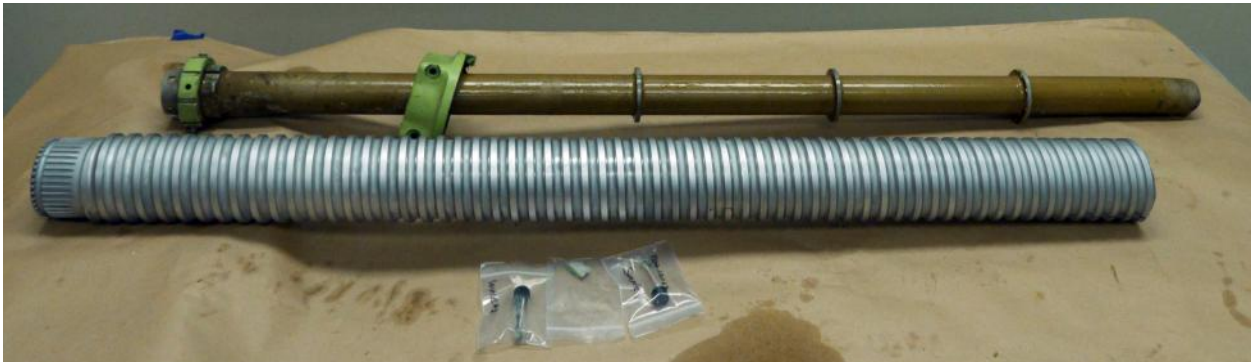
**Figure 73:** Parts and samples provided to BR&T

The parts and samples provided to BR&T were photographed prior to being delivered; see Figure 73.
