NATIONAL TRANSPORTATION SAFETY BOARD

System's Group Chairman's Factual Report

NTSB ID No.: CEN17FA168

Location: Amarillo, Texas
Date: April 28, 2017
Time: 2348 Central Daylight Time
Aircraft: Pilatus PC-12, N933DC

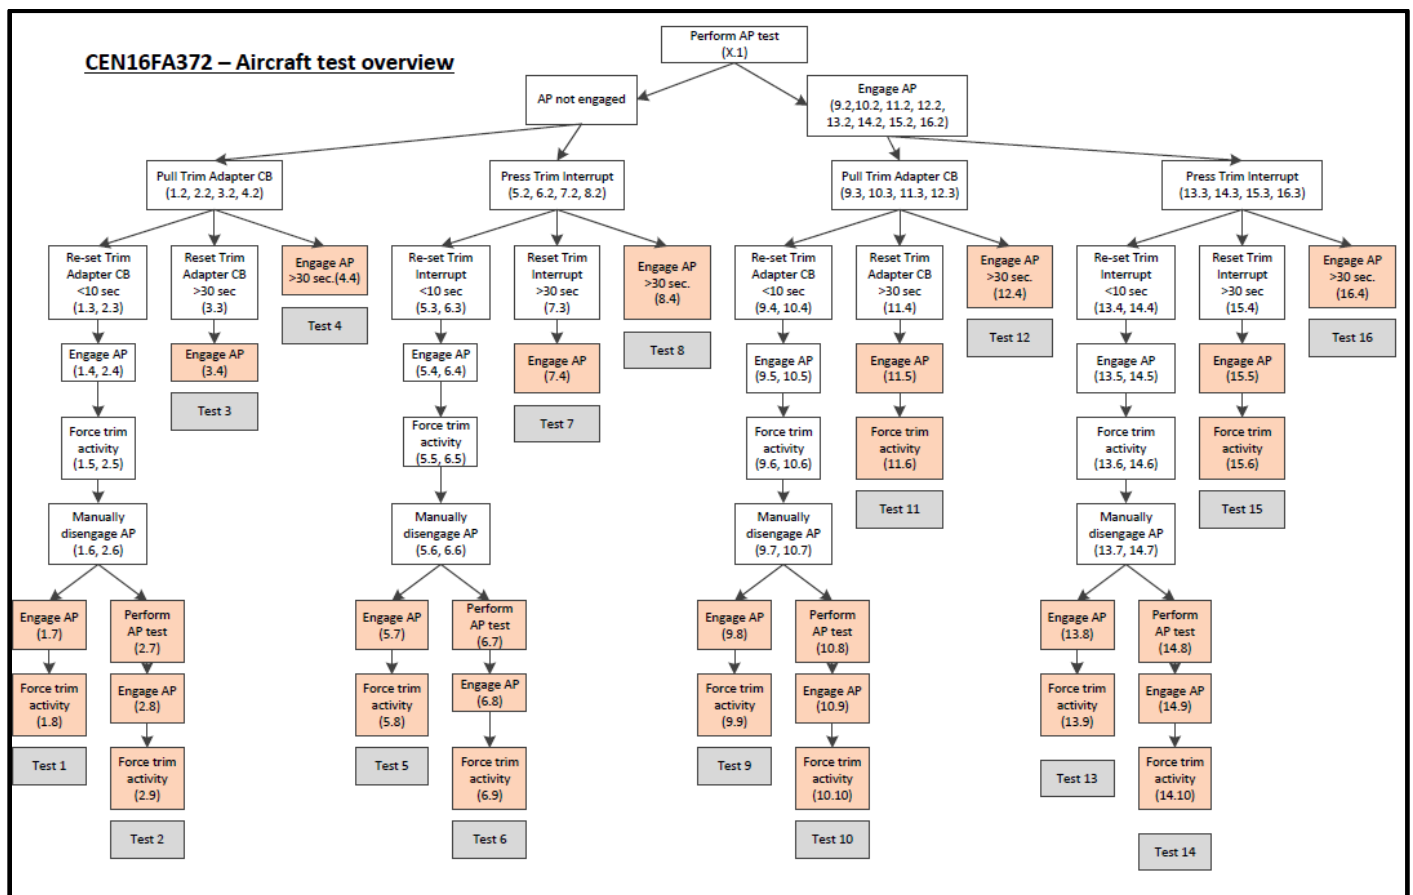
Figure 5 Test Scenarios

Pilatus developed a comprehensive aircraft test plan⁷ consisting of 16 individual system tests (Reference Figure 5) to evaluate the effects (autopilot status, timing of warnings and cautions) that a pitch trim adapter in an untested state would have on the autopilot operation. The tests, highlighted in orange in Figure 5, indicate hypothetical scenarios which would be in contradiction to the Aircraft flight manual (AFM) if the pilot performed them. Testing was performed on an exemplar Pilatus PC-12/45 airplane (MSN 362) in Olathe, Kansas on June 22, 2017.

¹³ For tests 1-4, power was removed from the pitch trim adapter by pulling its circuit breaker and for tests 5-8, power was removed by pressing the trim interrupt switch.
