ATTACHMENT 1

DEEC Circuit Card Examination – Honeywell Report

This report is the documentation associated with the DEEC CCA Download attempt that occurred on March 29, 2016 at the HON Tucson facility. Oversight was provided by the NTSB.

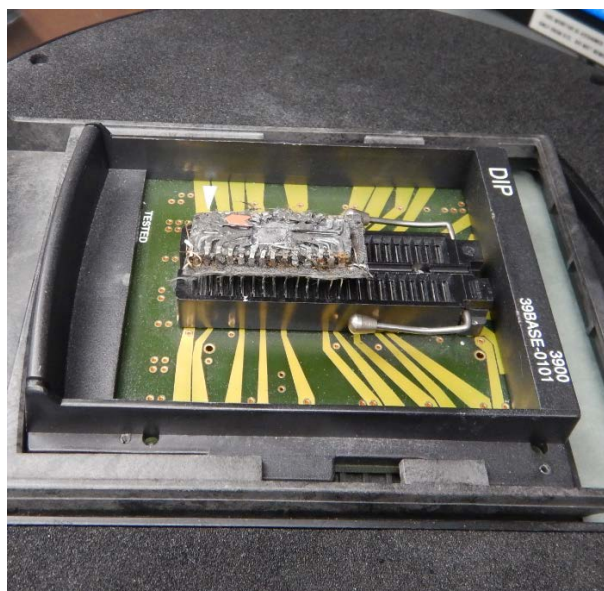
The IC was installed in the Data I/O.

- 1st attempt: “Continuity Test Fail” Message received.

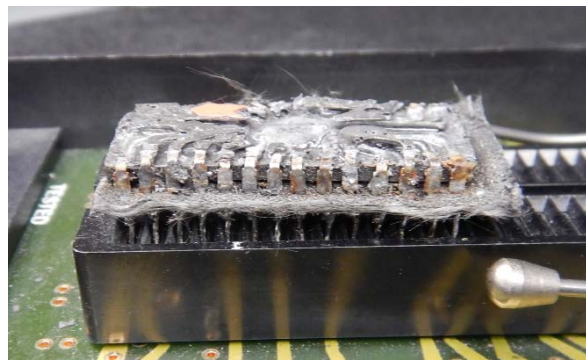
- Reseated IC in test socket

- 2nd attempt: “Continuity Test Fail” Message received.
 - Reseated IC in test socket
- 3rd attempt: “Continuity Test Fail” Message received.
 - Disabled Continuity Test in software
 - Software identified IC Data CHECKSUM 8000 (Equivalent to empty device)
- 4th attempt:
 - Reseated IC in test socket
 - Software identified IC Data CHECKSUM 7FF0 (Small amount of data) – File saved “DEEC_hanger6\hanger6_P1001”

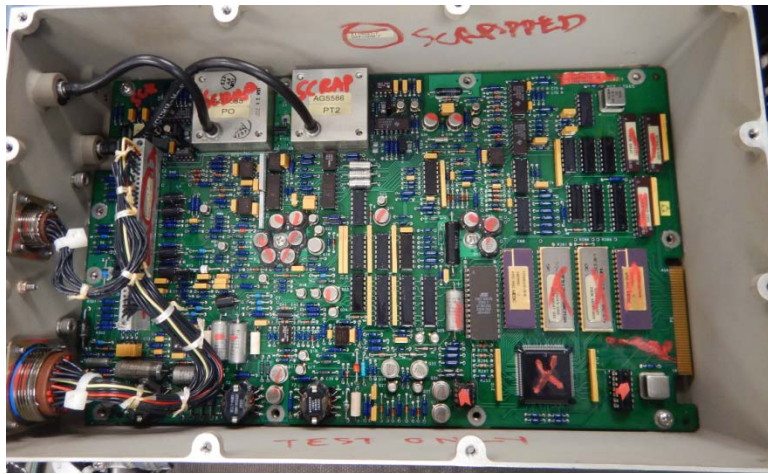
The saved file was copied onto a slave U26 IC and installed in a slave socketed DEEC for download and interrogation by the Honeywell ENGINE CONDITION AND TREND MONITORING SOFTWARE (ECTM).

ECTM stated the download operation was successful. However, the operation of creating and saving the directory (output) failed during multiple attempts.
