NATIONAL TRANSPORTATION SAFETY BOARD

SYSTEMS GROUP CHAIRMAN'S FACTUAL REPORT

CEN13FA038

Location: Boyne City, MI
Date: October 31, 2012
Time: 0930 local
Aircraft: Piaggio P180, N401WS

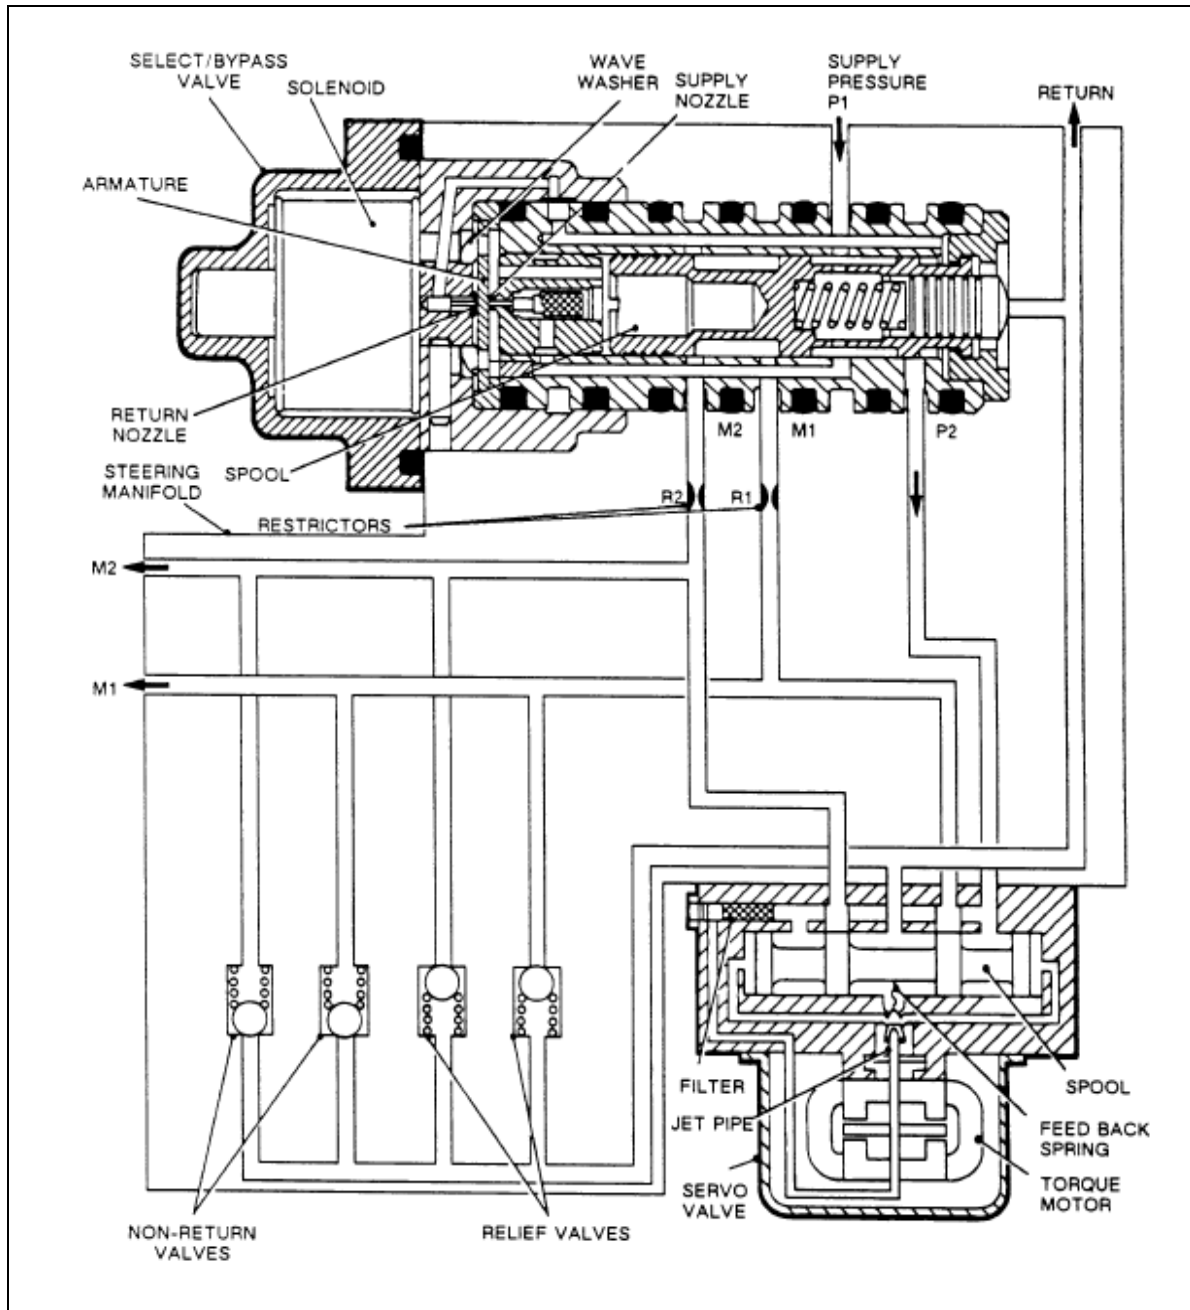
Figure 2: Schematic of the Steering Manifold Assembly

The steering manifold assembly includes the following components (See Figure 2):

The select/bypass valve supplies hydraulic pressure to the servo valve. It also isolates the hydraulic supply and connects the actuator ports together to allow the nose wheel to castor when the steering is set to off. The servo valve controls the direction of fluid flow in proportion to the electrical control input signal from the rudder command potentiometer. The restrictors give shimmy damping when the steering is off. The relief valves protect the unit against pressure surges caused by external loads on the steering mechanism. The non-return valves prevent cavitation in the steering lines.
