NATIONAL TRANSPORTATION SAFETY BOARD

Systems Group Chairman's Factual Report

WPR-15-IA-046

Operator: Hawkeye Aviation Holdings Ltd
Location: Palm Springs International Airport (PSP), Palm Springs, California
Date: November 23, 2014
Time: 1052 pacific standard time
Vehicle: Embraer EMB-505, C-GJOL

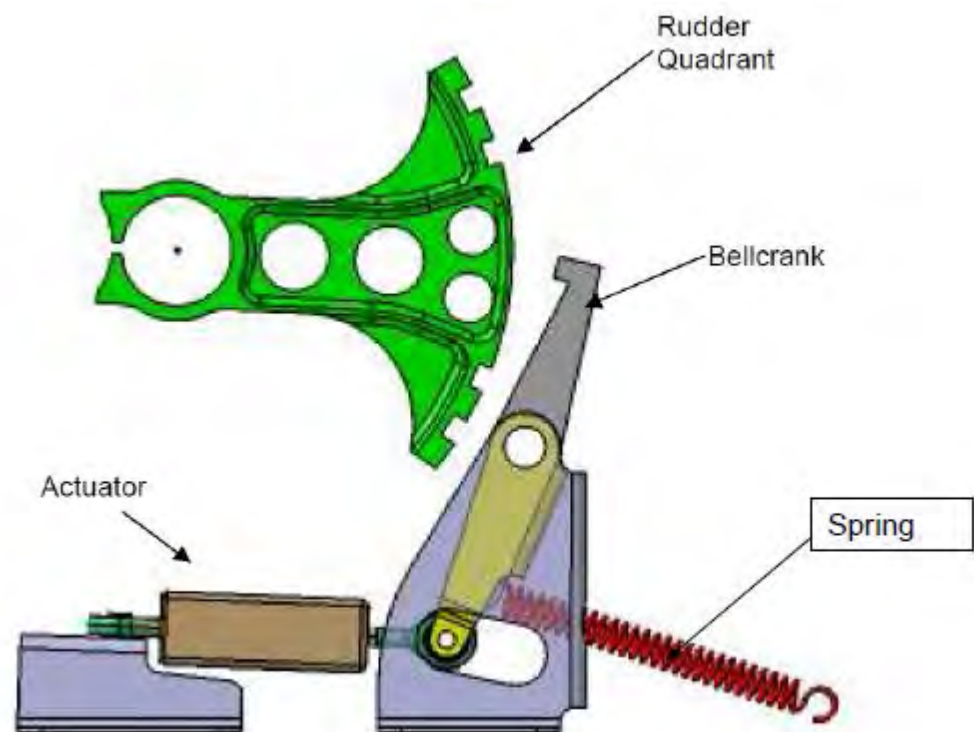
Figure 1
Rudder gust lock actuator components

The bellcrank, pivoted by the action of the actuator, locks one of the grooves on the gust lock quadrant, which is connected to the rudder rear torque tube, therefore preventing the movement of the rudder surface in case of gust (see figure 1).

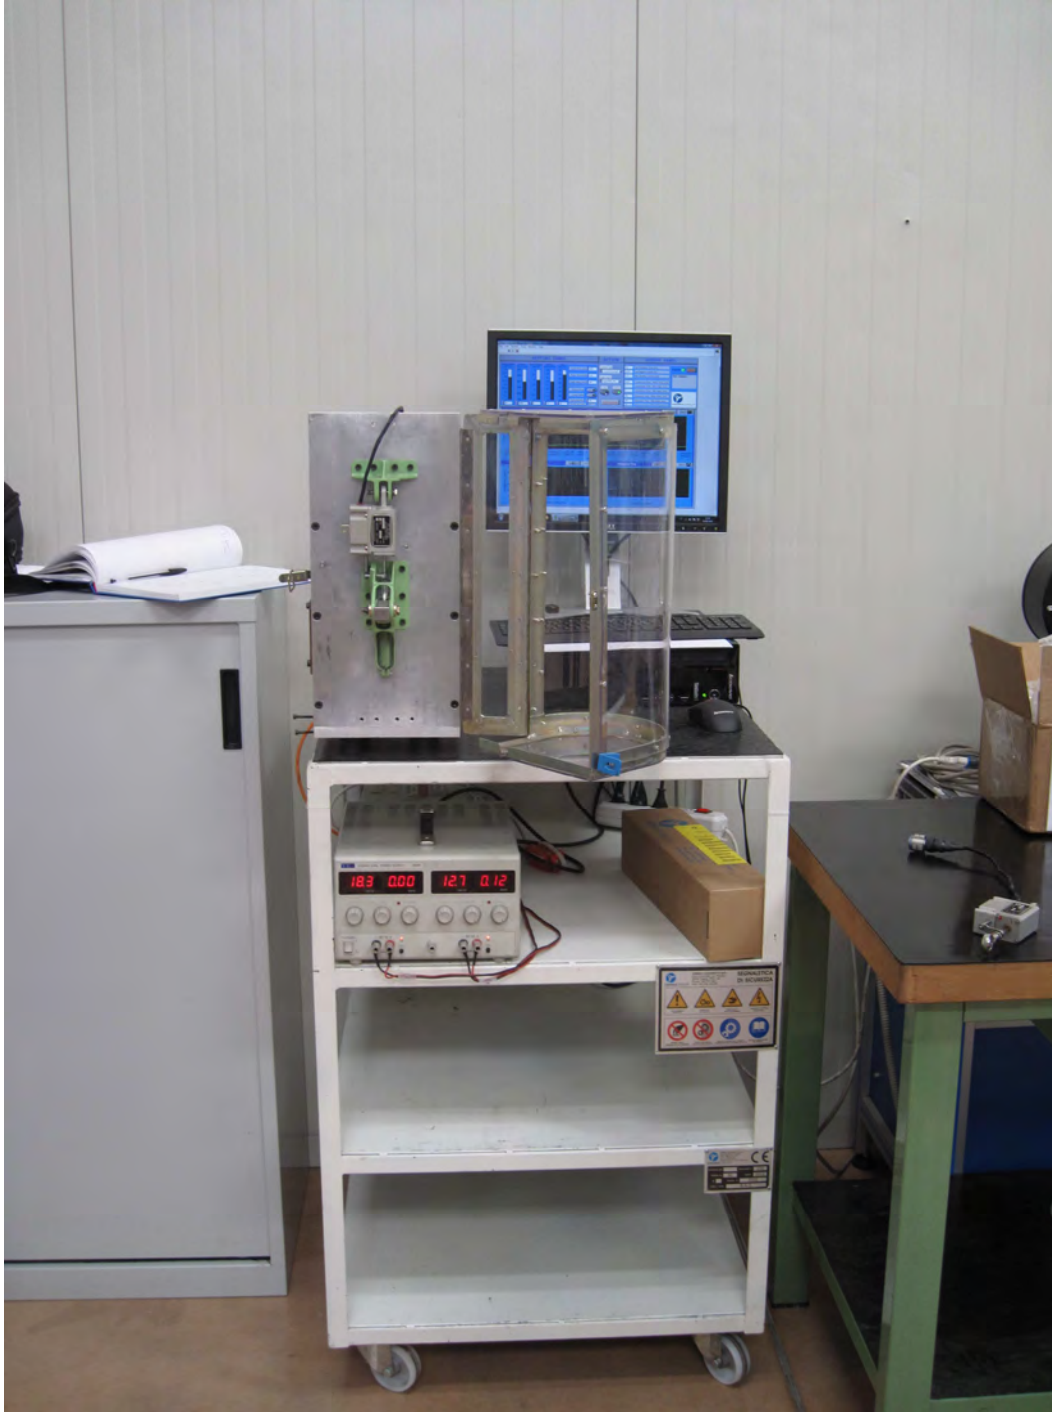
Photo 2 Gust Lock Test Rig
(a new Actuator is installed)

<p>DIMENSIONAL CHECKS / VISUAL INSPECTION</p> <p>Check of pin to pin distance Scope To verify if the Actuator is at its end stroke position or locked in an intermediate one. Check The Actuator has been installed in the test rig (see photo 2 and 3), which is tuned at the correct pin-to-pin distance, and it was not possible to insert the Pin 2 because the Actuator length is shorter than required. Measurements of the rod end in respect of the Actuator body confirm the pin-to-pin distance is shorter in respect of the full-extended position (i.e. 6.8 mm shorter, 29.2 vs. 22.4 mm, new and 00075 unit respectively). The minimum stroke is 25.4 mm. See photos 4, 5, 6 and 7. Result The Actuator is locked in a position closed to the extended one.</p>

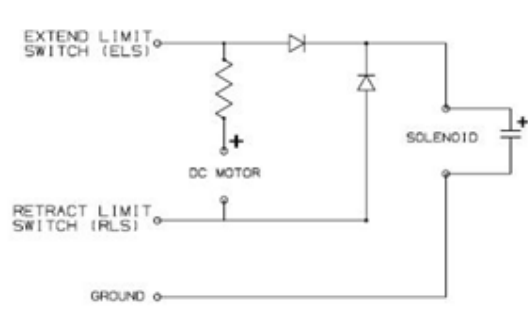
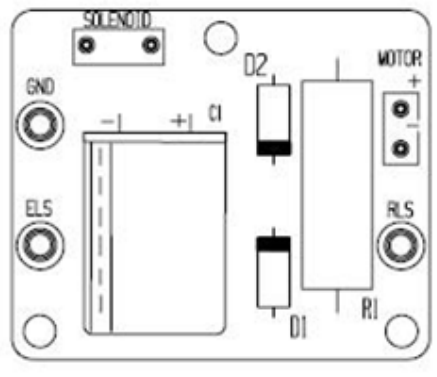
No evidence of mechanical failure on components and PCB. Surface coatings has been found damaged.

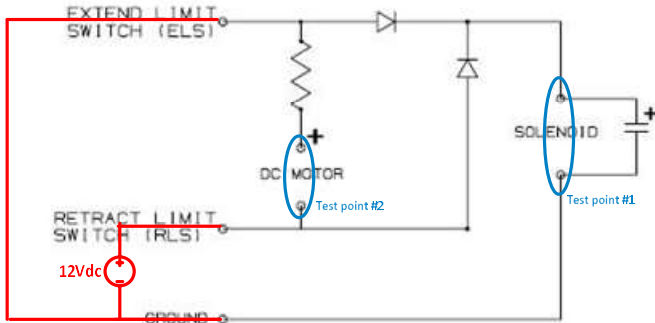
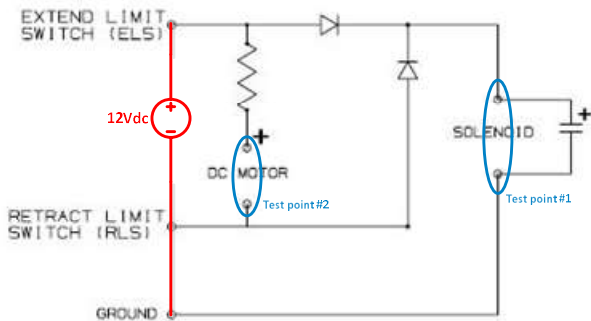
The test was performed according the test set-up below. See Photo 16.

Test #	Type of test	Test Condition	Expected results	Test results
Test #1	To retract configuration test	ELS → +12Vdc RLS → 0Vdc GND → 0Vdc	Voltage of 12Vdc at: <ul style="list-style-type: none"> Solenoid terminals Motor terminals 	Passed
Test #2	To extend configuration test	ELS → 0Vdc RLS → +12Vdc GND → 0Vdc	Voltage of 12Vdc at: <ul style="list-style-type: none"> Solenoid terminals Motor terminals 	Passed
