-----SYSTEMS GROUP CHAIRMAN'S FACTUAL REPORT -----

Location: McKinneyville, California
Date: July 29, 2016
Time: About 0105 Pacific Daylight Time
Aircraft: Piper PA-31T
Registration: N661TC

C. SUMMARY

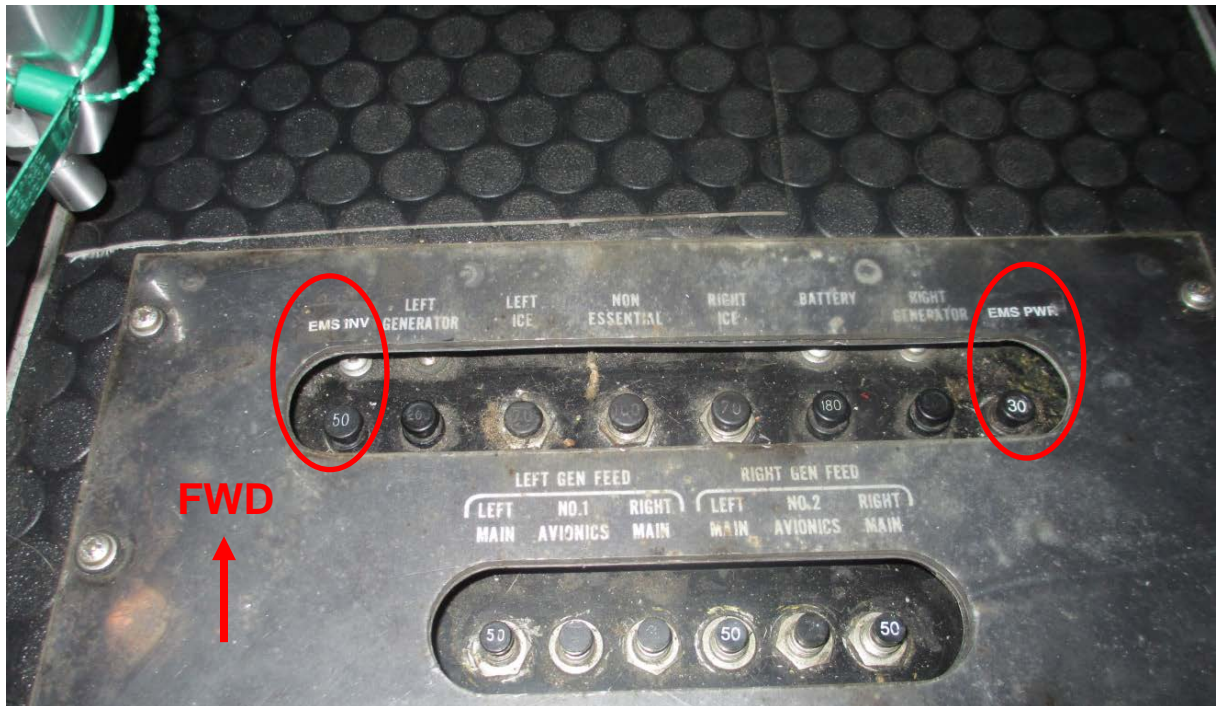
The main tie bus circuit breakers are located on a panel on the floor between the pilot and copilot's seats. The panel contained at the time of delivery twelve circuit breakers (C/B) in two rows of six with current ratings ranging from 50 A to 200 A. The accident aircraft also contained a supplemental type certificate (STC) modification, Lifeport STC (SA00528SE), for cabin medical equipment, which accommodated additional power requirements for medical equipment installed in the aircraft. The STC modification introduced two additional circuit breakers to the main bus tie panel with ratings of 30A and 50A. Figure 1 shows a similar installation in an exemplar aircraft. Based on a review of the aircraft wreckage and

discussions with the owner, the 50A C/B "EMS INV" was located next to the "Right Generator" C/B on the first row and the 30A C/B "EMS PWR" was located next to the "R Main 2" C/B on the second row.

Figure 1 – Main bus tie circuit breaker panel from exemplar aircraft with additional STC circuit breakers identified (Note: accident aircraft STC C/B's were in a different position on the panel).

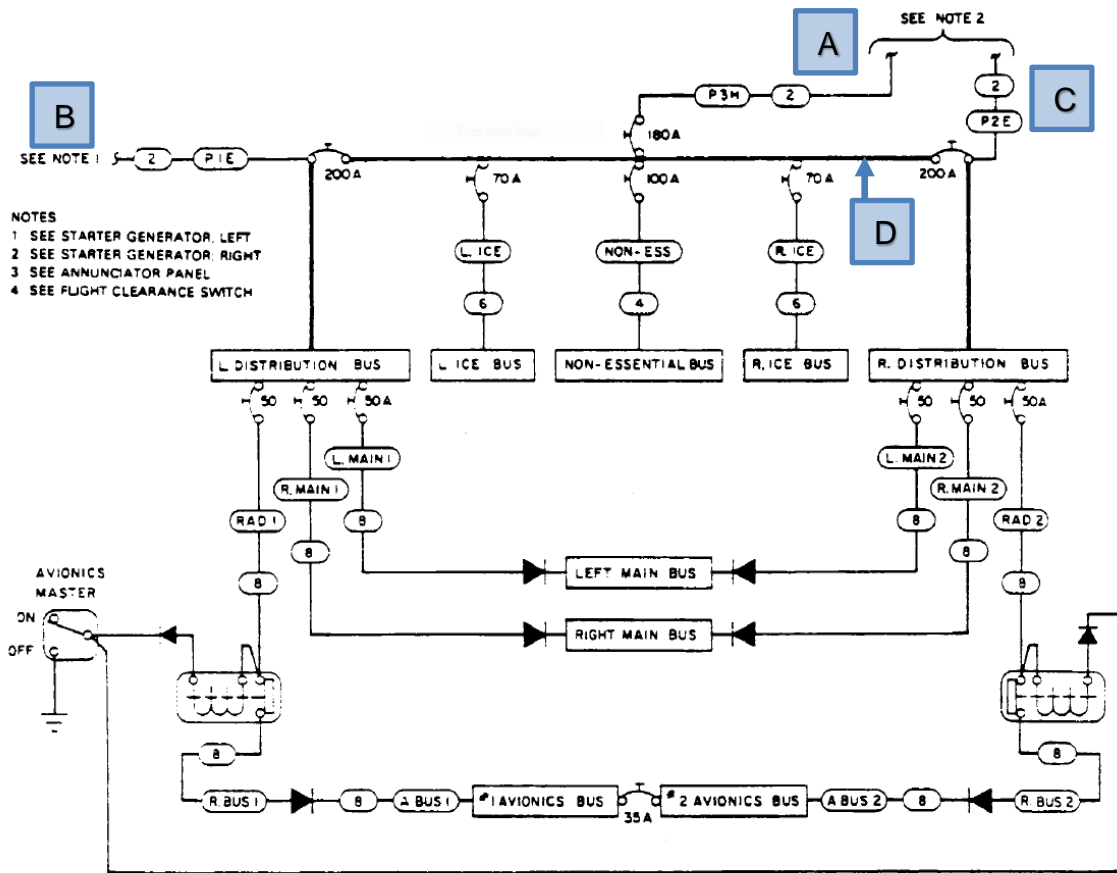
Figure 2 is an excerpt from the aircraft's service manual showing a schematic of the electrical system. In area A (refer to Figure 2), power is supplied from either the aircraft battery or the external power receptacle to the electrical system. Power from the battery or the external power receptacle is controlled by the Battery Master switch located in the overhead panel, refer to the red box on Figure 3.

In areas B and C (refer to Figure 2), power is supplied from left and right (respectively) starter/generators to the electrical system. Generator power from each engine is controlled by placing the appropriate starter/generator three position switch in the "GENERATOR" position, refer to the green boxes on Figure 3.

Area D (refer to Figure 2), highlights the area in the schematic where the additional electrical components for the LifePort STC were connected to the aircraft electrical system. As stated previously, the STC installs two additional circuit breakers, but the installation also installs an 80 Amp thermal fuse upstream of the two additional circuit breakers. The thermal fuse was installed in the structural bay, below the floor where the main bus tie panel was located.

Figure 2 – Excerpt from Electrical System Schematic from Piper Cheyenne Service Manual (dated 2/6/81)
 Courtesy of Piper Aircraft.

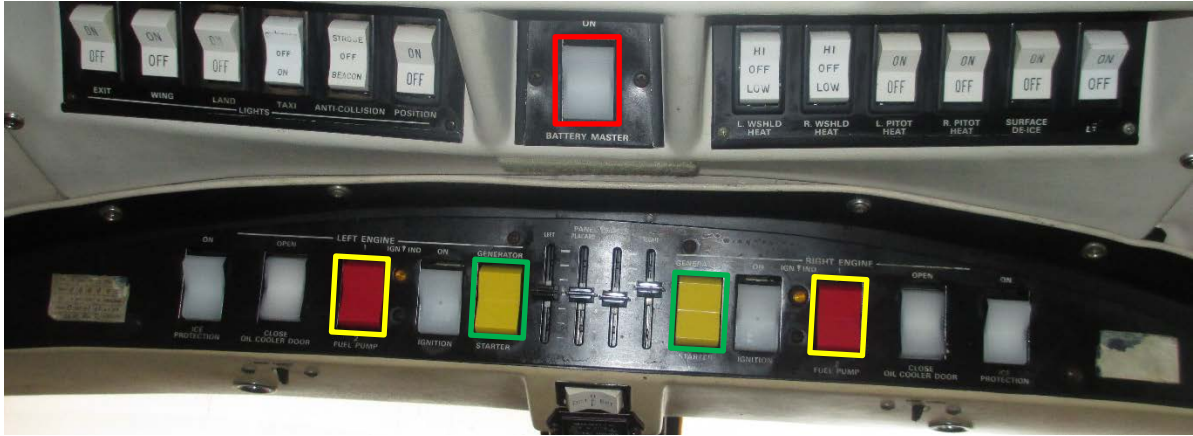
Figure 3 - Overhead panel from exemplar aircraft (older model) with, battery master, generator and fuel pump switches highlighted

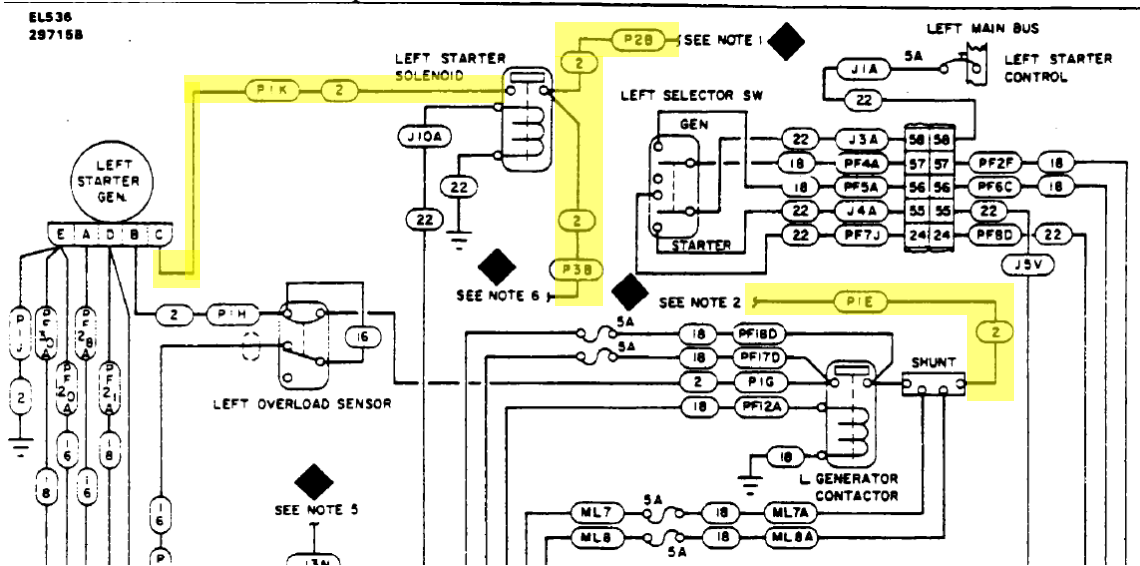
Figure 4 and Figure 5 contain excerpts of the starter generator system. Wiring and components (solenoids) from the starter generator system are located in the structural bay beneath the circuit breaker panel.

Figure 4 - Excerpt from Left Starter Generator System Schematic from Piper Cheyenne Service Manual (dated 2/6/81) Courtesy of Piper Aircraft., wires recovered in wreckage are highlighted.

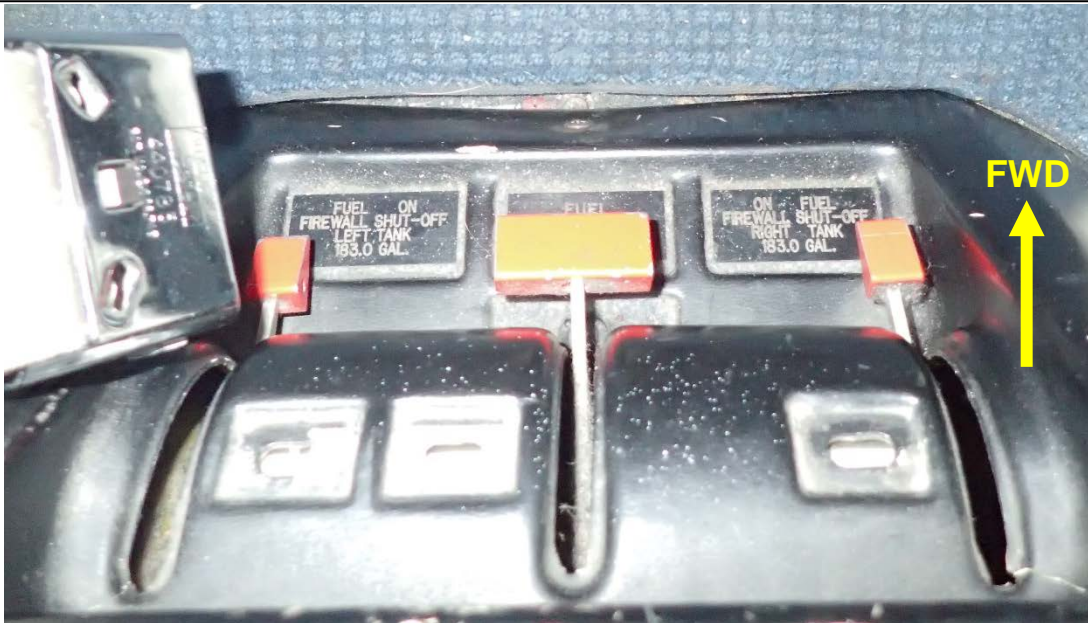
Each set of wings tanks contain a fuel shutoff valve mounted on the inboard side of its respective wing root. The fuel crossfeed valve is mounted on the inboard side of the left wing root. Each valve is operated by a push-pull control lever which is mounted on the cockpit on the floor against the main spar housing just aft of the circuit breaker panel.

Figure 6 - Fuel shutoff and crossfeed valve panel from an exemplar aircraft (view looking down towards cockpit floor)
