NATIONAL TRANSPORTATION SAFETY BOARD

SYSTEMS GROUP CHAIRMAN'S FACTUAL REPORT

CEN11IA234

Location: Akron-Canton Regional Airport, Canton, OH USA
Date: March 18, 2011
Time: 12:08 AM EDT
Aircraft: Express Jet, Embraer EMB 145 XR, N11187

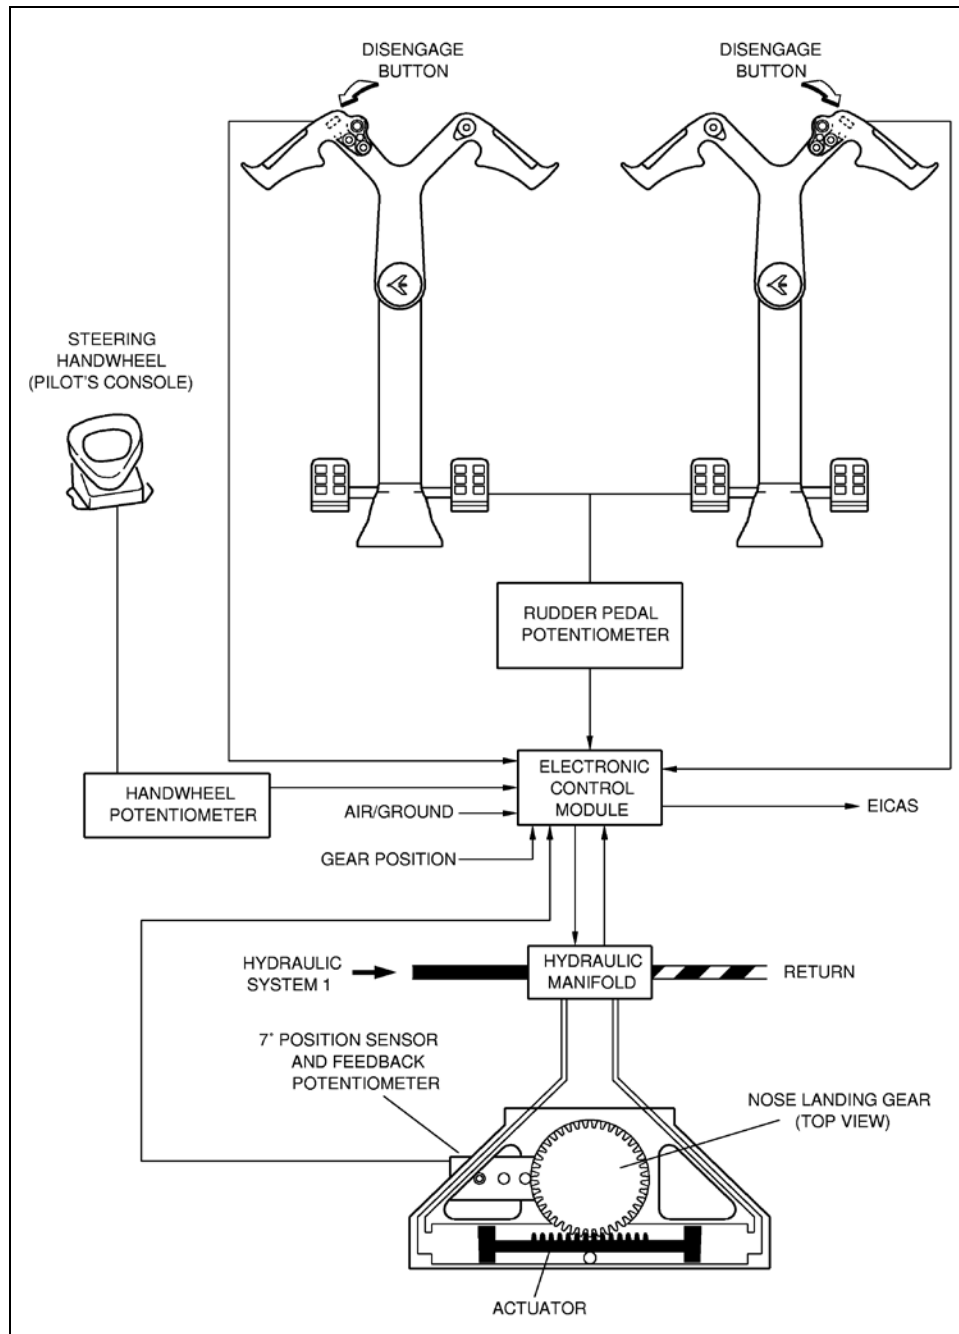
Figure 4: Nose Wheel Steering System Schematic 145AOM2120012.MCE A

The nose wheel steering can be commanded to a maximum angle of 71 degrees when using the tiller, 5 degrees when using the rudder pedals, or 76 degrees using both tiller and rudder pedals. A proximity sensor connected to the feedback unit sensor disengages the system if the nose wheel is rotated beyond 7 +/- 1 degrees when the tiller is not engaged. If the NWS system disengages in this manner, the system can be reengaged by engaging the tiller when speed is below 25kts. The steering system may also be manually disengaged through switches located on either control wheel provided the tiller is not engaged. If the NWS system is disengaged for any reason while the aircraft is on the ground a caution oral alert will sound, the master caution light will illuminate, and the message "STEER INOP" will display on the EICAS. The system allows for the nose wheel to free caster any time the nose landing gear is on the ground and the NWS is disengaged.

This aircraft was equipped with an external steering disengagement switch which allows ground personnel to disengage steering prior to towing operations. The disengagement switch inhibits the steering actuation commanded by the steering handle and the rudder pedals. A caution message is displayed on the EICAS whenever the steering system is disengaged by the external switch. The NWS system is also automatically disabled when the aircraft is airborne. Nose wheel centering when weight is off wheels (strut extended) is mechanically provided by a cam.
