----- SYSTEMS GROUP CHAIRMAN'S FACTUAL REPORT -----

Location: Koehn Dry Lake, California
Date: October 31, 2014
Time: 1007 Pacific daylight time (PDT)
Vehicle: Scaled Composites LLC M339 – “SpaceShipTwo”
Registration: N339SS

3. SUMMARY

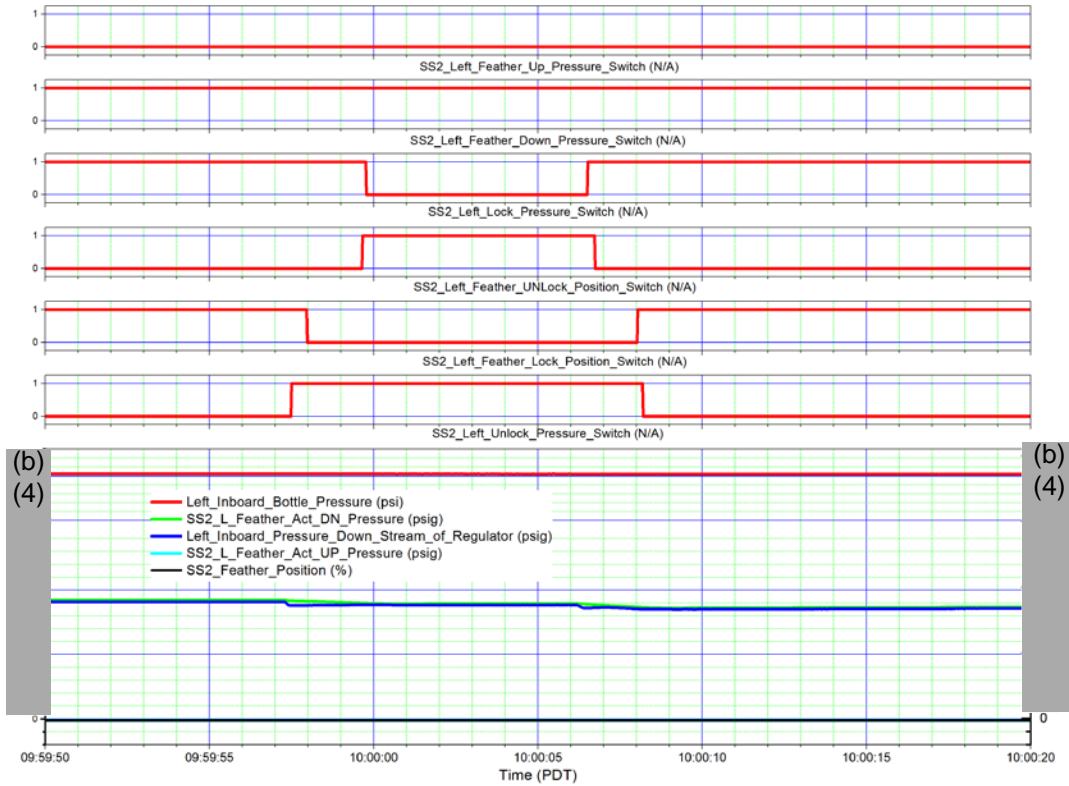
Figure 9 - Flight data from the L-10 left feather lock check

During the PF04 L-10 checks at approximately 10:00:00 PDT, Figure 9 and Figure 10, the feather actuator lock and unlock switches changed state as the lock actuators moved the hook from the lock to the unlock position. The downstream regulator pressure in the left side decreased slightly after the lock actuator cycling. Based on the micro-switch data, the locks cycled from a locked to an unlocked state in approximately 1.7 seconds and from an unlocked to locked state in 1.3 seconds.

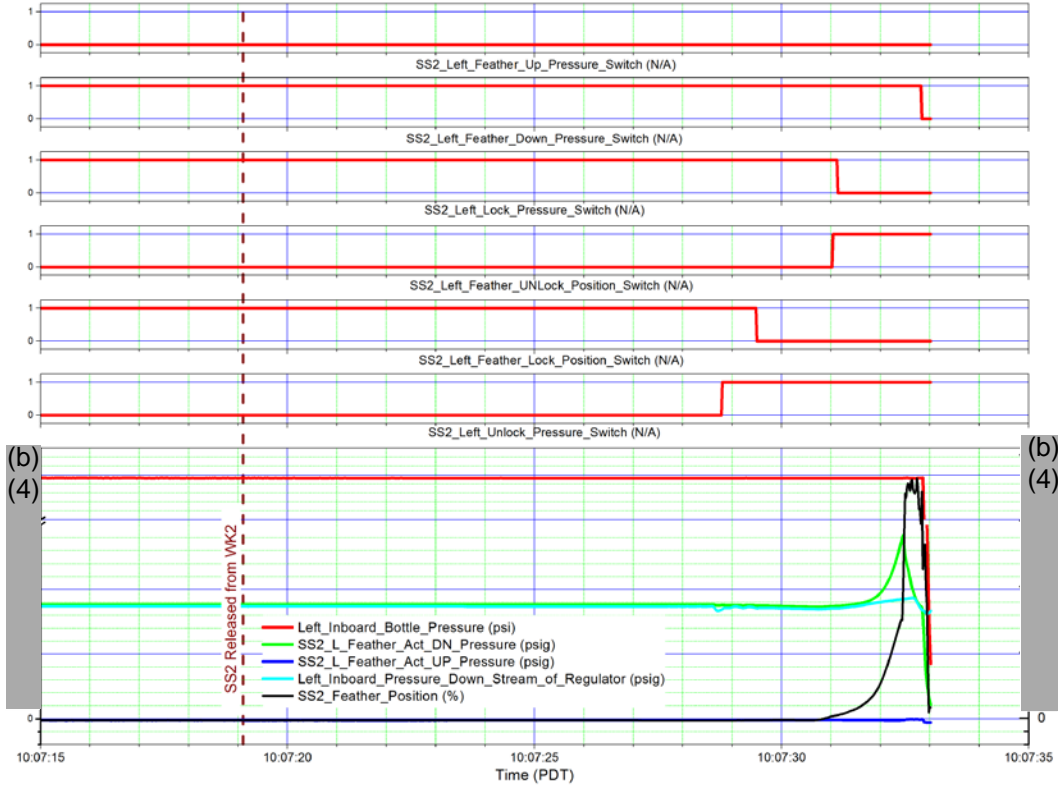
Figure 11 - Flight data from SS2 release to end of recording for the left feather system

For PF04, SS2 was released from WK2 at 10:07:19.10 PDT based on the SS2_Carrier_Separated discrete signal change of state. At 10:07:28.80 both the left and right unlock pressure switches indicated pressure in the unlock circuit, Figure 11 and Figure 12. The vehicle’s speed per the recorded data at this point was just above 0.92 M. At 10:07:29.50, both the left and right lock position switches transitioned from locked to not locked. At 10:07:31.04, the left unlock position switch transitioned from not unlocked to unlocked. At 10:07:31.10, the right unlock position switch transitioned from not unlocked to unlocked. The total unlock time was approximately 1.6 seconds.

a maximum pressure in the retract (down) side of the feather actuators of approximately 710 psig in the left actuator and 759 psig in the right actuator was recorded. The pressure readings for the extend (up) pressure for both actuators was slightly less than 0 psig during the feather extension. After 10:07:32.44, data for the feather position was considered unreliable.

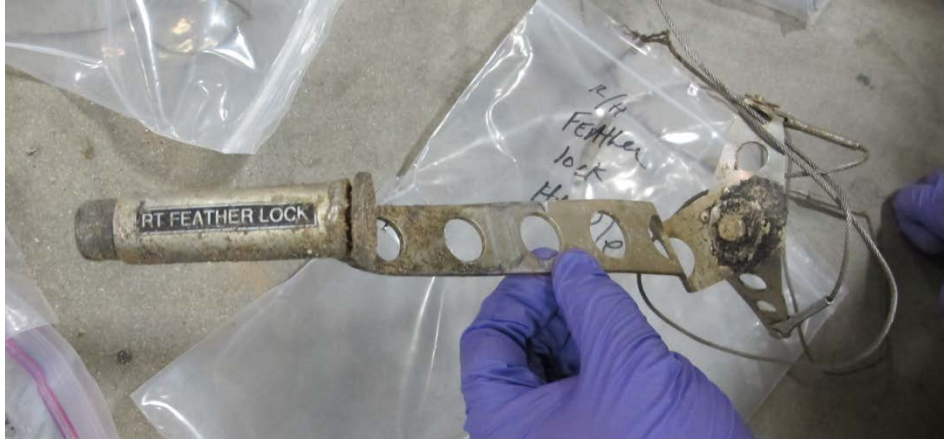
Figure 37 - RH feather lock handle

The RH feather lock handle was found separated from the center pedestal structure, Figure 37. The handle was bent in multiple directions. The handle position could not be determined. The control cables that connect with the feather lock valve were also attached to the handle.

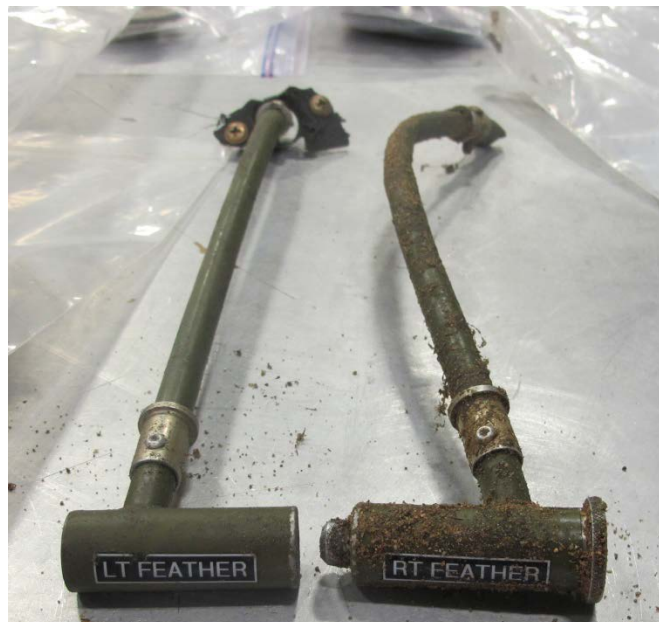
Figure 38 – Left and right feather extend handle

Both handles were found separated from the center pedestal structure and their respective mechanical linkages, Figure 38. The handle positions could not be determined.
