NATIONAL TRANSPORTATION SAFETY BOARD

Factual Report of Systems Group Chairman

A. ACCIDENT: ERA15LA140
Location: Marco Island, FL
Date: March 1, 2015, 16:15 EST
Aircraft: Bombardier CL-600-2A12, N600NP¹

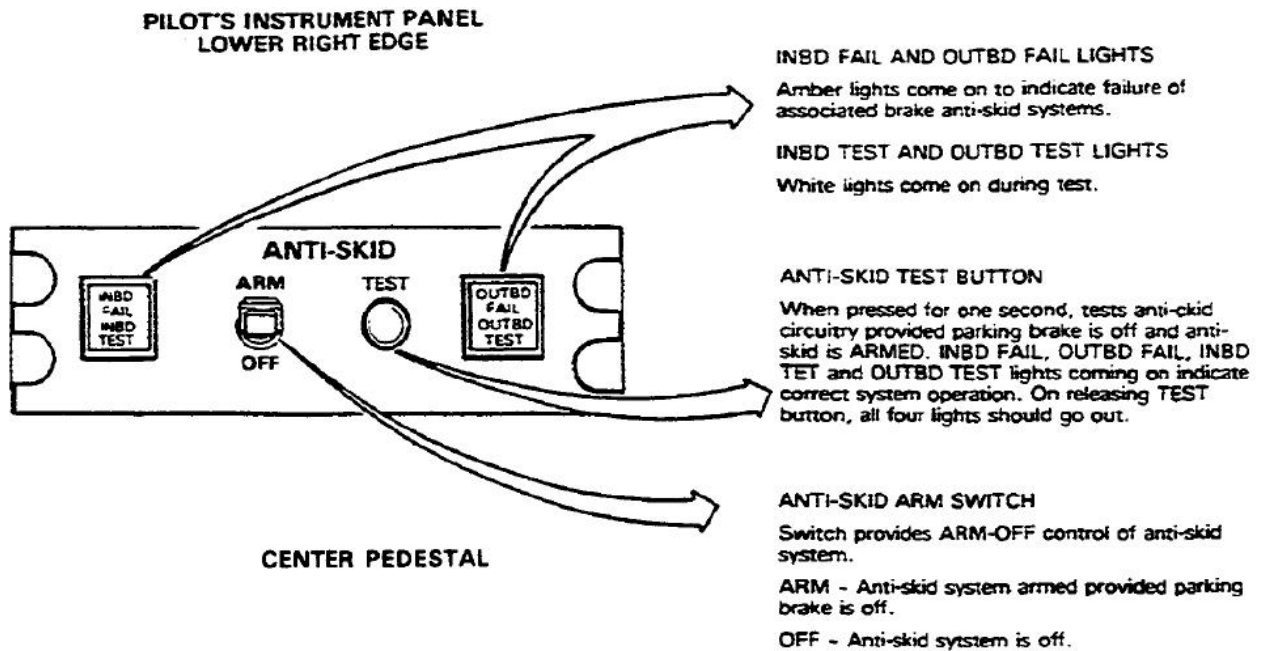
Figure 6. AMM illustration of the antiskid control panel in cockpit.

The AFM landing procedure calls for the pilot to press fully on each pedal immediately to utilize the anti-skid and that the pilot must maintain the pressure on the brake pedals until the airplane comes to a stop. There is not a standard or objective definition for “moderate” in the Bombardier Challenger documentation, as described by the Captain, and the anti-skid control selections are ARM, OFF, TEST, with no “MODERATE” option. (See Figure 6)

The Captain stated that he did not feel deceleration with the use of “moderate” brake pressure, so he released the brakes and turned off the anti-skid, then re-applied the brakes pressing hard.¹³

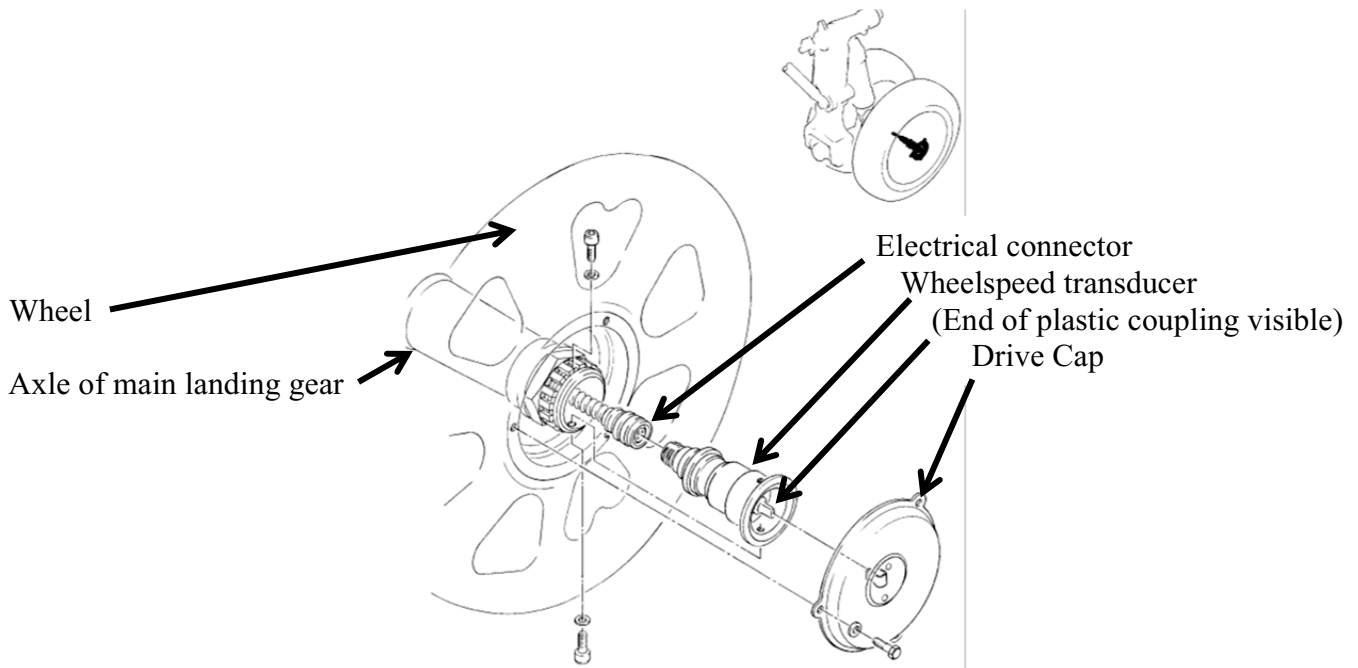
Figure 7. AMM illustration of the wheel speed transducer and drive cap components

The antiskid control system stops wheel skids, it is electrically activated through the arming switch installed on the landing-gear control panel. Each main wheel/tire assembly is connected to the wheel speed transducer which sends electrical signals to the antiskid control unit.¹⁴ [See Figure 7] The antiskid control unit sends control signals to the dual antiskid control valve which increases or decreases the pressure of the hydraulic fluid which goes to the brake unit.

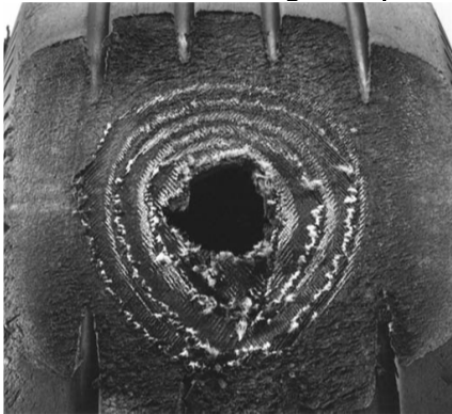
Figure 9. Photo of flat spot through tread of tire in Goodyear Aircraft Tire Care & Maintenance Manual. Caption states “Skid”

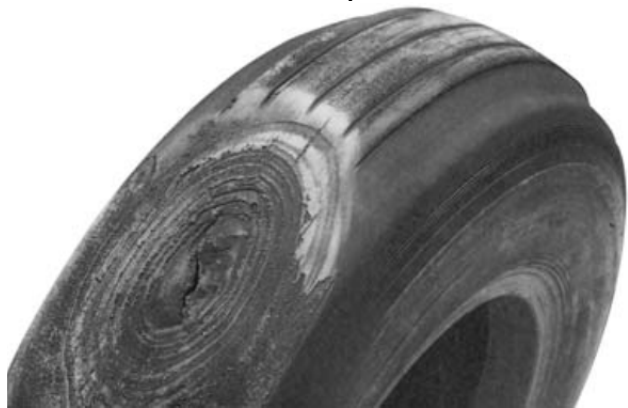
Figure 10. Photo of flat spot through tread of tire in Dunlop Care & Maintenance Manual. Caption states “Dry Braking Flats. Locked (or almost locked) wheels during a landing on a dry runway can cause a dry braking flat spot on a tyre. This is a flat scuffed surface on a part of the tread circumference.”

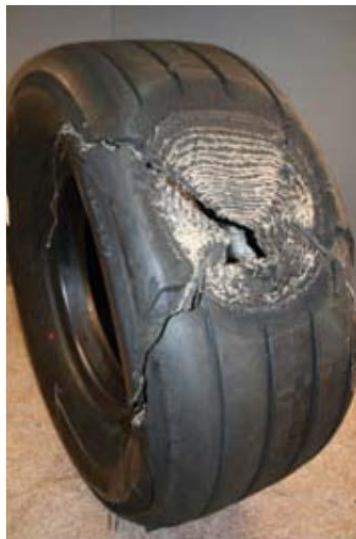
Figure 11. Michelin photograph of flat spot on tire.

The #1 (outboard left) main landing gear tire strongly resembled the Michelin example with a flat spot through the tread and casing of the tire which had an X-shaped tear through the plies at the center which had not been ground away. (Figures 11 through 13) The tear was consistent with rupture of the inner bladder by release of pressure. Detailed examination of the #1 tire revealed no evidence of operation at low pressure, pre-existing damage, or of manufacturing defects. The tire also had a tear/cut to a hole at the edge of the flat-spotted area.

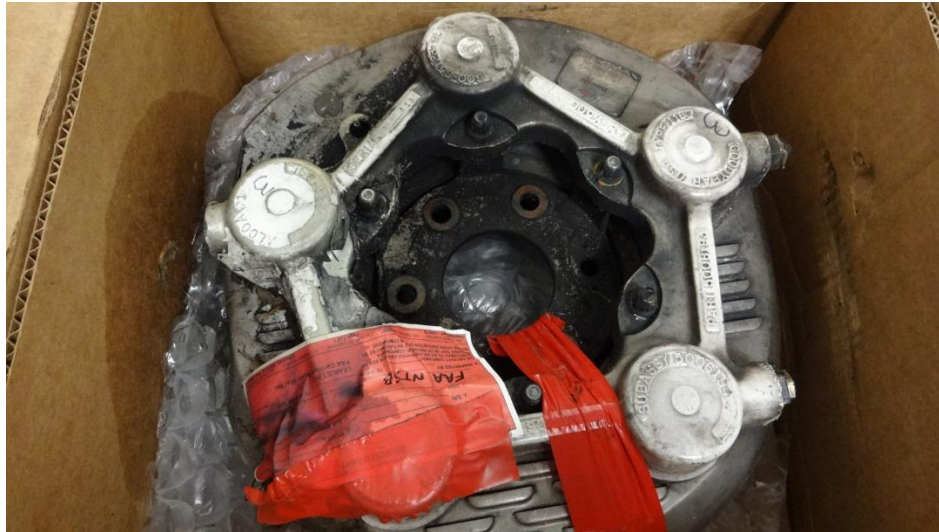
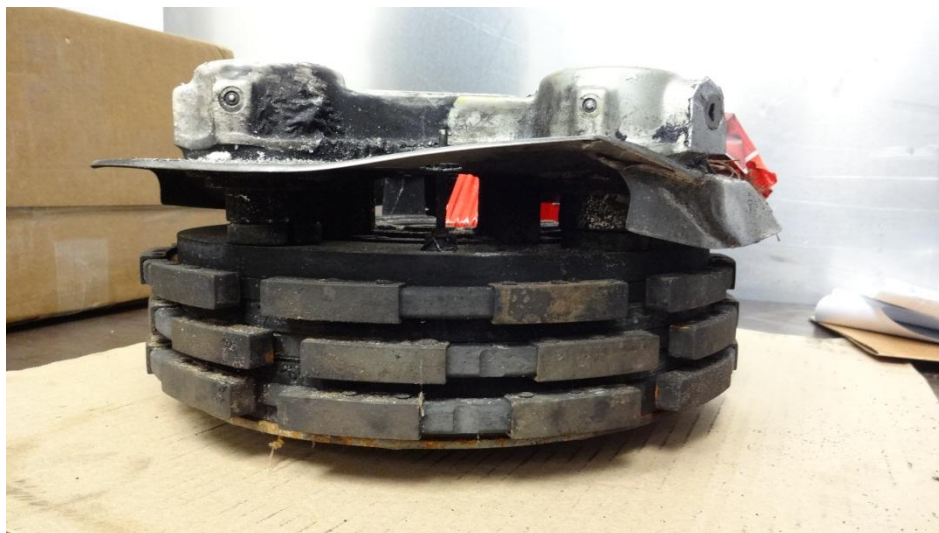
Brake assembly 5009027-5 s/n MAY82-418

A visual inspection of the brake assembly took place. Serial Number MAY82-814 had considerable damage to the water shield and at one port of the housing. The housing was damaged enough to not allow the brake to be pressurized to validate function.

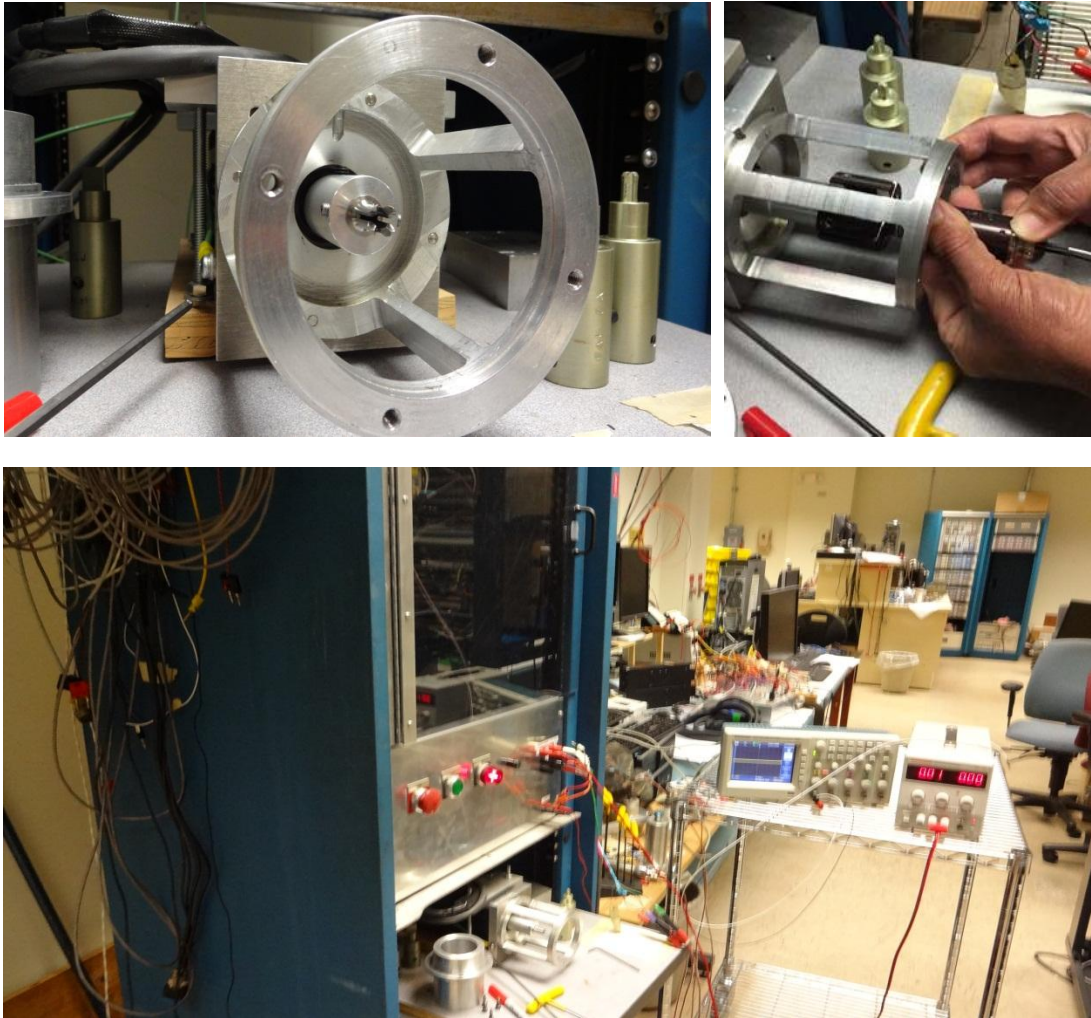
WST assembly 6002504 s/n AUG79-1068

Upon completion of Brake #3, the team went up to the Systems Test Lab to witness the functional check of Wheel Speed Transducer #1. The transducer was connected to the test rig and varying speeds were applied through an external power supply.

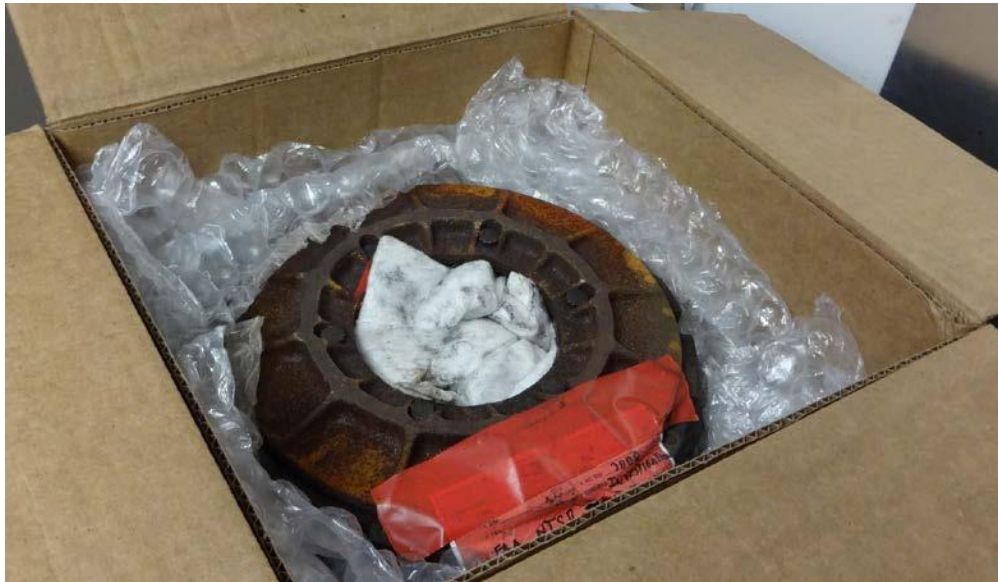
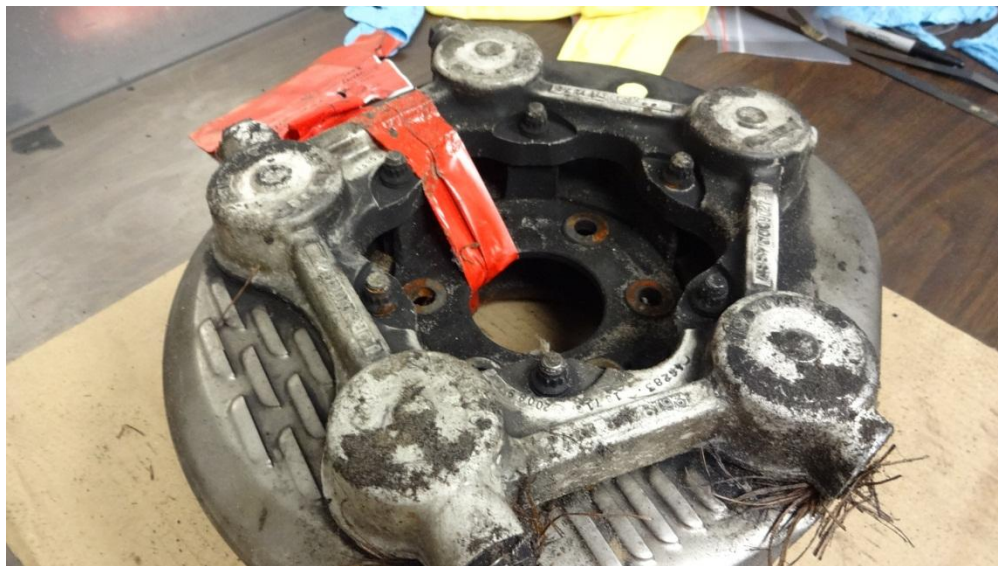
Brake assembly 5009027-5 s/n OCT81-84

A similar visual inspection of brake #4 took place. Serial Number OCT81-84 showed similar damage to that of brake #3. Again, there was considerable damage to the water shield and at one housing port location. The housing was damaged enough to not allow the brake to be pressurized.

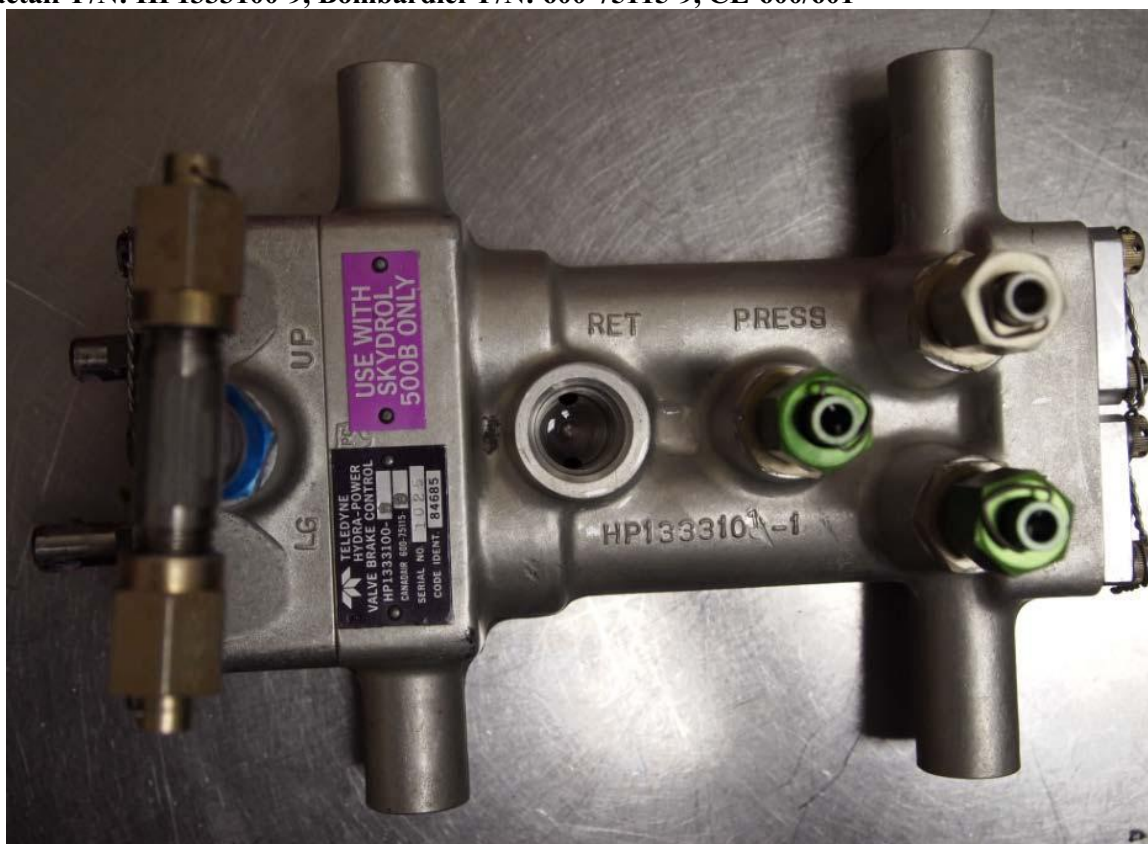
#1 Tactair P/N: HP1333100-9, Bombardier P/N: 600-75115-9, CL-600/601
