**TECHNICAL RECONSTRUCTION GROUP CHAIRMAN'S  
FACTUAL REPORT**

**Chattanooga, TN**

**HWY15MH009**

**NATIONAL TRANSPORTATION SAFETY BOARD  
OFFICE OF HIGHWAY SAFETY  
WASHINGTON, D.C.**

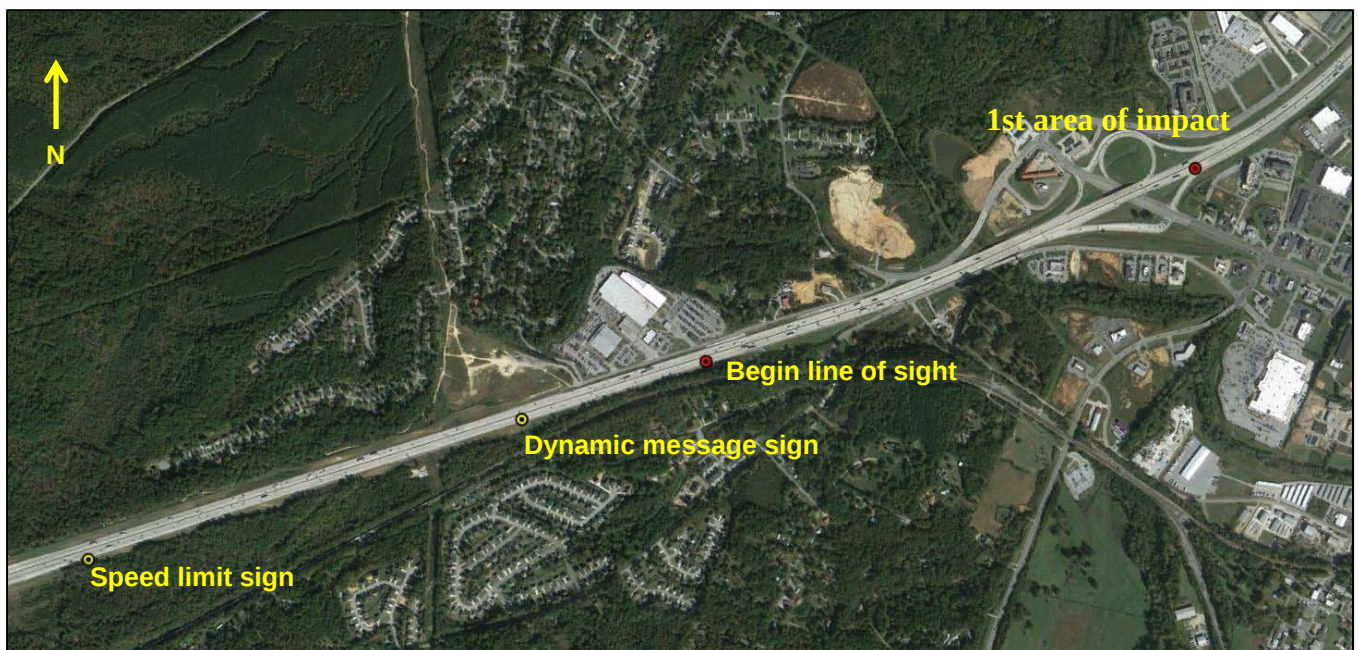
The highway speed limit preceding the work zone was posted at 65 mph for cars and 55 mph for trucks. The last posted speed limit signs before the collision were located on both sides of the northbound roadway about 2.2 miles before the collision. Figure 29 depicts the location of certain signage and the possible driver line of sight relative to the area of the collision.

Figure 29: Illustration using Google Earth imagery depicting the relative locations of certain features along the northbound heading toward the collision area.

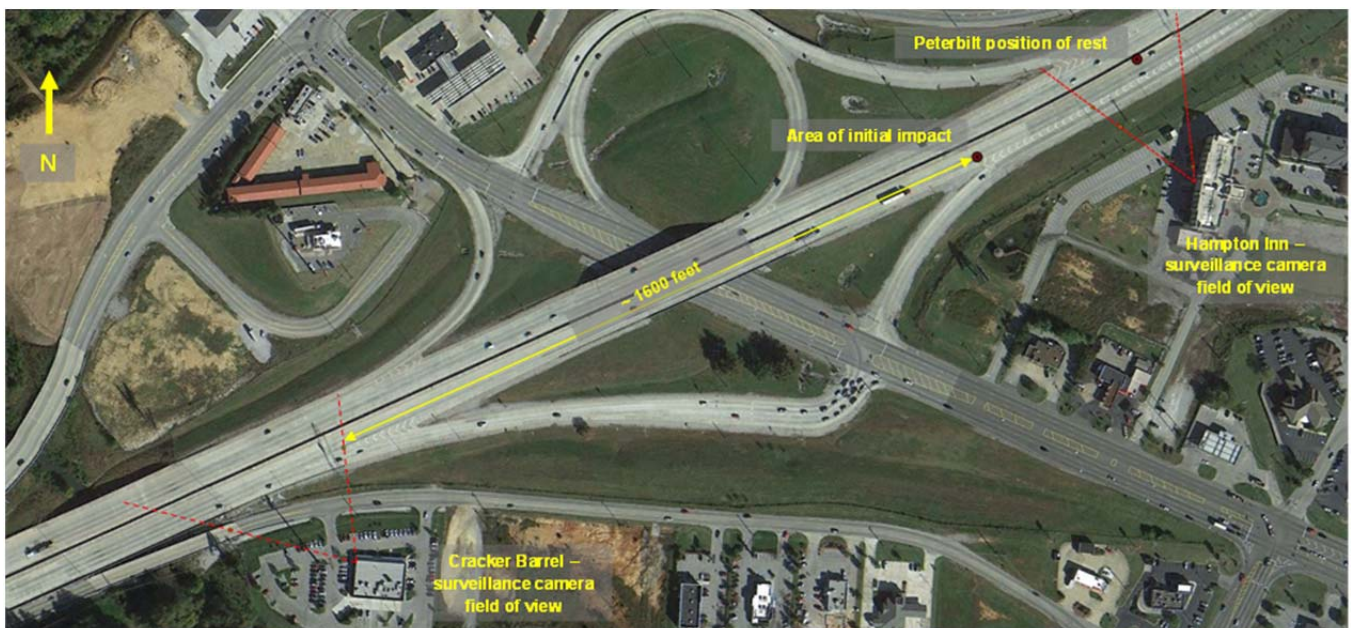
The approximate distance within the center lane between the camera fields of view for the two cameras was about 1896 feet. The distance was approximately 1600 feet from the north end of the field of view for the Cracker Barrel camera to the initial area of impact. The camera locations relative to the highway were also documented by 3D scanning. For reference, Figure 31 provides an illustration that depicts the approximate camera locations and their respective fields of view.

Figure 31: Illustration using Google Earth imagery depicting the relative locations of the video surveillance cameras and their approximate fields of view. The major roadway intersecting with I-75 is Lee Highway.
