**NATIONAL TRANSPORTATION SAFETY BOARD
OFFICE OF HIGHWAY SAFETY
WASHINGTON, D.C.**

**TECHNICAL RECONSTRUCTION GROUP CHAIRMAN'S
FACTUAL REPORT**

Location: US Highway 83 (US-83) near milepost 553.4 in Uvalde County, 6.5 miles north of Concan, Texas

NTSB #: **HWY17MH011**

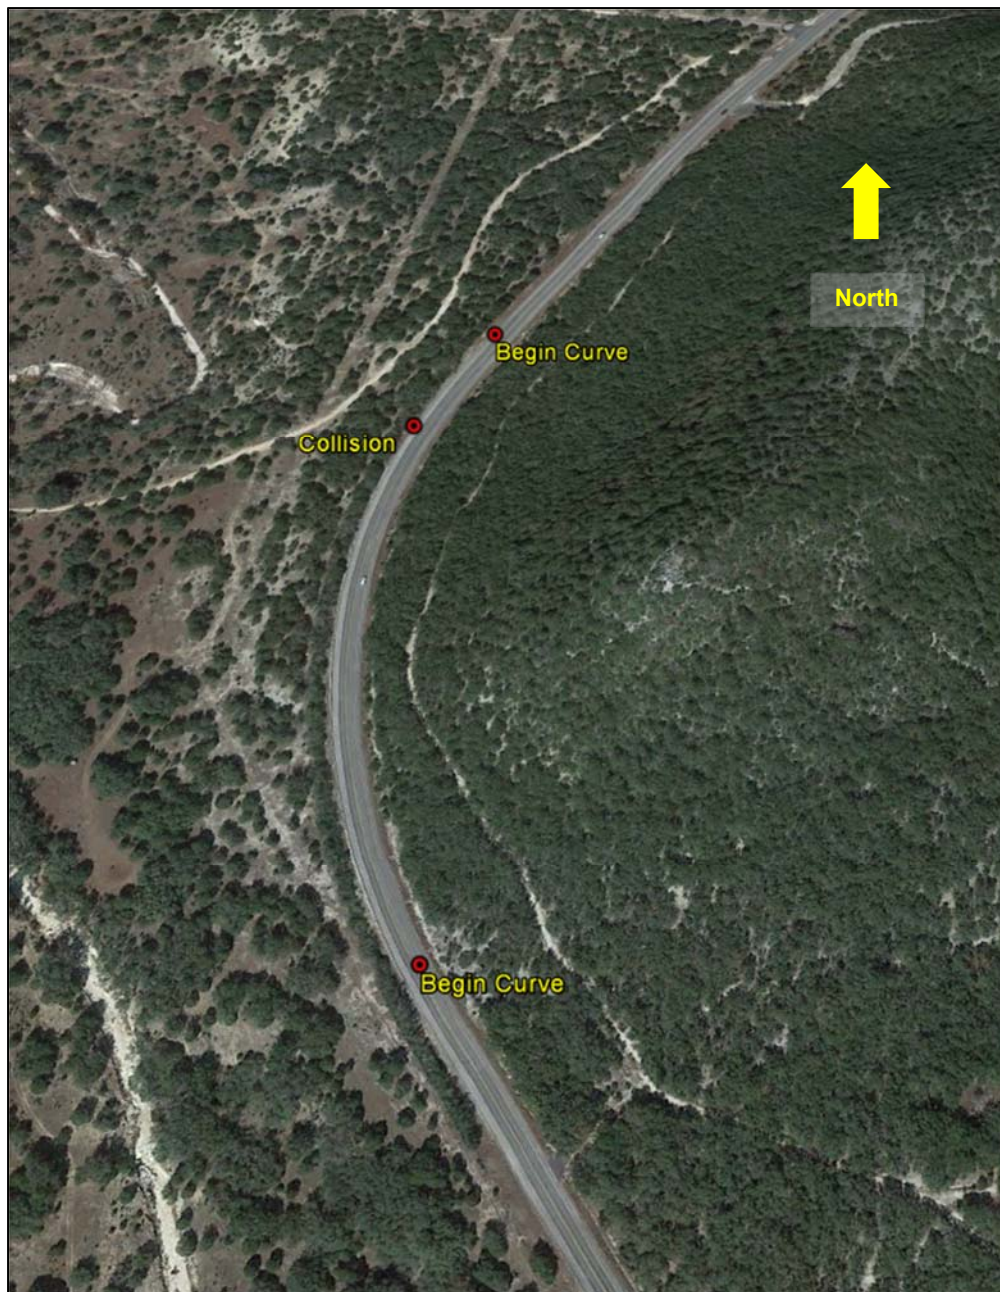
Figure 1 depicts a Google Earth image of US-83 through the area of the collision. The area of impact and geometric curve tangents are illustrated.

Figure 1: Google Earth image of US-83 depicting the collision site relative to the northern end of the curve. Imagery dated 11/2014.

The onset of roadway evidence appeared approximately 287 feet south of the northern end of the curve (curve point of tangent) and was primarily confined to the southbound travel lane.² Excluding displaced debris, such as vehicle components, scene evidence consisted of road surface metal scars, tire friction marks and fluid debris stains that extended over a linear distance of about 13 feet, as measured from the first onset southward to the approximate midpoint of the vehicle positions of rest. The metal scars and tire friction marks exhibited a southwestward orientation that began near the center of the southbound lane and extended toward the right shoulder. Roadway evidence extended no further than approximately 6.2 feet into the southbound travel lane as measured from the edge line. The tire friction marks appeared further south from the onset of the metal scars and were related to the rotation of the Ford. Similarly, the metal scars were consistent with deformation of the Ford that resulted in the transmission case and surrounding structure to contact the pavement. All the roadway evidence was related to the post-impact movement of the vehicles. No pre-collision roadway evidence, created by either of the involved vehicles, was observed.
