**NATIONAL TRANSPORTATION SAFETY BOARD  
OFFICE OF HIGHWAY SAFETY  
WASHINGTON, D.C.**

**TECHNICAL RECONSTRUCTION GROUP CHAIRMAN'S  
FACTUAL REPORT**

Location: Intersection of Northern Boulevard and Main Street, Flushing, NY  
Vehicle #1: 2015 Motor Coach Industries Motorcoach  
Operator #1: Dahlia Group Inc., of Flushing, NY  
Vehicle #2: 2015 New Flyer Transit Bus  
Operator #2: New York City Transit  
Vehicle #3: 2009 Honda Odyssey  
Operator #3: Parked at curb, not running, unoccupied  
Vehicle #4: 2002 Toyota Sequoia  
Operator #4: Parked at curb, not running, occupied by two passengers (one in the driver's seat, and one in the right-front passenger seat)  
Date: Monday, September 18, 2017  
Time: 6:16 a.m. Eastern Daylight Time (EDT)  
NTSB #: **HWY17MH015**

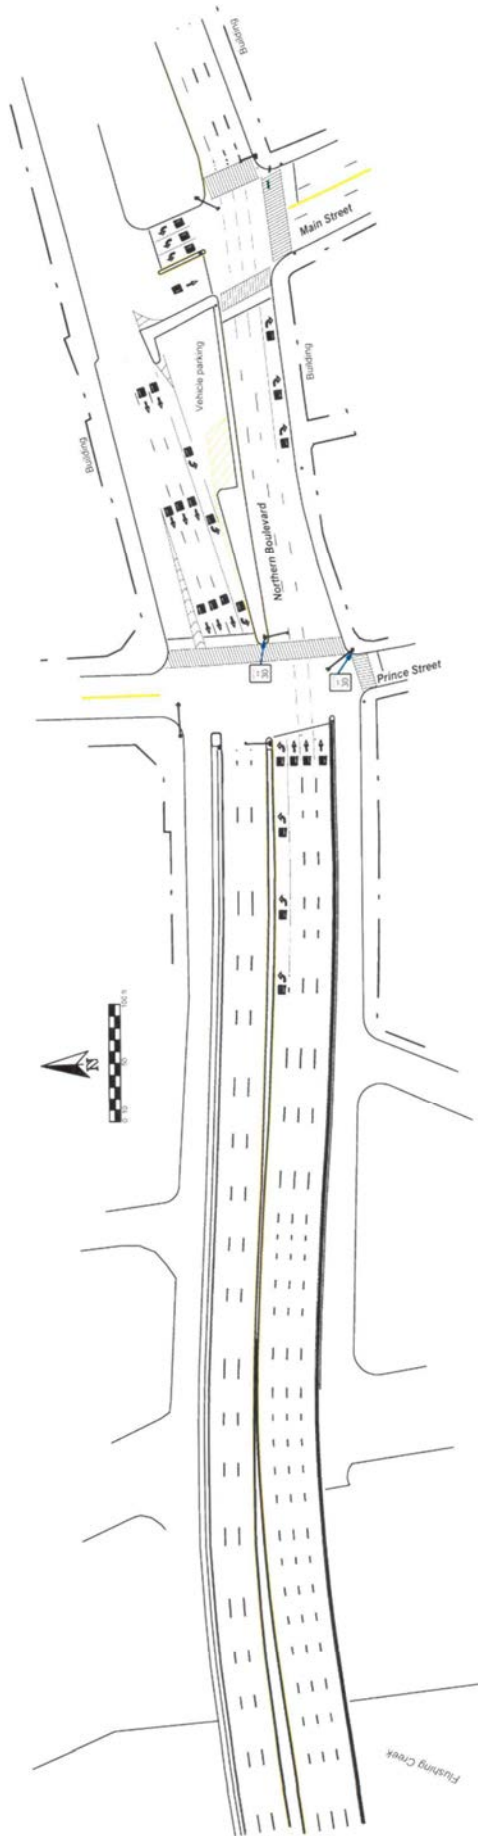
A site plan covering the eastbound roadway between the crest vertical curve on the bridge and the Main Street intersection is provided in **Figure 1**. **Figure 2** provides additional references regarding the eastbound roadway grade and other features. The NTSB Highway Factors Group Factual Report should be consulted for addition, and specific highway data.

Figure 1: Scaled site map depicting the eastbound roadway of Northern Boulevard between the Flushing Creel bridge and Main Street intersection.

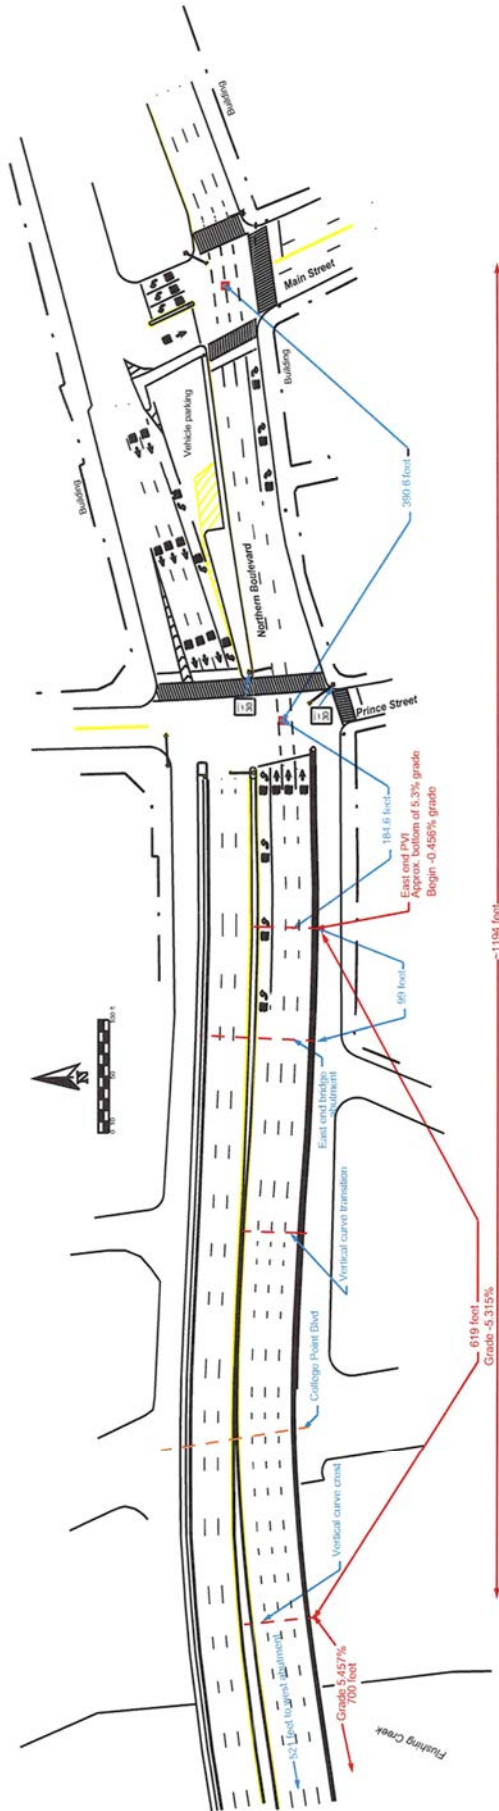
Figure 2: Scaled site map depicting the eastbound roadway of Northern Boulevard between the Flushing Creel bridge and Main Street intersection depicting certain dimensional data.

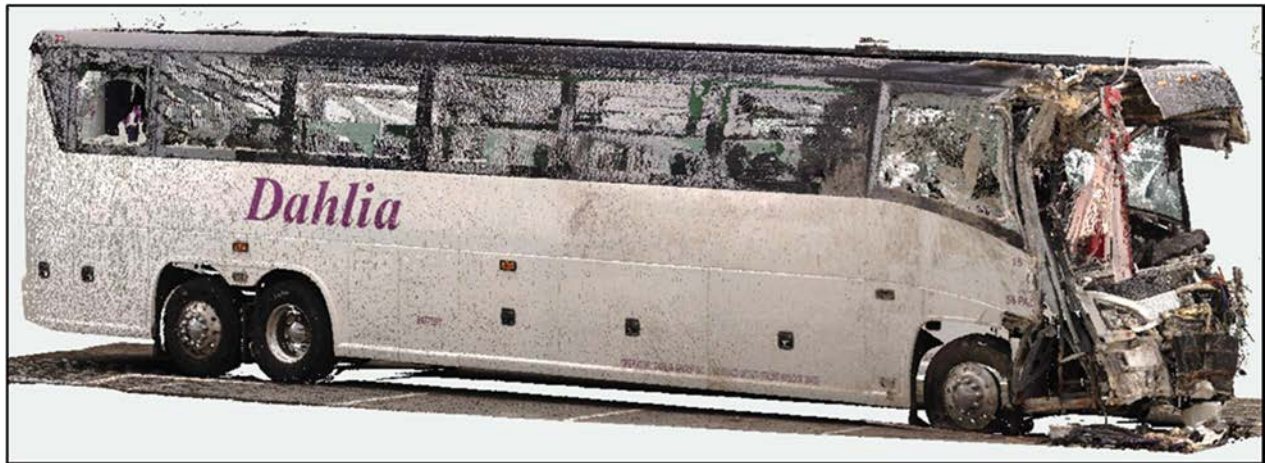
Figure 4: Depiction of linked 3D scans of the involved MCI motorcoach from the passenger side.

The MCI exhibited frontal impact damage with additional contact and induced damage extending rearward to the steer axle tires. During the examination, both steer axle tires were found deflated and unable to rotate due to impingement from structural displacement. Impact damage across the front the vehicle appeared relatively uniform from ground level to a vertical height of about six feet. The frontal structure at about the level of the interior floor was displaced rearward approximately 27 inches, while the structure at the bumper level exhibited a rearward displacement of about 17 inches. Vertically above the approximate six-foot level, structures on the right (passenger) side exhibited slightly more rearward displacement than on the left (driver) side due to contact with the building. **Figure 7** is a line drawing depicting the rearward displacement of the frontal structure as observed from the left (driver) side.

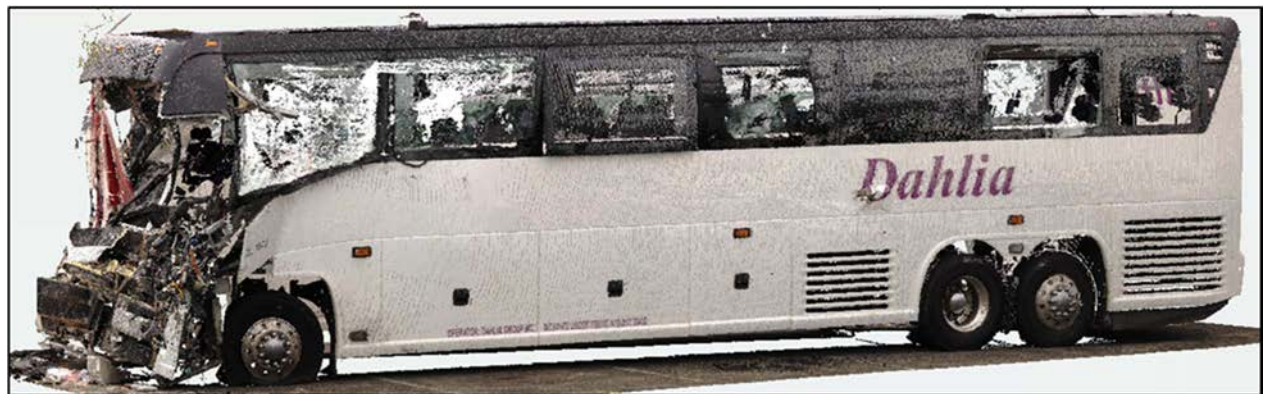
Figure 5: Depiction of linked 3D scans of the involved MCI motorcoach from the driver side.

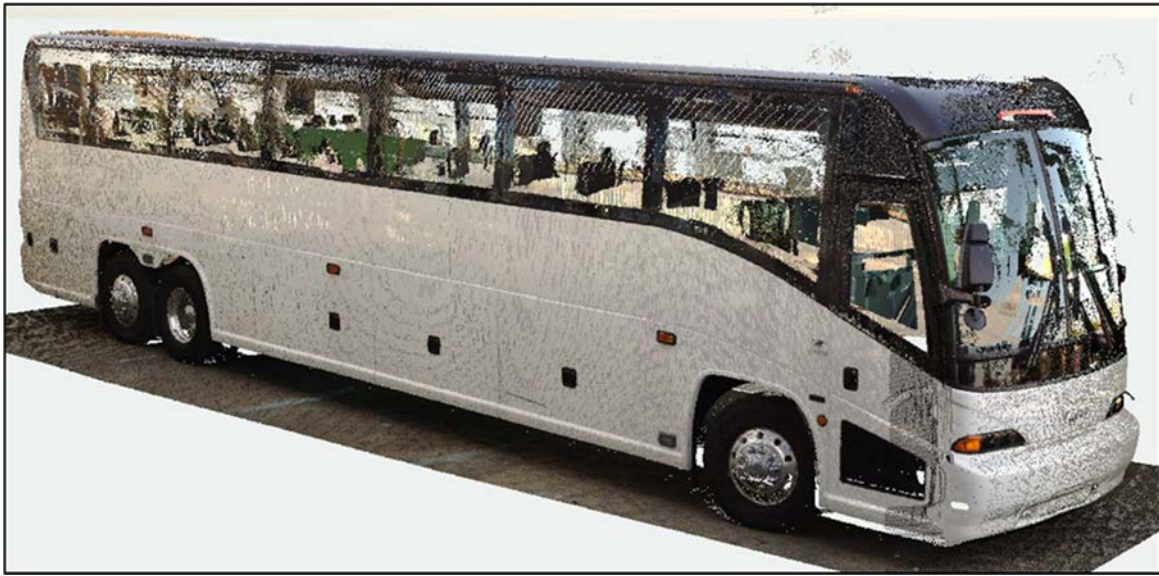
Figure 6: Depiction of linked 3D scans of the exemplar MCI motorcoach from the passenger side.

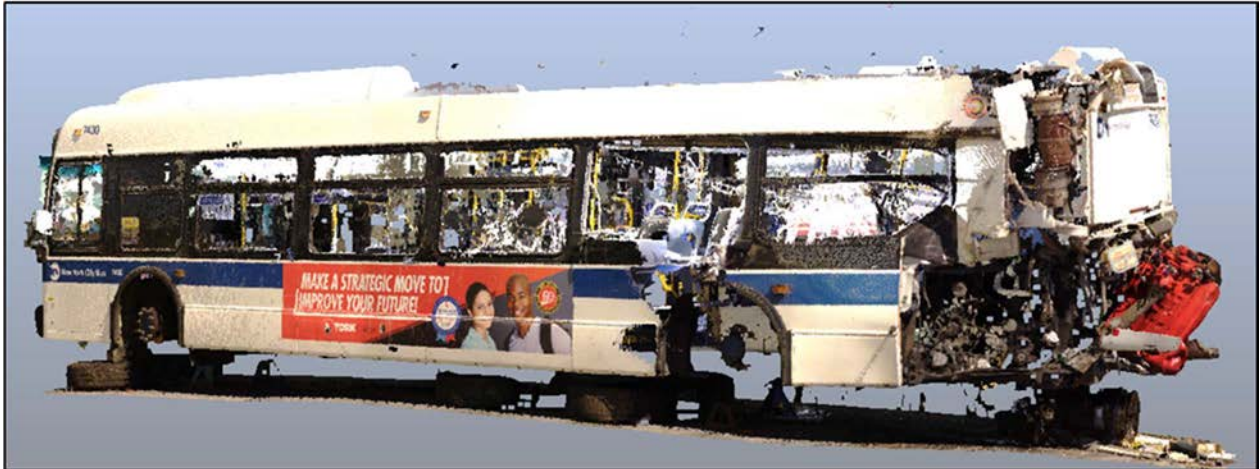
Figure 8: Depiction of linked 3D scans of the MTA New Flyer transit bus involved in the collision.

The transit bus exhibited evidence of impact damage to the left (driver) side rear beginning approximately five feet aft of the drive axle. The impact force displaced the entire body aft of the drive axle toward the right (passenger) side of the vehicle approximately 16 inches and partially ejected the engine through the rear of the vehicle. **Figure 10** is a line drawing depicting the area

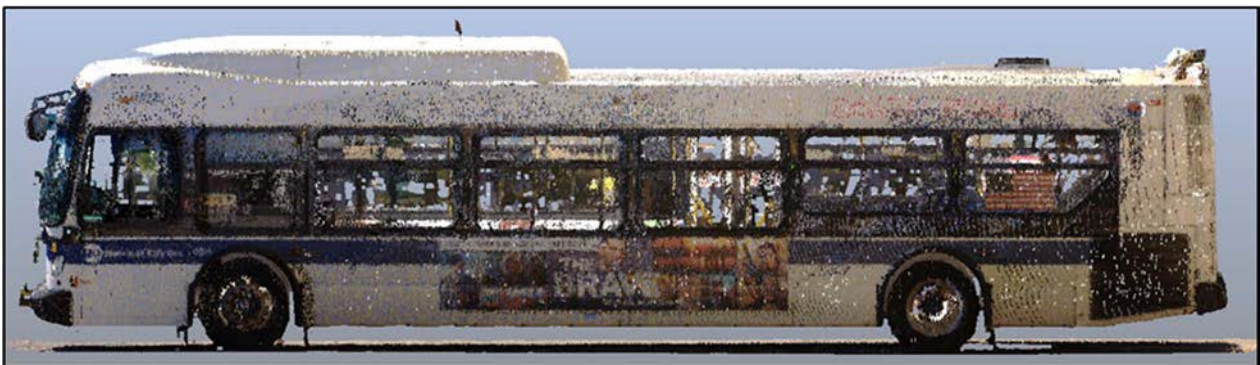
Figure 9: Depiction of linked 3D scans of an exemplar MTA New Flyer transit bus.

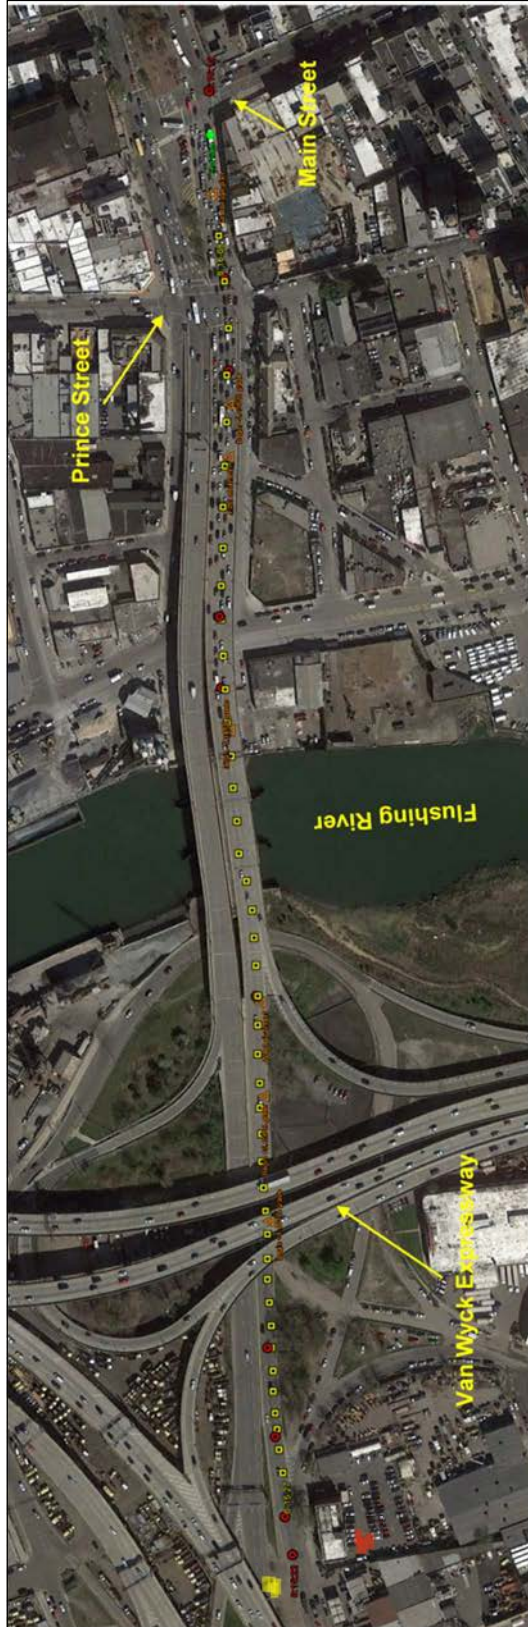
Figure 12 depicts a Google Earth image with the track of the MCI as expressed by the Garmin and TracManager position data.

Figure 12: Modified Google Earth image depicting MCI track along Northern Boulevard as indicated by TracManager
