ENGINE ANALYSIS REPORT

ENGINE MODEL IO-470-U (Right)

ENGINE SERIAL 118267-R

REGISTRATION NUMBER N8145M

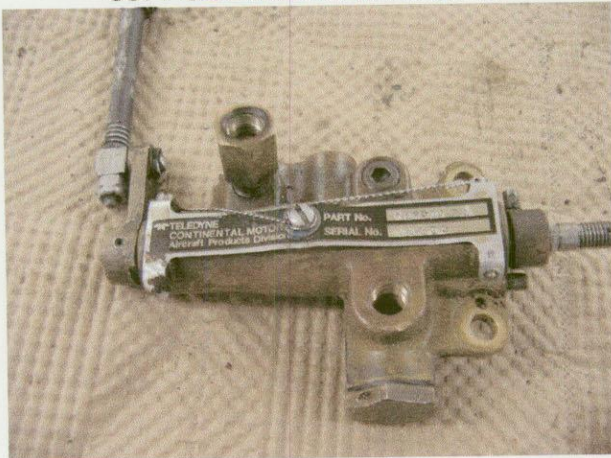
63. FUEL METERING UNIT

The throttle link rod (throttle shaft to metering unit) was bent from impact. The throttle body was broken up. The mixture return fitting was broken off the metering unit.
