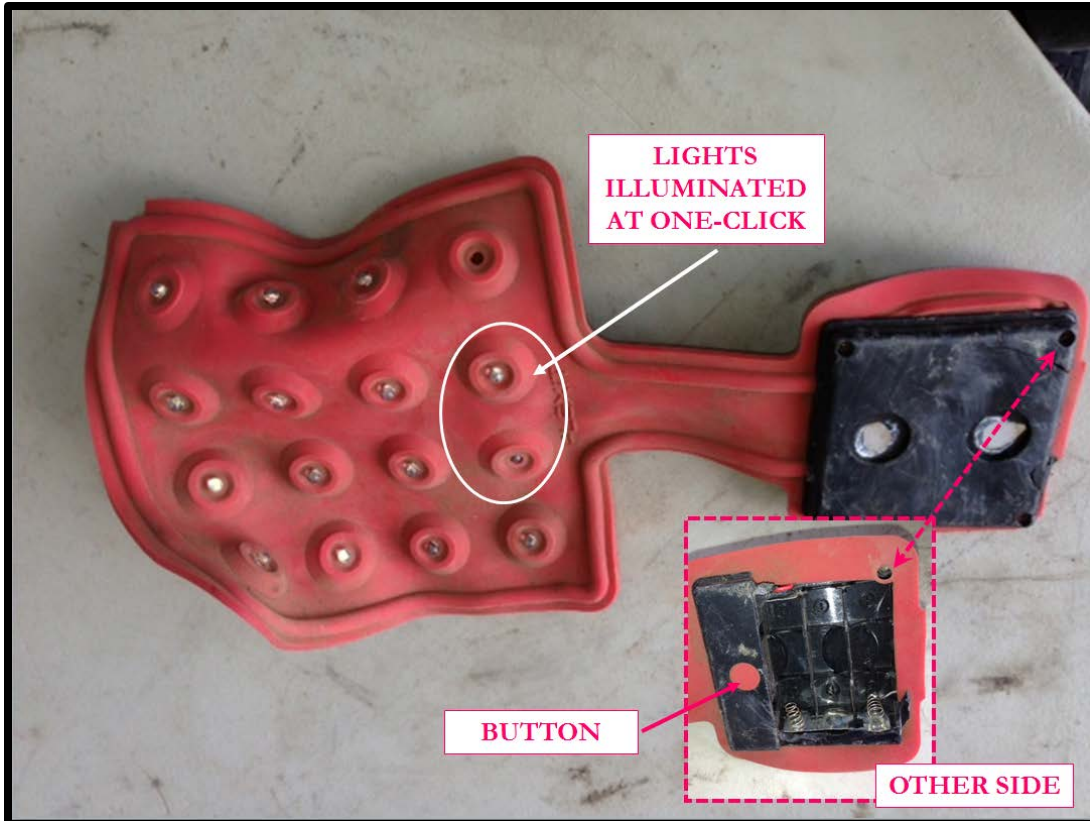
Picture 6: FLEXiT Light

The light placed in the cockpit for the purpose of illuminating the actor for the mounted GoPro camera was found with in the wreckage. The Stiker FLEXiT Light was a flat red flexible silicone panel measuring 13 in by 7 in that contained 16 white 5mm LED lights. The light was equipped with 2 magnets for mounting and powered by AA batteries. The light was operated by depressing a 3-mode electronic switch (button) that would activate a low (2 lights illuminated), medium (4 lights illuminated), high setting (16 lights illuminated), of which the highest setting would emit 128 lumens. Osteopathic 503-224-8399
