The ShakeOut Scenario

Oil and Gas Pipelines

By
Donald Ballantyne
MMI Engineering, Inc.
Tacoma WA
May 2008

M7.8 Southern San Andreas Fault Earthquake Scenario: Oil and Gas Pipelines

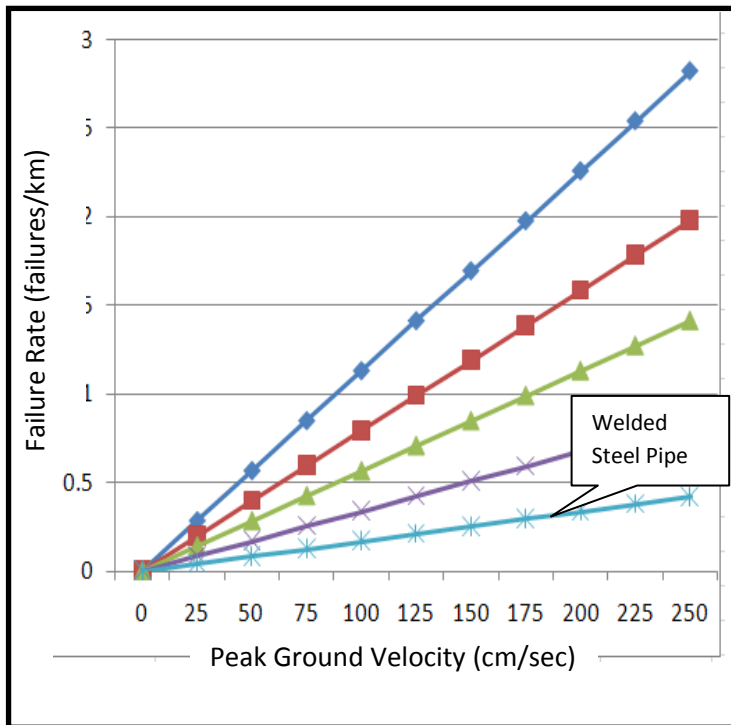
Figure 2. Wave Propagation Pipeline Fragility (After ALA 2001)

The most extreme shaking intensity in the study area is expected to be about 250 cm/second, located just north of Cajon Pass and in the Palm Desert-Coachella area along the Kinder Morgan pipeline. For this level of shaking, the American Lifelines Alliance (2001) estimates failure rates on the order of 0.4/km for high quality welded steel pipelines (Figure 2). Pipelines in the San Bernardino and Palmdale areas would be expected to experience velocities of 150 to 200 cm/sec resulting in failure rates of 0.28/km for high quality electric arc joint welded pipe.

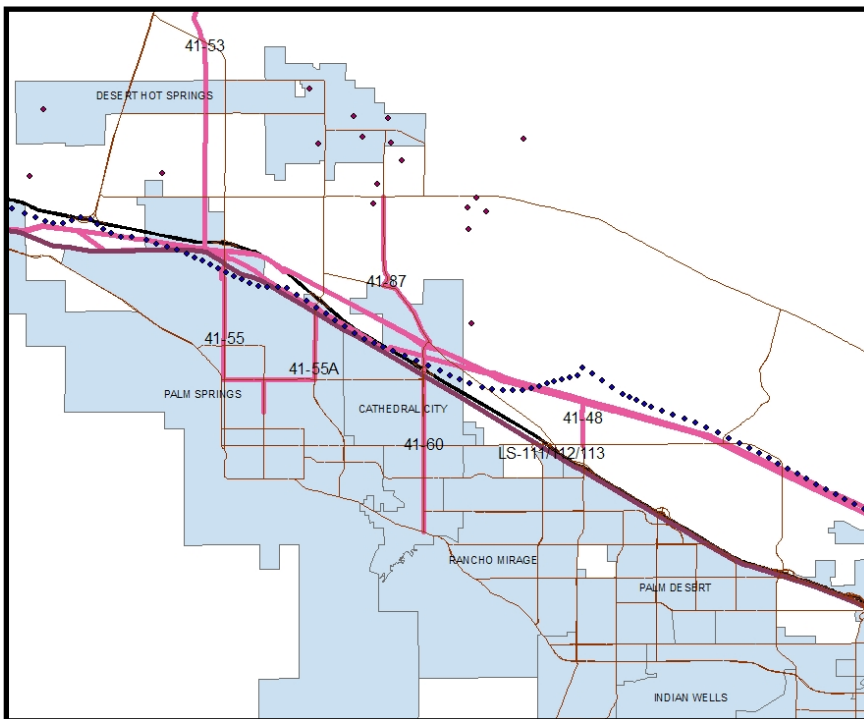
The 20-inch Kinder Morgan product line is ruptured in Palm Springs (Figure 6). The pipeline is aligned directly over the fault. When the earthquake occurs, the pipeline is shortened five meters causing it to wrinkle and rupture (Figure 7). The pipeline is carrying diesel which is sprayed into the air. Ultimately 200,000 gallons of product is discharged into the local drainage until the line can be isolated. A smaller natural gas distribution pipeline is located in the same right-of-way. The fault displacement also ruptures this line. Although the volume of discharging gas is much smaller than that coming from the break at Cajon Pass, the gas hampers response efforts. The Kinder Morgan Pipeline fails at an additional 15 locations due to shaking at locations along the 60 km alignment paralleling the fault trace. Each failure location requires environmental cleanup of the discharged diesel product.

Figure 6. Layout of Kinder Morgan 20-inch Product Line (brown) and Southern California Gas Pipelines (pink). Relative the San Andreas Fault in Palm Springs (dotted).
