**NATIONAL TRANSPORTATION SAFETY BOARD
OFFICE OF RAILROAD, PIPELINE AND HAZARDOUS
MATERIALS INVESTIGATIONS
WASHINGTON, D. C. 20594**

Track & Power Group Factual Report

Location: Commerce Street Grade Crossing on the Metro-North Harlem Line,
Valhalla, Westchester County, New York

NTSB #: **DCA15MR006**

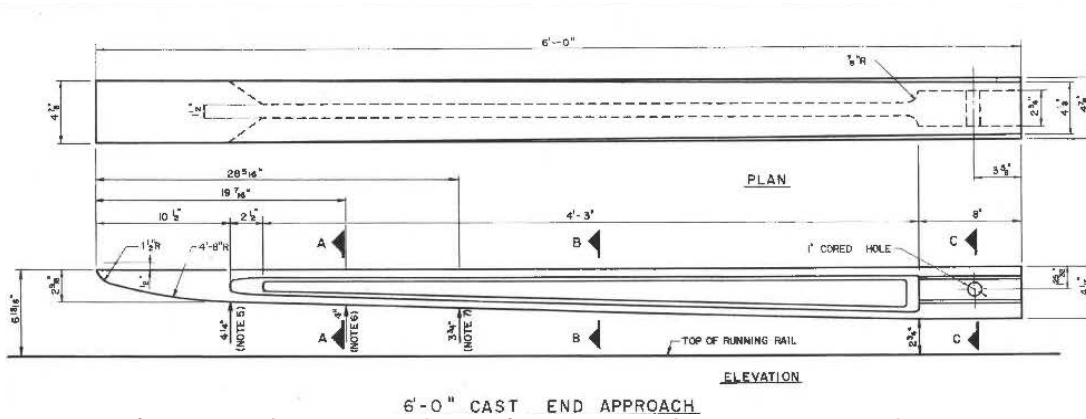
Figure 5-View of a contact rail arrangement diagram from Metro-North Power Department drawing STD-303

The 3rd rail is 150 pounds per three foot section of a rolled thick flange beam. Each section is 39 feet long, but the length may be adjusted as required during maintenance.⁶ Connected to the leading edge of the beam is a 6 foot cast tapered end approach beam. These components are attached to a bracket and the bracket is then attached to every sixth tie (approximately every 10 feet) that supports the third rail. The contact surface of the third rail is on the bottom of the section. The third rail has a protective cover to keep the elements off the top section of the rail. See Figures 4, 5, and 6.
