1
2
3
4 **NATIONAL TRANSPORTATION SAFETY BOARD**

10
11
12 **TRACK & ENGINEERING GROUP FACTUAL REPORT**
13

14
15 **DCA16MR011**
16

17
18 **New Jersey Transit Passenger Train Accident, Hoboken Station**
19

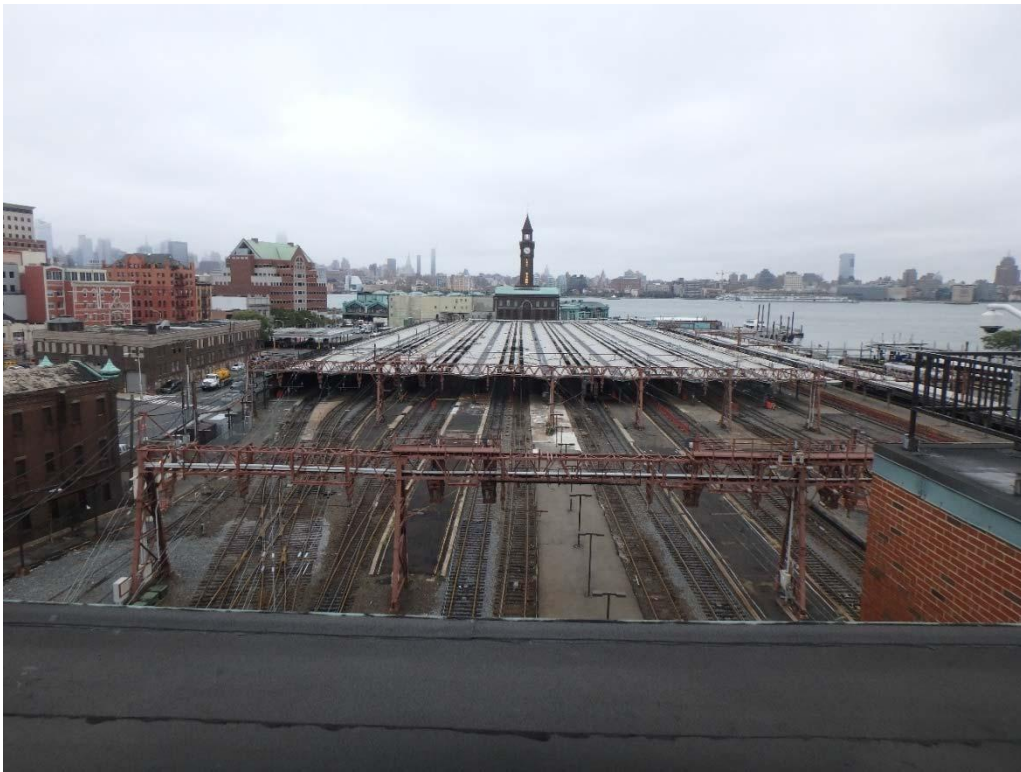
Figure 2. Photo taken from Hoboken Terminal tower facing east toward the station. Depot tracks and canopy shown (Photo NTSB)
