NATIONAL TRANSPORTATION SAFETY BOARD

TRACK & ENGINEERING GROUP CHAIRMAN FACTUAL REPORT

DCA-12-MR-009

**CSX Transportation Derailment with
Non-Railroad Fatalities**

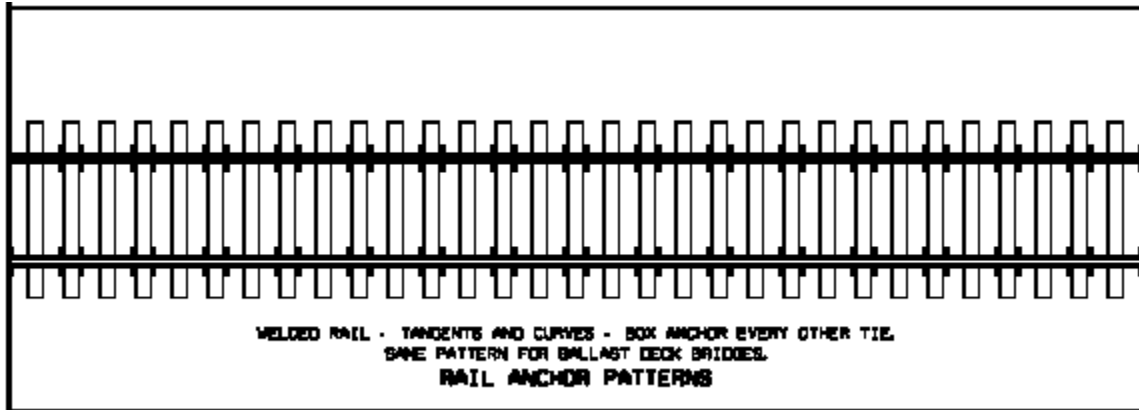
Figure No. 2. The above is a CSX schematic showing anchor pattern for CWR.

Investigators did not take exception to the anchoring patterns or rail restraint effectiveness of the anchors in the area of the derailment. Investigators observed that the track adjacent or outside of the disturbed area were box anchored every crosstie. No rail movement was noted.

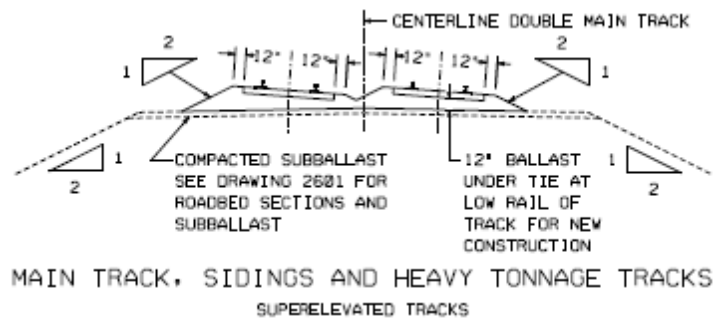
Figure No. 3. The above is a schematic of a cross-section of a standard ballast section.

Investigators noted that several locations prior to and at the point of derailment exhibited fouled ballast conditions or saturation of the subgrade. Investigators observed that the south ditch line was wet and there was evidence of water flow along the ditch line (See Post Accident Inspection/Testing of Track section of this report).

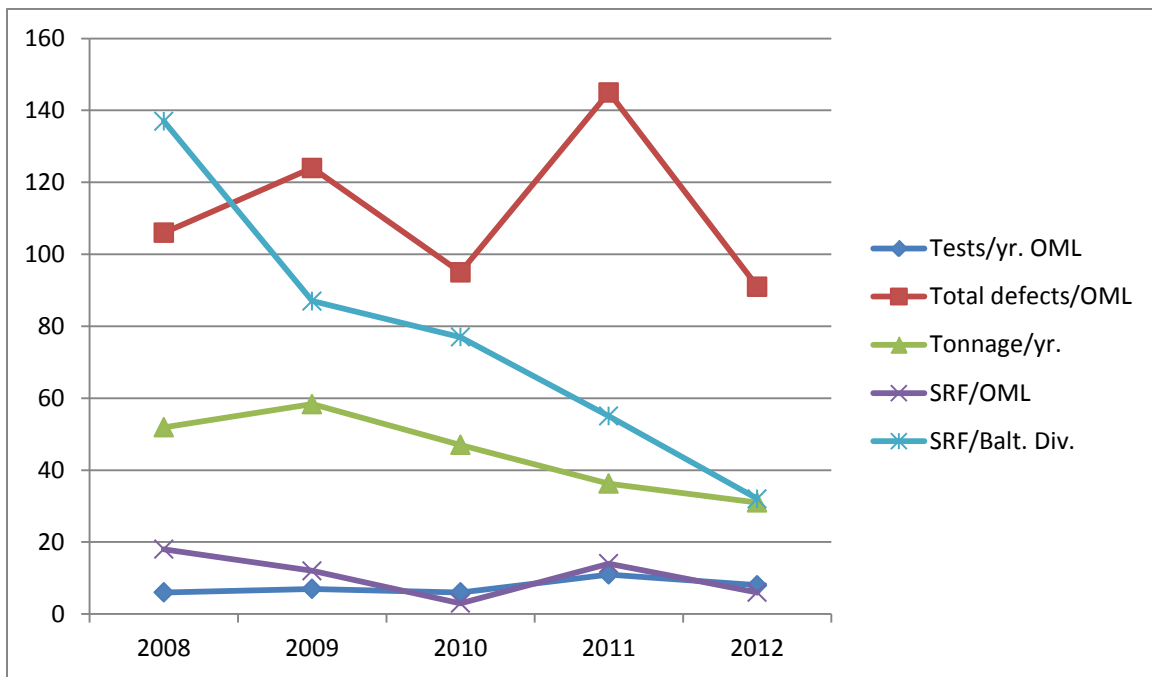
Figure 9. Graph of OML annual tonnage data, internal rail flaw detection tests, defect numbers and service rail failures (SRF) for OML and Baltimore Division.

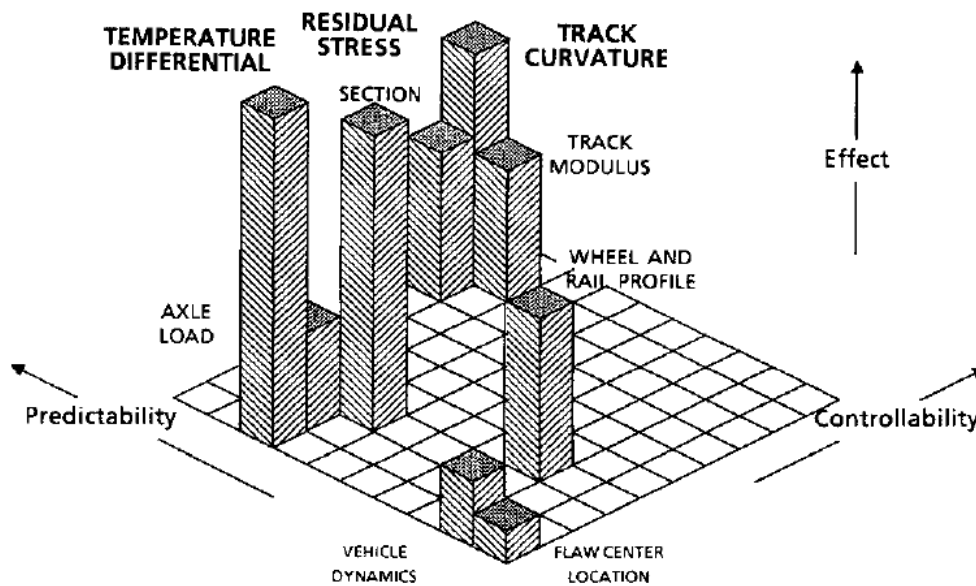
- Temperature differential, rail residual stress and track curvature have strong effects on detail fracture growth life;
- Rail section, track foundation quality (modulus), center of contact (wheel and rail profile) and average axle load all have moderate effects on detail fracture growth life;
- Vehicle dynamics and flaw center location in the rail head have only small effects on detail fracture growth life.

Figure 10. Effects and Attributes of Environment Factors¹⁶
