Figure 1. Overall view of the examined lock pieces relatively arranged as if on the bridge.

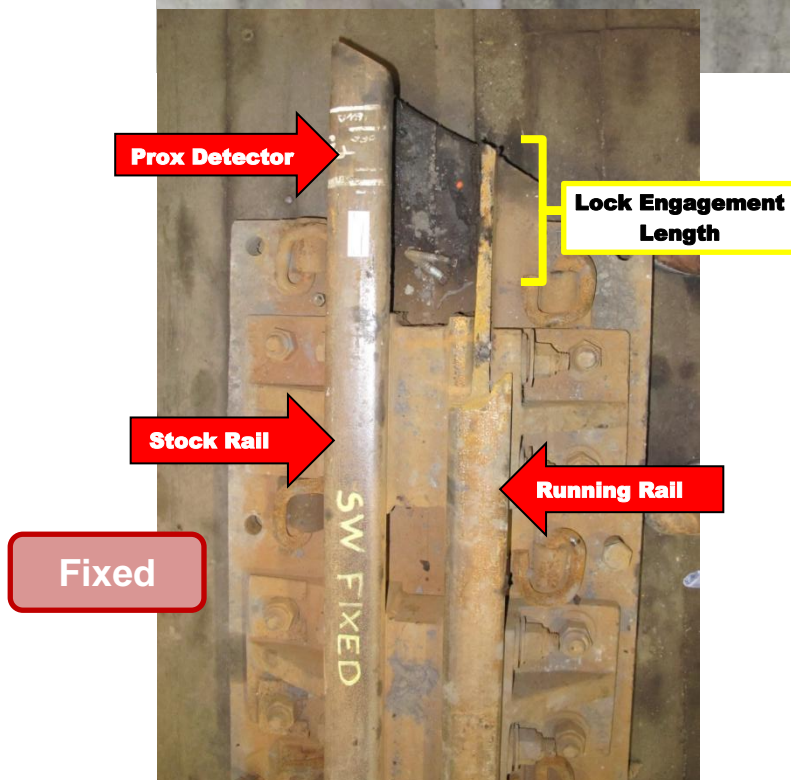
Figure 4. Images showing the arrangement of components at the south side of the bridge with many of the components labeled. West rail shown. The swing side components have been arranged with the sliding block in the extended locked position but not engaging the fixed side components (shown below). The approximate lock engagement length is also indicated.
