**Date of Accident:** April 7, 2015

**NTSB File No.:** CEN15FA190

**Aircraft:** Cessna 414A

**Turbocharger Teardown Report****Date of Investigation:** September 3, 2015**Location:** Hartzell Engine Technologies, Montgomery, AL

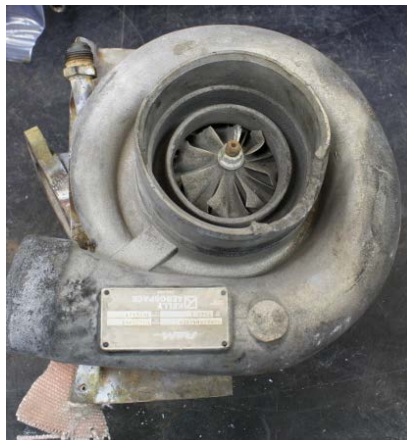
Any evidence of eroding, fretting, or damage to attachment/mounting surfaces?  
**DAMAGED INLET ON THE COMPRESSOR HSG & TURBINE EXIT FLANGE**

Able to Turn/Spin the Turbine Wheel? NO  
Measured Resistance (in Ounce/Inches): N/A; UNABLE TO TURN

\* UNABLE TO ROTATE DUE TO BENT SHAFT.

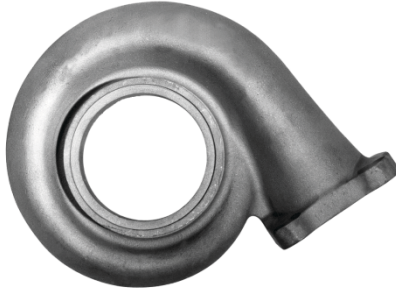
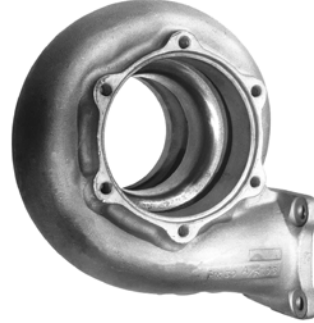
- Compressor Housing Clamp Locations N/A; V-BAND STYLE
- Are tabs on Lockplates folded over wrenching flats of bolt heads? YES
- Condition of Compressor Housing: DAMAGED INLET
  - Any Helicoil repairs? N/A

Turbine Housing Crack Locations: N/A

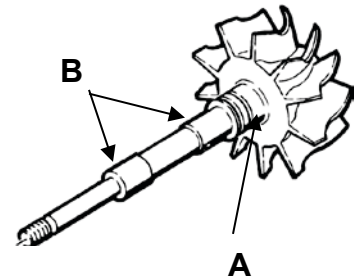
THE DAMAGE TO THE COMPRESSOR BACKPLATE, COMPRESSOR WHEEL/HSG AND THE BENT TURBINE WHEEL SHAFT WAS CONSISTENT WITH THE ACCIDENT IMPACT (SEE FIGURE 1).

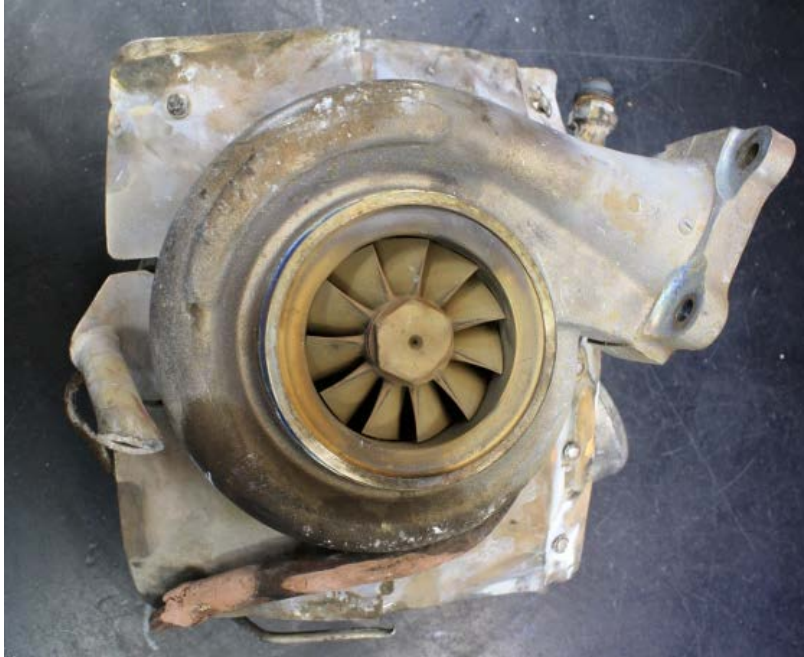
Any evidence of eroding, fretting, or damage to attachment/mounting surfaces?  
DAMAGED INLET ON THE COMPRESSOR HSG.

Able to Turn/Spin the Turbine Wheel? NO  
Measured Resistance (in Ounce/Inches): N/A; UNABLE TO TURN

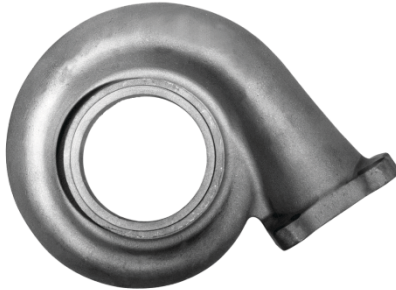
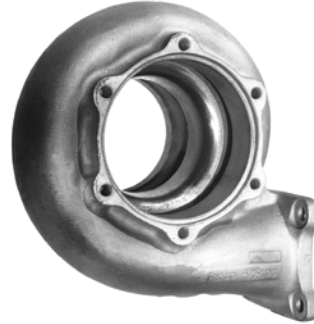
- Compressor Housing Clamp Locations N/A; V-BAND STYLE
- Are tabs on Lockplates folded over wrenching flats of bolt heads? YES
- Condition of Compressor Housing: INTERNAL SOOTING; DAMAGED INLET
  - Any Helicoil repairs? N/A

Turbine Housing Crack Locations: N/A

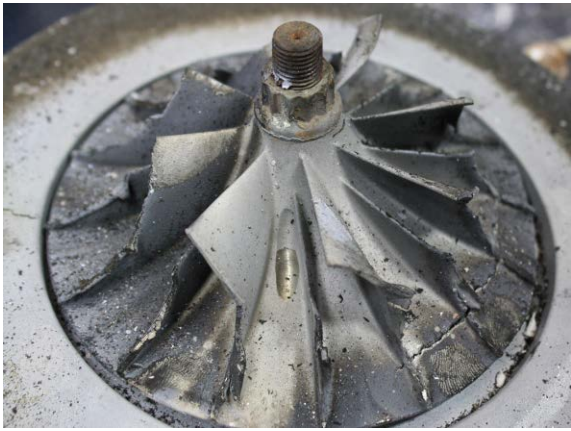
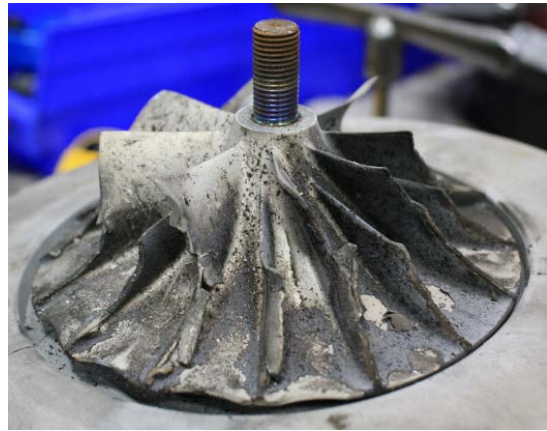
Any Residual pieces? NO

THE DAMAGE TO THE COMPRESSOR BACKPLATE, COMPRESSOR WHEEL/HSG AND THE BENT TURBINE WHEEL SHAFT WAS CONSISTENT WITH THE ACCIDENT IMPACT.
