Arriel 1D1 Engine S/N 9872 Examination

AS350 B2 S/N 3728

Registration N352LN

CEN11FA599 / A-2011-011 / RA-11-260

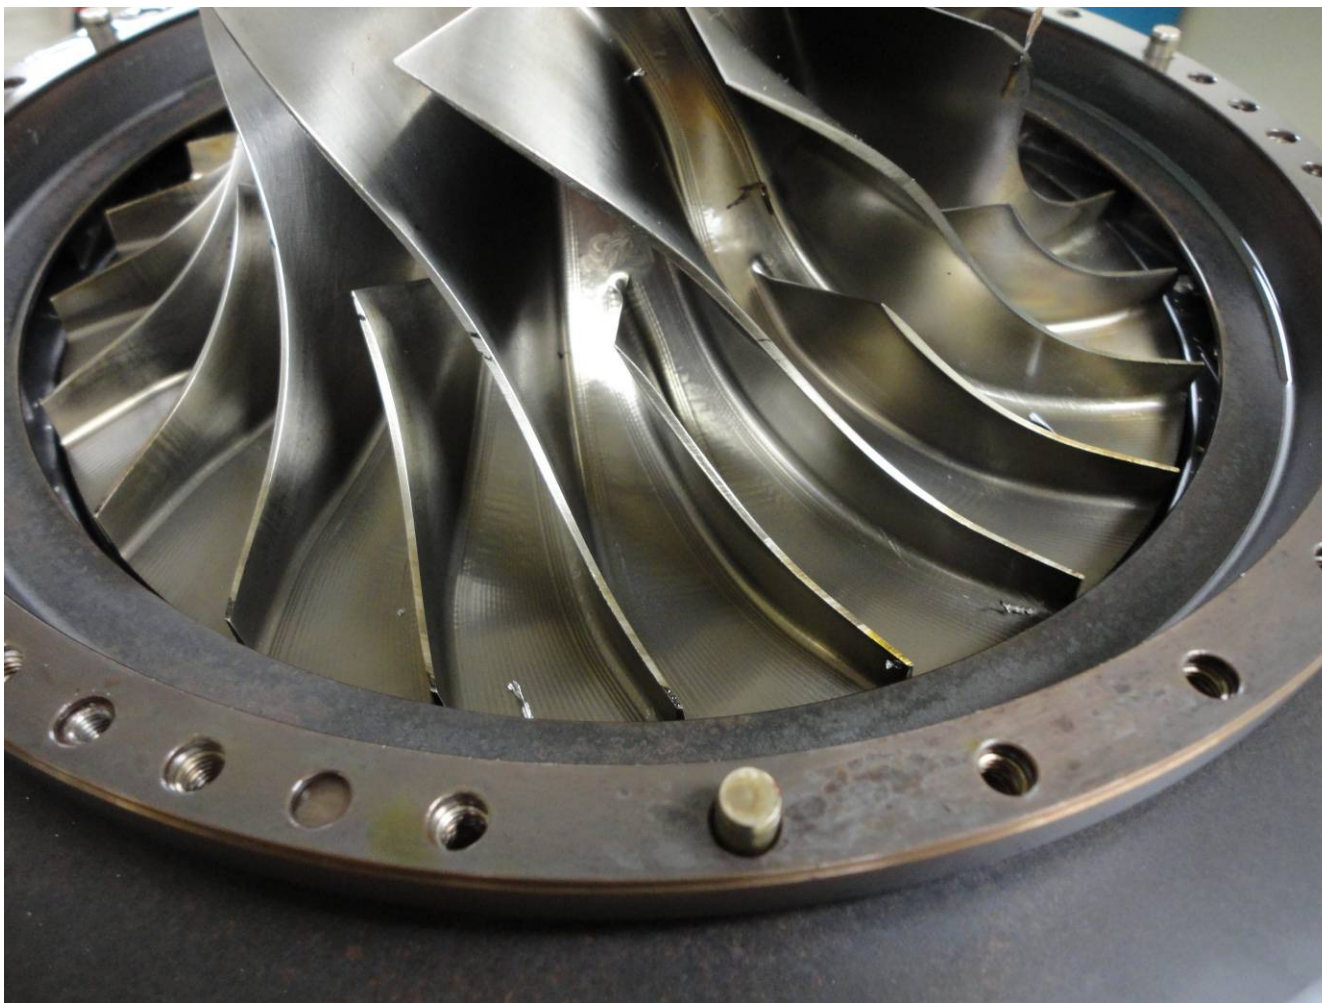
Photos / Compressor cover removed

- **Module 3 : Complete disassembly . Inspect for the presence of melted foreign material (aluminum from A/C intake).**
- **Disassembly revealed debris (metal shavings) distributed throughout the module. The centrifugal compressor, combustion chamber, and turbine blades exhibited a black substance (soot). No FOD observed to the turbine blades. The rear bearing was intact and rotated by hand.**
