Twin Commander Aircraft Field Notes

NTSB Identification: WPR14LA194

Accident occurred Saturday, May 17, 2014 in Fort Huachuca, AZ

Aircraft: Aero Commander 500 S, Registration: N40TC

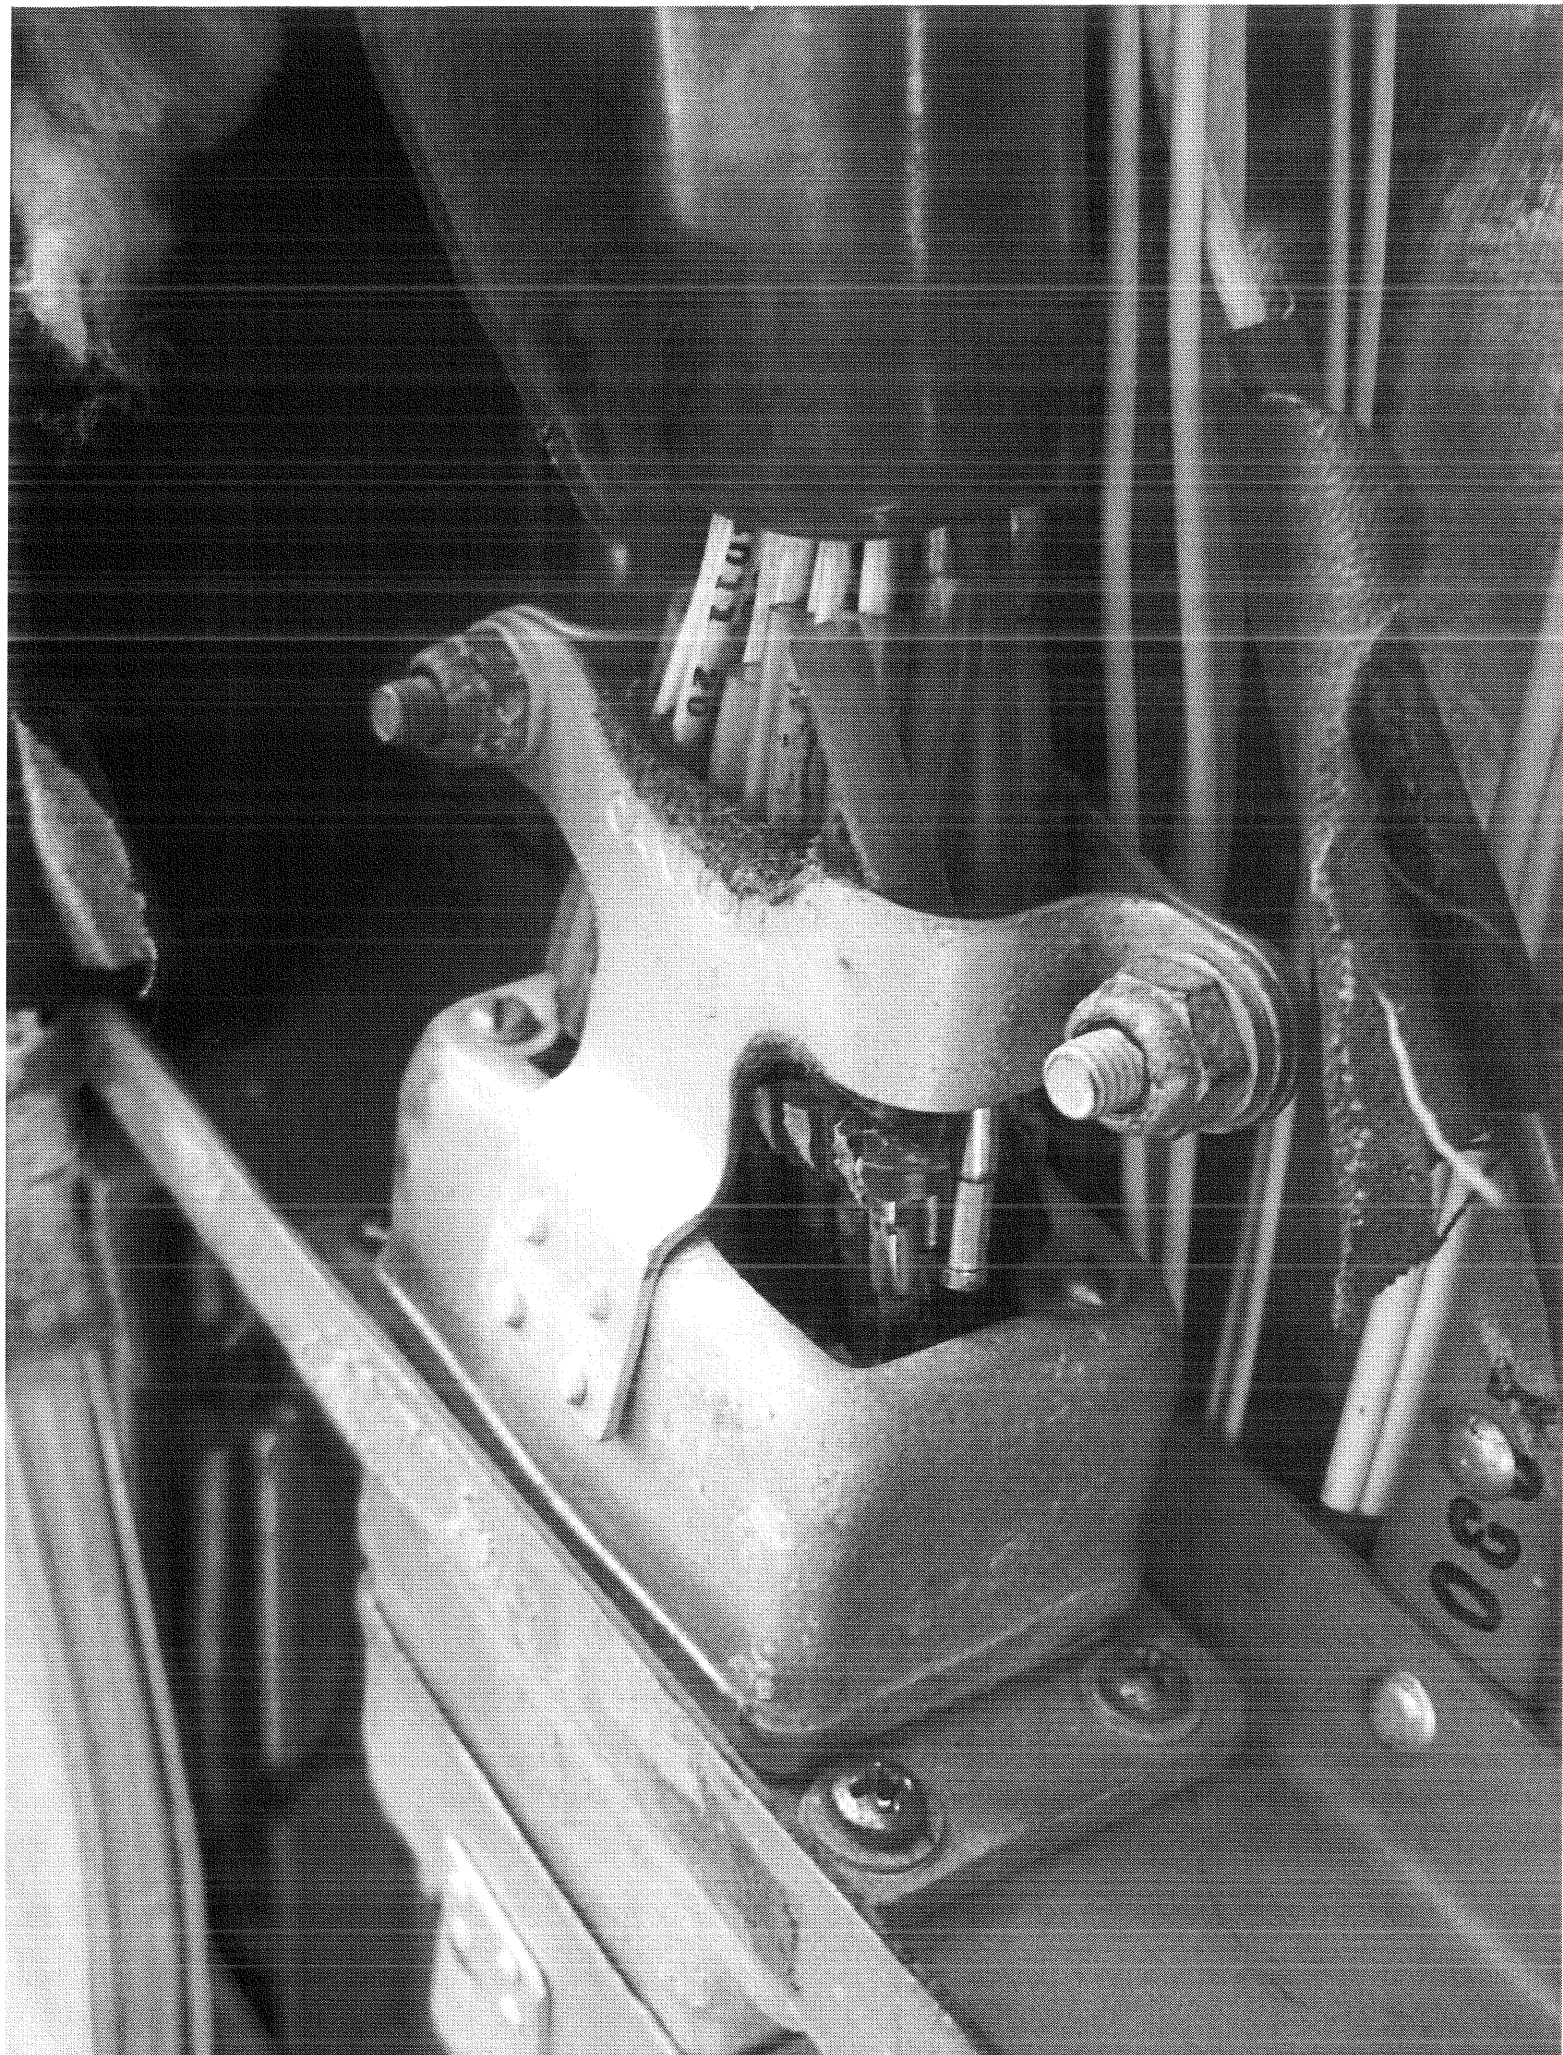
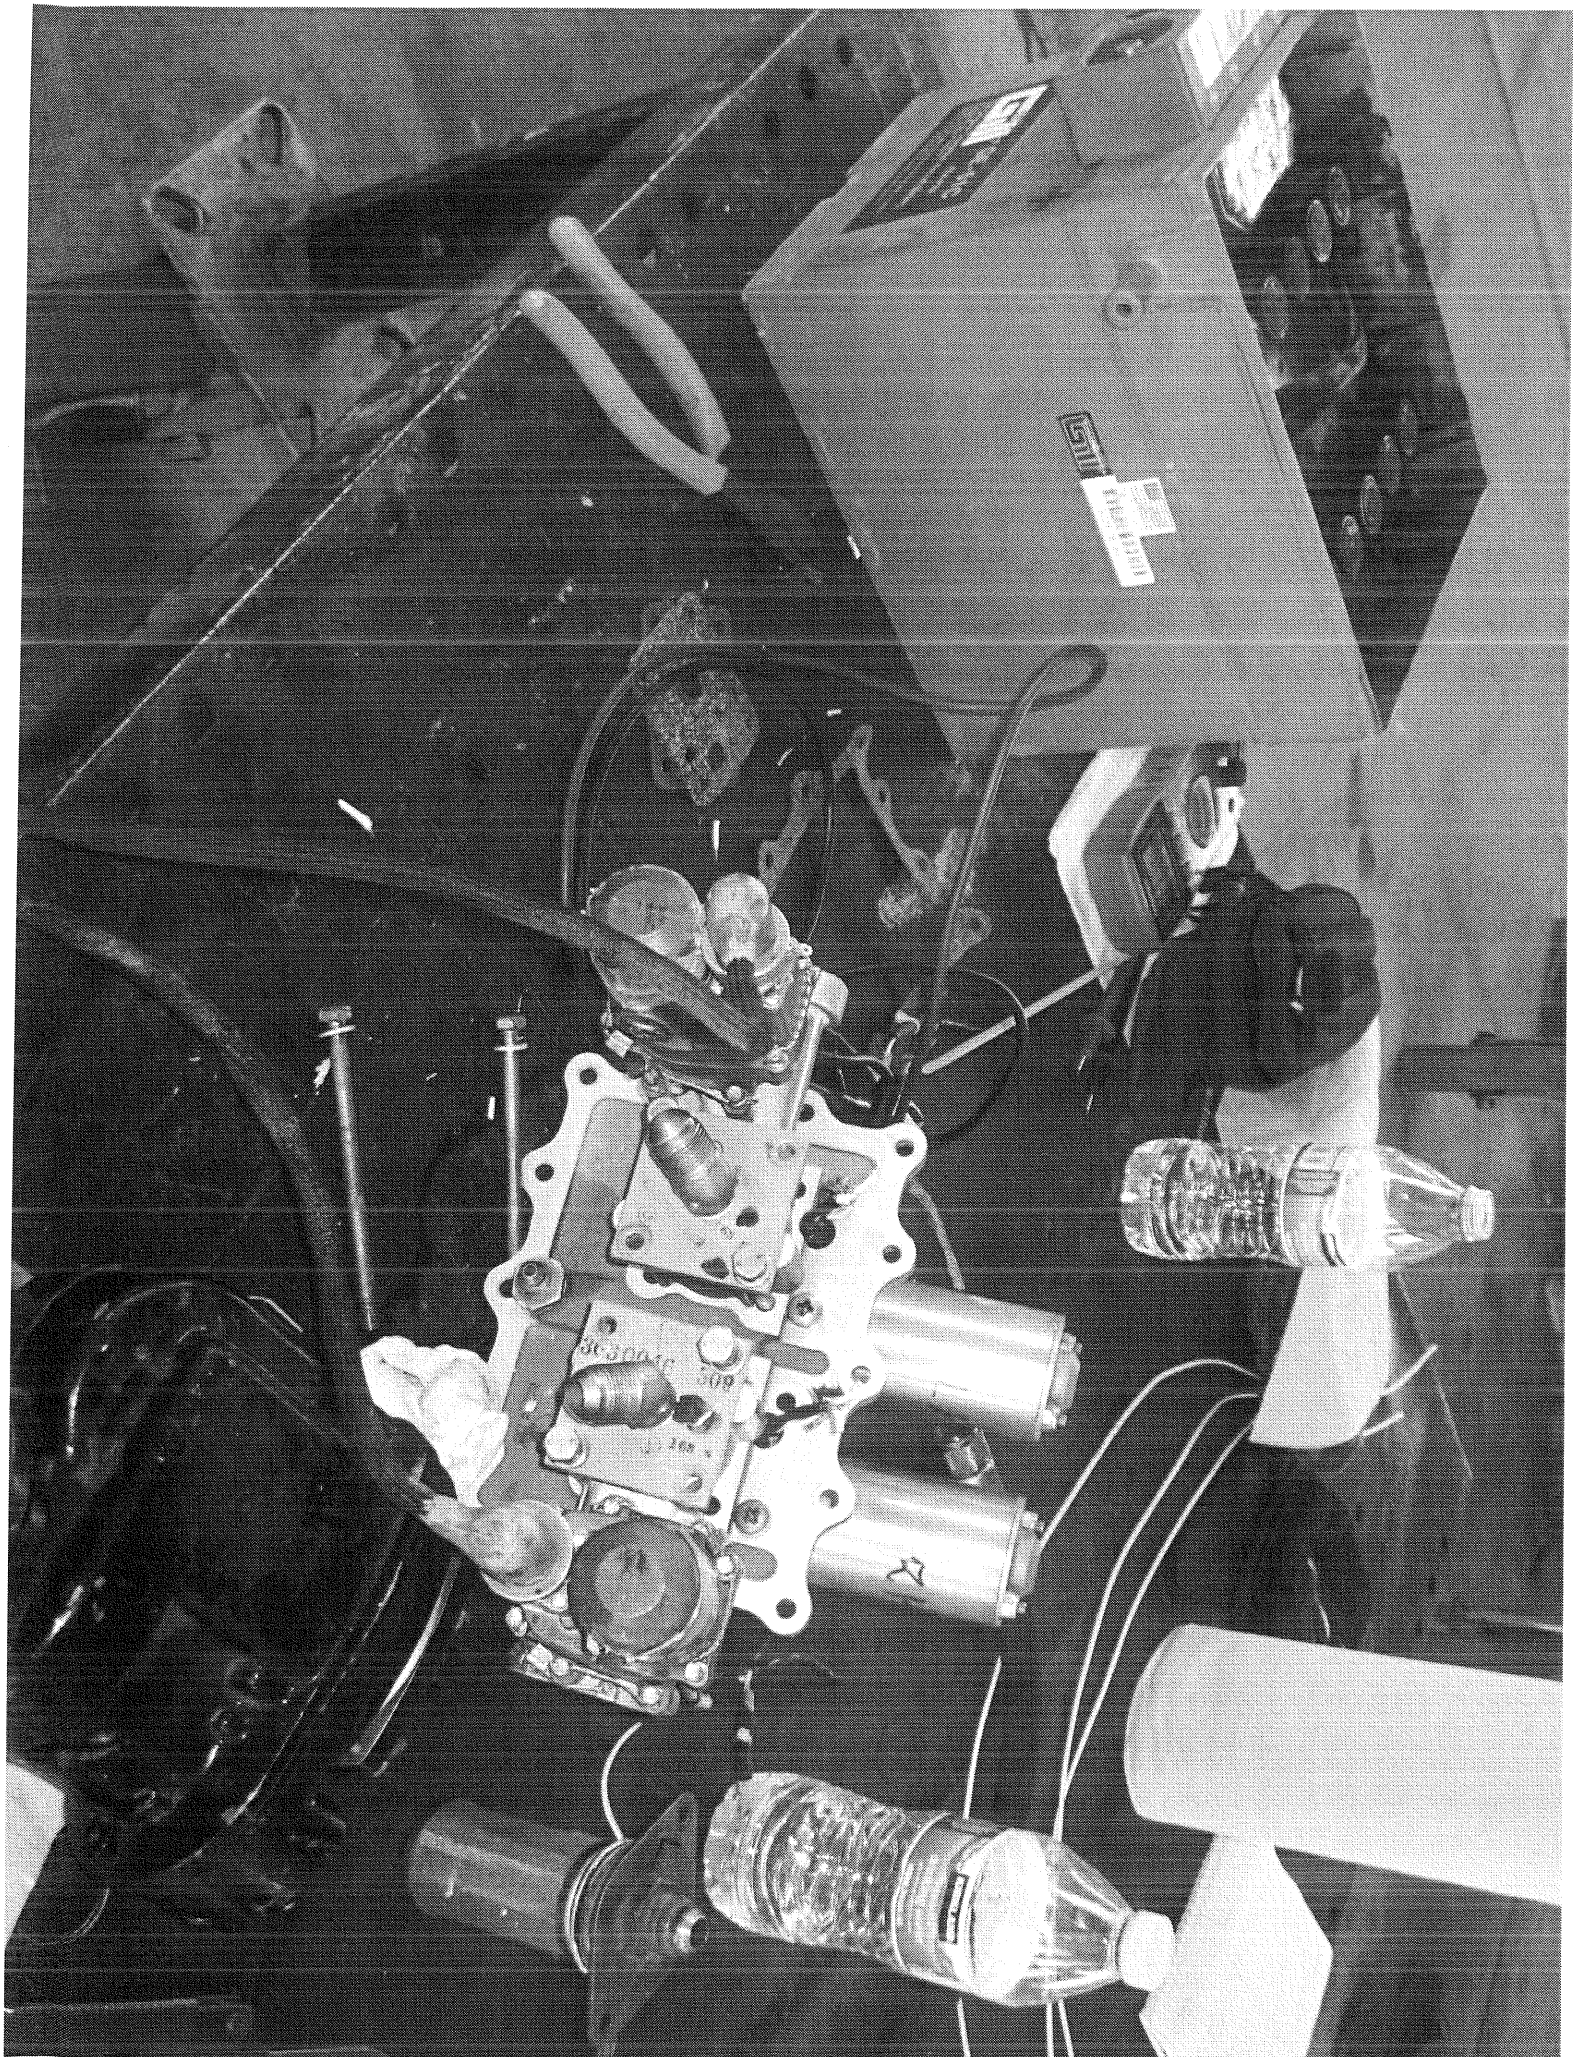
Figure 10-28. Fuel Boost Pumps

Power was applied to the Black Stripe wire and a Ground applied to the White wire on the LH and RH fuel boost pumps. Both of the pumps operated normally without being submersed in fuel. There was no grinding or binding noises noted. Damage to the wiring to the LH pump did not affect operation. Refer to Figure 10-28 for fuel boost pump wiring detail.
