August 7, 1998

# Submissions Supplement USAir 737-300

Accident Near Pittsburgh  
9 September 1994

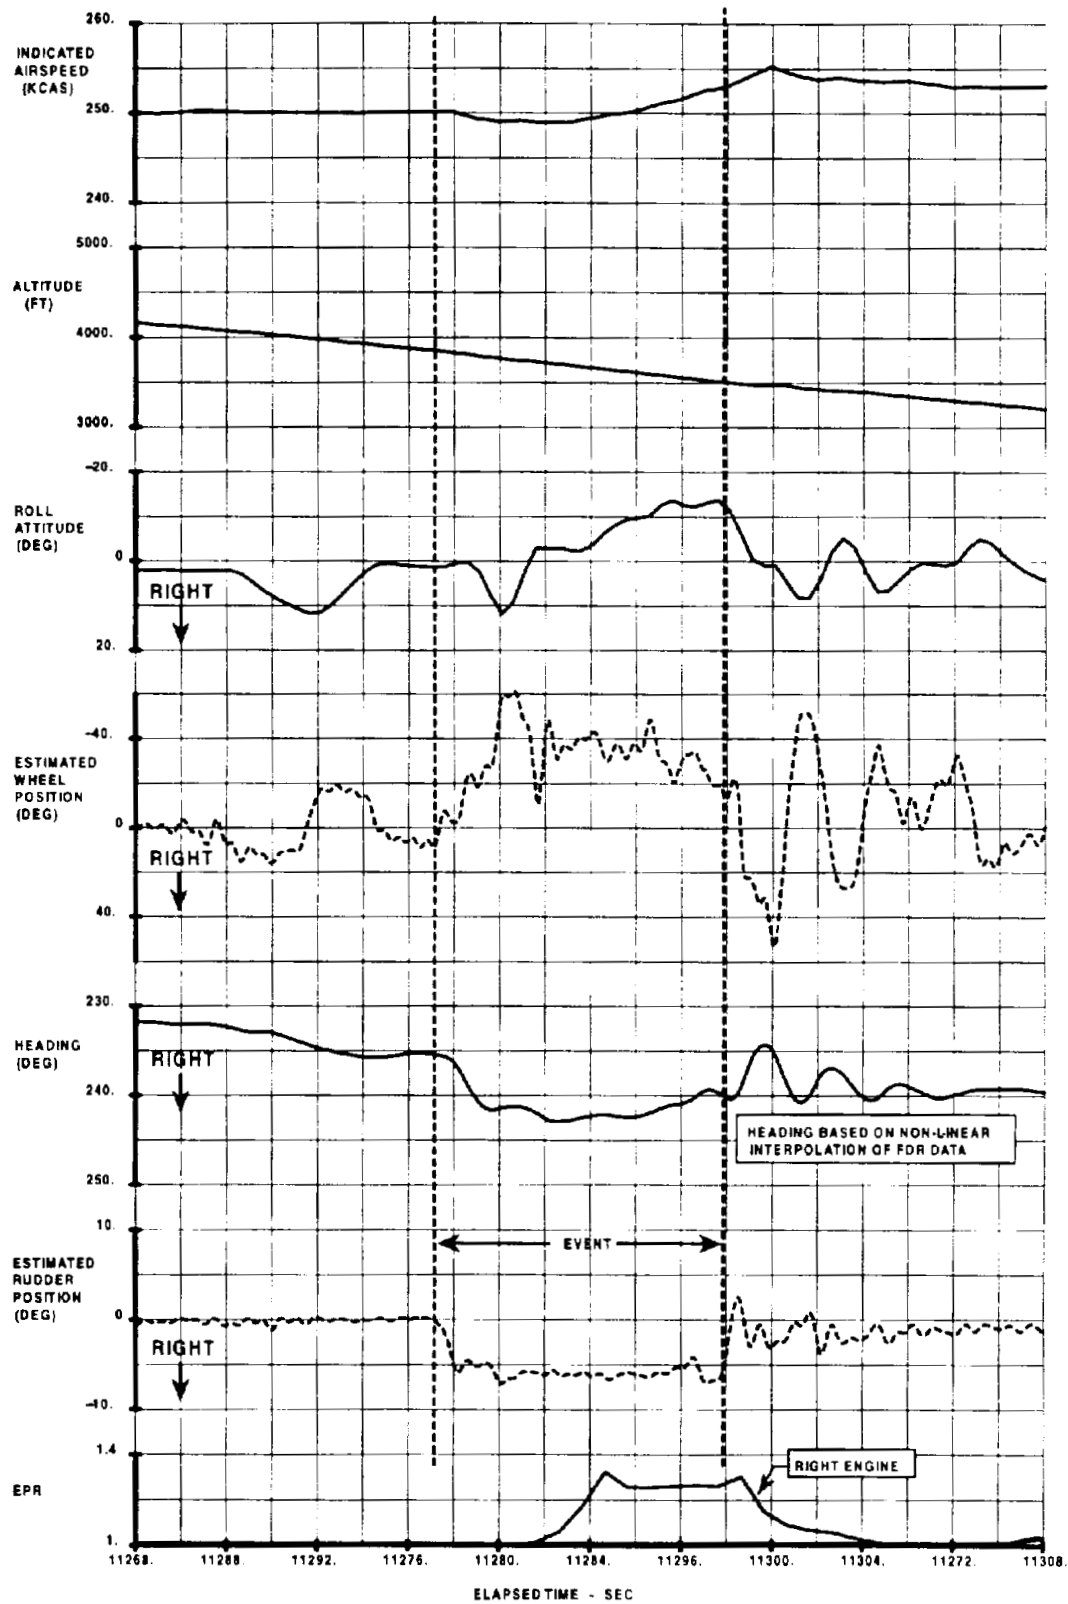
The results of the kinematic analysis are shown in Figure 1 (page 18), along with the pertinent flight data recorder information parameters. As noted above, the accuracy of this analysis is constrained by the limited number of parameters and low sampling rates of the event airplane's flight data recorder. Nevertheless, this kinematic analysis confirmed that the rudder deflection required to cause this event was greater than that which would be expected from an operational yaw damper experiencing an electrical fault and going hardover, even if the yaw damper had a misrigged linear variable differential transformer as found on the event airplane.

Figure 1  
Time Histories of Pertinent Parameters

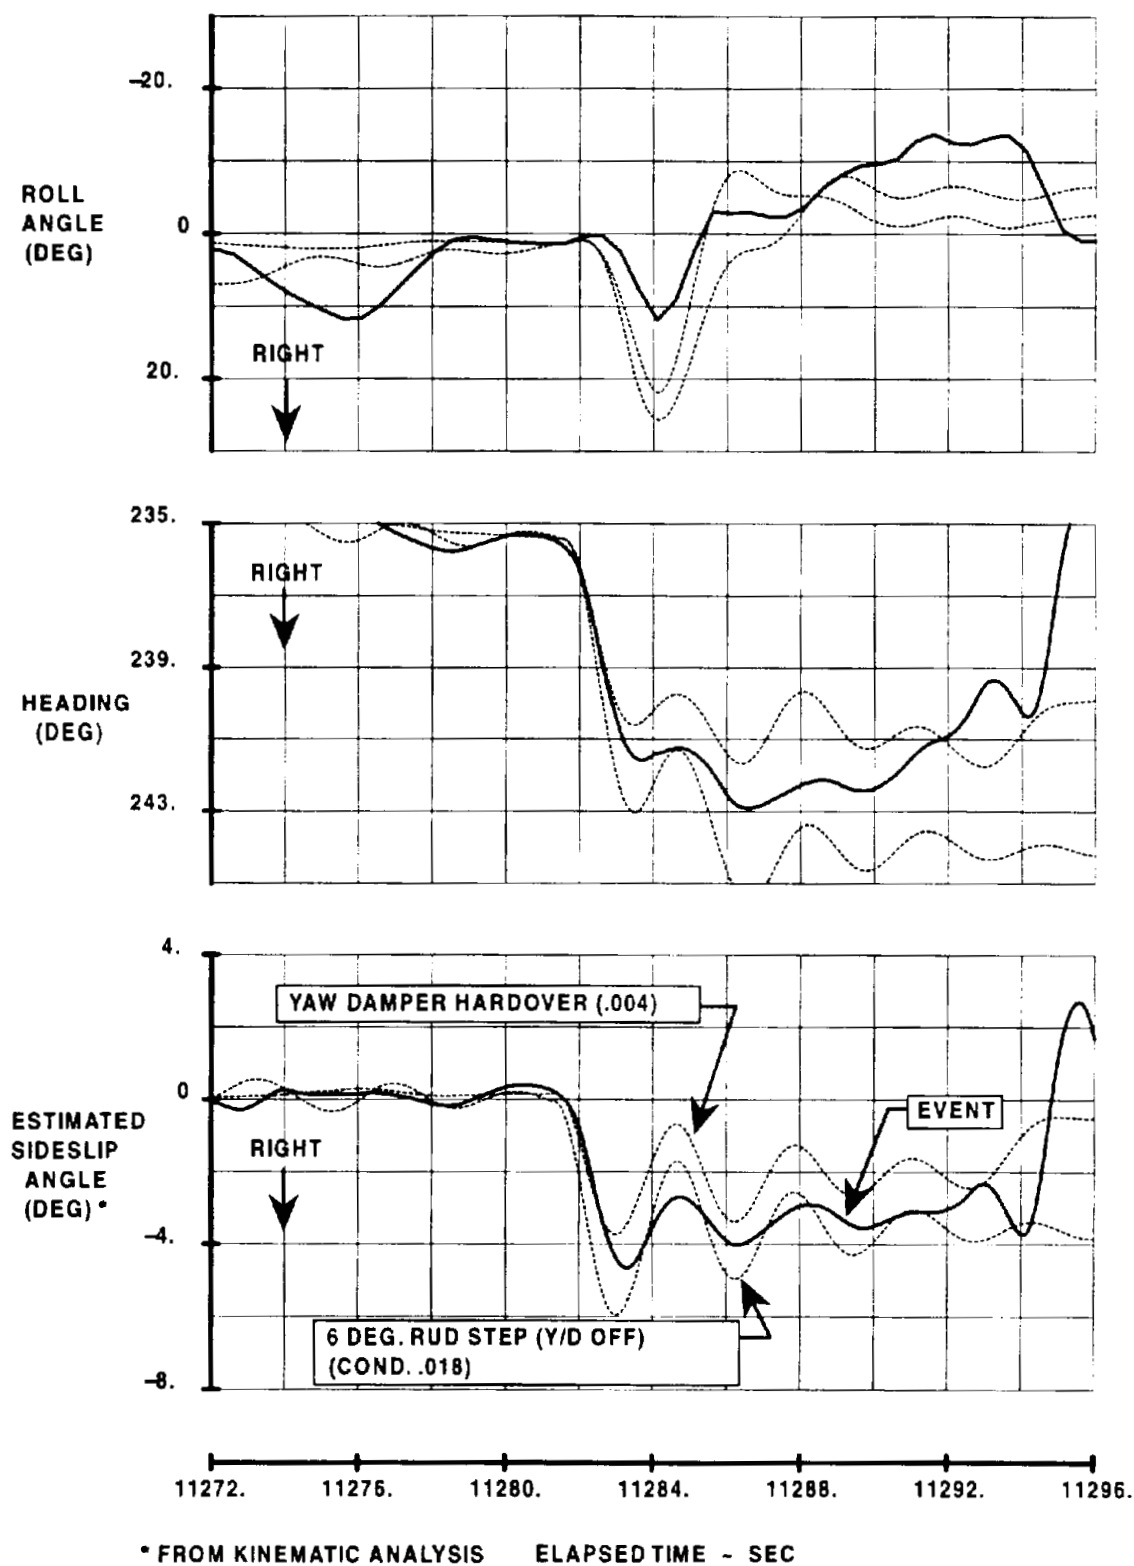
- A comparison of the Dutch-roll characteristics shown in Figures 3 and 4 (pages 20 and 21) demonstrates that the event sideslip amplitude (peak to peak) is about half that of the yaw-damper-OFF flight test data, and about the same as the yaw-damper-ON flight test data.

Figure 3  
Comparison of Airplane Roll, Yaw and Sideslip Response for Eastwind Event Vs. Yaw-Damper-Off Flight Test Conditions.

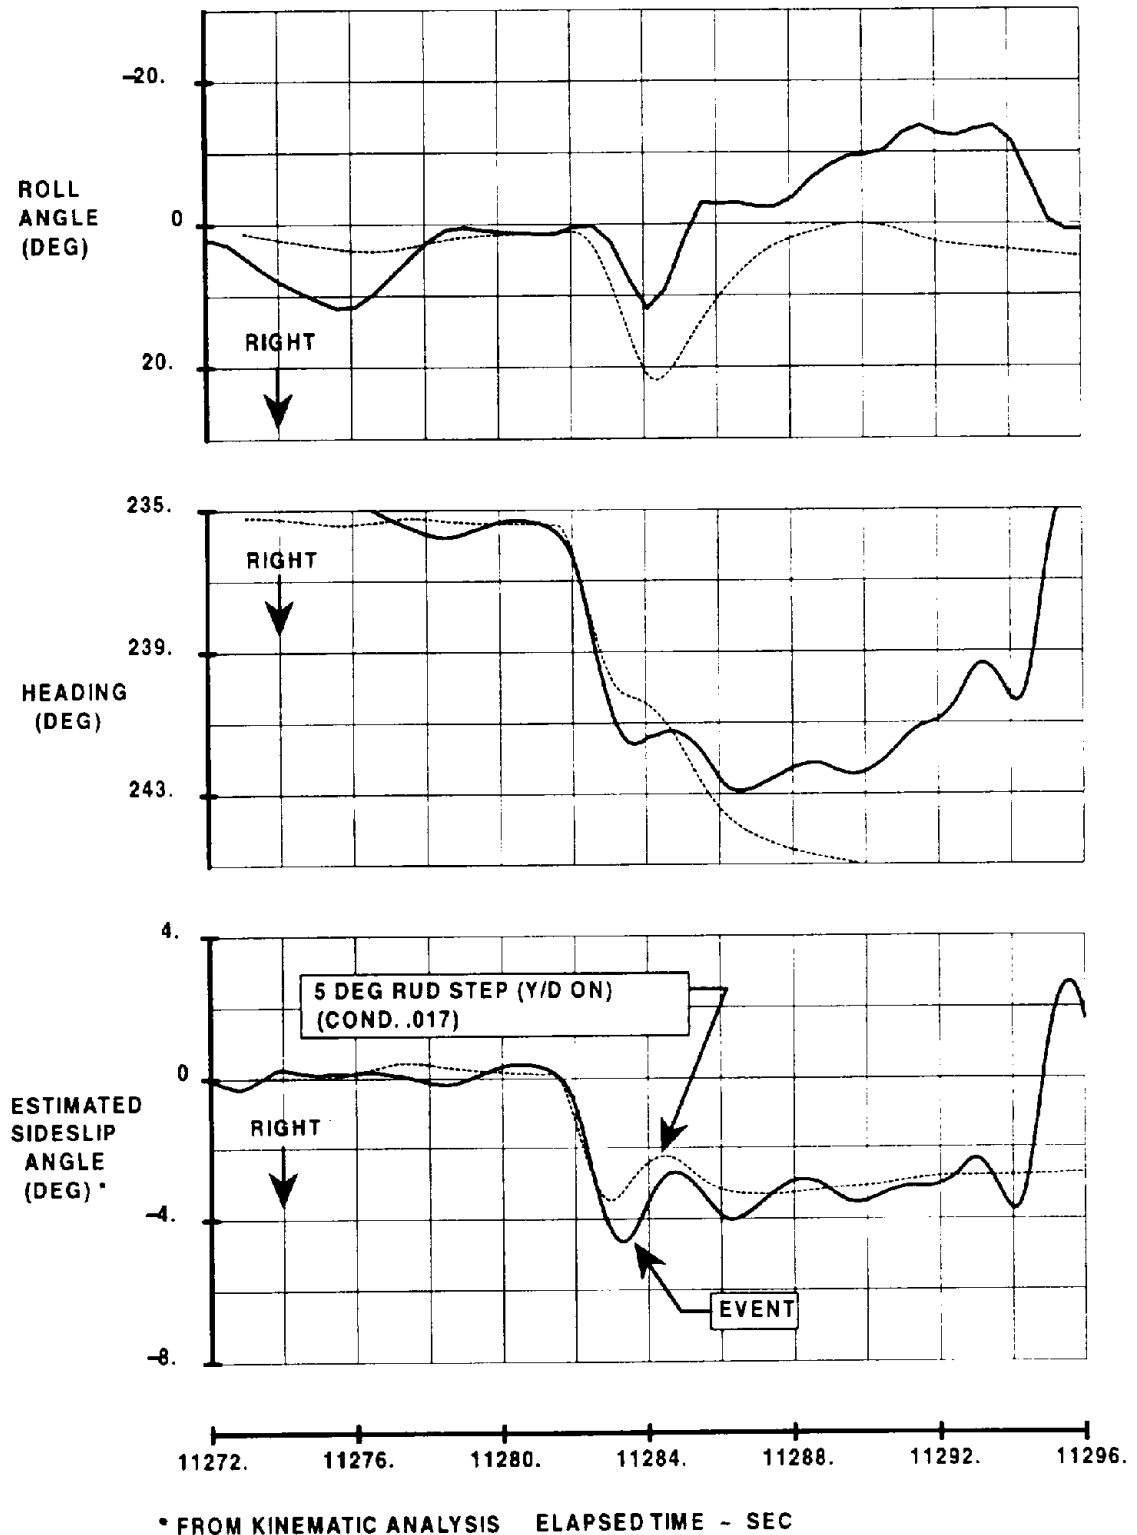
Figure 4

Comparison of Airplane Roll, Yaw and Sideslip Response for Eastwind Event Vs. Yaw-Damper-On Flight Test Condition

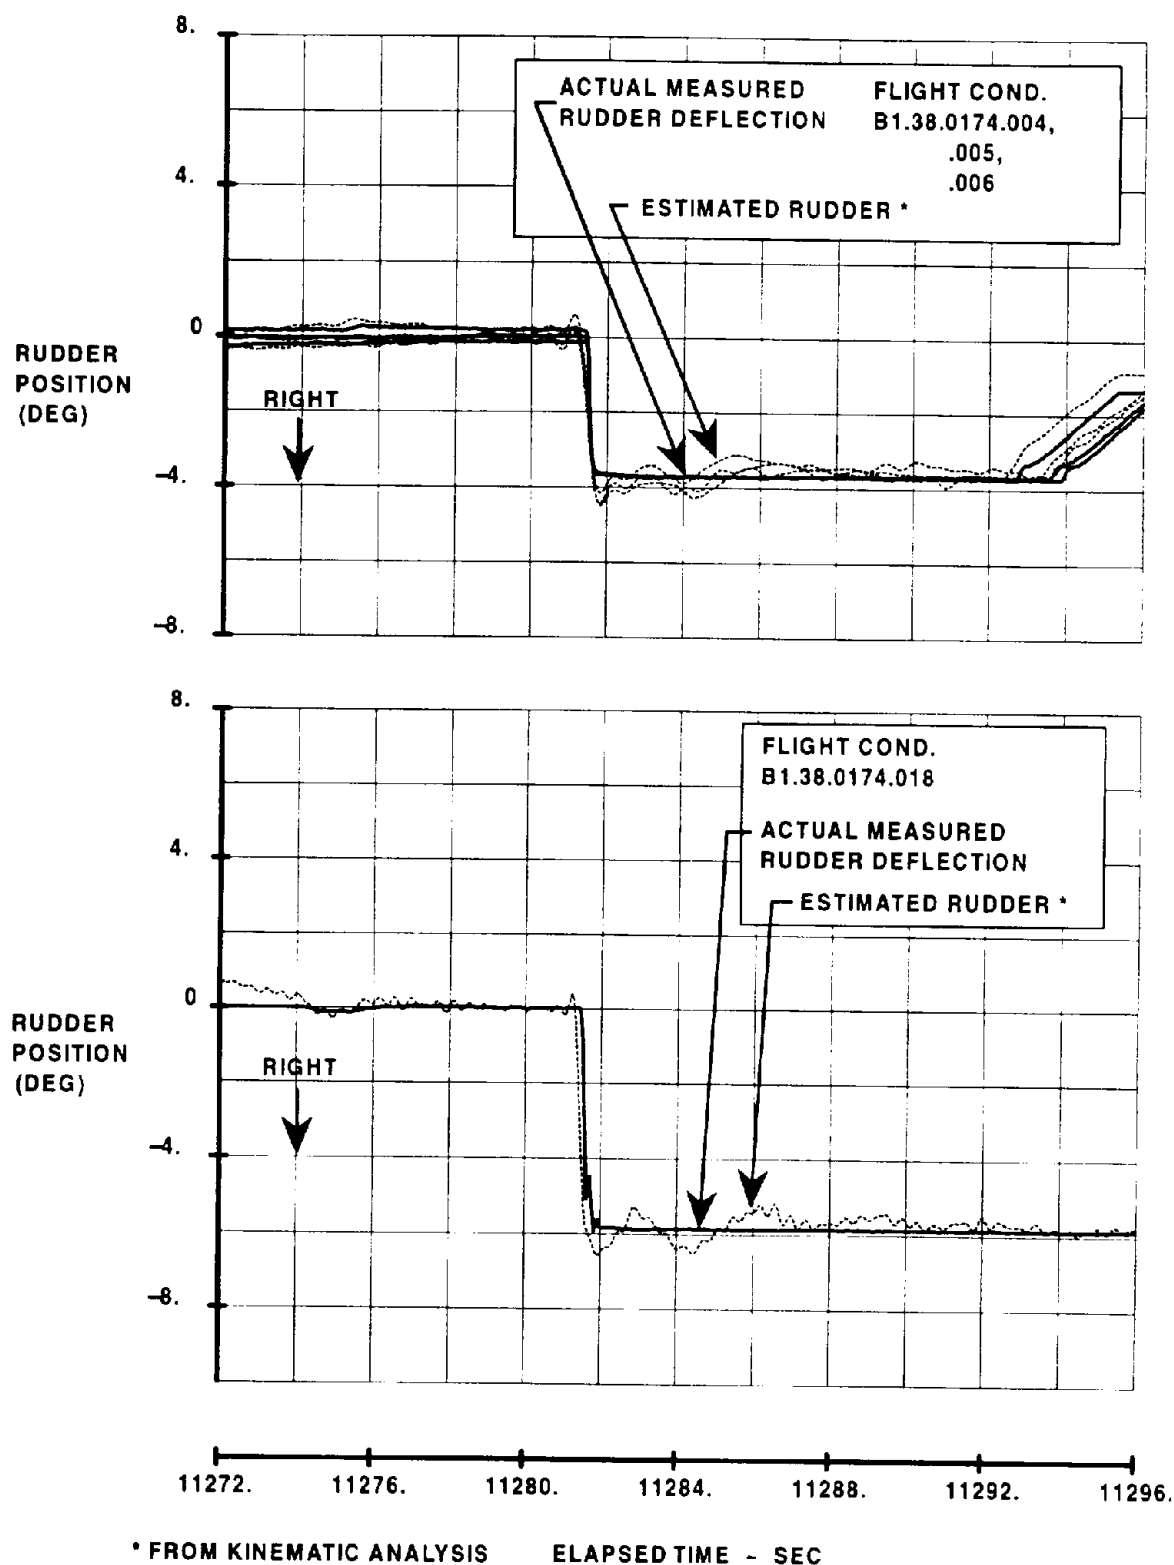
- Figure 5 (page 22) compares the rudder estimated from Portable Airborne Digital Data System information with the actual measured rudder deflection for a series of flight test yaw damper hardovers and a 5.9-degree step rudder with the yaw damper OFF.

Validation of Estimated Rudder Position  
for a Series of Induced Y/D Hardovers  
and a 5.9 Deg Rud Step (Yaw Damper OFF)

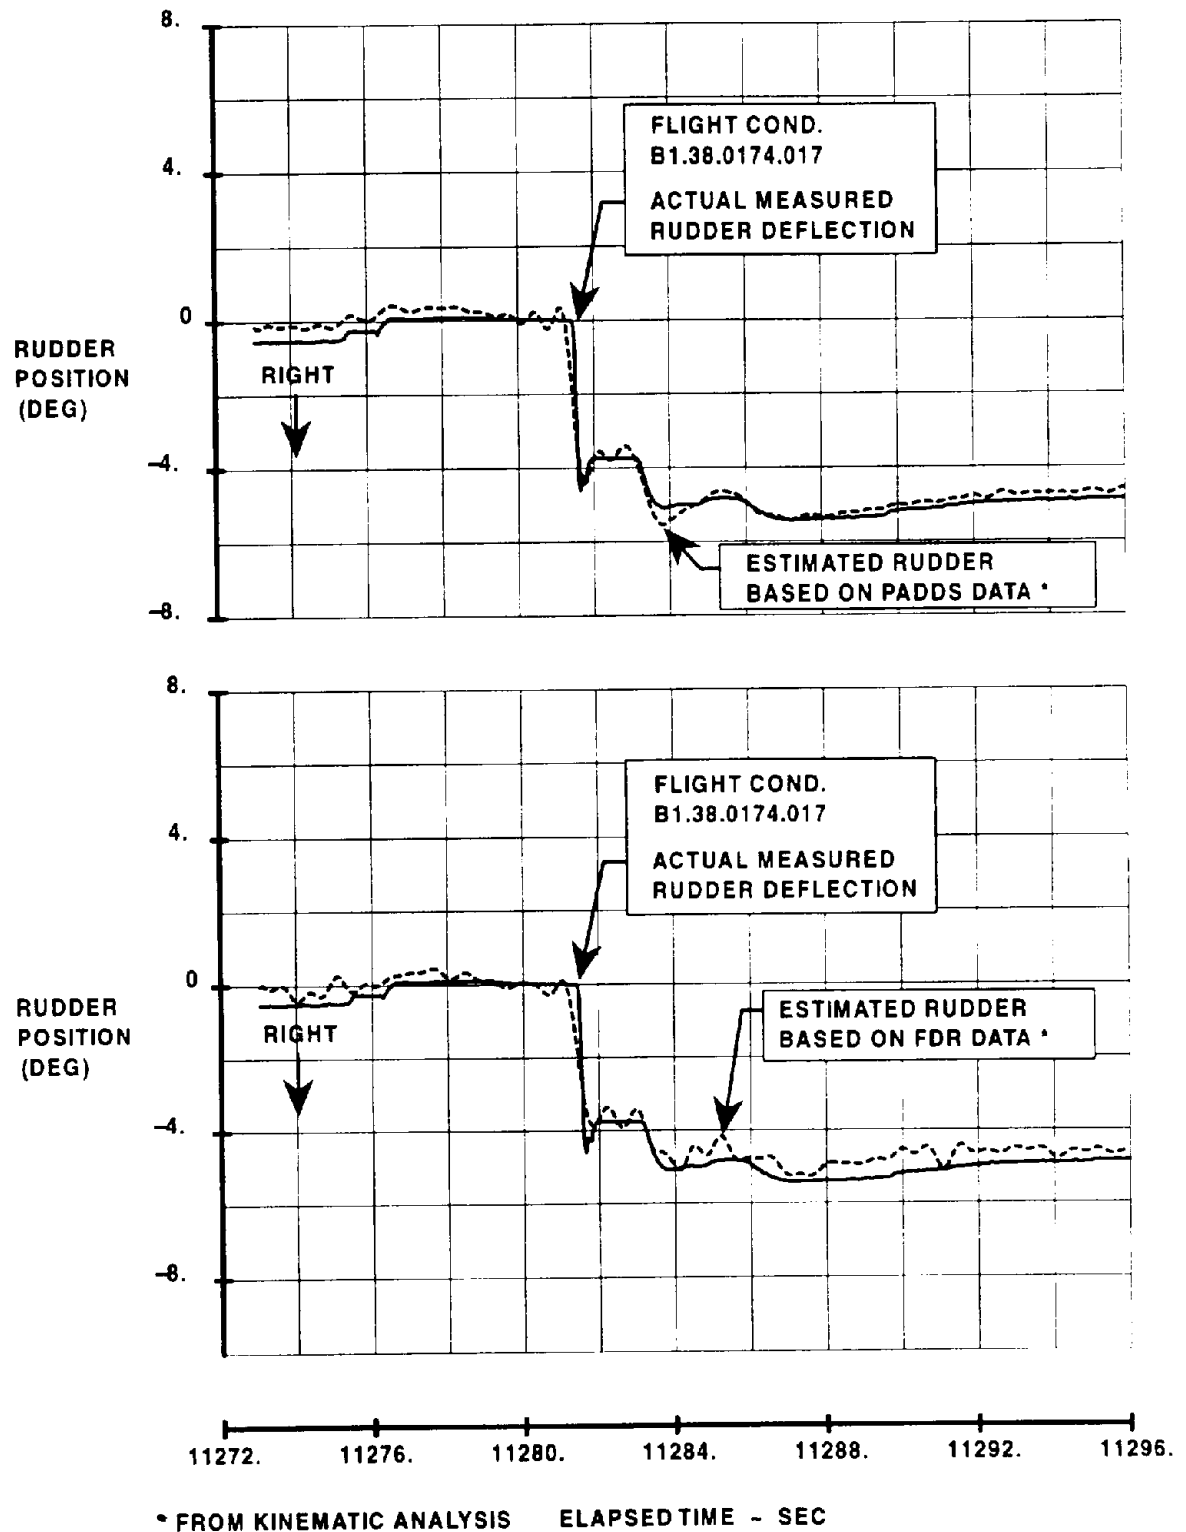
- Flight test rudder deflection for a yaw-damper-ON condition is shown compared to rudder estimated from Portable Airborne Digital Data System and flight data recorder information in Figure 6 (page 23).
- Figure 7 (page 24) shows an example of predicted rudder deflection that results from flight test measured pedal displacement, combined with the response of the yaw damper control law to actual yaw rate for a given test condition. This calculated rudder is compared to the rudder deflection measured during the test condition and to that which was estimated kinematically from the flight data recorder information.

Validation of Estimated Rudder Position  
for a 5 Degree Rudder Step (Y/D ON)  
(FDR Data)

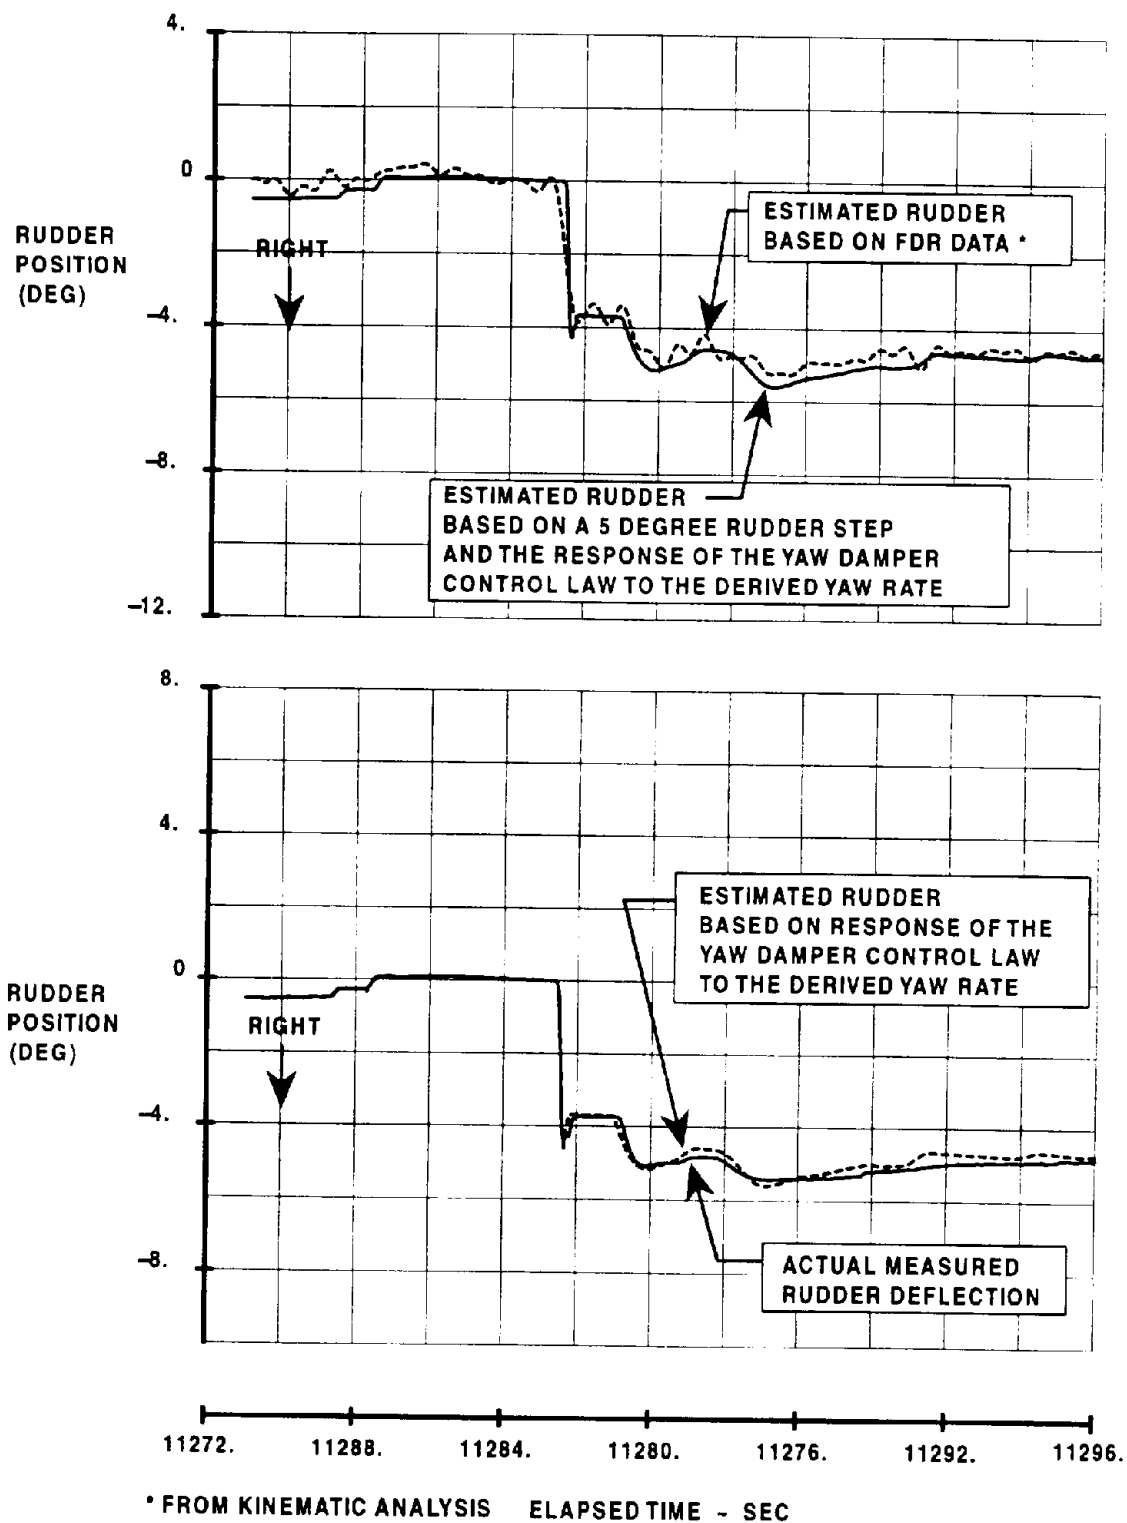
Figure 7

Validation of the Predicted Yaw Damper  
Response to a 5 Degree Rudder  
Step Input

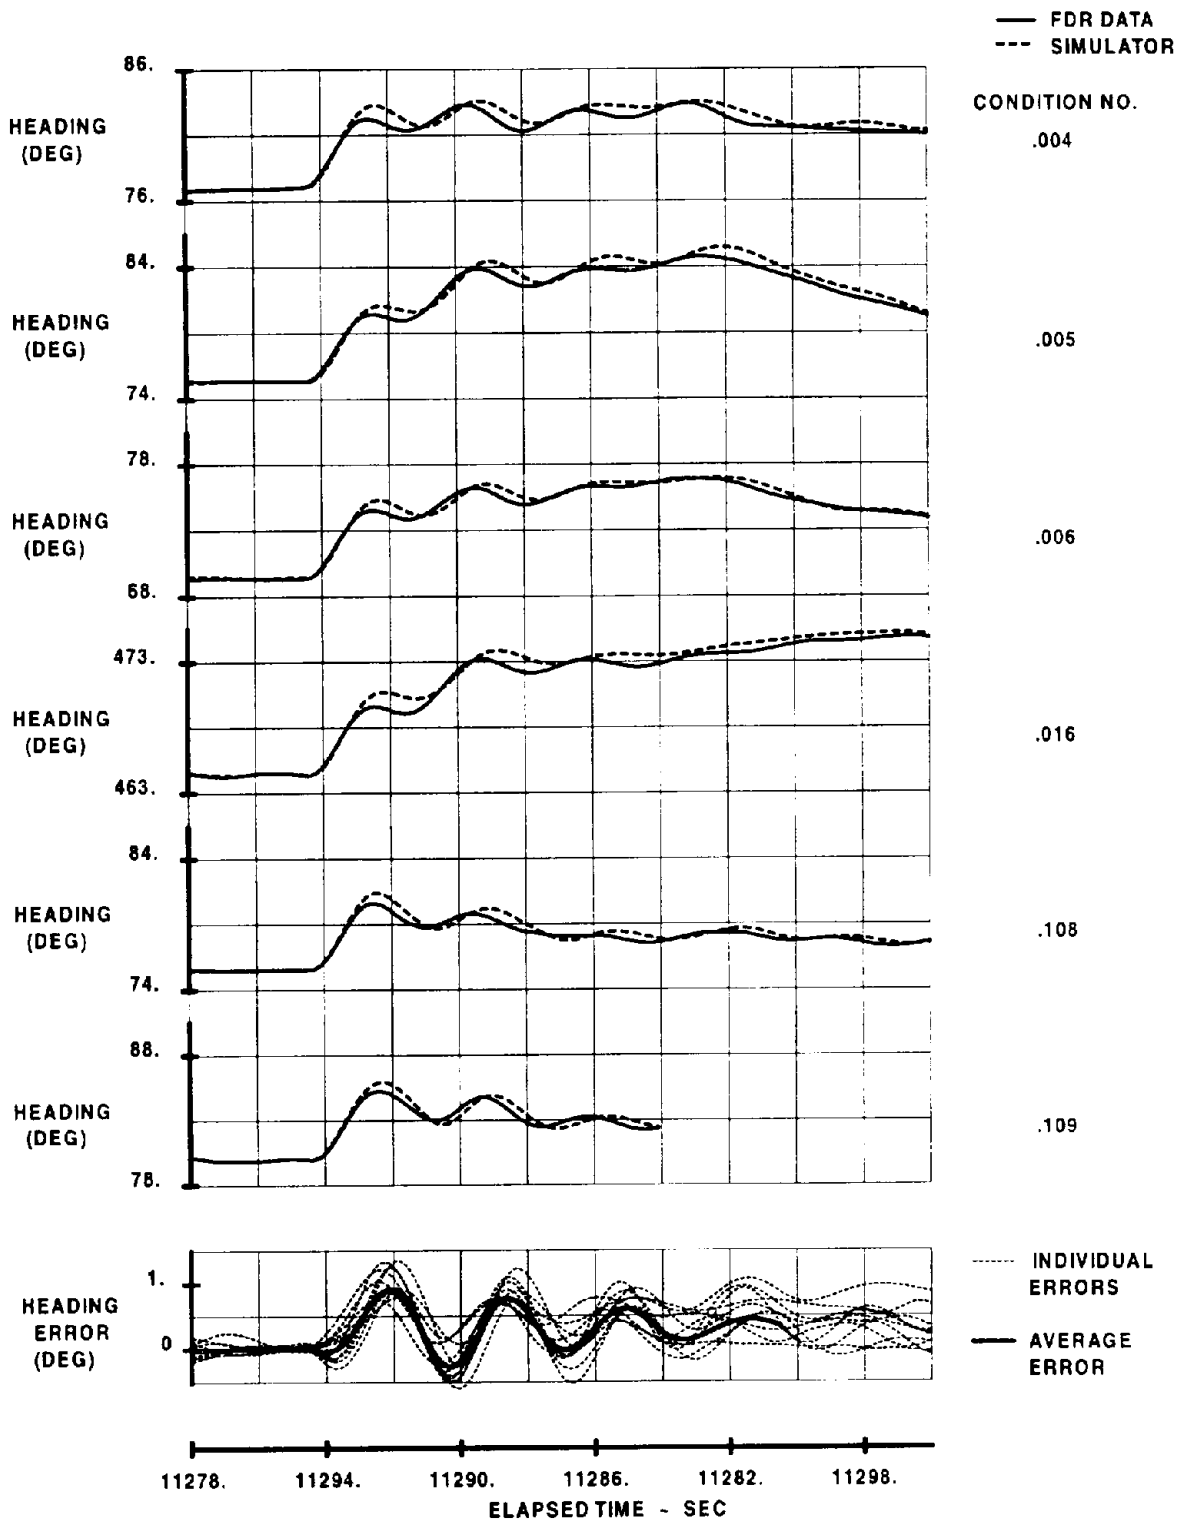
The rudder deflection from a flight test condition was used to drive the 737-200 simulator while the pitch and roll angles were maintained at the measured levels by wheel and column. The resulting error in heading between the simulator and measured heading values is plotted in Figure 8 (page 25) for the six conditions evaluated. Also plotted is the average error of all the flight test conditions evaluated. The errors were determined only for rudder steps and hardovers confirmed to be similar in magnitude and character to the event upset. This average error was then used to adjust the free response heading data for the various proposed scenarios. The results are discussed in Section 2.3.5, *Scenario Discussion Summary*.

**Open Loop Simulator Matches For Eastwind  
Flight Test Conditions  
(Based on 737-200 Simulation)**

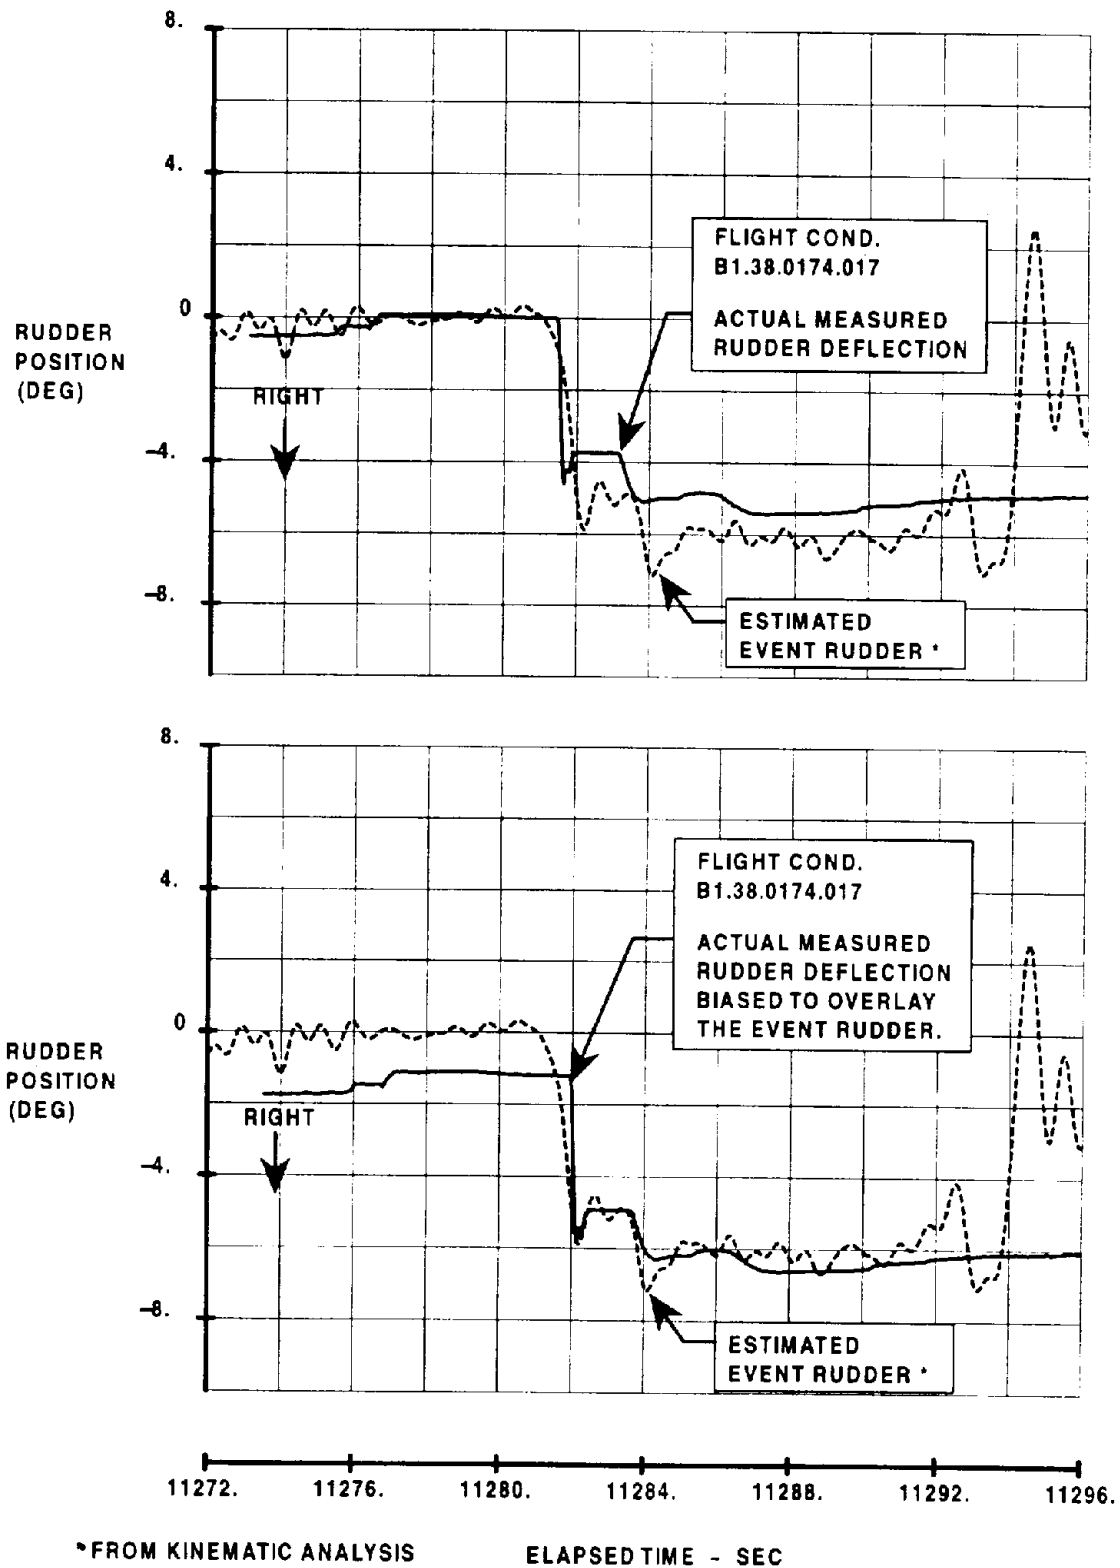
Comparison of the event flight data recorder information with the data obtained in the Eastwind flight testing *showed a marked similarity between the extracted rudder data for the event and for a yaw-damper-ON rudder step as shown in the top graph in Figure 9 (page 26)*. To better illustrate the similarity between the two time histories, the bottom graph in Figure 9 shows a comparison of the flight test rudder biased to overlay the event rudder.

Figure 9  
Comparison of Eastwind Event Estimated  
Rudder and Wheel Vs. Flight Test Data  
for 5 Degree Rudder Step (Yaw Damper ON)

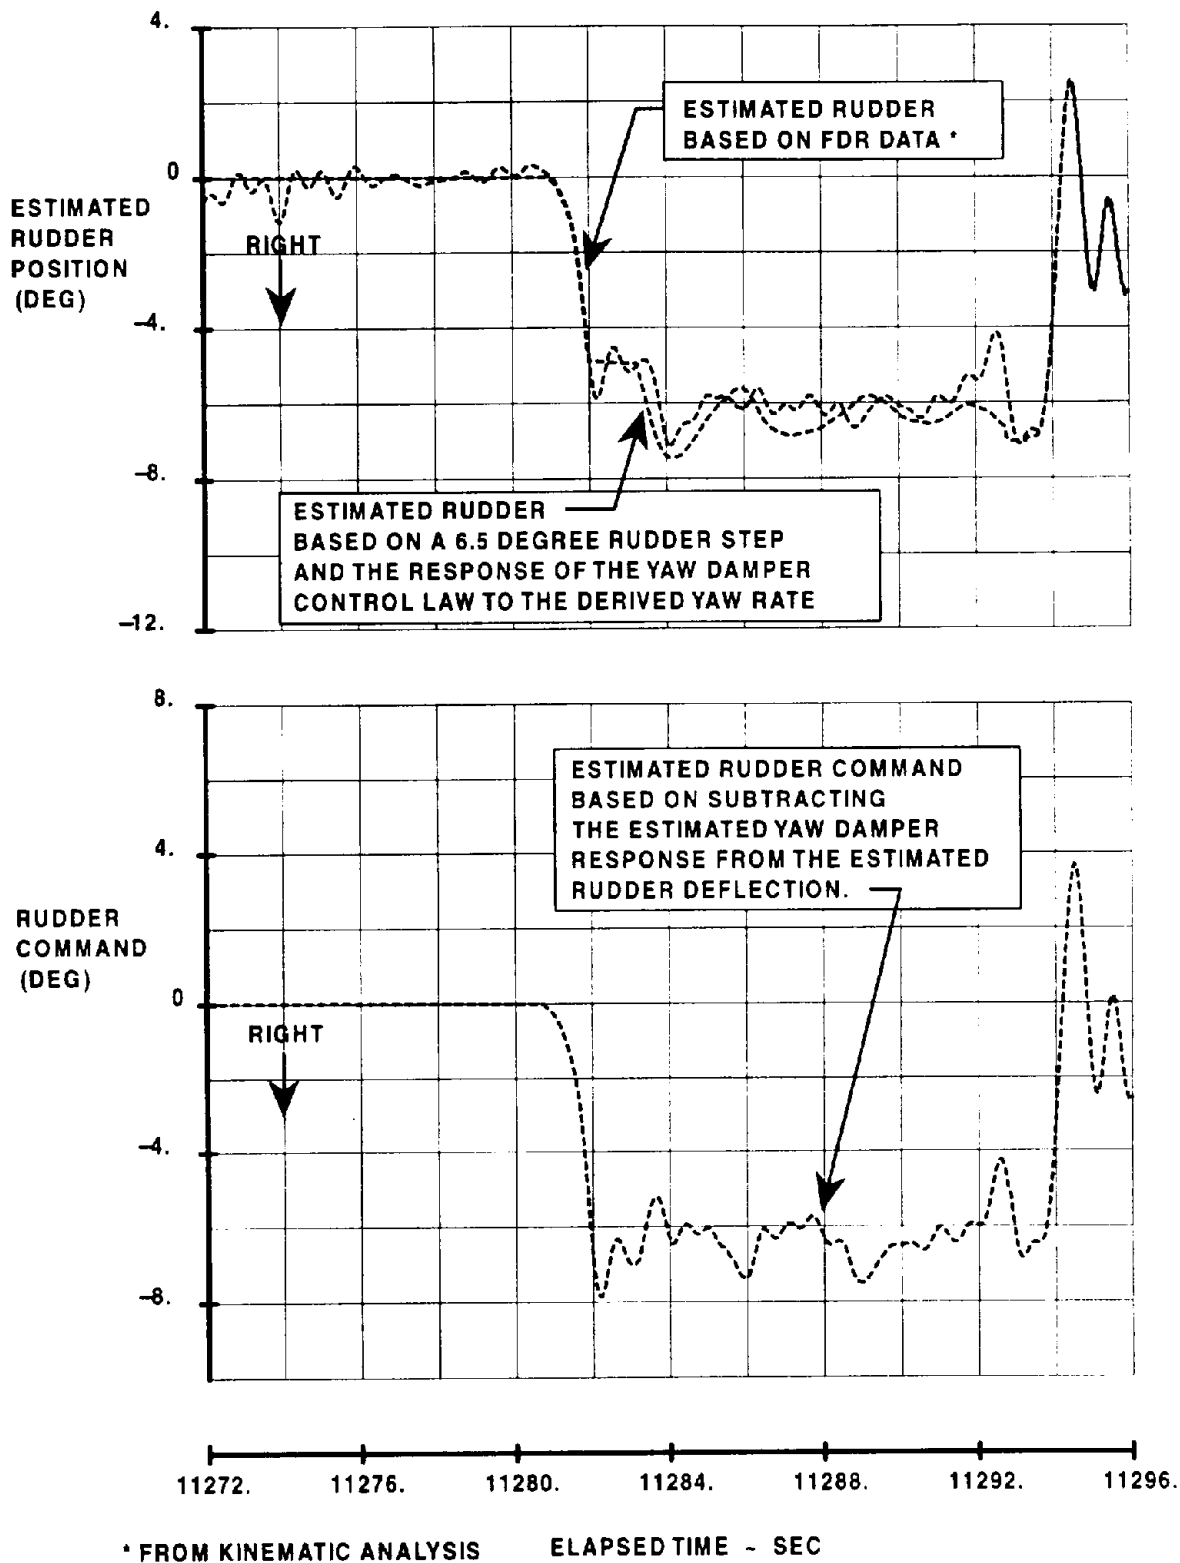
Figure 10  
Estimated Rudder, Yaw Damper Response  
and Rudder Command to Match the  
Eastwind Event

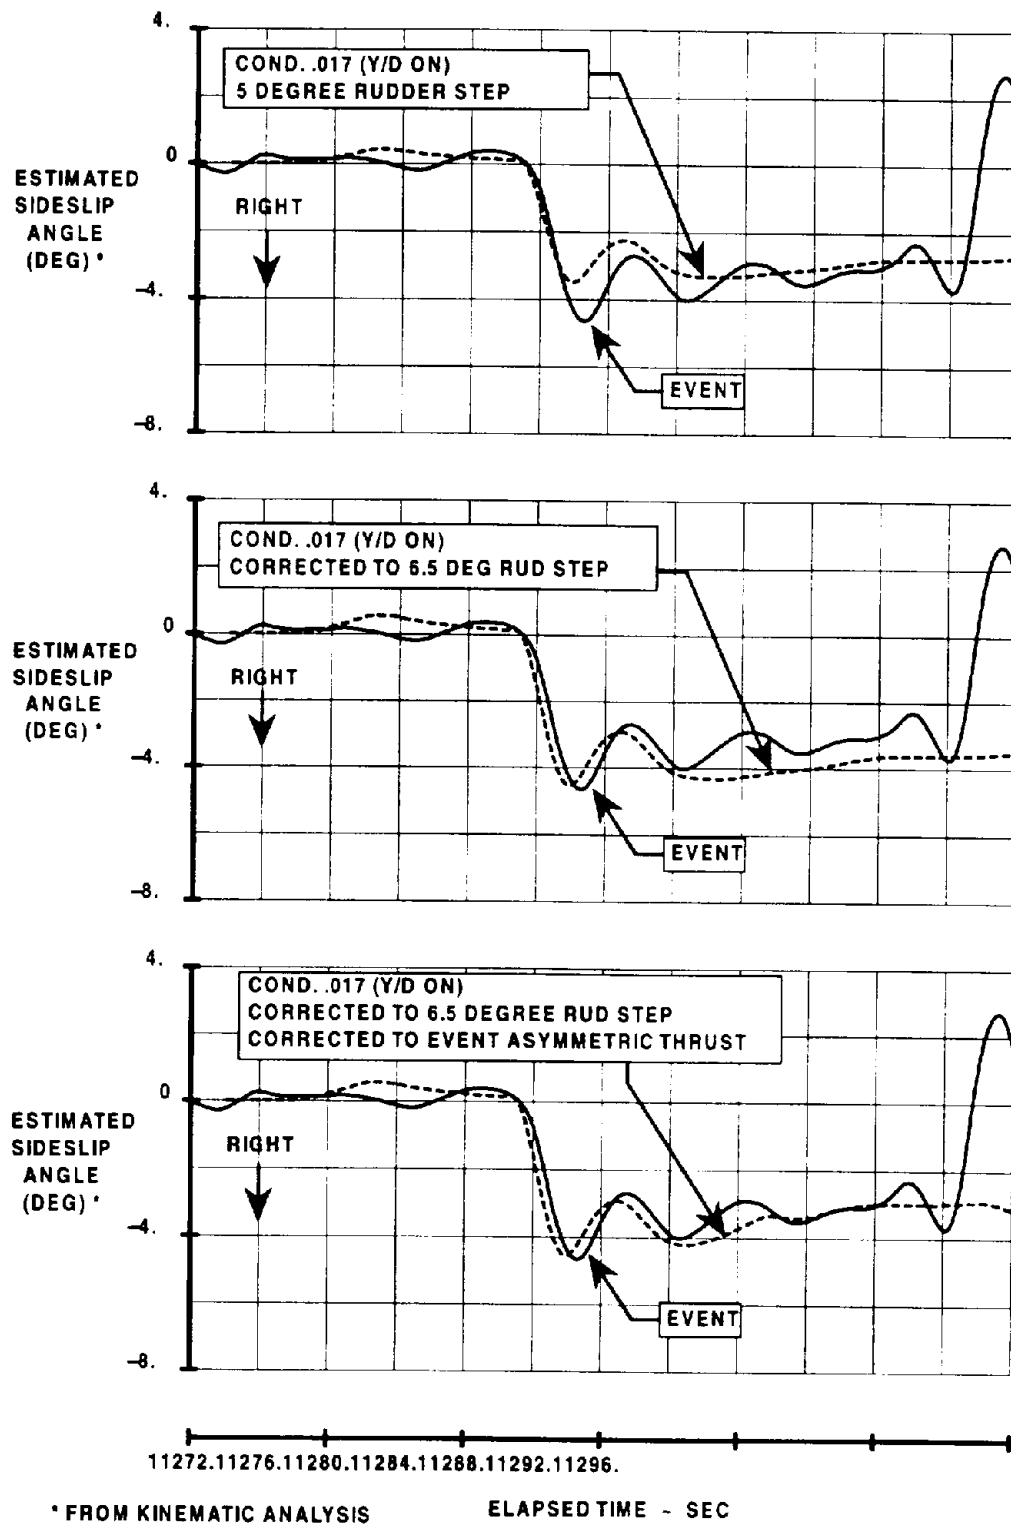
Figure 11  
Comparison of Sideslip Response for  
Eastwind Event Vs. Yaw-Damper-ON  
Flight Test Condition (.017)

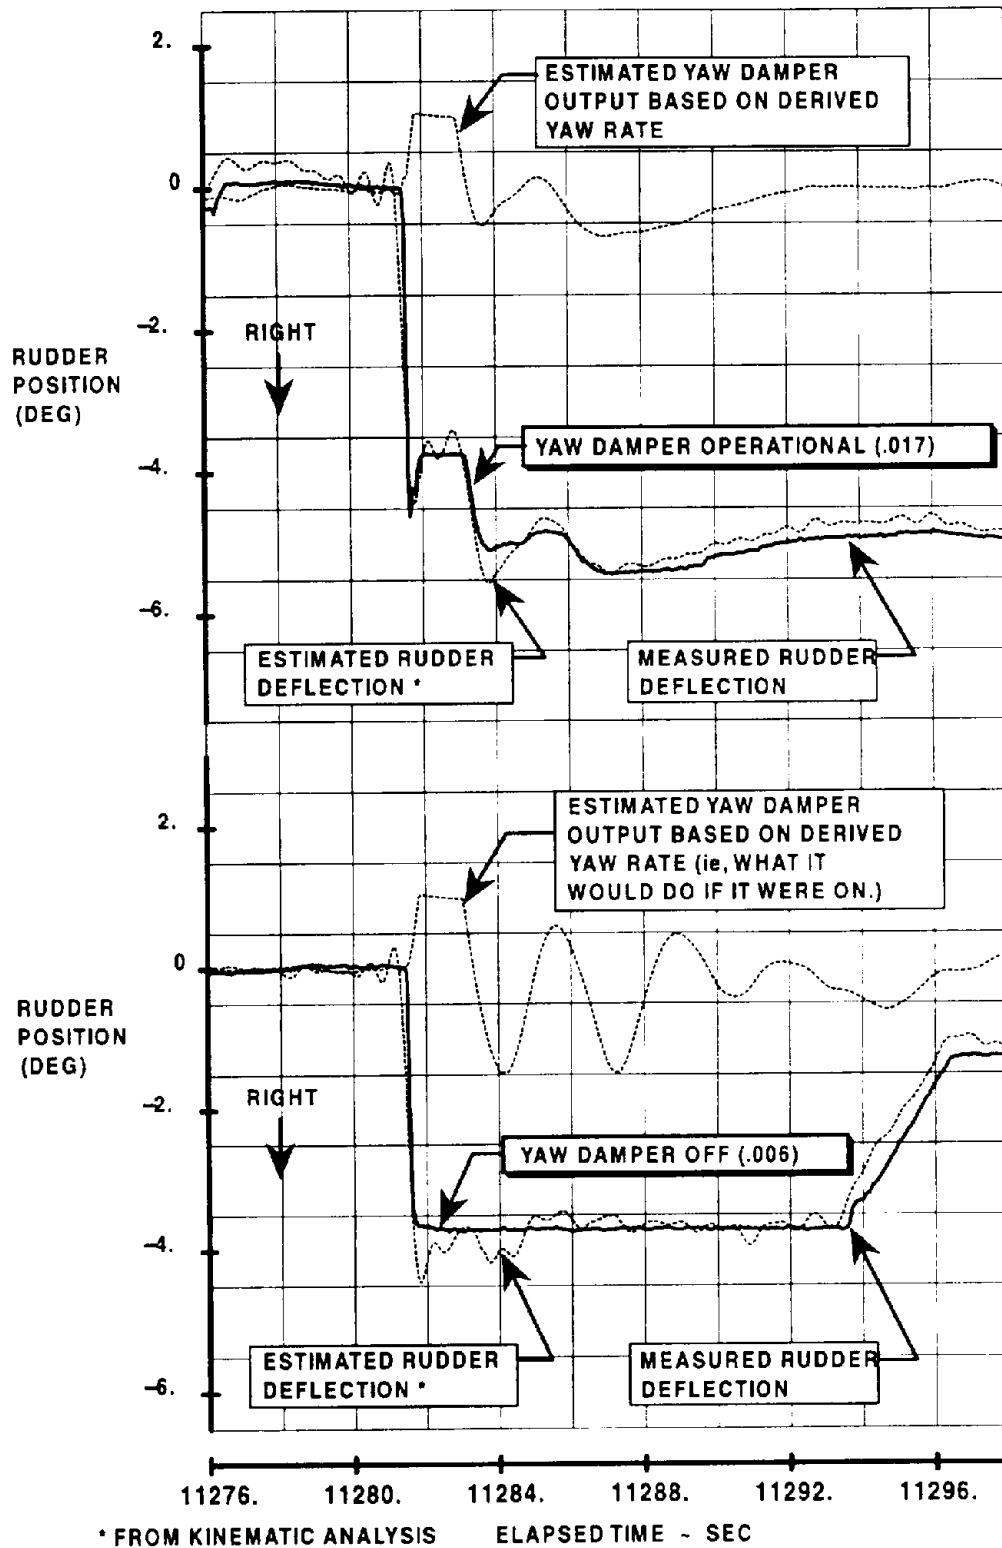
Figure 12  
Comparison of Measured Rudder,  
Kinematically Predicted Rudder and  
Yaw Damper Response to Yaw Rate

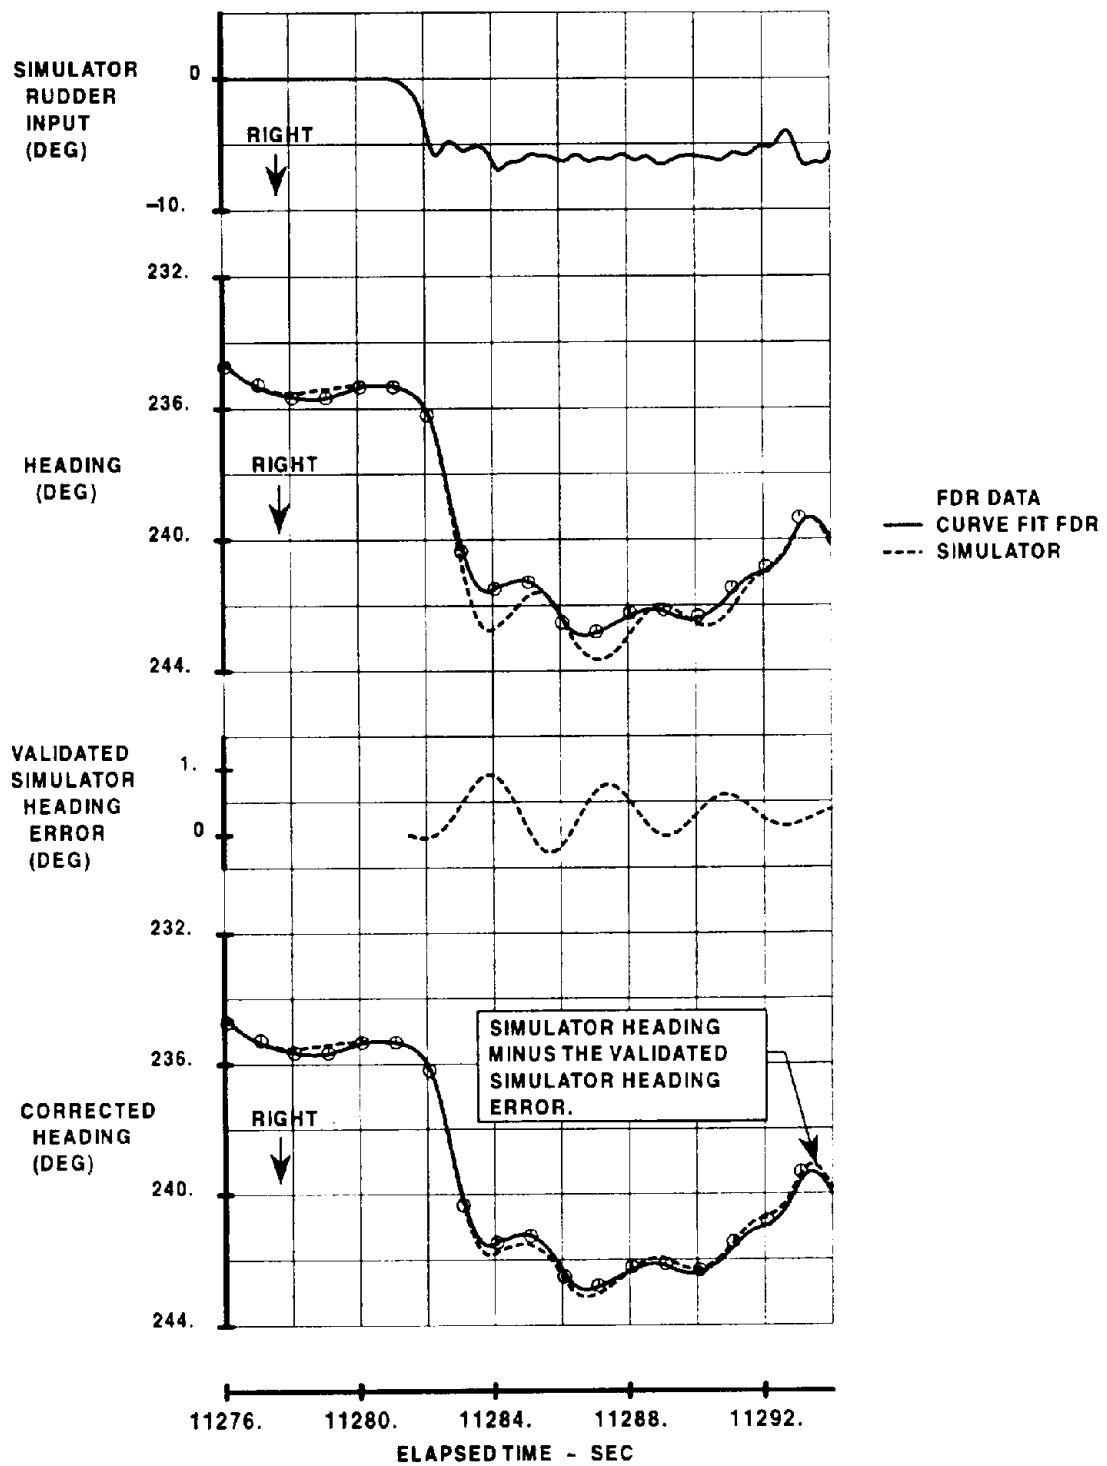
Figure 13

Open-Loop Match For Eastwind Event  
Y/D 6 Degree H/O, Pilot Input to Right  
(Based on 737-200 Simulation)
