August 7, 1998

# Submissions Supplement USAir 737-300

Accident Near Pittsburgh  
9 September 1994

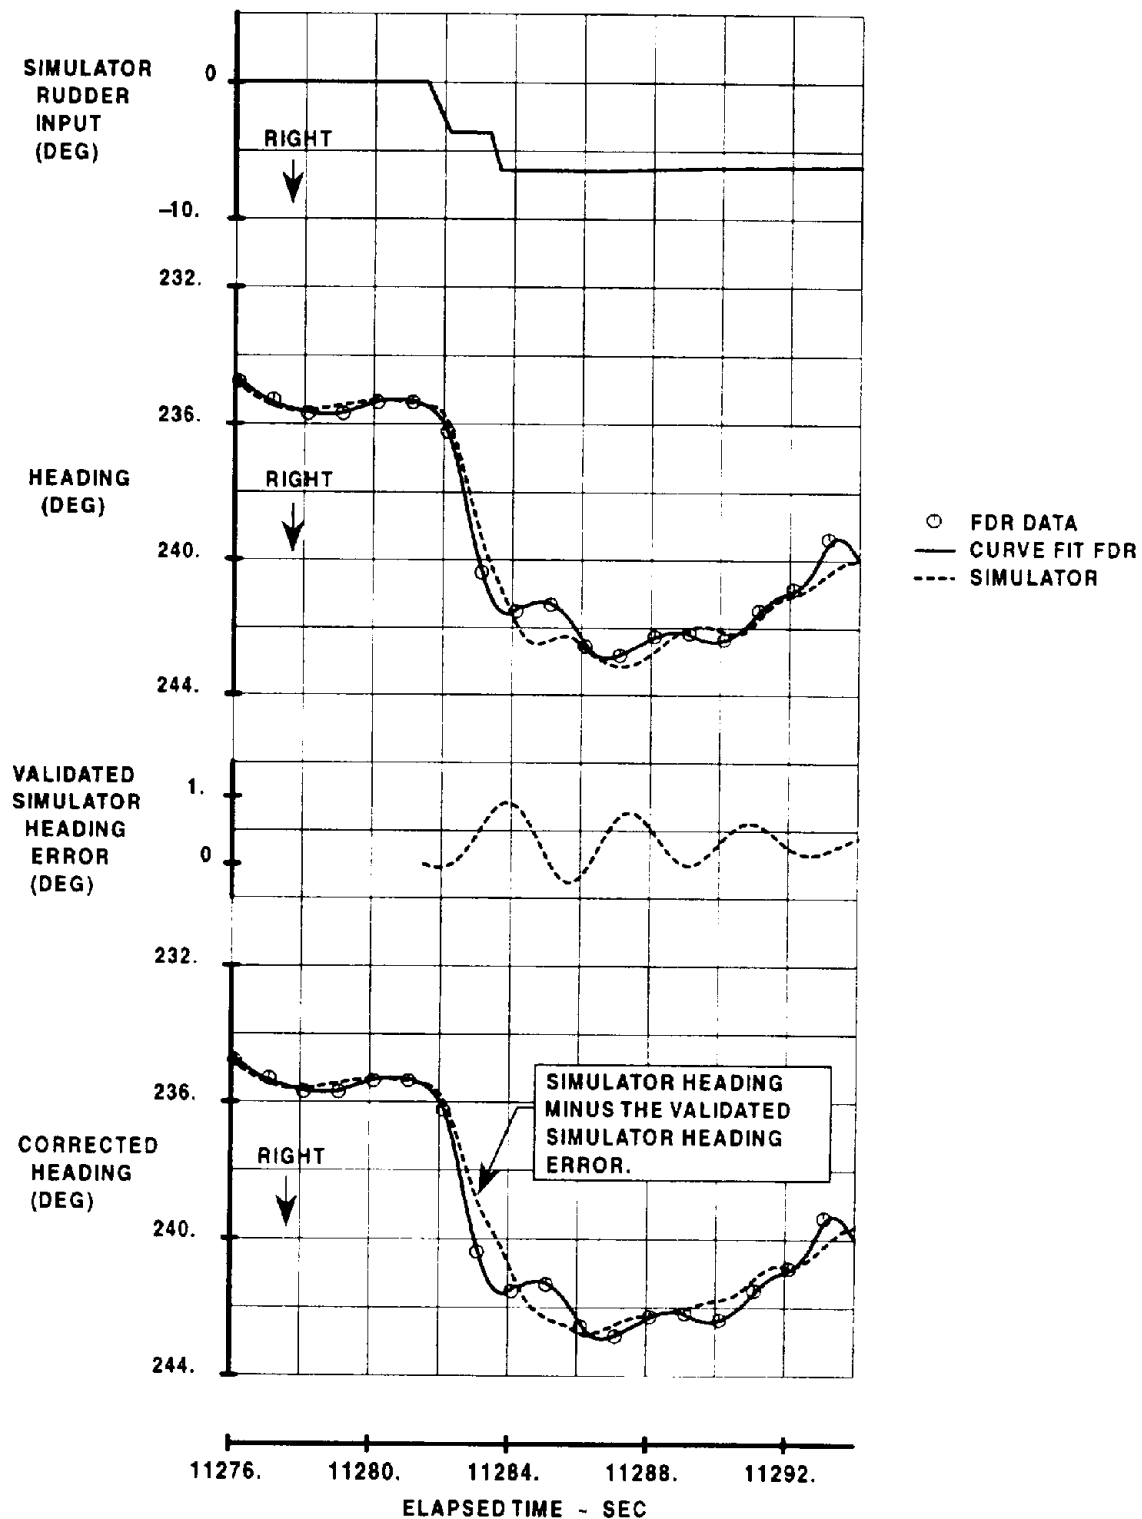
Figure 14  
Open-Loop Match For Eastwind Event  
Yaw Damper Hardover / 43% Jam / Reversal  
(Based on 737-200 Simulation)

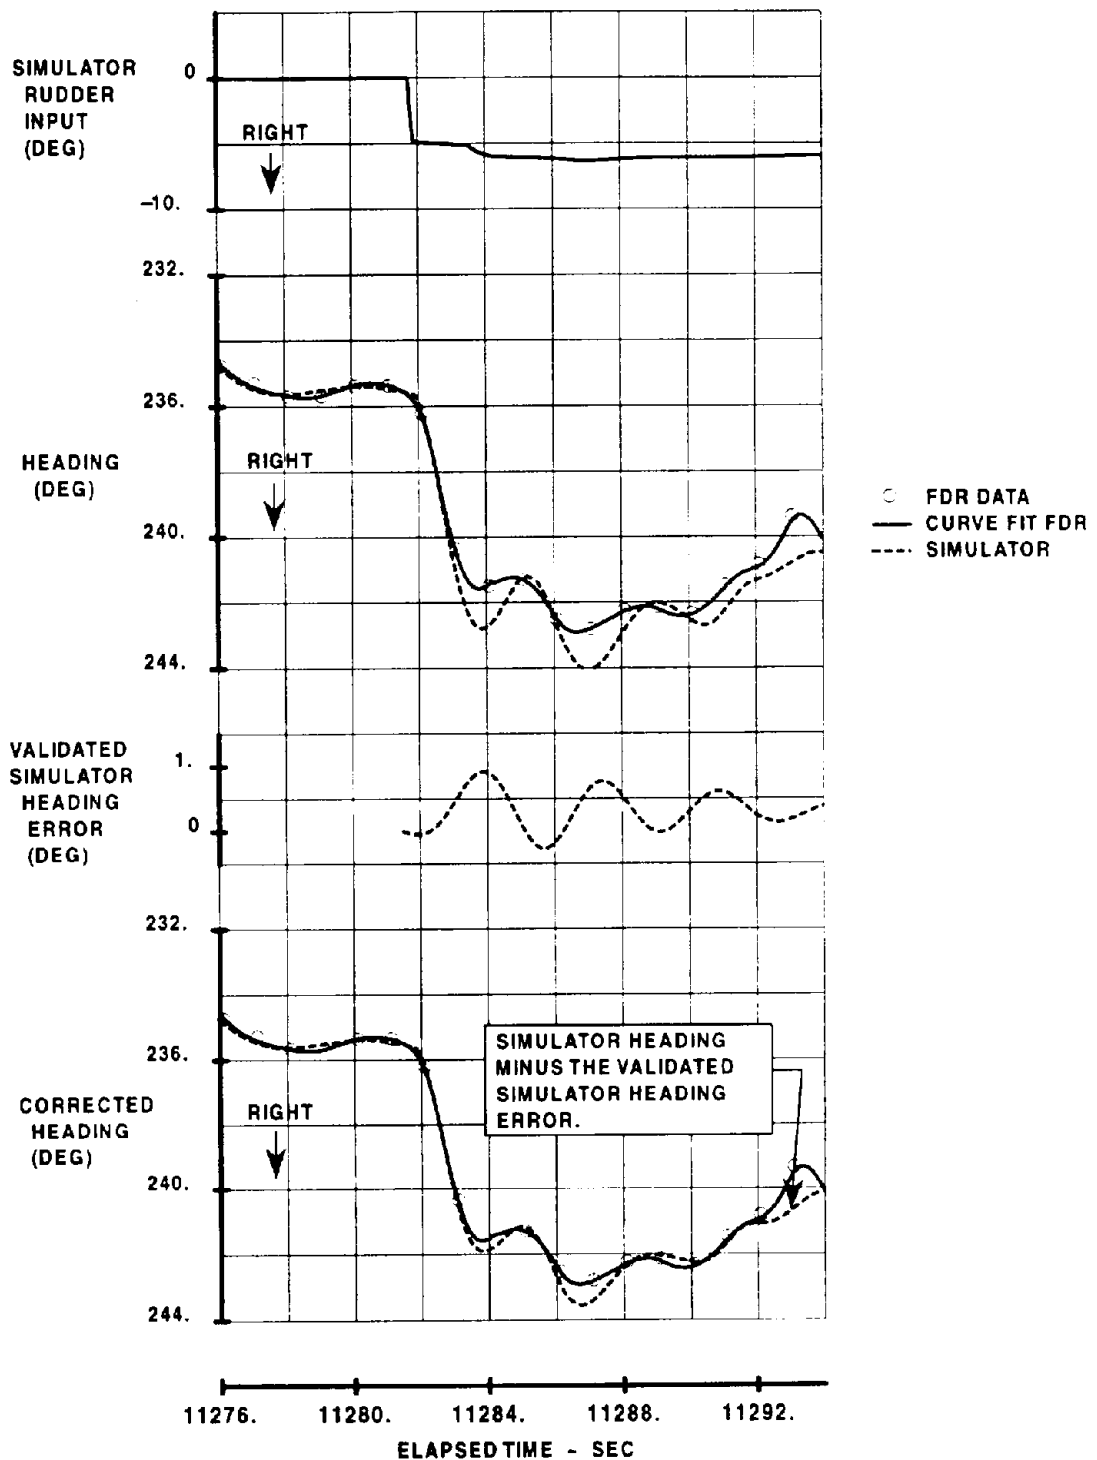
Figure 15

Open-Loop Match For Eastwind Event  
 Double Y/D Hardover / 39% Jam / Reversal  
 (Based on 737-200 Simulation)

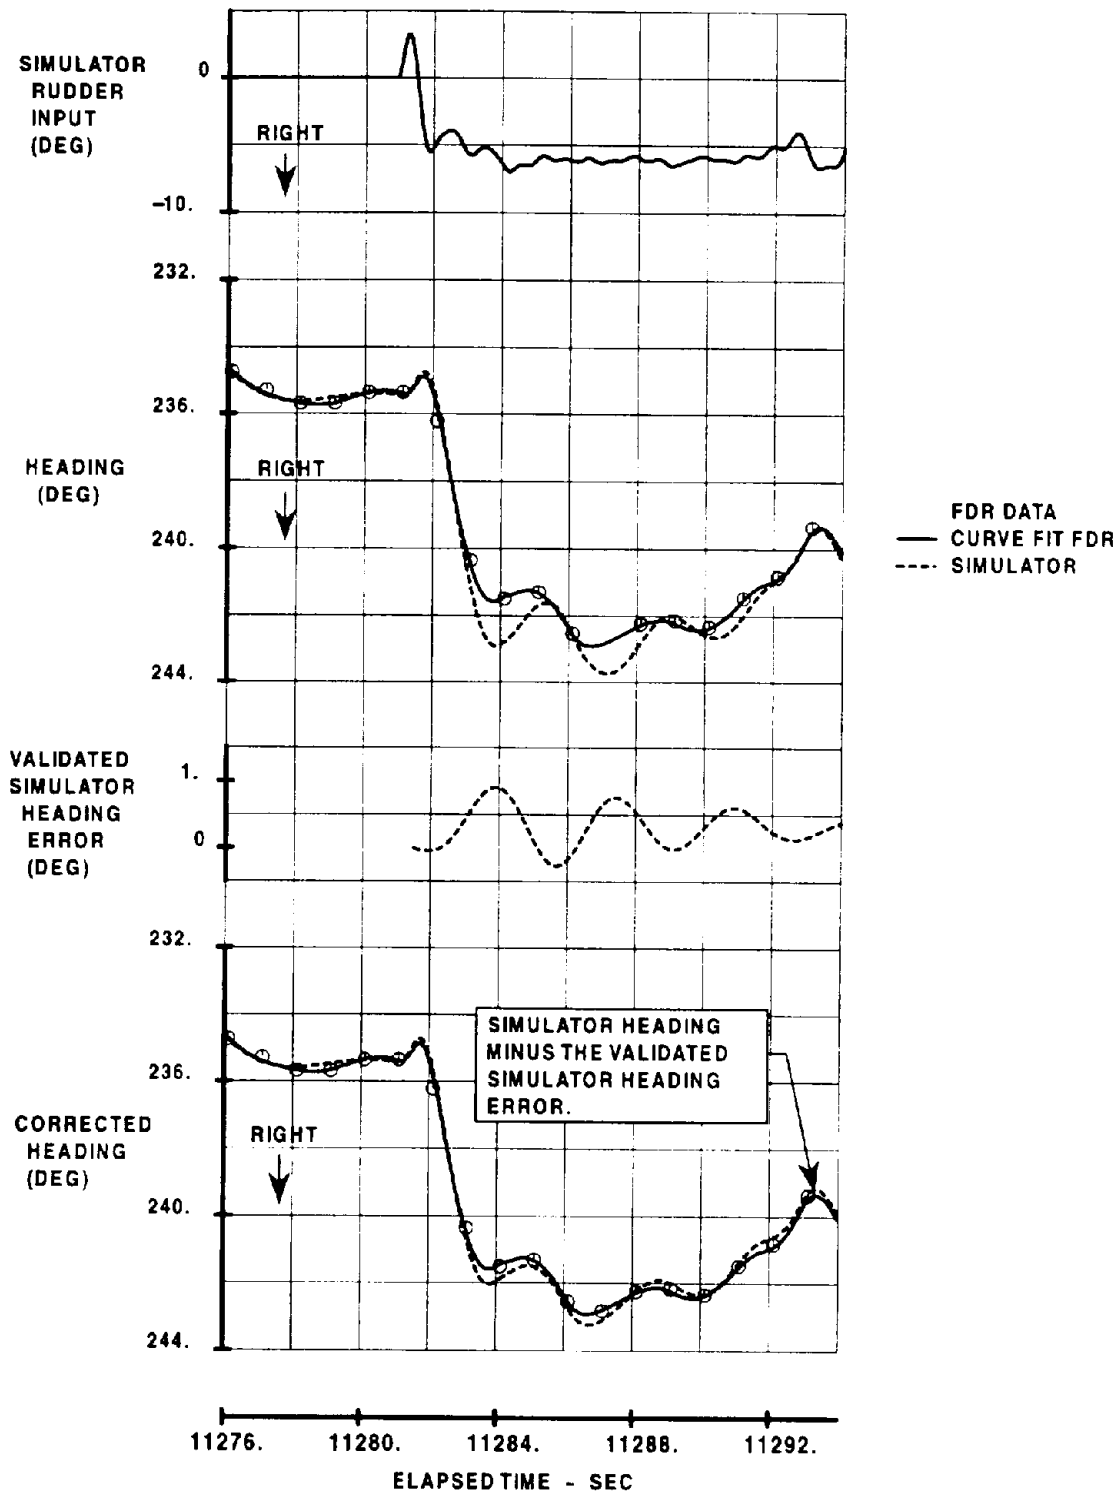
This scenario matches certain pilot comments and known conditions related to the event. The airplane rolls to the left during the initiation of the event and matches the heading very closely as shown in Figure 16 (page 38). This scenario correlates with the reported nearly simultaneous input of rudder and wheel during the recovery. Rudder pedal deflection would be much closer to the reported 3 to 4 inches, since the pilot would have to overcome a yaw damper hardover to the left as well as put in enough rudder to the right to cause the roll to the right. This usage of a significant rudder input to recover from the initial upset is consistent with the manner in which the pilot used rudder to recover from an unexpected upset created during the flight testing. The stiff rudder comment may have been caused by the lack of expected airplane response to the significant rudder pedal input made by the pilot. The only significant discrepancy with the pilot report is the direction of his pedal command and his report that there was no yaw to the left.

FIGURE 16  
 Open-Loop Match For Eastwind Event  
 Y/D H/O Release, Pedal Step, Y/D Working  
 (Based on 737-200 Simulation)

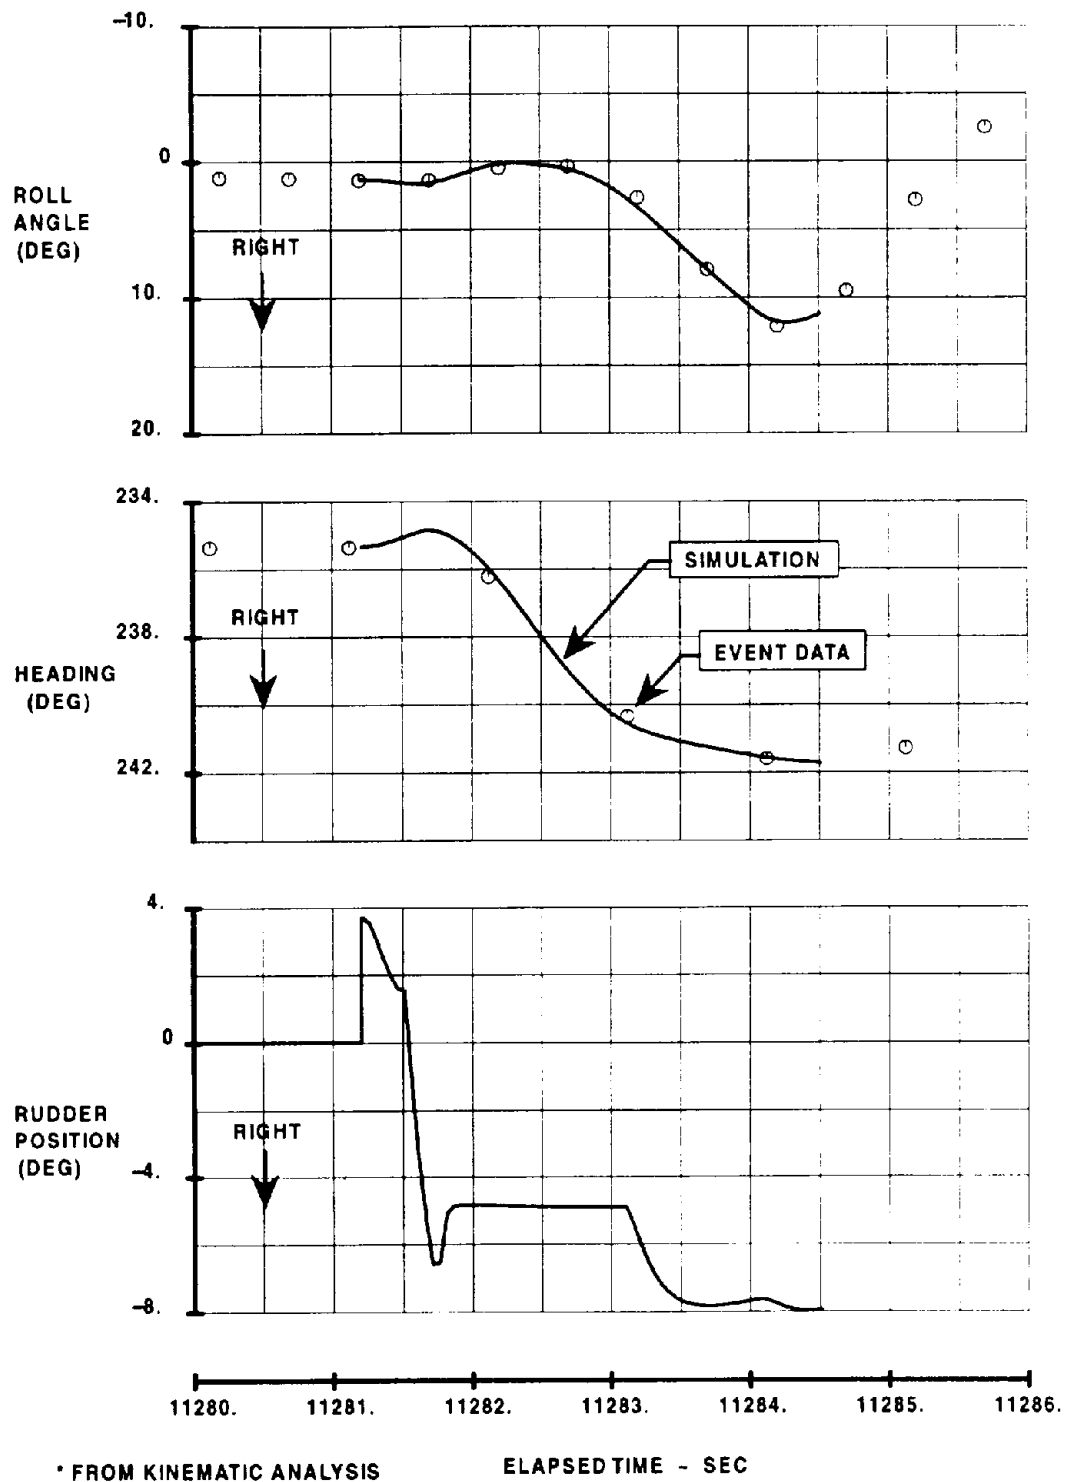
- A free response to a hardover to the left is shown in Figure 17 (page 39). This shows in more detail the simulator roll and heading compared to the flight data recorder event data, demonstrating that yaw damper hardover and recovery proposed in Scenario 4 does match the flight data recorder information.
- Figure 18 (page 40) shows the rudder commanded by the Eastwind captain during the post-event flight test compared to the rudder required during the event for Scenario 4. Note that he responded to a hardover of the same magnitude as Scenario 4 with an equivalent rudder input.

FIGURE 17  
Comparison of Airplane Response for the  
Eastwind Event Vs. Simulated  
Y/D Hardover-Release

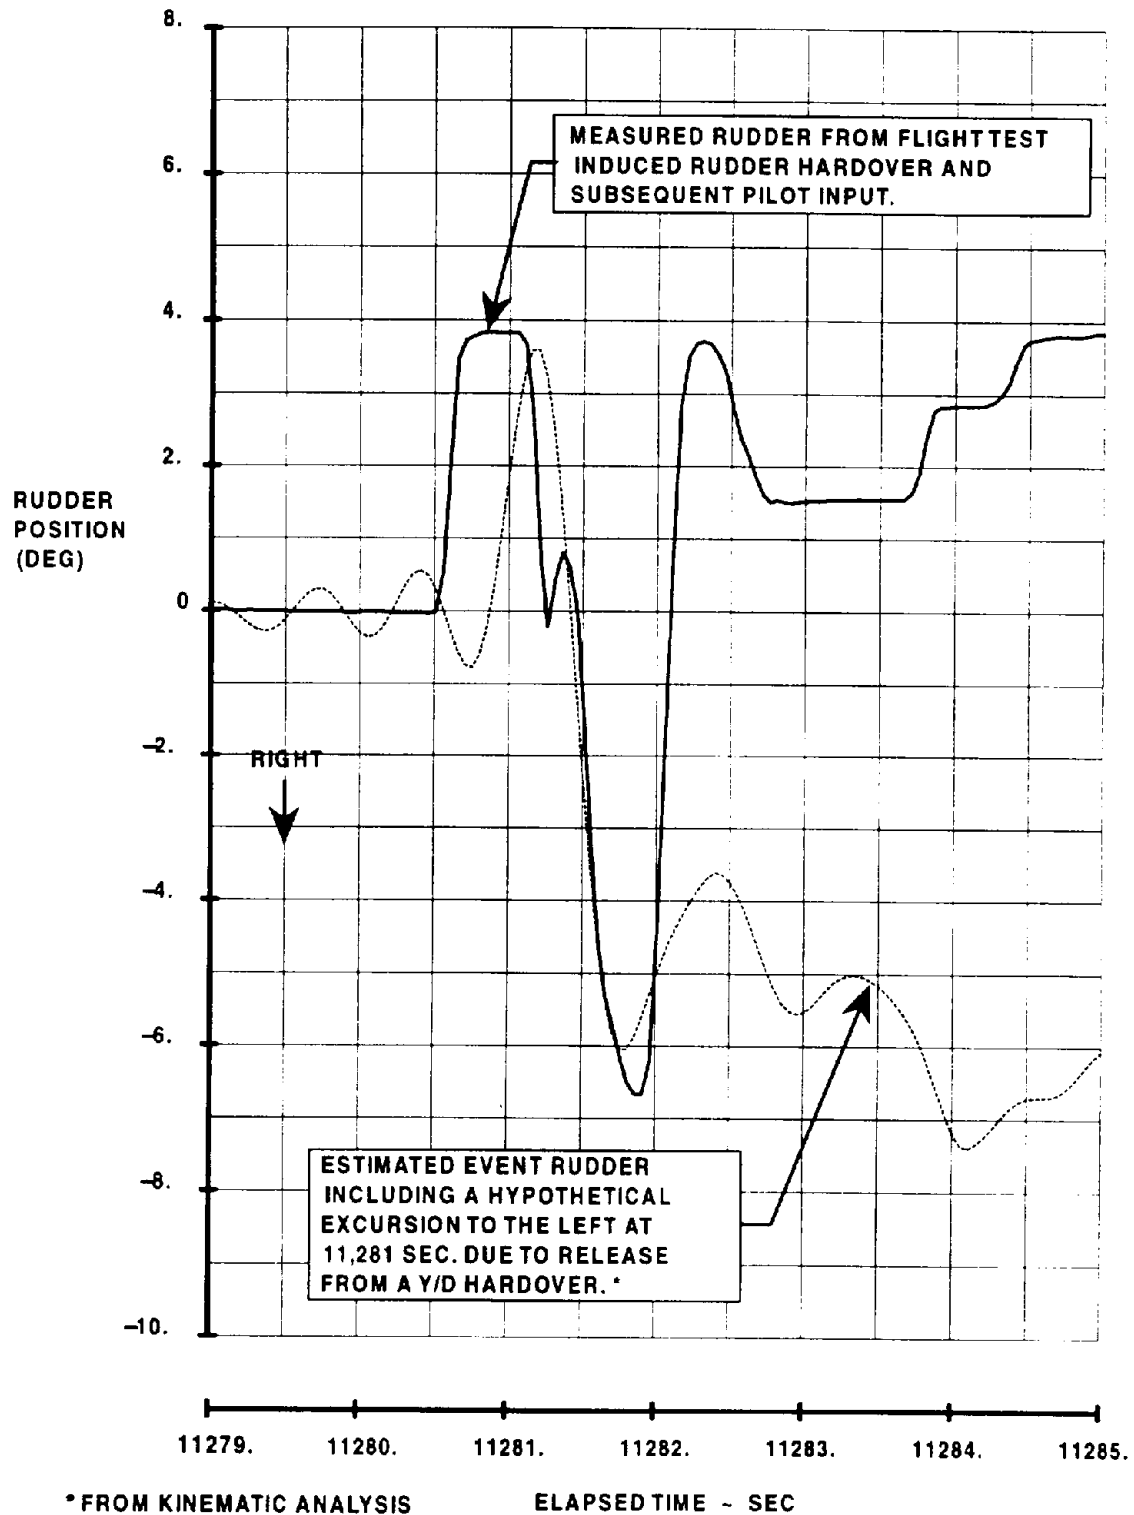
Figure 18

Comparison of Predicted Rudder vs.  
Flight Test Rudder Data From an Induced  
Y/D Hardover and Subsequent Pilot Input

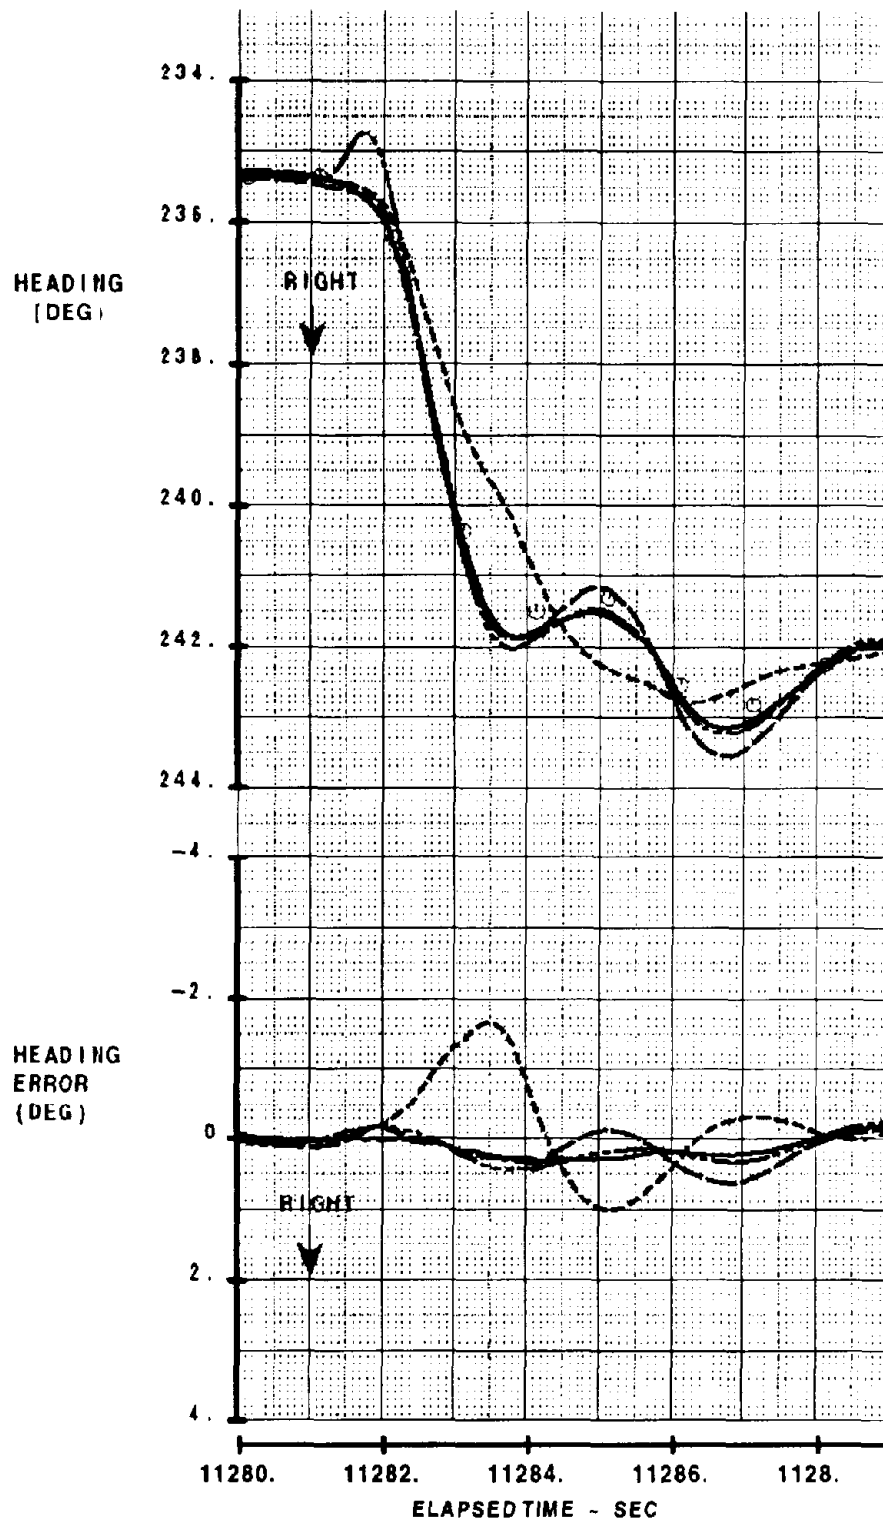
A comparison of these four scenarios has been made based on a free response to the theorized control inputs. The errors that result when the corrected flight data recorder heading is subtracted from the heading calculated for the four preceding scenarios are shown in Figure 19 (page 41). These data show that several of the scenarios result in relatively small heading errors.

Figure 19  
Comparison of Heading Errors for  
The Various Open Loop Matches  
(Based on 737-200 Simulation)

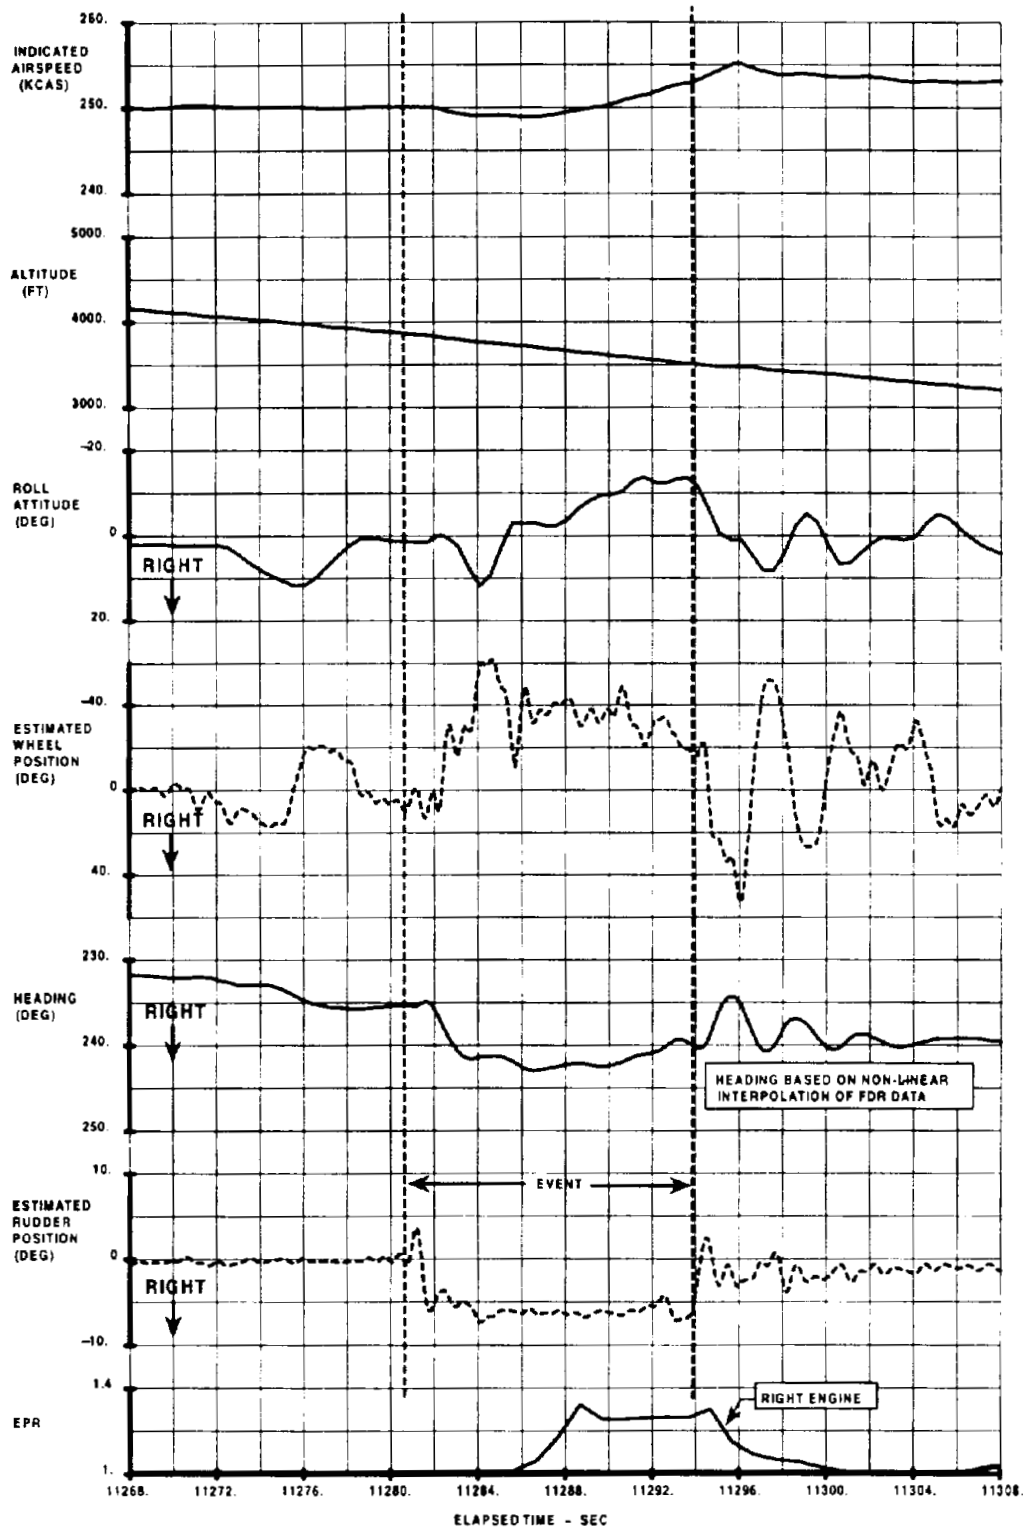
As shown in Table II, Scenario 4 appears to match more of the crew comments and known airplane conditions than the other scenarios considered. The estimated rudder and wheel for this scenario are shown in Figure 20 (page 42) along with the flight data recorder parameters. The heading trace shown in this figure has been adjusted so that it shows a movement to the left while still going through all the original flight data recorder data points.

Figure 20  
Estimated Control Wheel and Rudder  
for Eastwind Airlines Yaw/Roll Event  
June 9, 1996 (Assuming Initial Left Yaw)
