UNDERWATER INSPECTION AND EVALUATION REPORT

**PIER 1-B
ST. GEORGE FERRY TERMINAL
MAINTENANCE FACILITY
STATEN ISLAND, NEW YORK**

December 2003

Prepared by:
Atlantic Engineering, LLC
170 Kinnelon Road, Suite 21
Kinnelon, NJ 07405

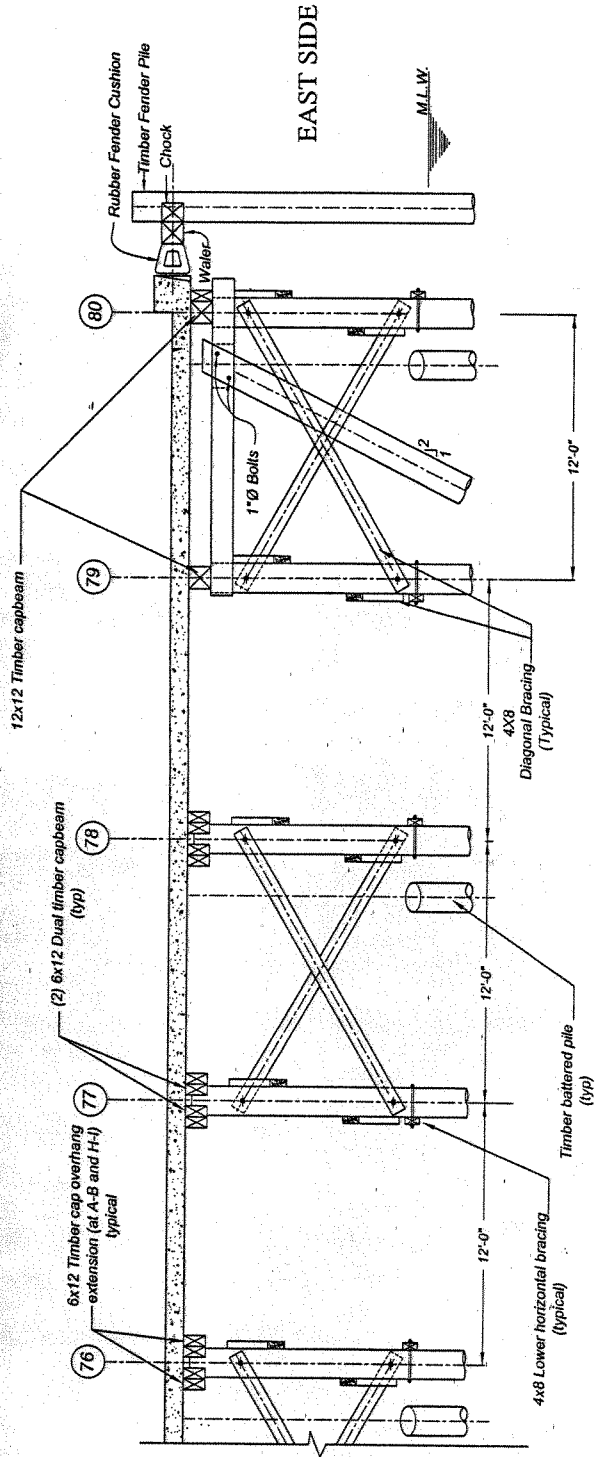
PILE/DECK DEFICIENCY PLAN
 Scale 1"=10'

Approximate location of broken concrete deck with entire SE corner section "hanging" from reinforcing
