**VEHICLE FACTORS GROUP CHAIRMAN'S
FACTUAL REPORT**

Vehicle Attachment 2 - 2005 Ford – Engine Visual Inspection Report from Navistar, Inc.

HWY15MH006

6.0L DIT ESN 6367159

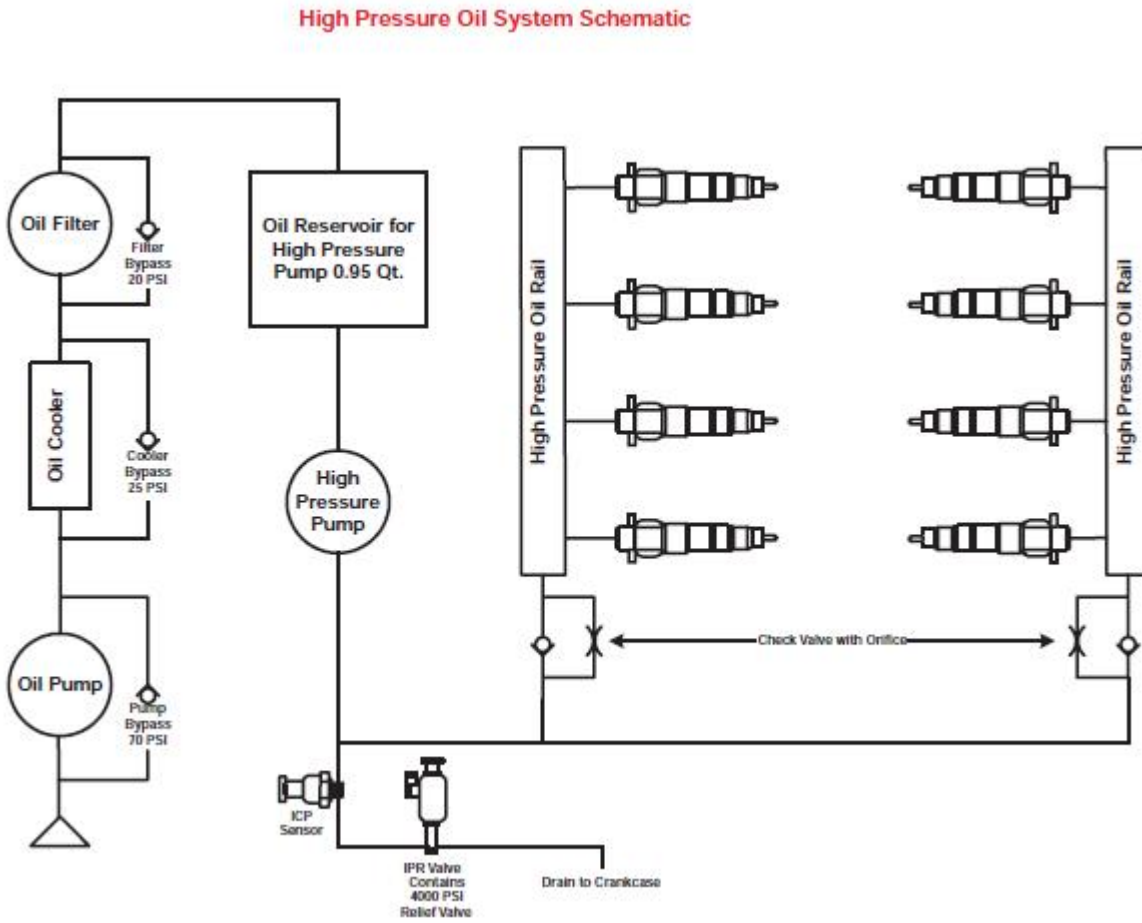
Figure 3 – High Pressure Oil Schematic

A schematic of the high pressure oil system is included in figure 3 in the appendix. IPR (injection pressure regulator) valve was removed from pump. The end screen was intact and in good condition. O-rings were intact and in good condition – see figure 4. Snap to connect fitting at pump was connected and in good external condition. Fitting was disconnected and reviewed - sealing surfaces were in good condition. O-rings between snap to connect fitting and branch tube were intact and showed no evidence of leakage. High pressure oil pump was removed and inspected. Pump gear was undamaged and pump turned freely. Mating crank gear showed no evidence of damage and teeth were in good condition. Oil supply cavity to high pressure pump was unobstructed. Oil reservoir in front valley of engine was full and screen was intact.
