**VEHICLE FACTORS GROUP CHAIRMAN'S
FACTUAL REPORT**

TRW Steering Gear Inspection Report

**MULTIPLE VEHICLE ACCIDENT
Chattanooga, TN**

HWY15MH009

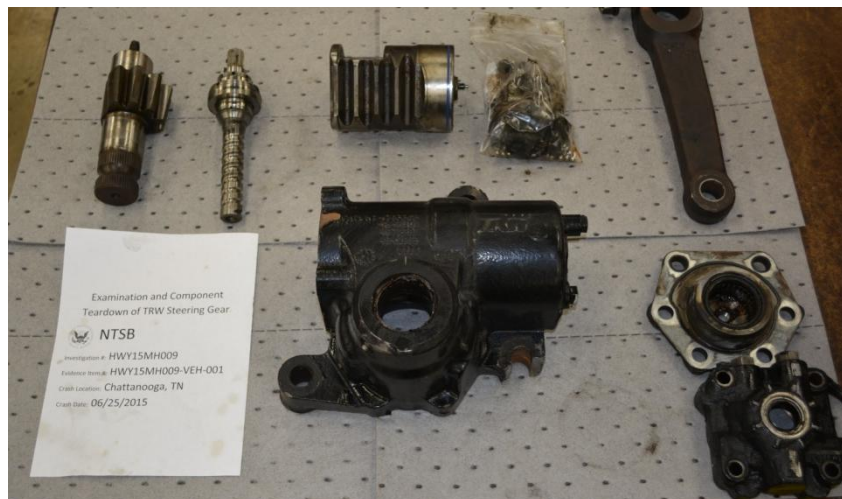
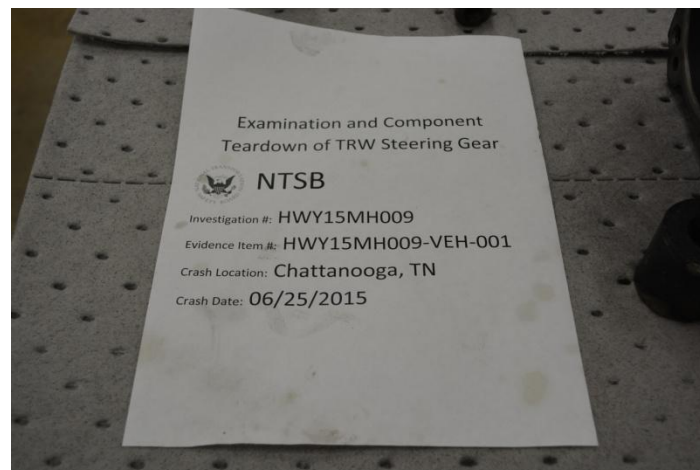
CONCLUSION: The steering gear was still mechanically functional as received. There were clear signs of impact since the mounting bosses showed fracture and damage. The output shaft showed brinell imprints from the needle bearings and the worm screw showed brinell imprints from the recirculating ball bearings. The position of the ball bearings indicate the steering gear was near straight ahead at the time of impact.
