**VEHICLE FACTORS GROUP CHAIRMAN'S
FACTUAL REPORT**

HWY17MH005

**NATIONAL TRANSPORTATION SAFETY BOARD
OFFICE OF HIGHWAY SAFETY
WASHINGTON, D.C.**

Location: Westbound Interstate 10 (I-10) in the vicinity of post mile marker 32.5,
near Desert Hot Springs, Riverside County, California

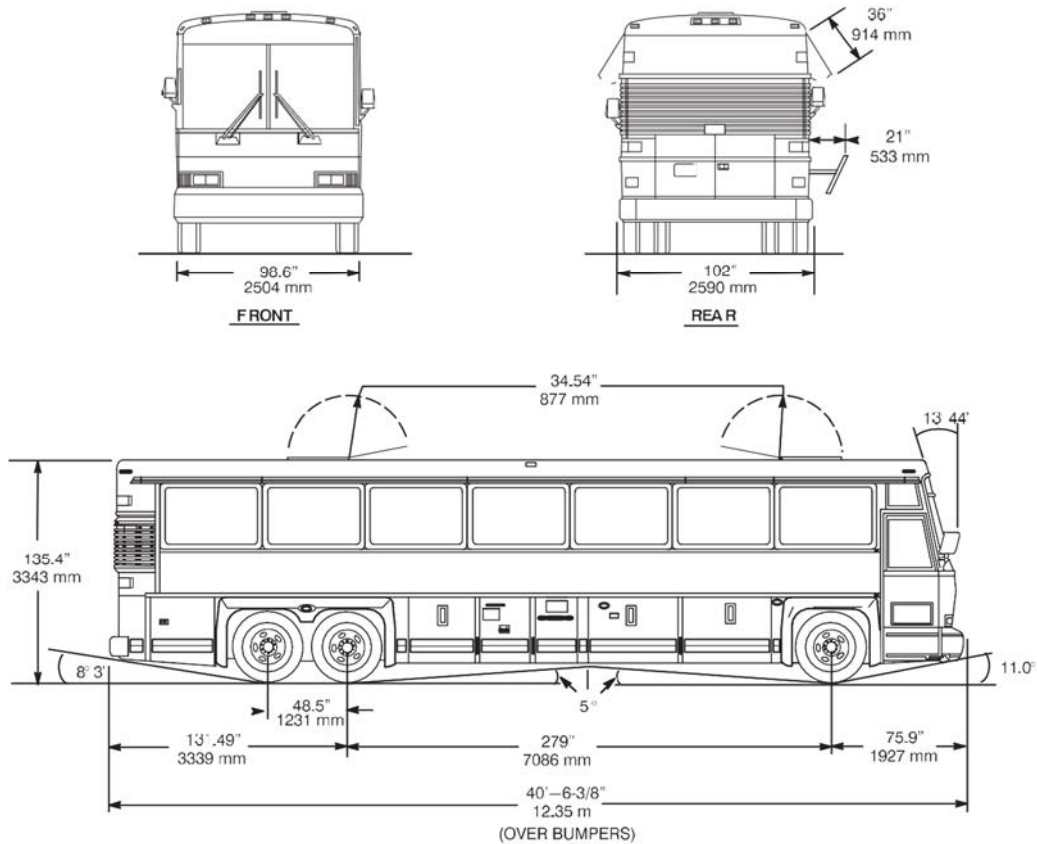
Figure 1: Measurements of Motorcoach

GVWR	44,400 lbs
Approximate Payload Capacity	11,500 lbs
Fuel Capacity	192 Gal.

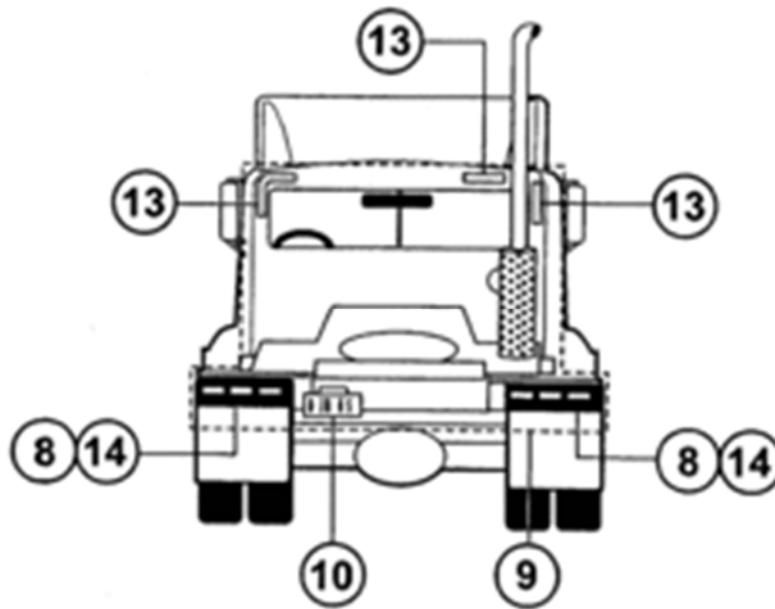
Figure 4: Truck Tractor Lamp and Reflective Requirements³⁸

All external lighting on the truck tractor was in working order. Since the truck tractor was manufactured in 2014, the vehicle must comply with the position and number of lamps and reflective devices required by 49 CFR 393.11(a)(1). During the inspection of the truck tractor, investigators confirmed the truck tractor was in compliance with regulation. See **Figures 4 and 5**.

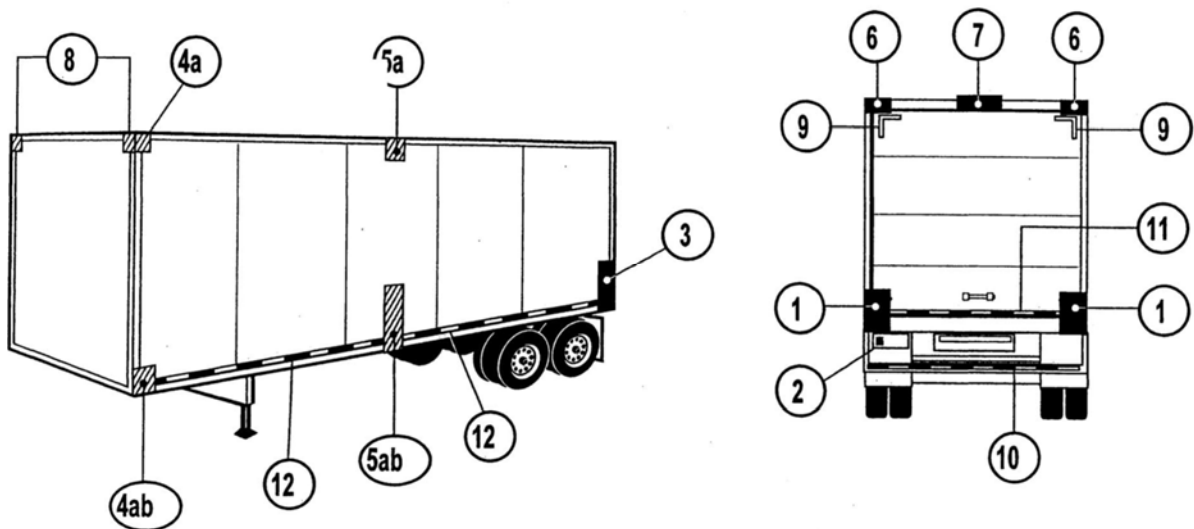
Figure 6: Semitrailer Lamp and Reflective Device Requirements⁴⁰

The semitrailer had retroreflective material attached along the sides and on the rear as required by 49 CFR 393.11(b). A sample piece of the retroreflective material was removed from the semitrailer for further testing. During the inspection of the semitrailer, investigators confirmed the truck tractor was in compliance with regulation. See **Figures 6 and 7**.
