**VEHICLE GROUP CHAIRMAN'S**

**Attachment H**  
**Bridgestone Tire Examination**  
**(19 Pages)**

**TIRE ANALYSIS REPORT**

**Description:** Motorcoach Run Off Roadway Bridge and Rollover  
**Location:** U.S. Highway 75, Sherman, Texas  
**Date of Accident:** August 8, 2008  
**NTSB Case No:** HWY-08-MH-022

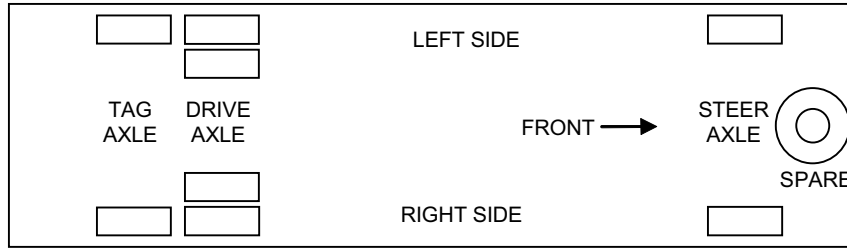
Figure 5: Motorcoach Tire Positions

Referring to the graphic in Figure 5, see Table 1 for a summary of the identification of the tires and wheels on the subject motorcoach.
