NATIONAL TRANSPORTATION SAFETY BOARD

17 - Video Factual Report

**Specialist's Factual Report
by Bill Tuccio**

Location: Scottsdale, Arizona
Date: July 9, 2012
Aircraft: Mooney M20L
Registration: N137MP
Operator: Private
NTSB Number: WPR12FA297

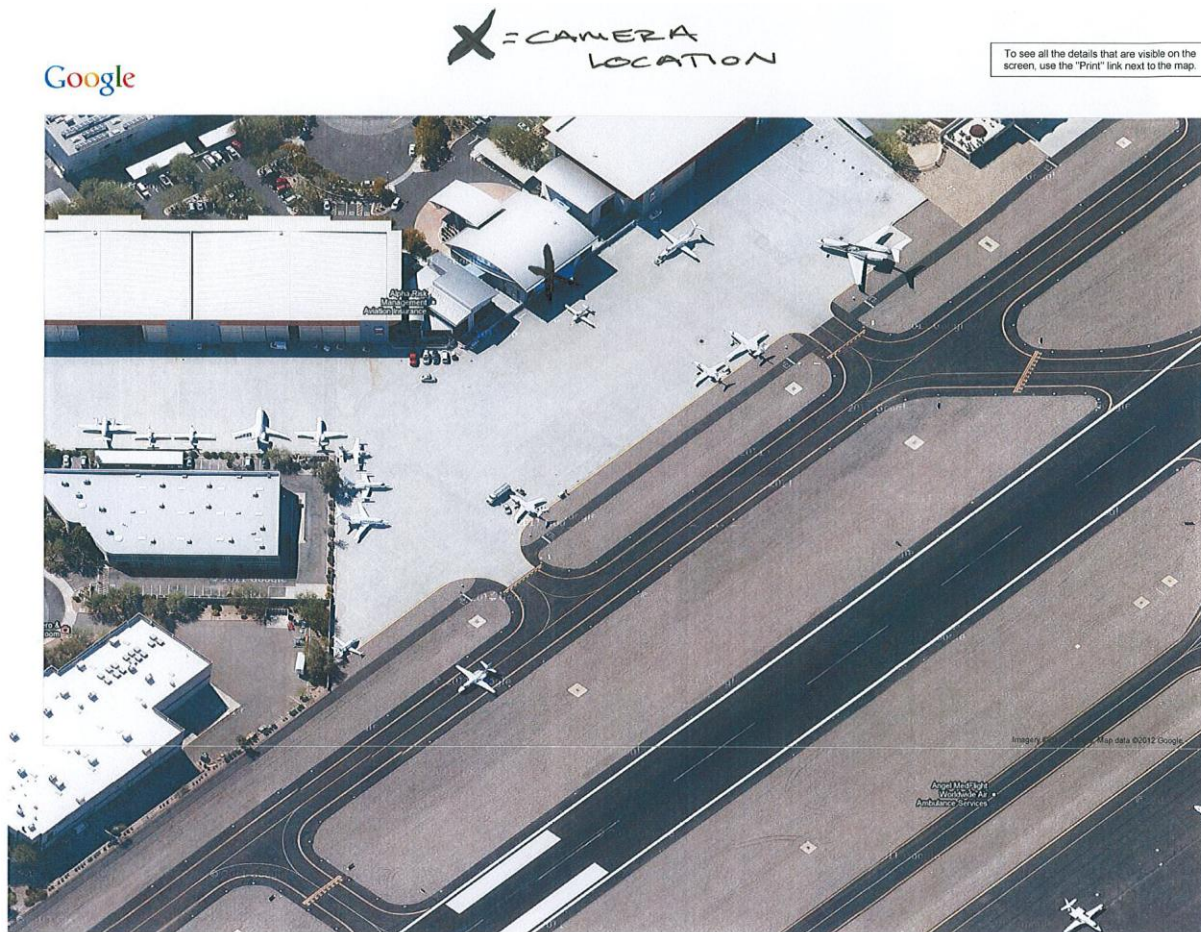
According to the investigator-in-charge, the security video camera location is as shown in figure 1. The camera was reported to be about 15 feet above the ground. The camera was located about 525 feet from the edge of the only runway on the airport, runway 3-21. The camera is facing northwesterly.

Figure 1. Approximate location of FBO security video camera.
