**NATIONAL TRANSPORTATION SAFETY BOARD
Office of Research and Engineering
Vehicle Recorder Division
Washington, D.C. 20594**

GROUP CHAIRMAN'S FACTUAL REPORT OF INVESTIGATION

WPR13FA370

Location: Paradise, California
Date: August 13, 2013
Aircraft: Champion 7GCAA, N9607S
Operator: Private
NTSB Number: WPR13FA370

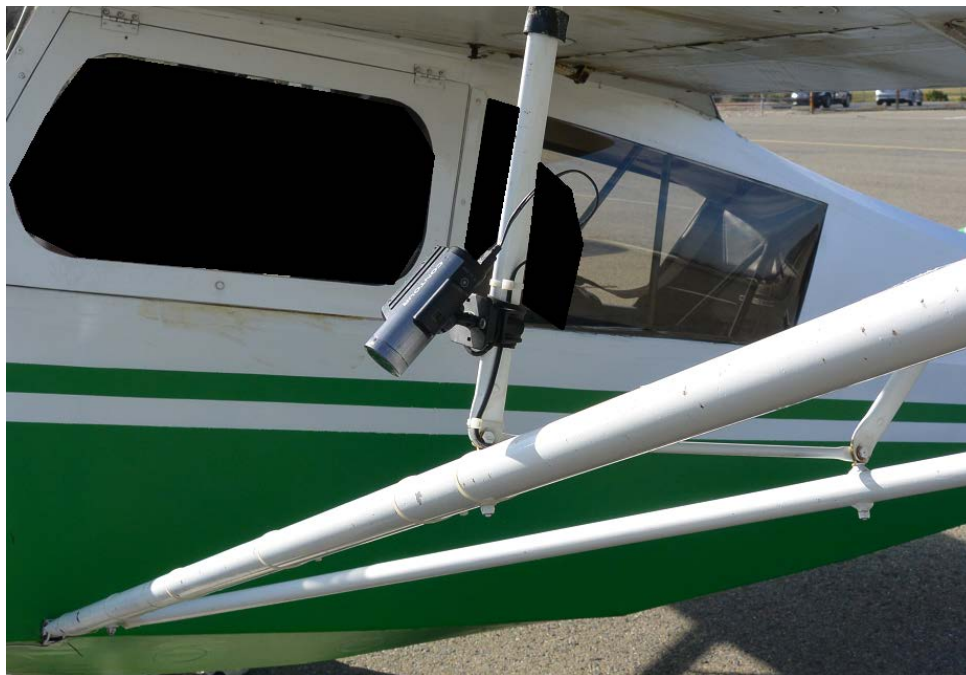
Figure 6. Camera mounting configuration on exemplar aircraft.

The camera suffered significant heat and structural damage, as shown in figures 1 through 3. Figure 4 shows the camera model after the damaged lens was removed. Despite the damage to the camera, the 32GB microSD card was not physically damaged and was removed from the camera without difficulty, as shown in figure 5. The mounting configuration of the camera is shown in figure 6, using an exemplar aircraft. According to the operator, the camera was typically pointed down about 45 degrees relative to the longitudinal axis of the aircraft.

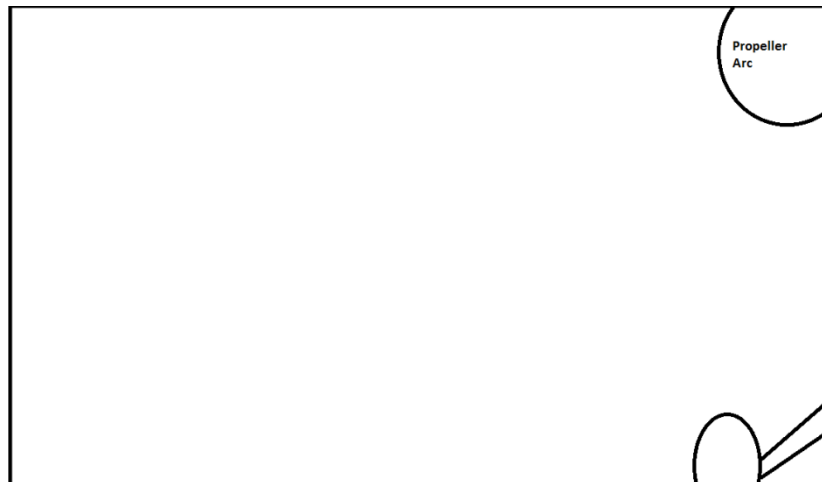
Figure 7. Camera field of view.

The recovered video resolution was 1280x720 pixels recorded at 30 frames per second. Figure 7 shows the field of view of the camera from the accident flight. The image was fish-eye distorted due to the wide angle lens used on the camera.
