NATIONAL TRANSPORTATION SAFETY BOARD
Vehicle Recorder Division
Washington, DC 20594

Video Study

Specialist's Report By Sean Payne

Location: South Bend, Indiana
Date: March 17, 2013, 16:23 EDT
Aircraft: Hawker Beechcraft model 390, N26DK
Operator: Private
NTSB Number: CEN13FA196

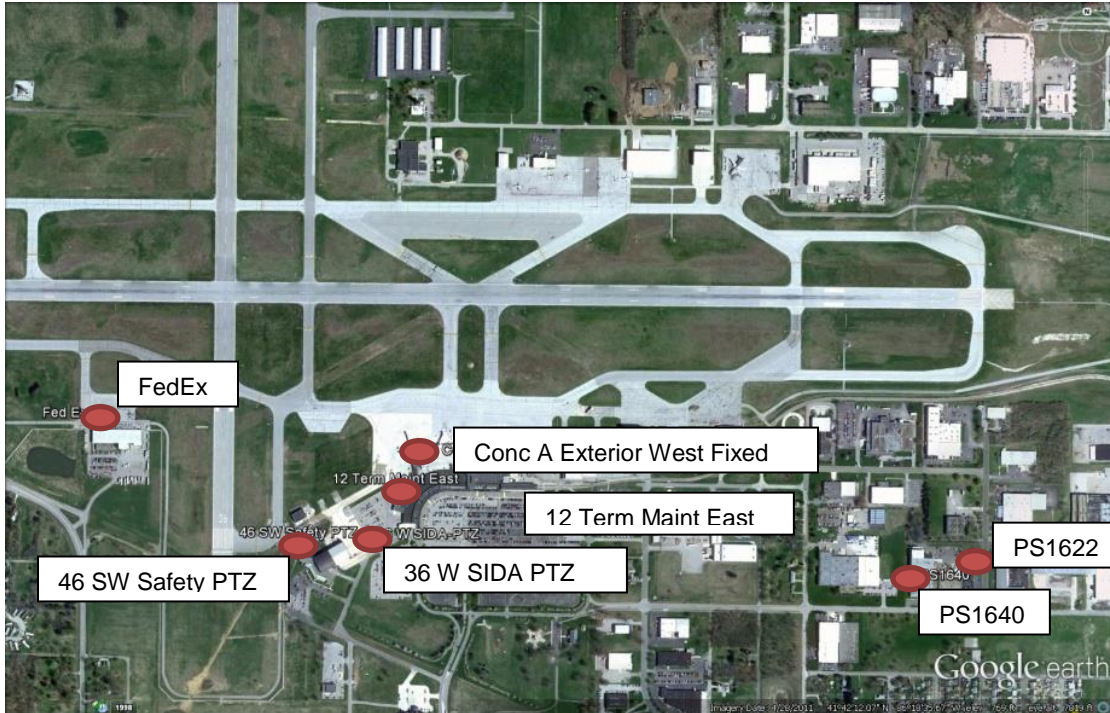
Fig 4.1: A diagram of the seven of the eight security camera locations that capture images in the immediate vicinity of the runway.

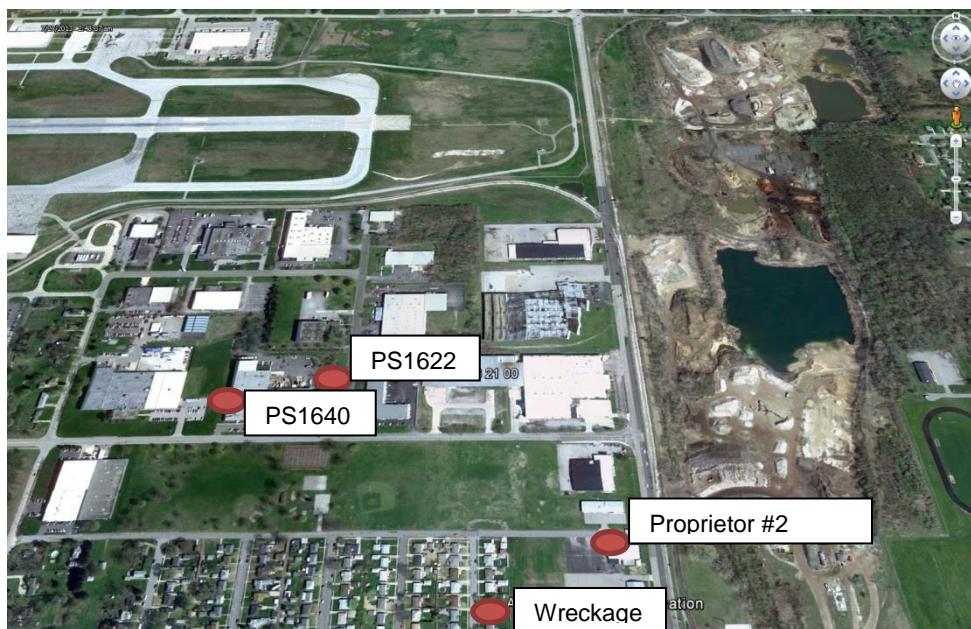
Fig 4.2: A diagram showing the eighth camera location as well as the approximate location of the aircraft wreckage.

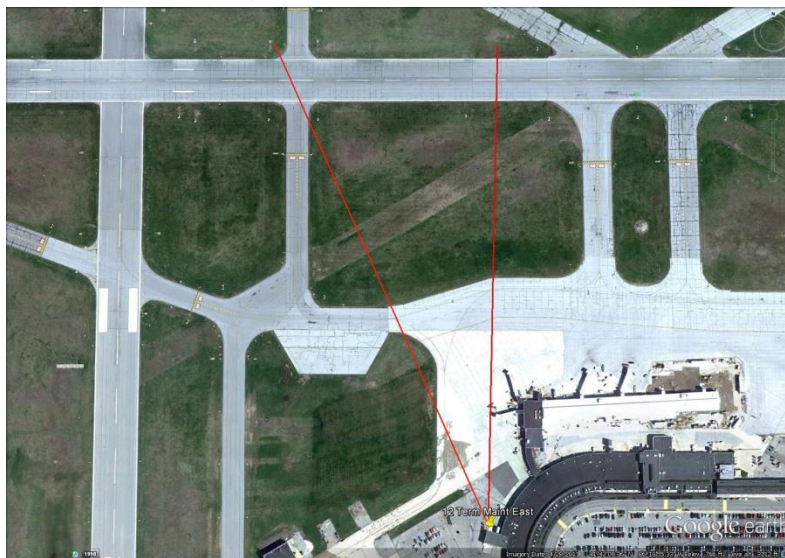
Since the exact location of the baggage claim security camera is known, it is possible to determine the camera's field of view in order to base measurements for subsequent calculations. The airport manager verified this camera's location as being just outside a gated ramp area at a position of 41°41'57.85"N 86°18'53.72"W.

Figure 4.12: The camera's position located on Google Earth and its field of view.

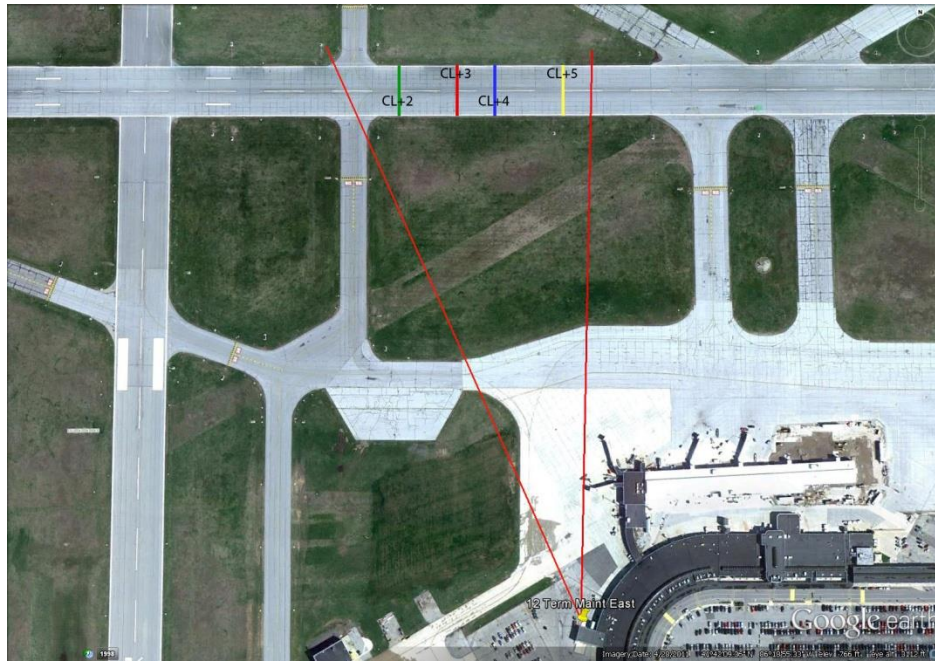
key locations in the recording, such as the runway centerline markings, runway calibration instructions were sent to the airport manager so an additional recording could be made that helps identify these locations. The calibration instructions called for an ARFF (Airport Rescue and Fire Fighting) vehicle to be parked at specific centerline locations annotated on the diagram below (Image 4.16). The recording was sent back to the NTSB where a comparison to the accident video was made that identified the runway centerline locations.

Image 4.16: The known points from the calibration study translated into Google Earth.

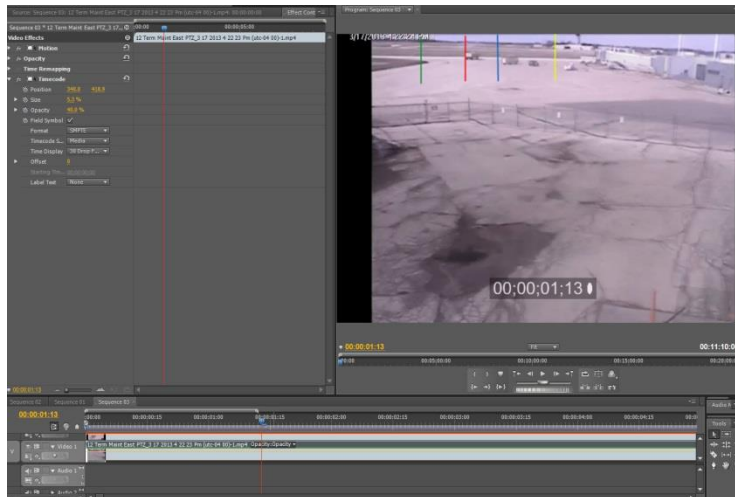
Image 4.11: An overlay of the perspective lines in a video editing software suite.

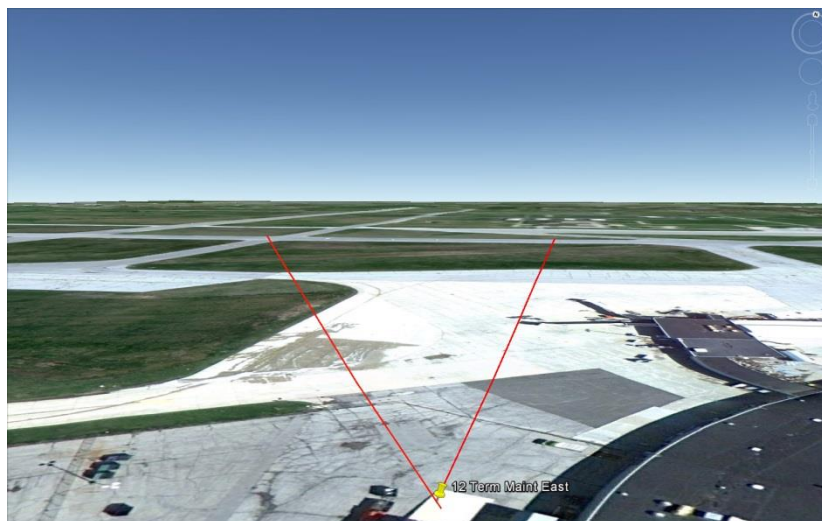
Figure 4.12: A virtual recreation of the baggage claim camera location and the perspective lines that were created in order to perform aircraft groundspeed calculations.
