**NATIONAL TRANSPORTATION SAFETY BOARD**

**Video Study Report**

**HWY07MH024**

Location: Minneapolis, MN  
Date: August 1, 2007  
Time: 1805 Central Daylight Time  
Event: Collapse of I-35W Bridge

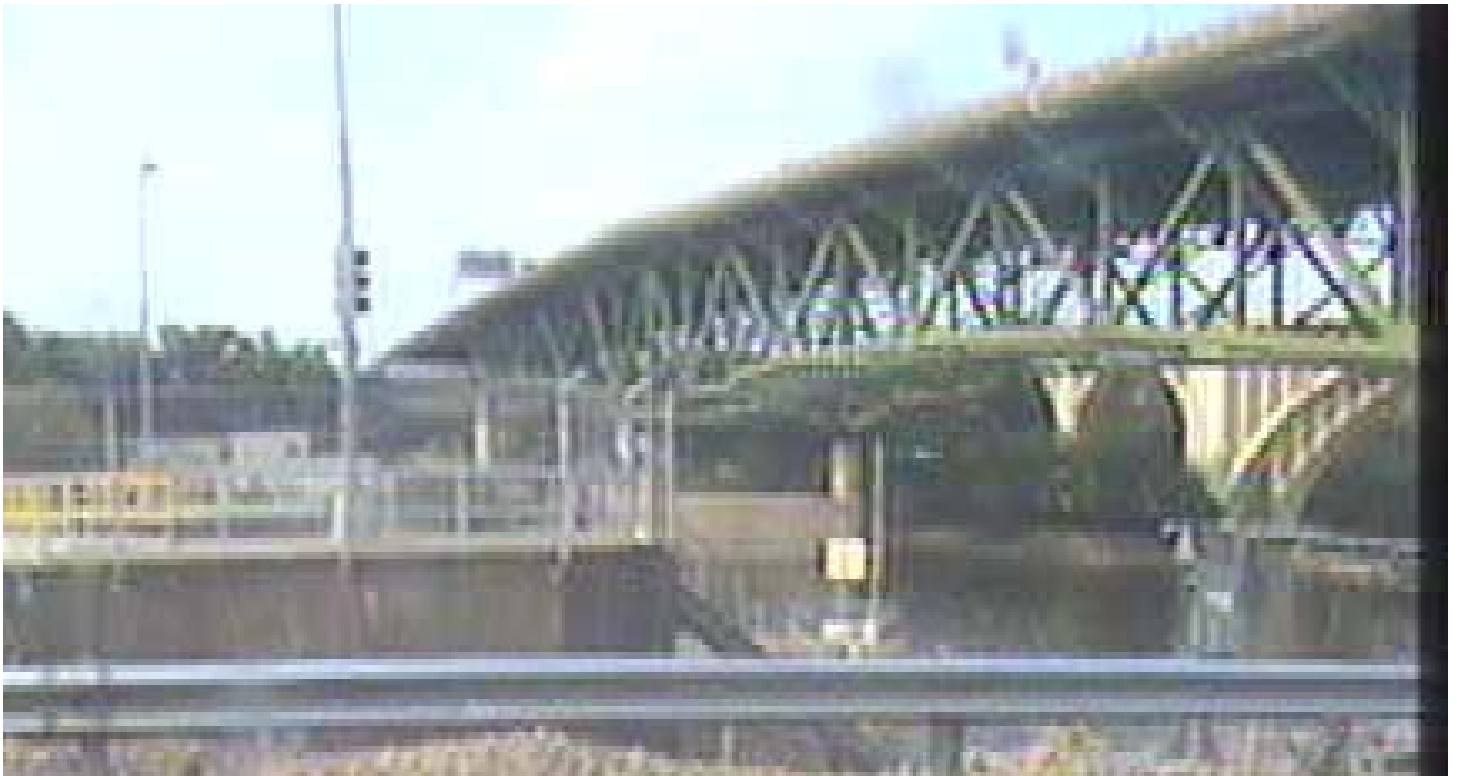
**18:04:57 (first image recorded of the collapse).**

Both of these apparent displacements can be seen when the 18:04:57 image is compared with the precollapse images. However, the motion seen at these locations may have been caused by artifacts introduced in the imaging process, such as distortion introduced during image acquisition or compression.<sup>6</sup>

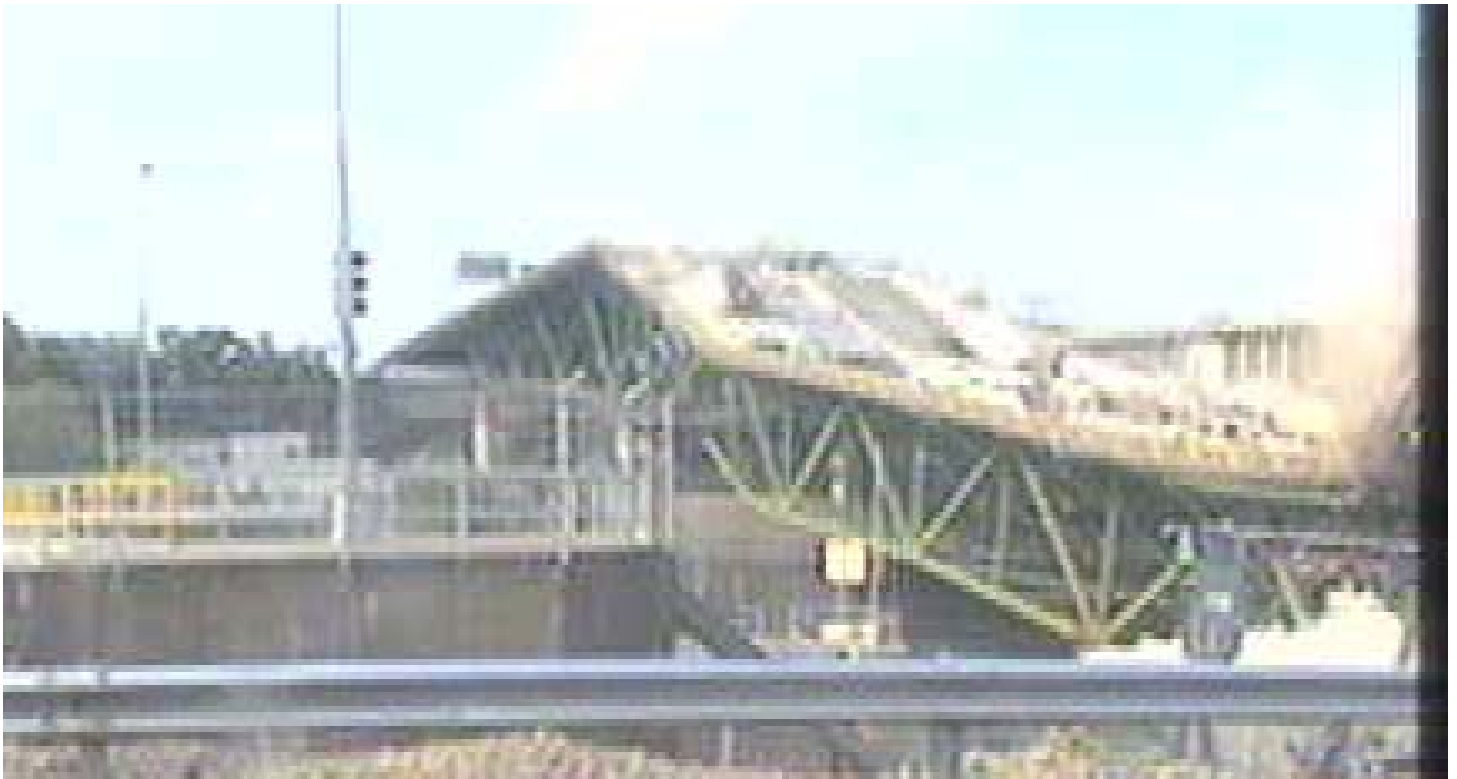
**18:04:58\_C**

Pier 7 is visible up until time 18:04:58\_C, which was about 1 $\frac{2}{3}$  seconds after the first image of the collapse was recorded. Up until this time, no motion of pier 7 is observed. Thereafter, pier 7 is completely obscured by bridge structure and dust/debris until 18:07:23. At this time, it appears that the east column of pier 7 was slightly displaced eastward (towards the right of the camera view), as compared to its precollapse position.

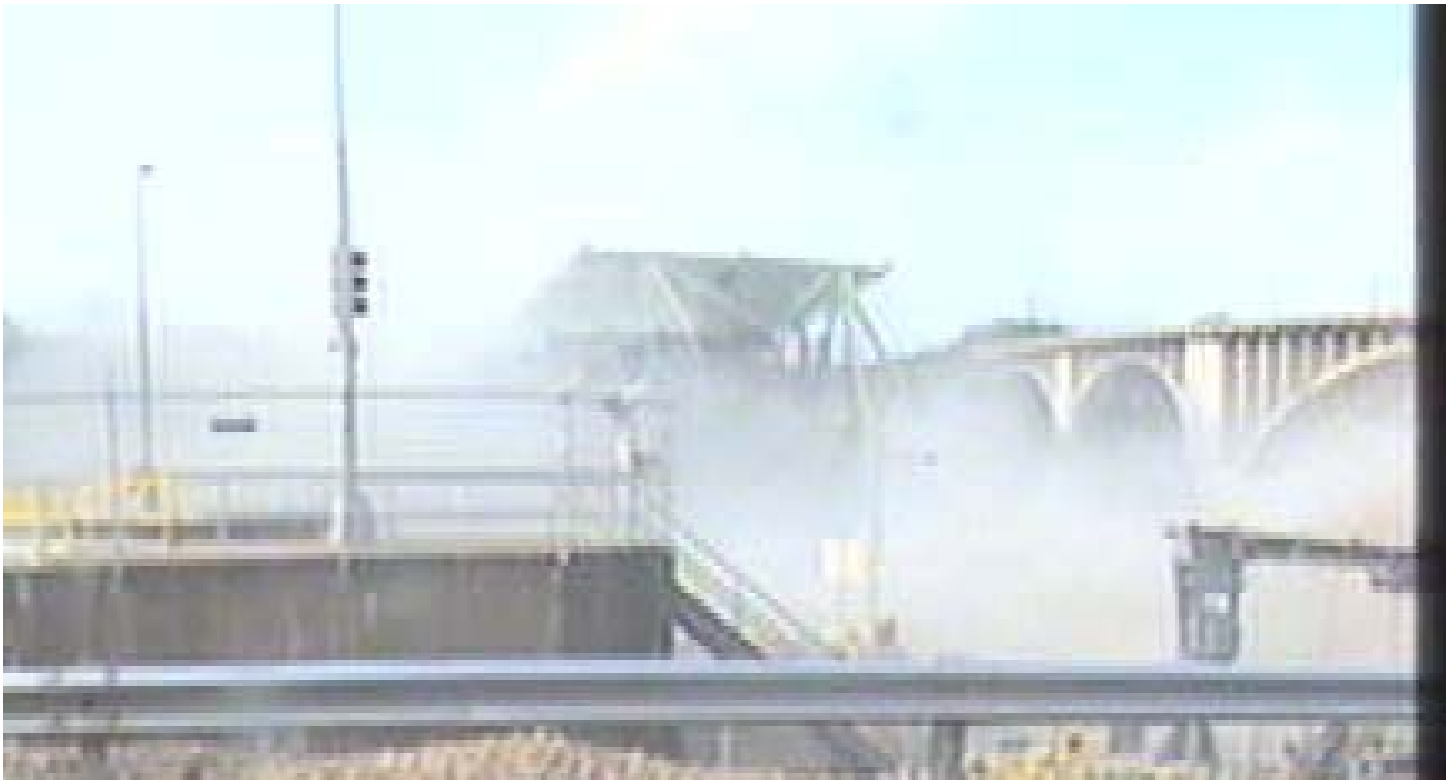
**18:05:07**

**Note: some ghosting of previous image is present; cause is unknown.**

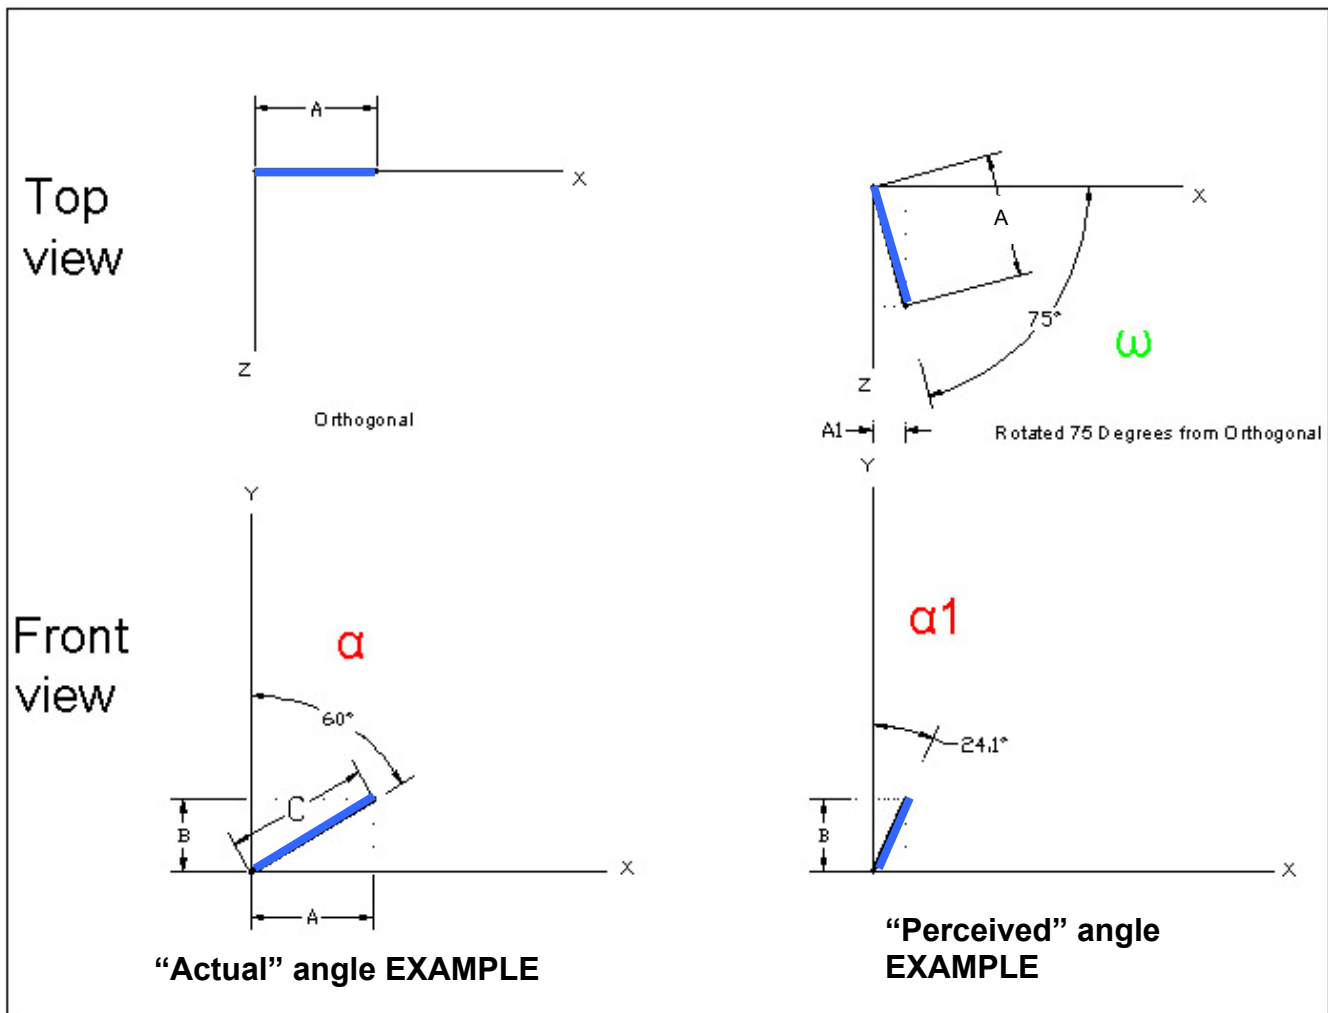
Figure 23. Perceived angle correction.

The lower left “front view” in Figure 23 shows a blue line in the XY plane at a true 60-degree angle to the Y-axis (angle  $\alpha$ ), as viewed orthogonally. In this view, a direct measurement of  $\alpha$  would yield its true angle of 60 degrees. (If the camera angle had been 90 degrees to the bridge truss, a true 60-degree angle between two truss members would measure as 60 degrees on the image.) The upper left top view shows the orientation of the blue line as viewed from directly above (looking down the Y-axis at the XZ plane).

The lower right graphic in Figure 23 shows how the same true 60-degree angle would appear if the blue line were rotated about the Y-axis toward the camera by 75 degrees. This would represent the orientation of the surveillance camera as it viewed the bridge truss. In this view, a direct measurement of the angle between the blue line and the verti-
