NATIONAL TRANSPORTATION SAFETY BOARD

Video Study

Specialist's Report
by Sean Payne

Location: Bagram Air Base, Bagram, Afghanistan
Date: April 29, 2013
Aircraft: Boeing 747-400
Registration: N949CA
Operator: National Airlines
NTSB Number: DCA13MA081

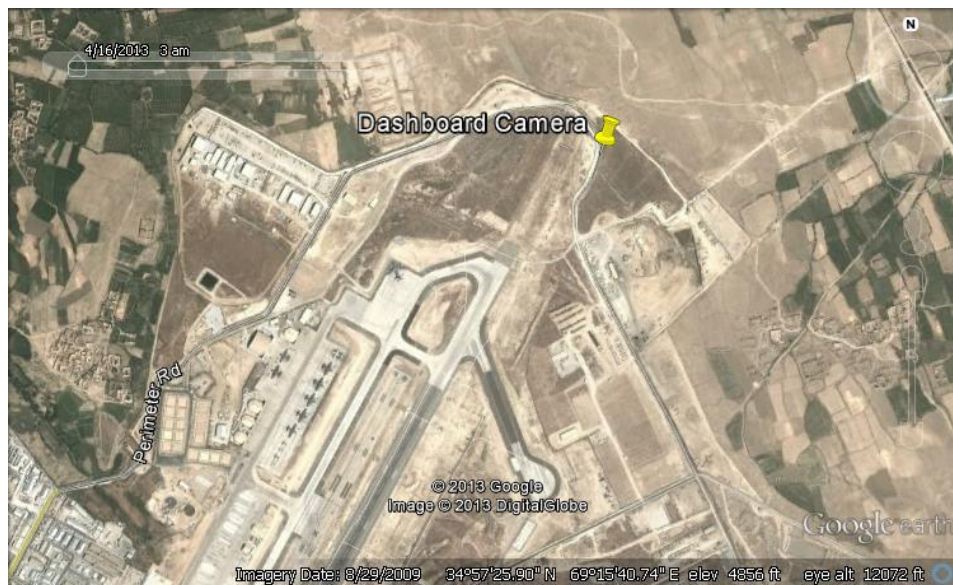
Figure 1: The approximate location of the Dashboard Camera Recording.

This file is the full length version of the dashboard camera footage from a moving vehicle in the vicinity of the airbase (Figure 1). It is 15 minutes and 47 seconds in length and is of AVI¹ file type. It is 640 by 480 pixels in resolution and was recorded at a rate of 30 frames per second in color. It includes 16 bit digital audio.

In this recording, the accident aircraft appears 11 minutes and 10 seconds into the video file. The accident aircraft enters the frame in a steep climb as it departs Runway 03. At 11 minutes and 20 seconds into the video, the aircraft reaches its apogee and begins to enter a roll to the right. At this time in the video, a sound similar to jet thrust noise is heard. The aircraft begins a rapid descent as it rolls back to the left. The aircraft impacts slightly nose down and nearly wings level. The landing gear is in an unknown configuration throughout the recording. The forward nose gear stowage door is shown in the open position. Overall, the aircraft appears in 541 video frames until the moment of impact.

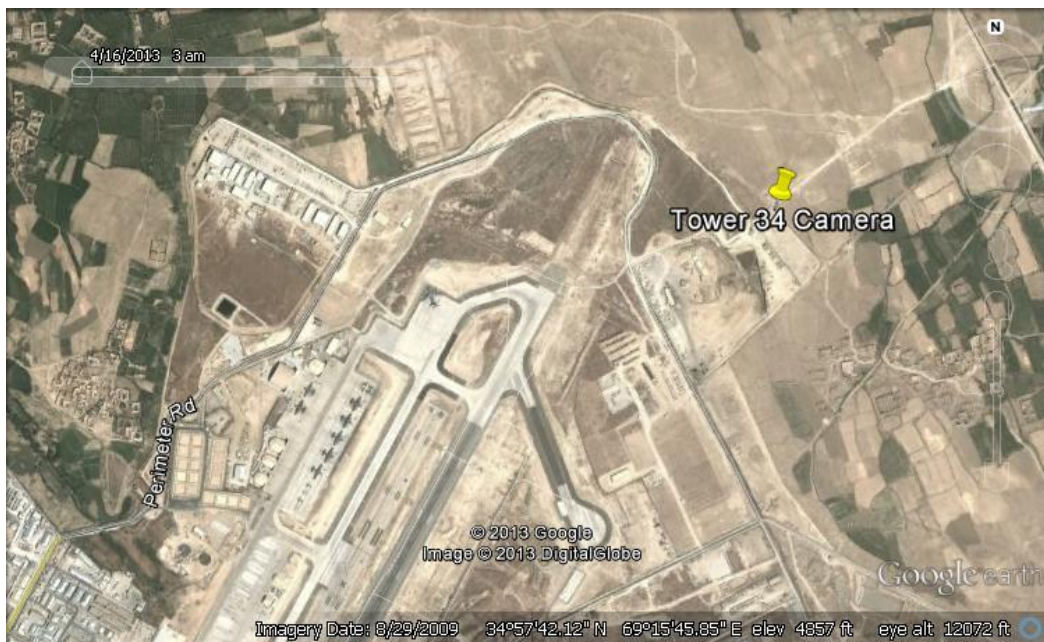
Figure 2: The location of the Tower 34 Camera.

This file is from a PTZ² controlled security camera near a base entrance on the northeast end of the airfield (Figure 2). It is 7 minutes and 43 seconds in length and is of AVI file type. It is 704 by 480 pixels in resolution and was recorded at a rate of 10 frames per second in color. It does not include audio.

In this recording, the accident aircraft appears 1 minute and 34 seconds into the video file. The aircraft's right wing enters the frame as it continues descending into the frame. The aircraft begins to roll back to the left and impacts the ground nose low and nearly wings level. The aircraft appears in 14 frames until the moment of impact.

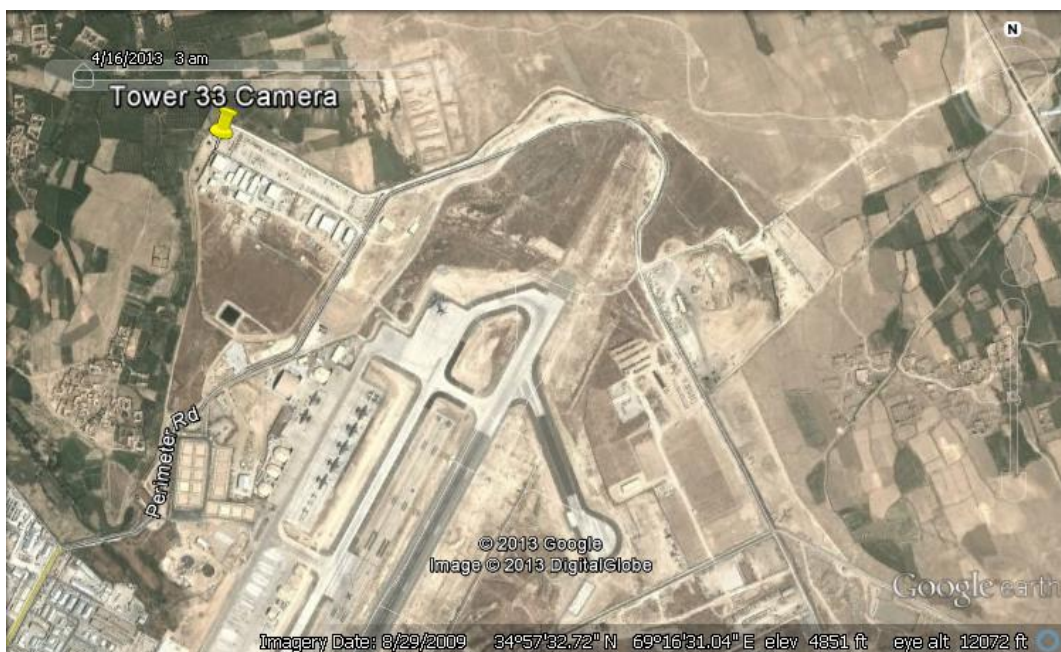
Figure 3: The approximate location of the Tower 33 Camera.

This file is from a fixed mounted security camera near the northwest perimeter of the airfield (Figure 3). It is 14 minutes and 54 seconds in length and is of MP4⁴ file type. It is 1280 by 720 pixels in resolution and was recorded at a rate of 23 frames per second in color. It does not include audio.

This video shows a left rear $\frac{3}{4}$ view of the accident aircraft as it impacts the ground. It enters the frame 25 seconds into the provided recording. The aircraft is right wing low and begins to roll level as it impacts the ground nose down. The aircraft becomes obscured by a structure in the final few frames. Overall, the accident aircraft appears in 17 frames until the moment of impact.
