NATIONAL TRANSPORTATION SAFETY BOARD
Vehicle Recorder Division
Washington, DC 20594

Video Study

Specialist's Study By Sean Payne

Location: Santa Monica, California
Date: September 29, 2013 18:20 Pacific daylight time (PDT)
Aircraft: Cessna 525A, N194SJ
Operator: Private
NTSB Number: WPR13FA430

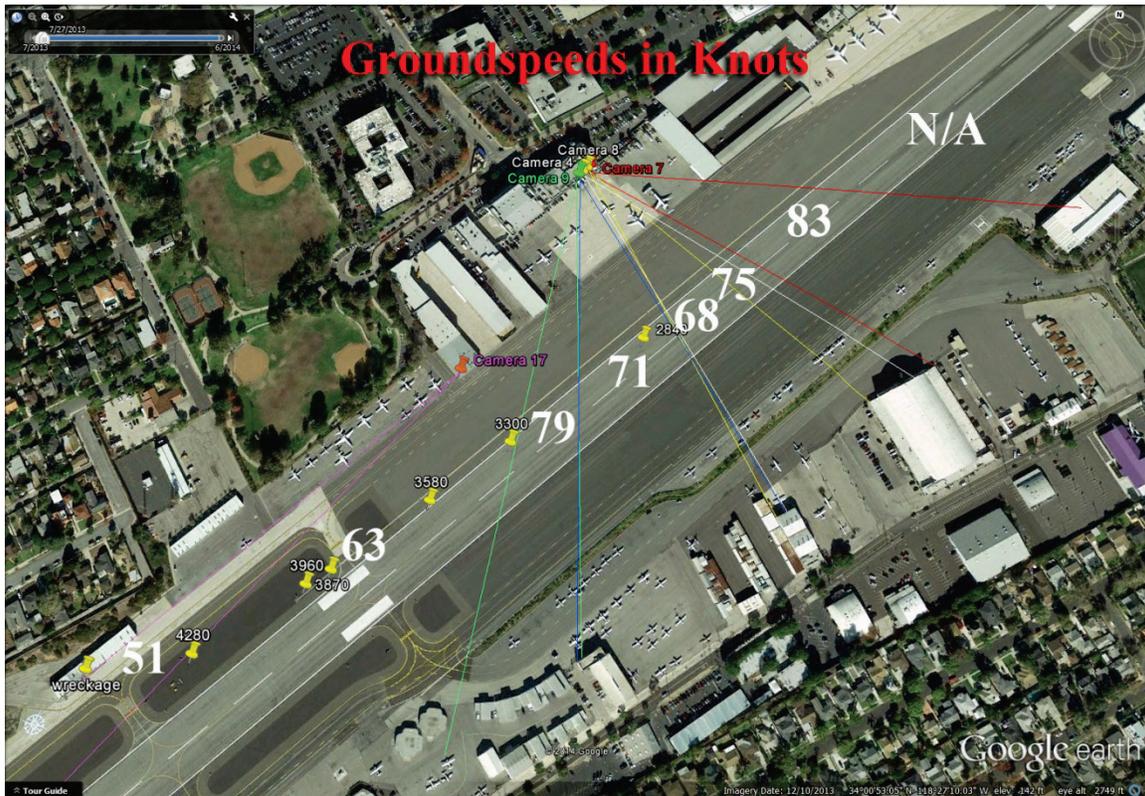
Figure 22. A graphical summary of the distance/position study for all cameras. Speeds are rounded to the nearest knot.

Figure 22 is a graphical representation of average groundspeeds from Table 4.1. It shows the calculated average groundspeed of the accident aircraft as related to its position on Runway 03/21 at KSMO. The values are shown rounded to the nearest knot.

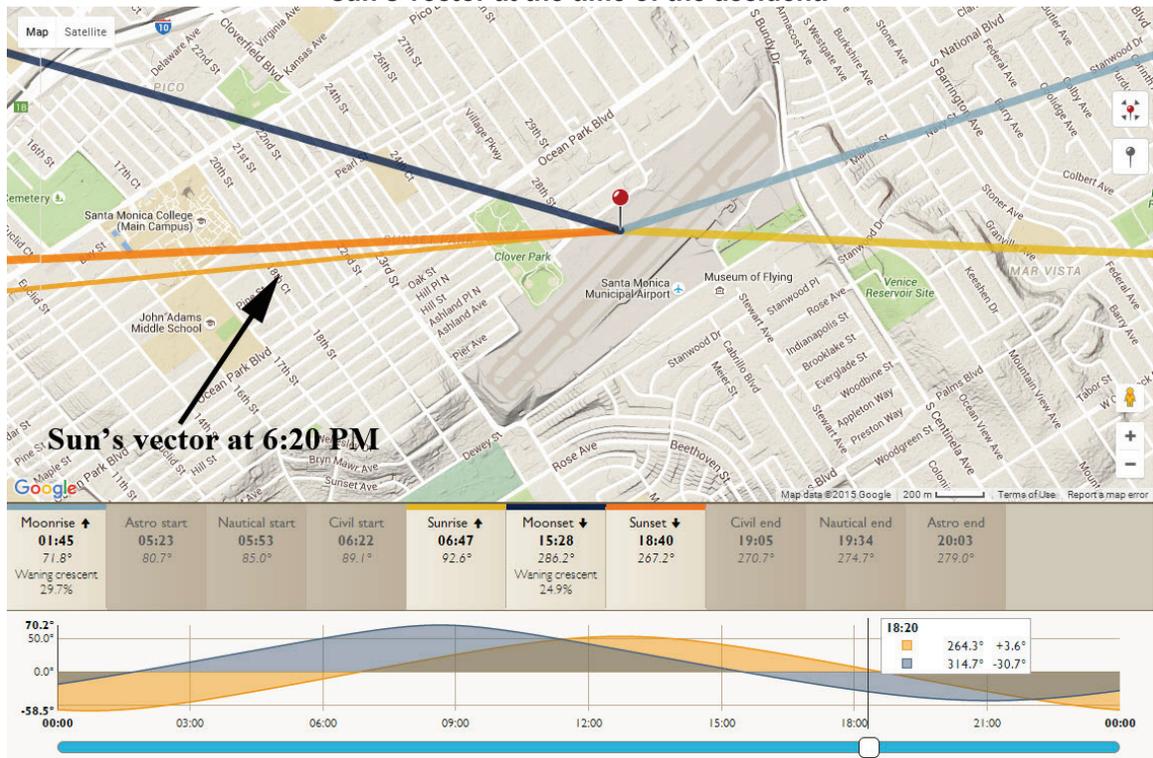
Figure 23. The position of the sun at the time of the accident. The arrow indicates the sun's vector at the time of the accident.

Figure 23 shows the sun's azimuth and altitude in relation to the airport property at the time of the accident, September 29, 2013, at 6:20 PM PDT. The direction of the sun was from an azimuth of 264 degrees with an altitude of +3.6 degrees. The sun's direction was quartering the right front of the accident aircraft, allowing only limited reflection of the aircraft's rear flap surfaces.

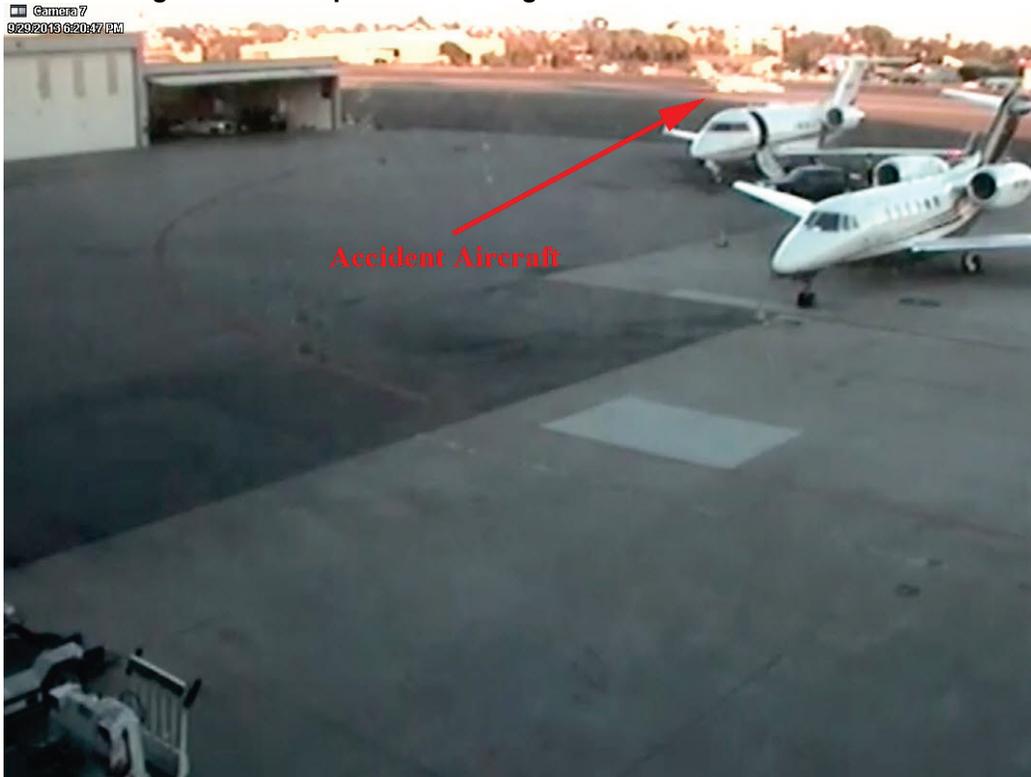
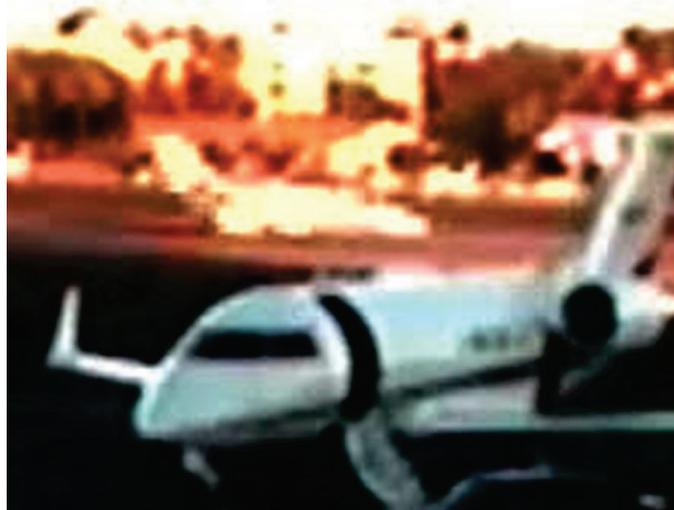
Figure 24. An exported still image from camera 7 at 6:20:47 PM.

Figure 24 is an exported still from 6:20:47 PM. The position of the aircraft's flap position is inconclusive. Figure 25 is the same image, enhanced to attempt to recognize the aircraft's flap position.

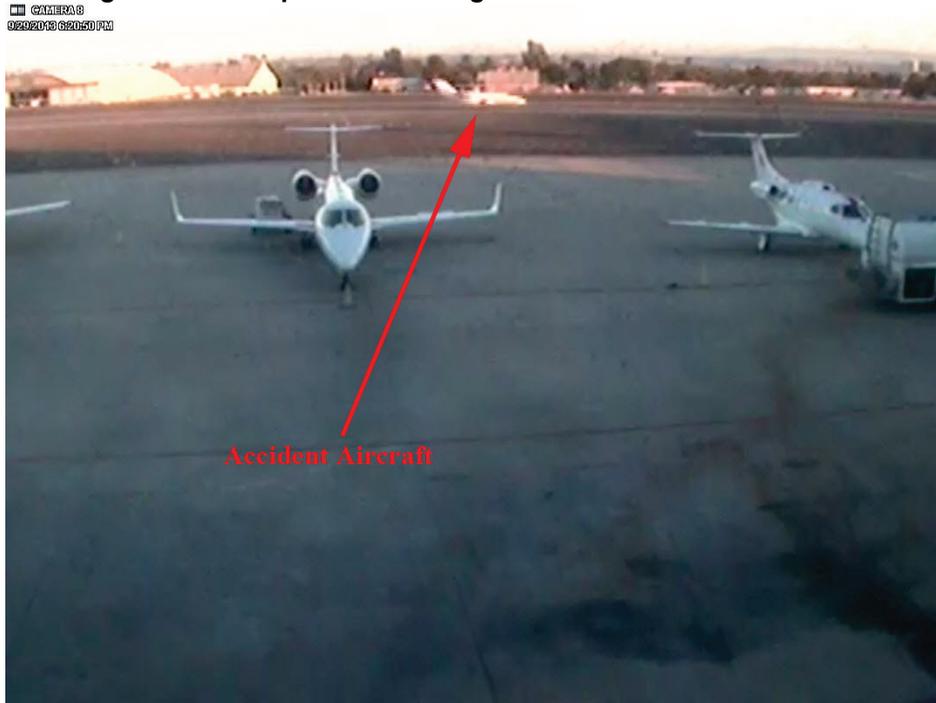
Figure 26. An exported still image from camera 8 at 6:20:50 PM.

Figure 26 is an exported still from 6:20:50 PM. The position of the aircraft's flap position is inconclusive. Figure 27 is the same image, enhanced to attempt to recognize the aircraft's flap position.

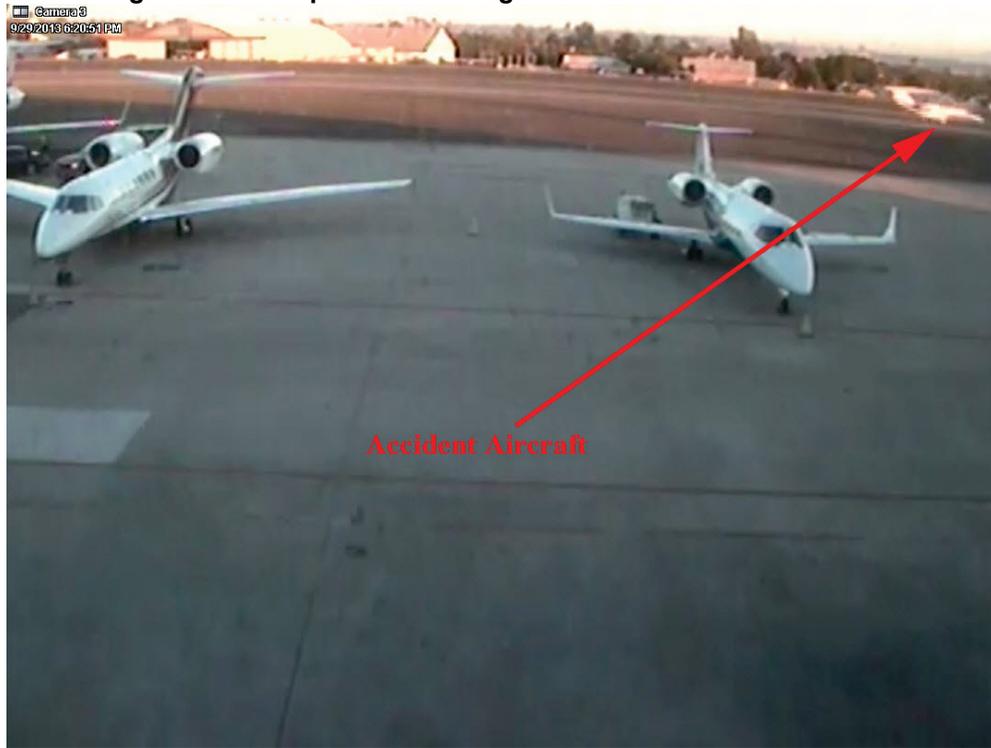
Figure 28. An exported still image from camera 3 at 6:20:51 PM.

Figure 28 is an exported still from 6:20:51 PM. The position of the aircraft's flap position is inconclusive. Figure 29 is the same image, enhanced to attempt to recognize the aircraft's flap position.

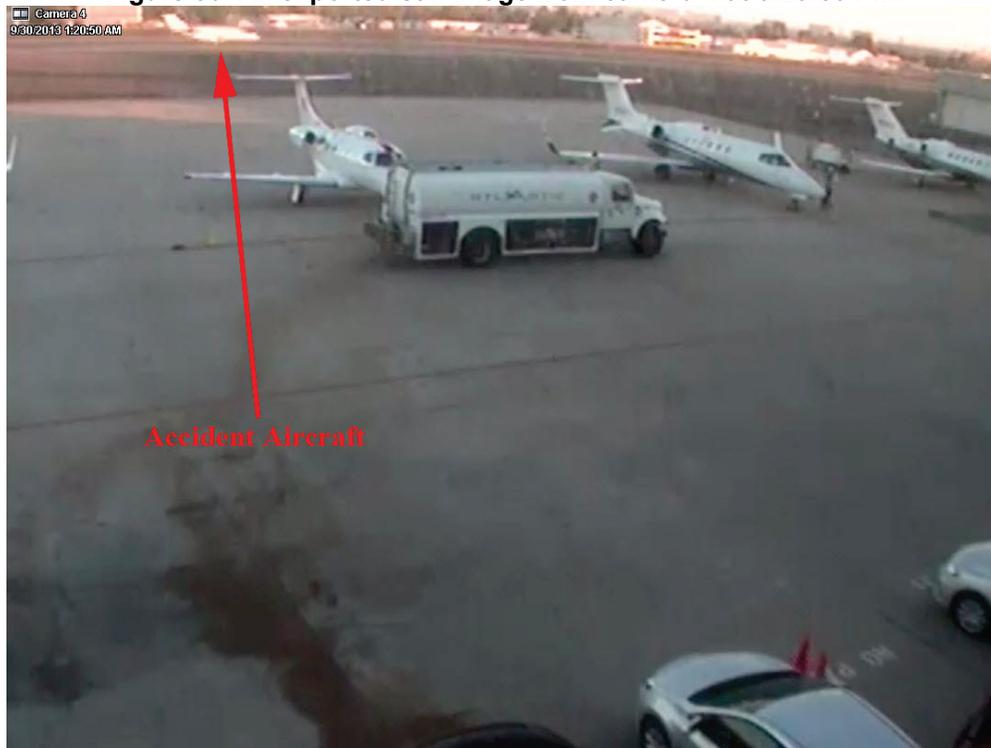
Figure 30. An exported still image from camera 4 at 6:20:50 PM.

Figure 30 is an exported still from 6:20:50 PM. The position of the aircraft's flap position is inconclusive. Figure 31 is the same image, enhanced to attempt to recognize the aircraft's flap position.

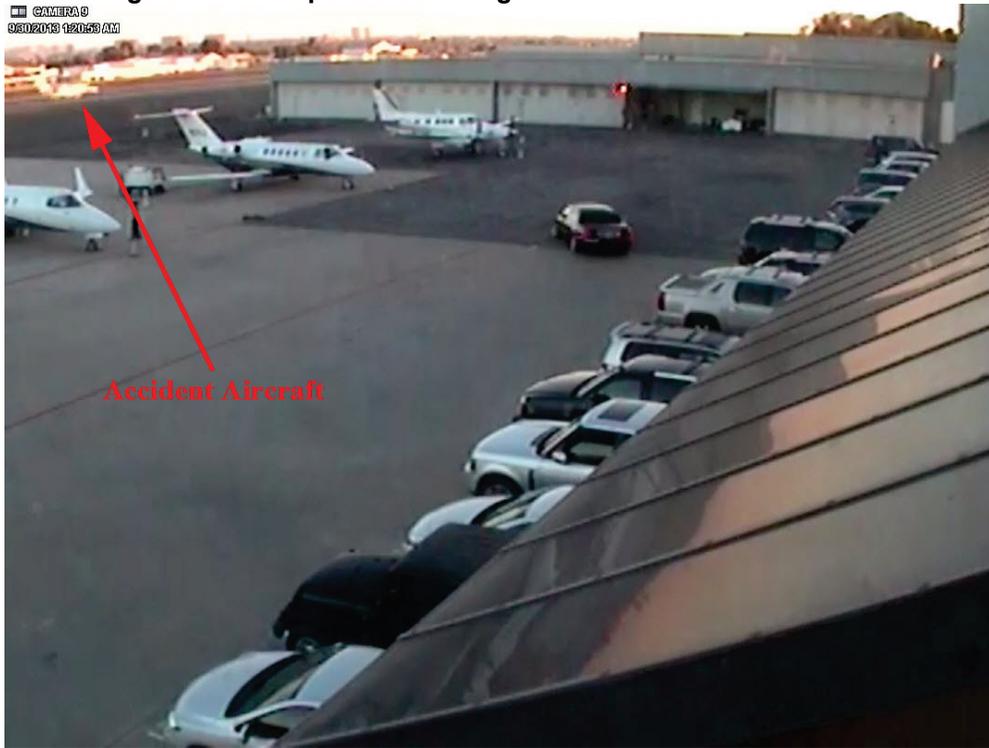
Figure 34. An exported still image from camera 9 at 6:20:53 PM.

Figure 34 is an exported still from 6:20:53 PM. The position of the aircraft's flap position is inconclusive. Figure 35 is the same image, enhanced to attempt to recognize the aircraft's flap position.

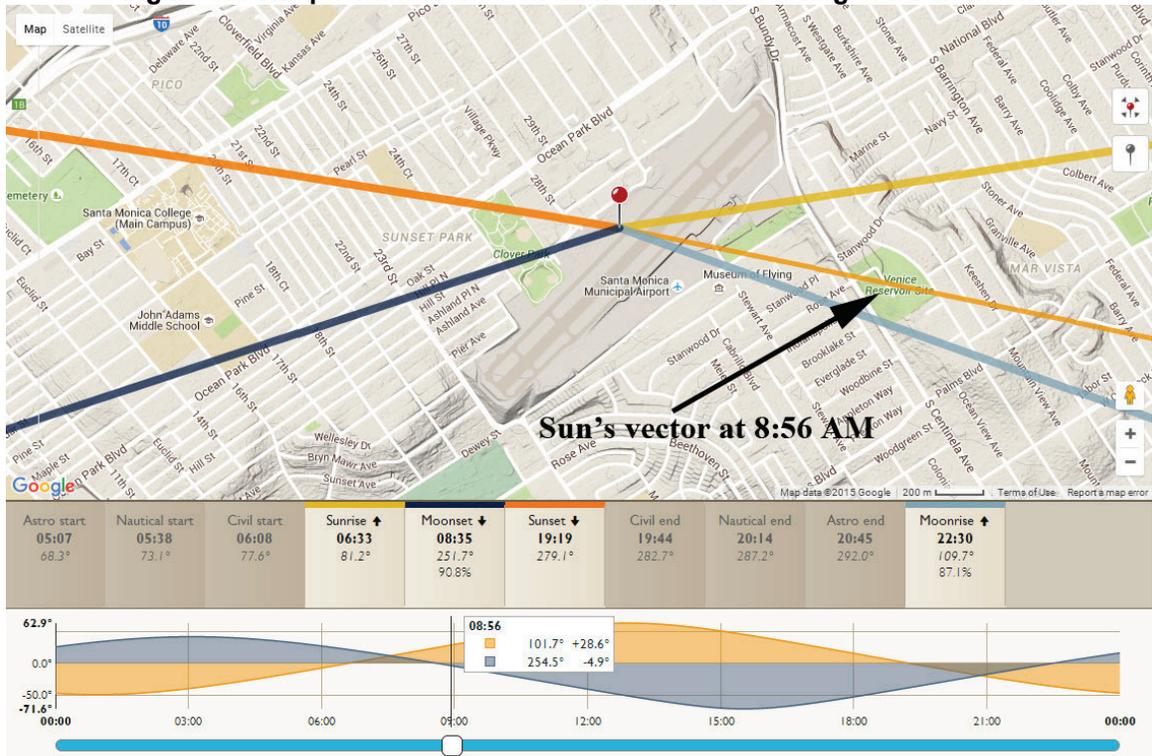
Figure 38. The position of the sun at the time of recording of batch file 1.

Figure 38 shows the sun’s azimuth and altitude in relation to the airport property at the time of the recording of the exemplar batch file on April 7, 2015 at 8:56 AM PDT. The direction of the sun was from an azimuth 101.7 degrees with an altitude of +28.6 degrees. The sun’s direction was quartering the left rear of the exemplar aircraft, allowing some reflection of the aircraft’s rear flap surfaces.

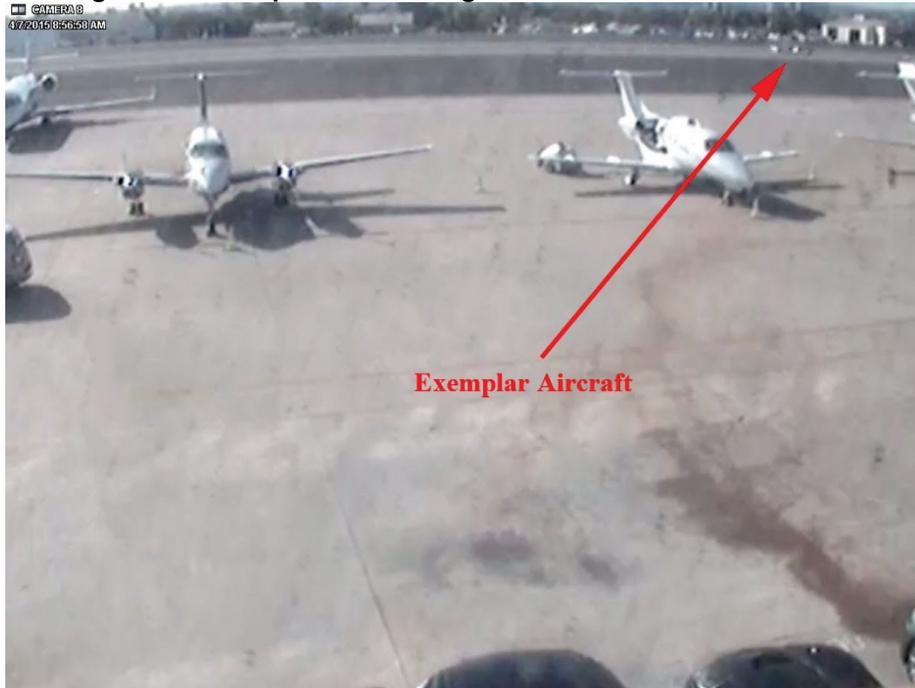
Figure 39. An exported still image from camera 8 at 8:56:58 AM.

Figure 39 is an exported still from camera 8 8:56:58 AM. The position of the aircraft's flap position is in an unknown extended position. Figure 40 is the same image, enhanced to attempt to recognize the aircraft's flap position.

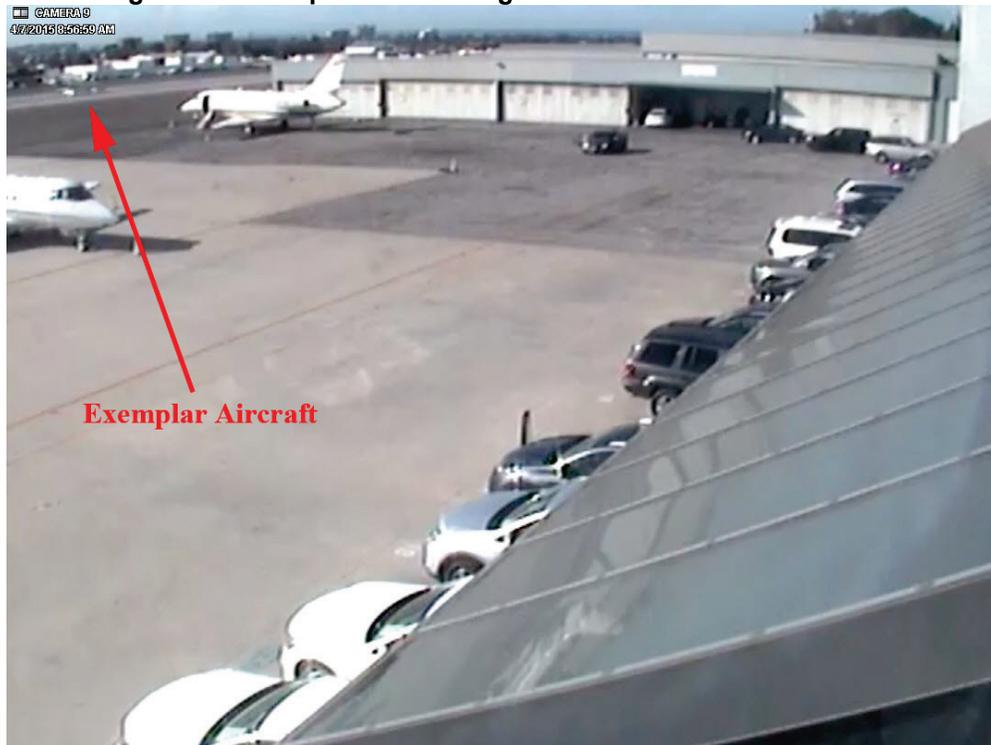
Figure 41. An exported still image from camera 9 at 8:56:59 AM.

Figure 41 is an exported still from camera 9 8:56:59 AM. The position of the aircraft's flap position is in an unknown extended position. Figure 42 is the same image, enhanced to attempt to recognize the aircraft's flap position.

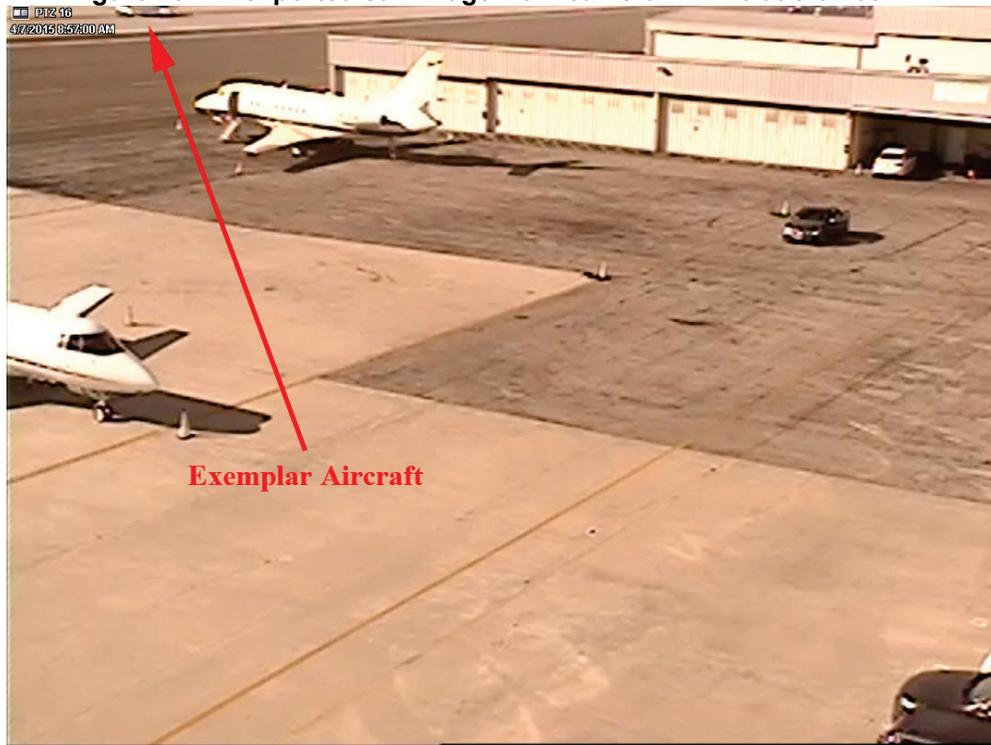
Figure 43. An exported still image from camera PTZ 16 at 8:57:00 AM.

Figure 43 is an exported still from camera PTZ 16 take at 8:57:00 AM. This camera view did not capture the accident sequence on September 29, 2013. The camera at this location shows the flaps of the exemplar aircraft in an unknown extended position. It was captured within two seconds of cameras 8 and 9. Figure 44 is an enhancement of the image in figure 43.

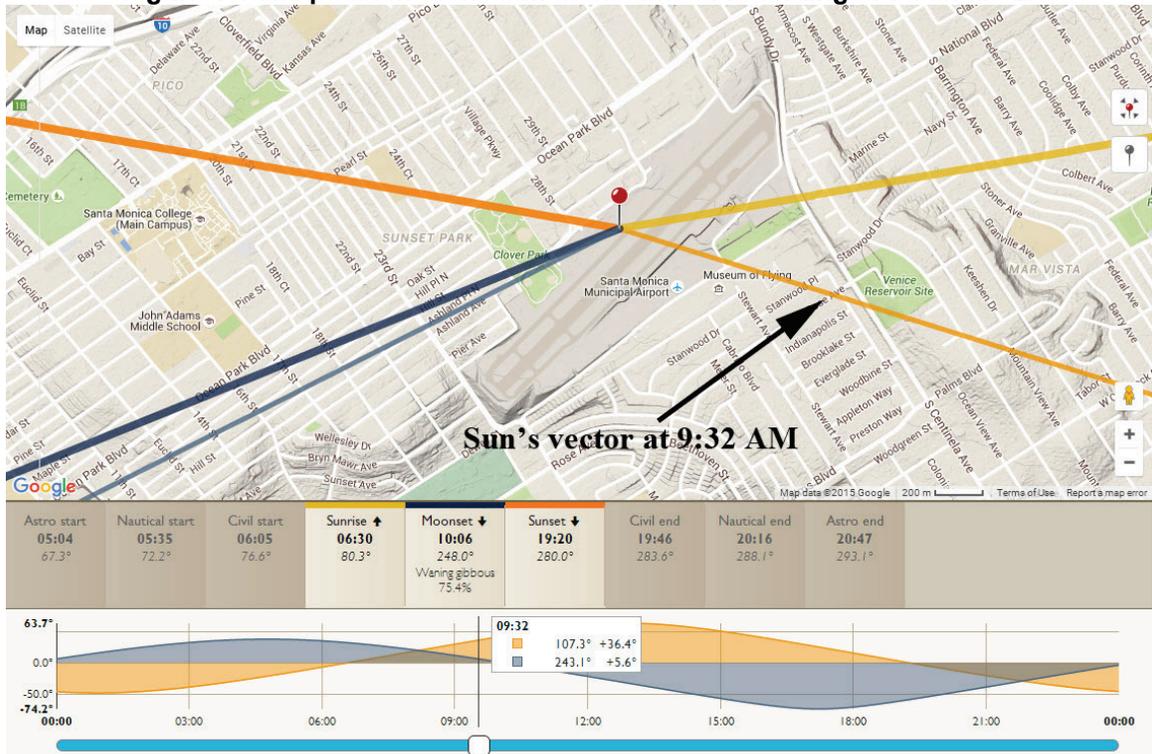
Figure 45. The position of the sun at the time of recording of batch file 2.

Figure 45 shows the sun's azimuth and altitude in relation to the airport property at the time of the recording of the exemplar batch file on April 9, 2015 at 9:32 AM PDT. The direction of the sun was from an azimuth 107.3 degrees with an altitude of +36.4 degrees. The sun's direction was quartering the left rear of the exemplar aircraft, allowing some reflection of the aircraft's rear flap surfaces.

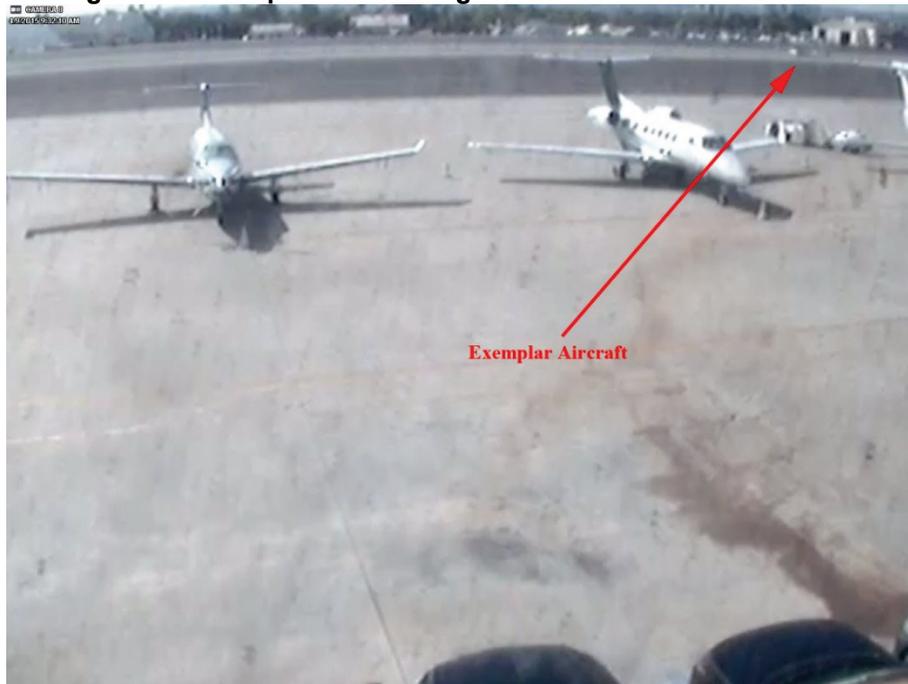
Figure 46. An exported still image from camera 8 at 9:32:10 AM.

Figure 46 is an exported still from camera 8 9:32:10 AM. The position of the aircraft's flap position is in an unknown extended position. Figure 47 is the same image, enhanced to attempt to recognize the aircraft's flap position.

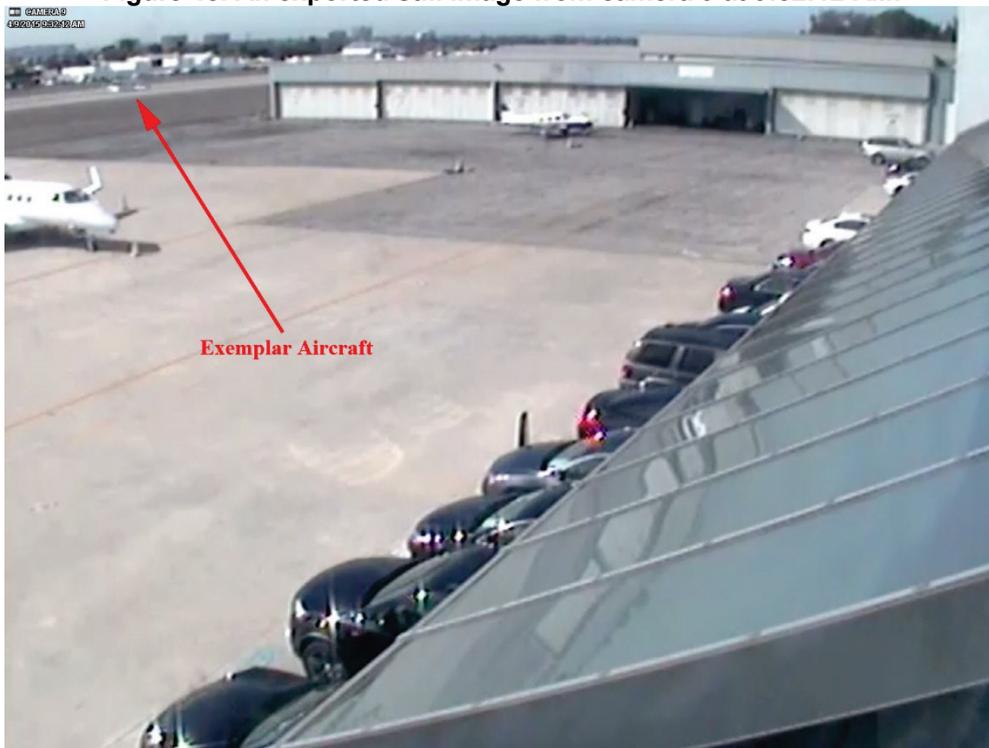
Figure 48. An exported still image from camera 9 at 9:32:12 AM.

Figure 48 is an exported still from camera 9 9:32:12 AM. The position of the aircraft's flap position is in an unknown extended position. Figure 49 is the same image, enhanced to attempt to recognize the aircraft's flap position.

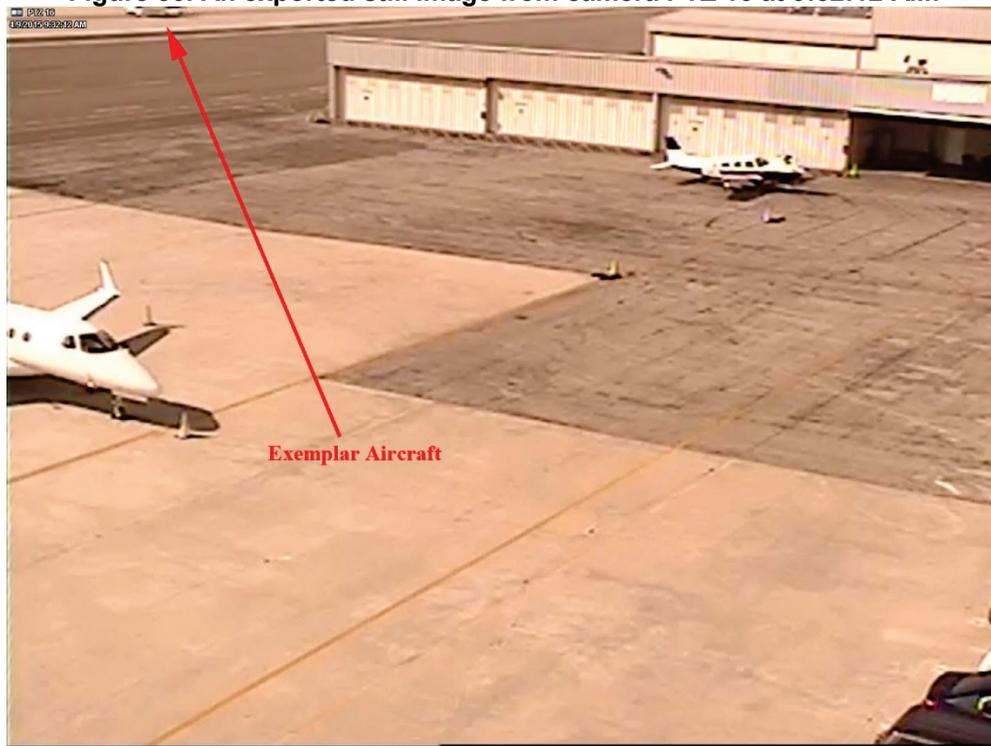
Figure 50. An exported still image from camera PTZ 16 at 9:32:12 AM.

Figure 50 is an exported still from camera PTZ 16 taken at 9:32:12 AM. This camera view did not capture the accident sequence on September 29, 2013.

The camera at this location shows the flaps of the exemplar aircraft in an unknown extended position. It was captured within two seconds of cameras 8 and at approximately the same moment as camera 9. Figure 51 is an enhancement of the image in figure 50.

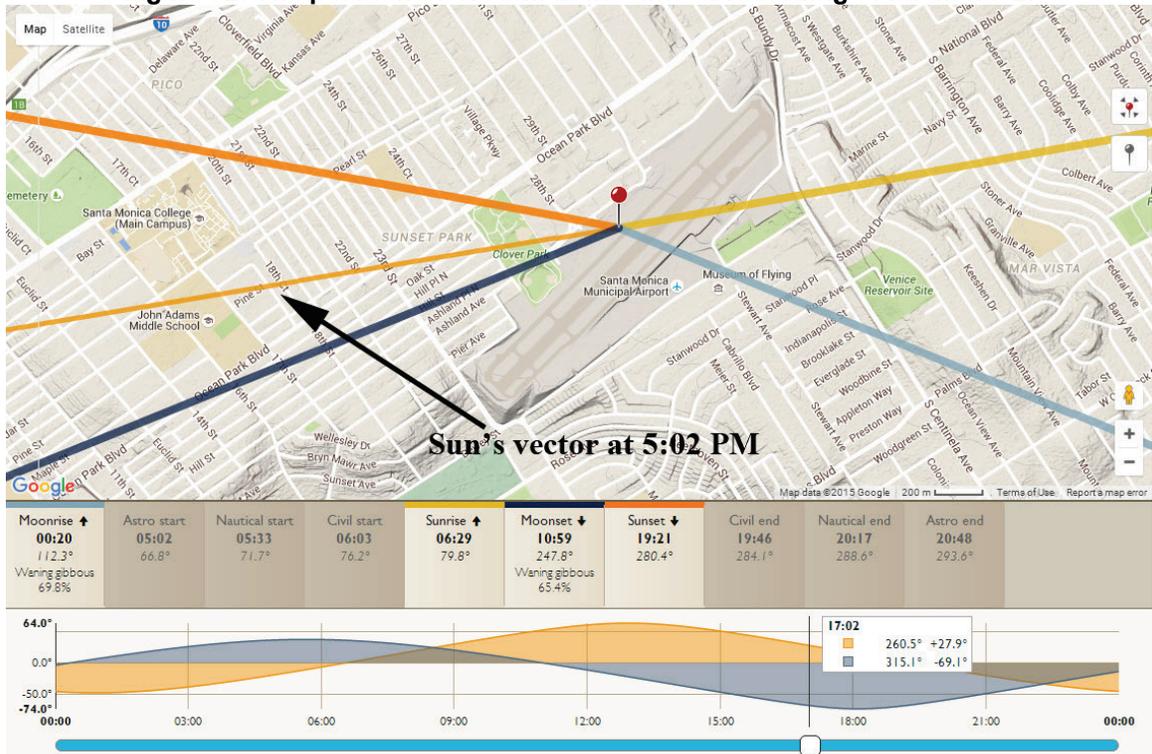
Figure 52. The position of the sun at the time of recording of batch file 2.

Figure 52 shows the sun's azimuth and altitude in relation to the airport property at the time of the recording of the exemplar batch file on April 10, 2015, at 5:02 PM PDT. The direction of the sun was from an azimuth of 260.5 degrees with an altitude of +27.9 degrees. The sun's direction was quartering the left rear of the exemplar aircraft, allowing some reflection of the aircraft's rear flap surfaces.

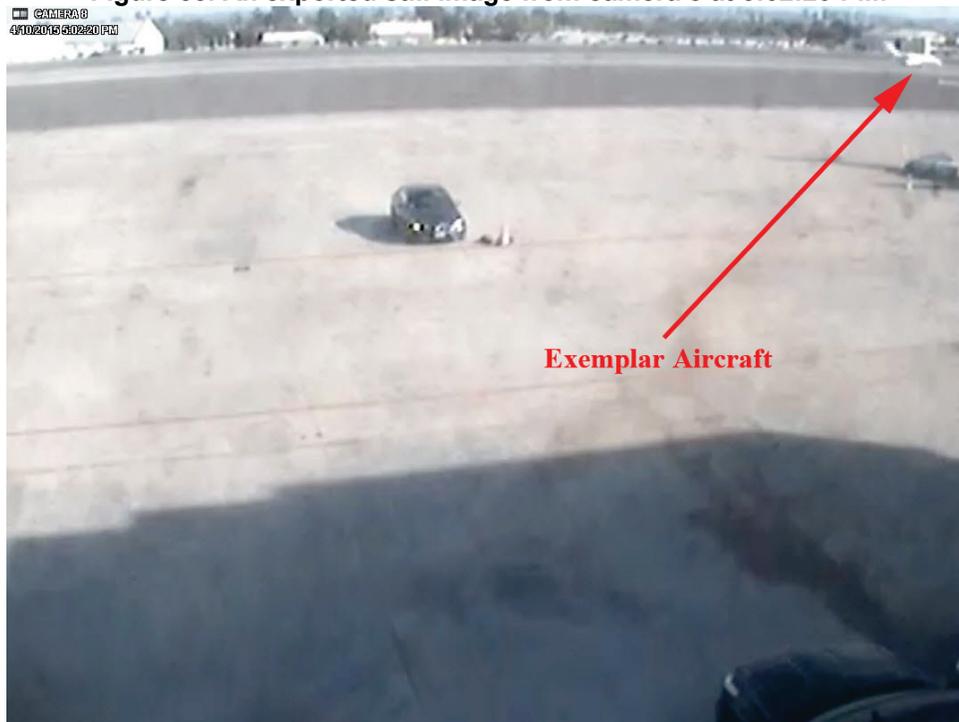
Figure 53. An exported still image from camera 8 at 5:02:20 PM.

Figure 53 is an exported still from camera 8 5:02:20 PM. The position of the aircraft's flaps are inconclusive. Figure 54 is the same image, enhanced to attempt to recognize the aircraft's flap position.

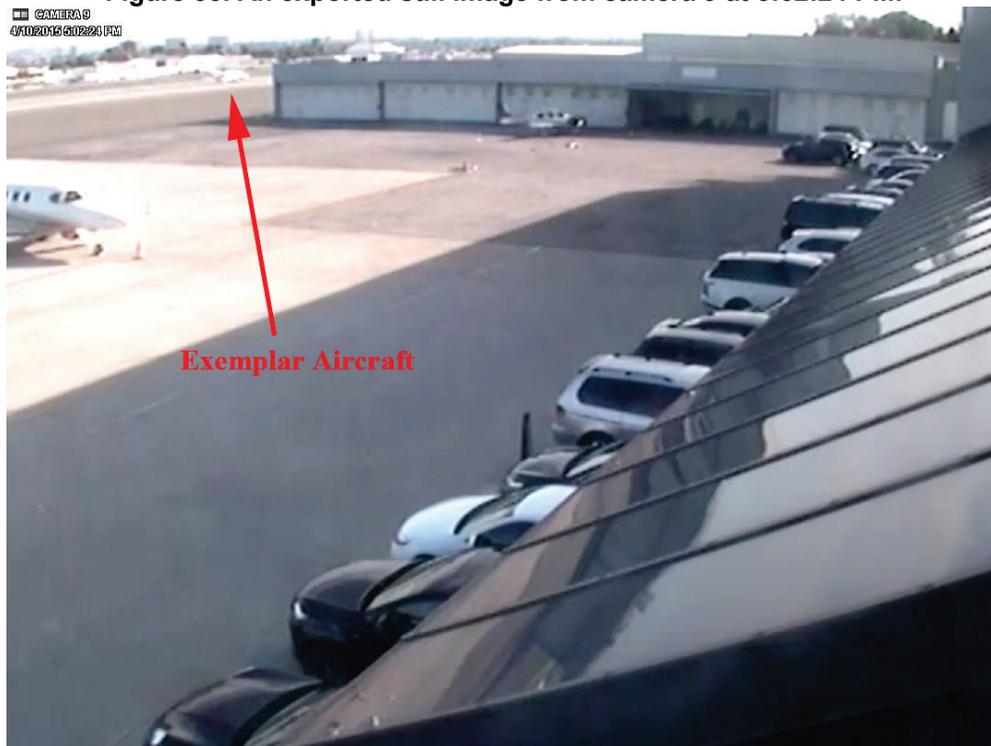
Figure 55. An exported still image from camera 9 at 5:02:24 PM.

Figure 55 is an exported still from camera 9 5:02:24 PM. The position of the aircraft's flaps are inconclusive. Figure 56 is the same image, enhanced to attempt to recognize the aircraft's flap position.
