**NATIONAL TRANSPORTATION SAFETY BOARD**  
Office of Research and Engineering  
Washington, D.C. 20594

## **Video Study**

**NTSB Case Number:  
HWY18FH013**

Location: Fort Lauderdale, Florida  
Date: May 8, 2018  
Time: 6:46 p.m. EDT  
Vehicle: Tesla Model S

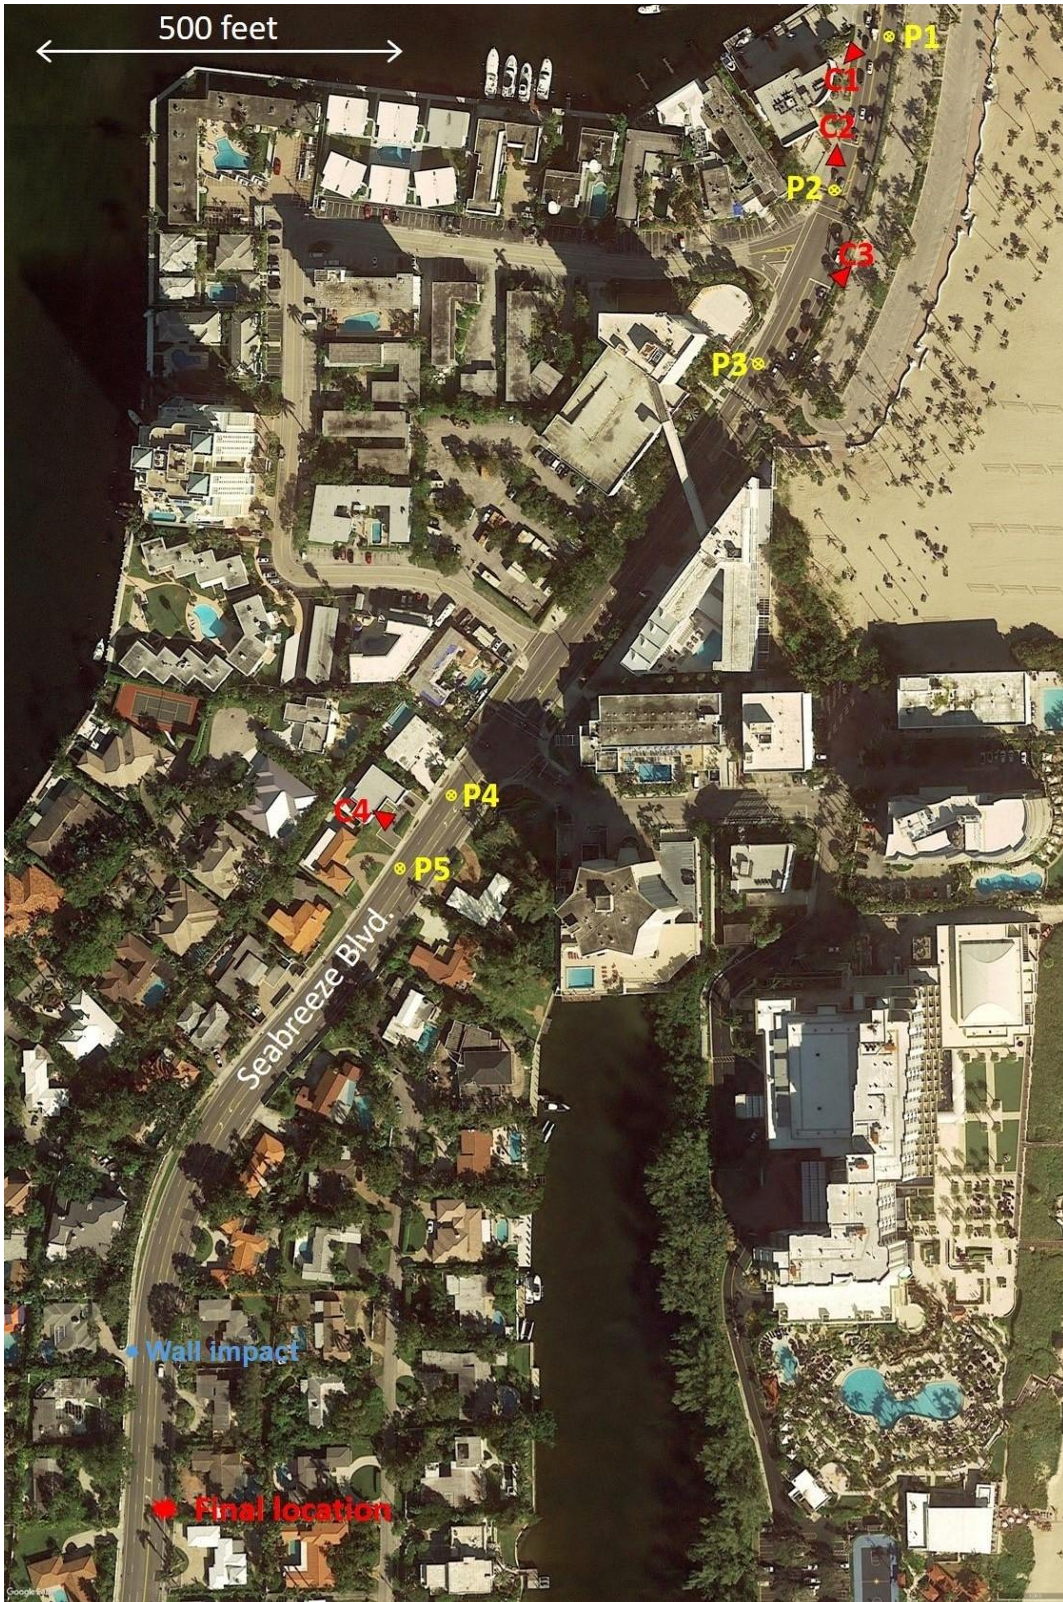
Figure 1. Aerial Map of the Accident Area

Figure 1 shows an aerial map of the accident area with marked locations related to the analysis of the videos. The traffic cameras are labeled C1, C2 and C3. The red triangles indicate the orientations of the cameras. Camera C1 was aimed at traffic moving south. Cameras C2 and C3 were aimed at traffic moving north. The accident vehicle was moving south on Seabreeze Boulevard. The line of sight of security camera C4 was approximately perpendicular to Seabreeze Boulevard.

There are five reference locations, P1, P2, P3, P4 and P5, marked in Figure 1. Camera C1 was used to estimate the speed of the accident vehicle as it was approaching from the north. It was estimated over a 280-foot-long road segment that ended at P1. The estimated average speed over that segment was  $48\pm 1$  mph. The accident vehicle was moving behind a white car that was moving at the same speed.
