The information in this report is preliminary and may be supplemented or corrected.

On July 18, 2013, CSX train no. Q704-19, consisting of two locomotives and 24 loaded flat cars carrying municipal waste, derailed at milepost 9.99 on Metro-North's Hudson Division in the Bronx New York while traveling northbound towards Spuyten Duyvil station, Figure 1.

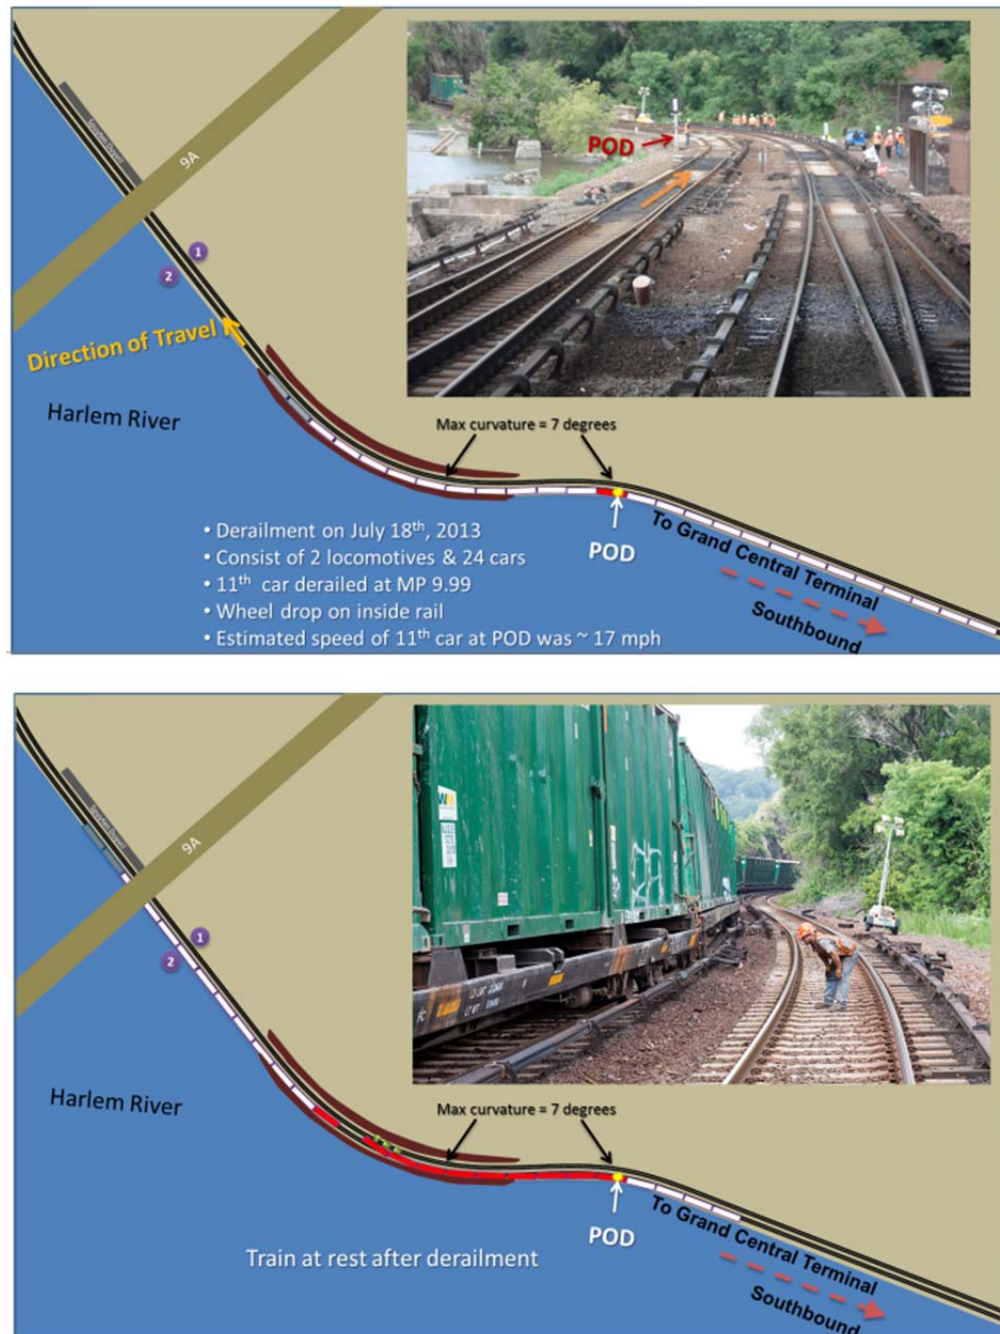
Figure 1: Sketch of derailment area: (1a, top) initial position of train no. Q704-19 when 11th car derailed; and, (1b, bottom) final position of train no. Q704-19 at rest following derailment, cars 11 – 20 derailed.

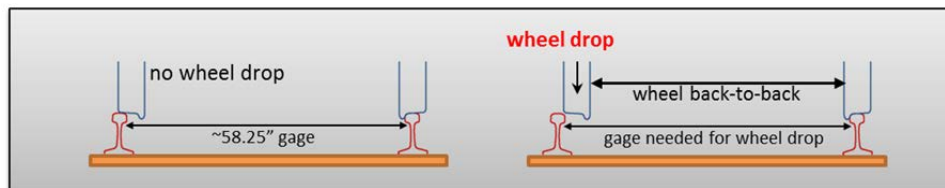
As shown in Figure 4, the minimum gage needed to have a wide-gage wheel-drop derailment is a function of the wheel thickness, the wheel back-to-back spacing, and the flange thickness. For a wheel thickness of $5 \frac{23}{32}$ inches (the standard dimension of a wide flange wheel), a wheel back-to-back spacing of $53 \frac{1}{16}$ inches (the average measured back-to-back), and a flange thickness of $1 \frac{1}{4}$ inches (the average measured flange thickness), a gage of approximately 60 inches is needed for wheel drop. As wheels wear to a thinner flange, wheel-drop can also occur with smaller gage.

Figure 4: Amount of gage needed for wide-gage wheel-drop derailment is a function of wheel thickness, wheel back-to-back spacing, and flange thickness.

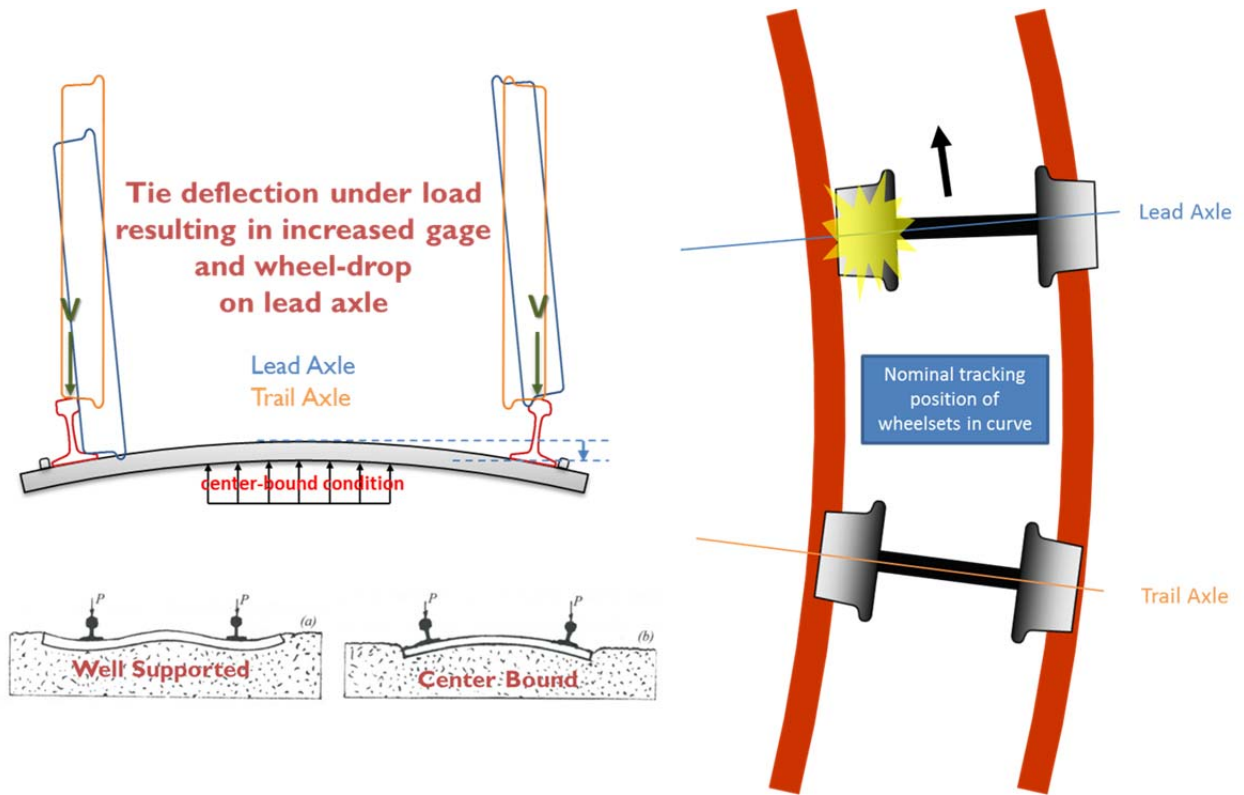
The mechanism of gage widening is usually gradual and relatively slow depending on the overall track condition. Crosstie damage and ballast deterioration is likely to have increased (rapidly) with accumulated tonnage and time in the fouled ballast zone found at the derailment site, eventually to the point that 41 kips became sufficient to result in catastrophic failure of the most-severely-damaged-center-bound-supported concrete crossties, Table 2. As described in greater detail later in the Track Condition section below, three crossties retrieved from the track at the POD were found to have failed catastrophically (two of them possibly just prior to the derailment) while many other crossties on both sides of the POD were damaged with center cracks and abrasion on the bottom. The combination of 3 catastrophically failed crossties and multiple damaged crossties were likely sufficient to result in a loaded gage of 60 inches and create the previously mentioned wide-gage scenario in which the rails momentarily spread apart just enough for a wheel-drop derailment of the flanging lead axle of car 11, but not enough for a wheel-drop of the centered trail axle of car 11, Figure 6.

Figure 6: Schematic showing flexing of center-bound supported crosstie deflection under load resulting in increased gage and wheel-drop on the lead axle.

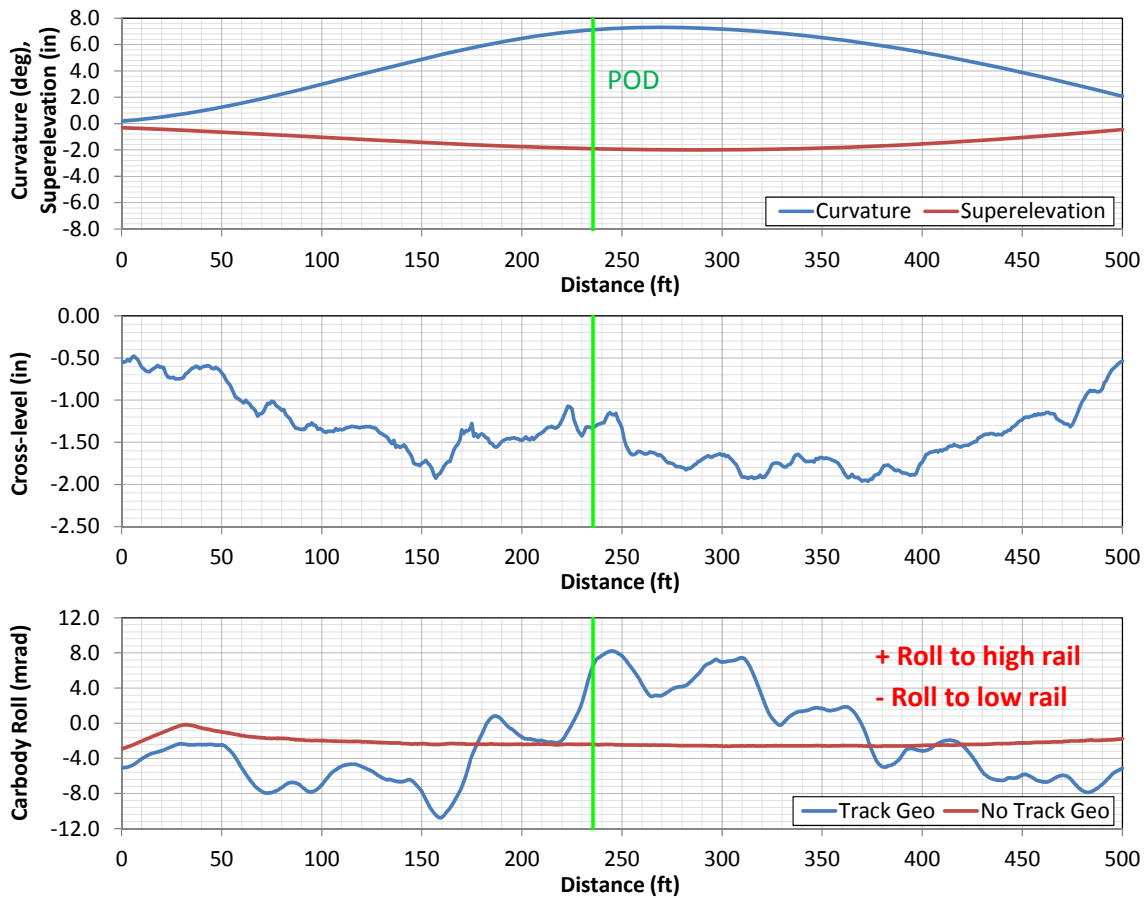
As an indicator of model validation, the motion of the carbody predicted in the simulation was compared to carbody motion that was recorded from a locomotive-mounted camera. Figure 7 shows the carbody roll motion through the derailment zone. Prior to the POD the carbody was leaning slightly towards the low-rail when it suddenly rolls towards the high-rail in a short period of time at the POD in response to the track geometry deviations. A similar carbody motion was observed in the video recorded from a locomotive-mounted camera. This roll motion towards the high-rail near the POD corresponds to the location of maximum dynamic vertical load shown in Figure 5.

Figure 7: Predicted carbody roll in derailment curve for baseline case defined by a car weight of 280 kips and center of gravity of 93 inches: comparison of simulations with and without measured track geometry deviations.

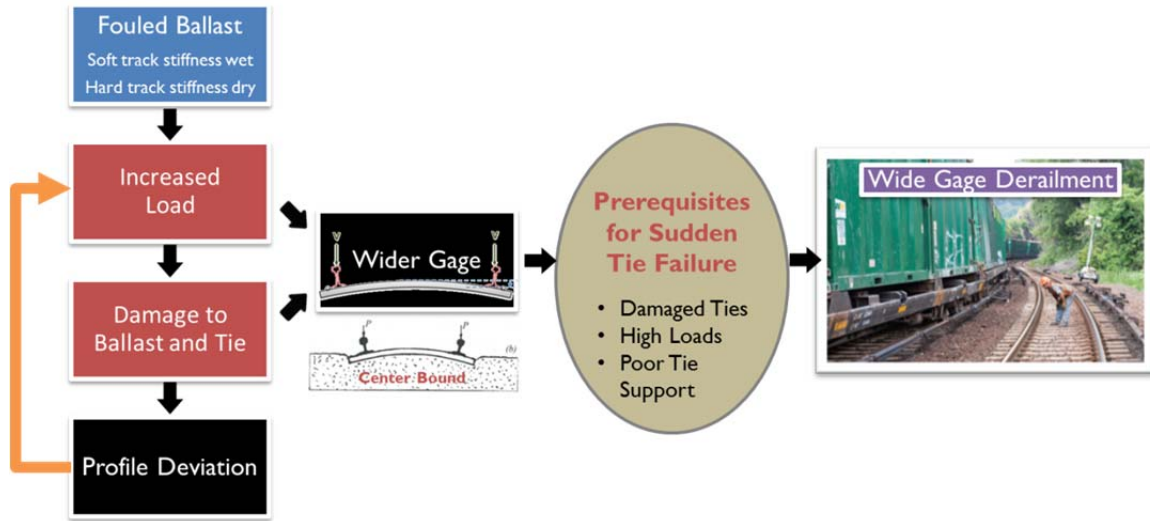
While these conditions can occur anywhere, they are more likely to exist together in a fouled ballast track section. In fouled ballast, increased dynamic vertical wheel loads exist due to profile variations, track stiffness variations, or both, Figure 8. The repetitive application of dynamic vertical wheel loads incrementally and permanently damage crossties and ballast. The appearance of pulverized, compacted, or missing ballast that develops gaps at the interface between the ballast and crossties underneath the rail seats eventually evolves into a center-bound crosstie support condition. As crosstie damage develops (i.e. development of center cracks and reduced cross-section), gage is incrementally and permanently widened from its initial position, Figure 9. Hence, gage variations are an indication of the amount of crosstie damage. If the reduction in crosstie cross-section is uneven and larger on the tie ends due to the dynamic up-and-down pumping action of the crosstie-ends, then gaps at the interface between the ballast and crossties underneath the rail seats may further increase, thus worsening the crosstie support condition.

Figure 8: Wide-gage wheel-drop derailment scenario resulting from progressive deterioration and sudden cross-tie failure.

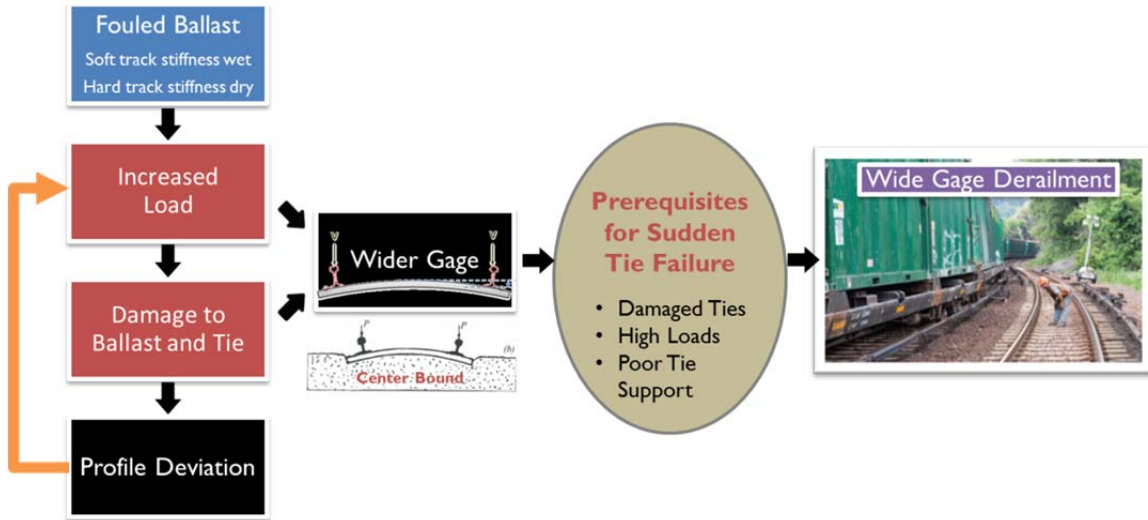
Figure 15: Wide-gage wheel-drop derailment scenario resulting from progressive deterioration and sudden crosstie failure.

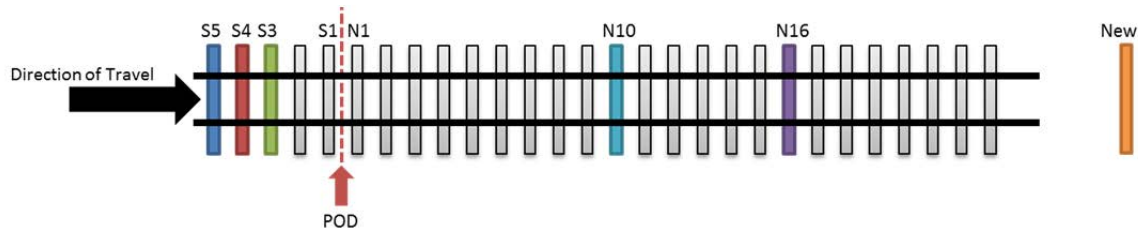
Testing⁷ was conducted using one new concrete crosstie and five used (damaged) concrete crossties retrieved near the POD to characterize the deflection behavior of the Metro-North crossties⁸ under load. The five damaged included crossties leading to the POD (namely, S3, S4, and S5) and crossties located some distance after the POD (namely, N10 and N16) – crossties were numbered incrementally north and south from POD, Figure 17. Because the three crossties nearest the POD were already broken (N1, S1, and S2), testing of those crossties was not possible.

Figure 17: Numbering convention of concrete crossties in derailment curve.

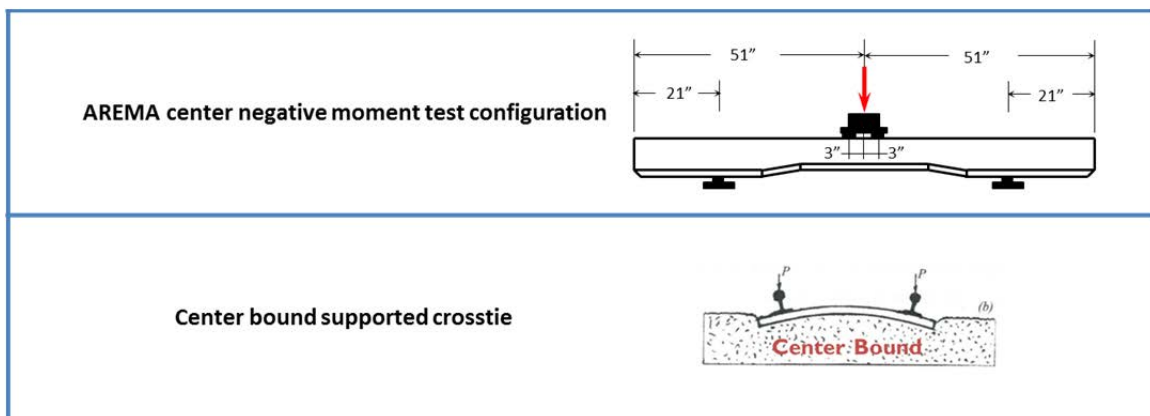
AREMA center negative moment tests⁹ were conducted on the selected concrete crossties. In order to evaluate their ultimate center negative moment capacities, loads were increased until the crossties failed catastrophically. Although the crossties were tested upside down with their rail seats resting on two rubber supports, the AREMA tie center negative moment test configuration bends the tie in a similar manner to the center-bound ballast support condition, Figure 18. However, because the AREMA configuration represents a more severe support condition than that found in-service with ballast, it results in a lower load to failure than would be seen when supported by ballast in the field.

Figure 18: Comparison between AREMA tie center negative moment test configuration and a center-bound supported crosstie.

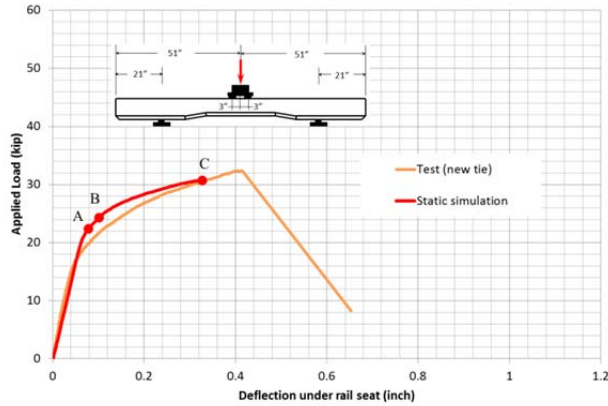
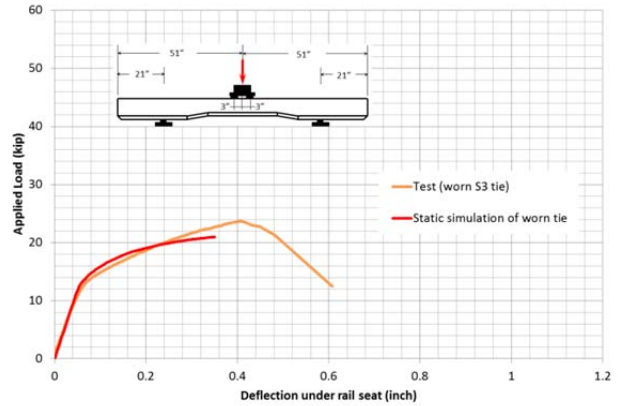
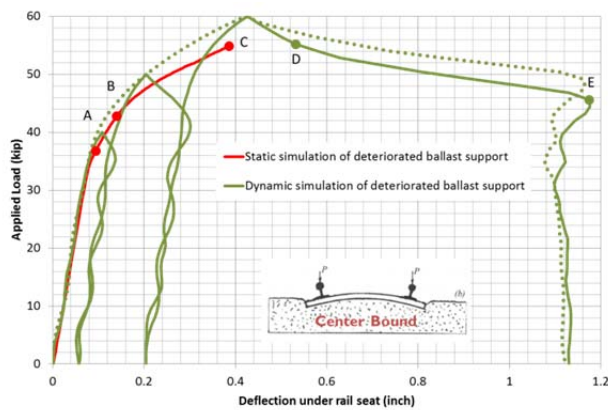
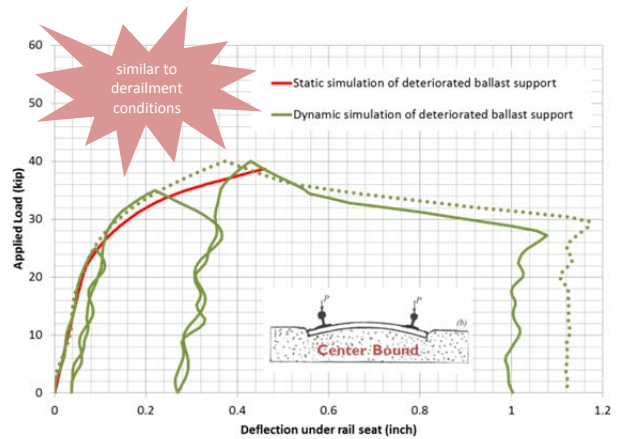
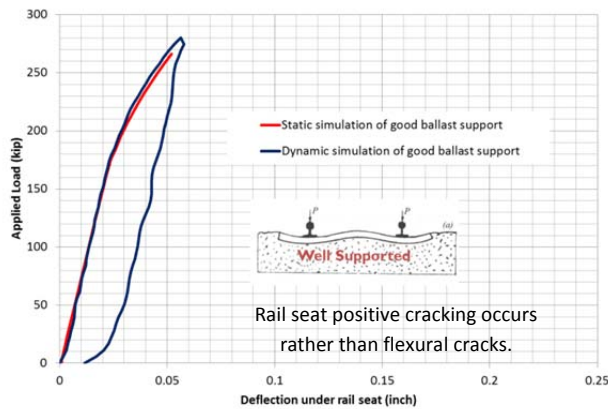
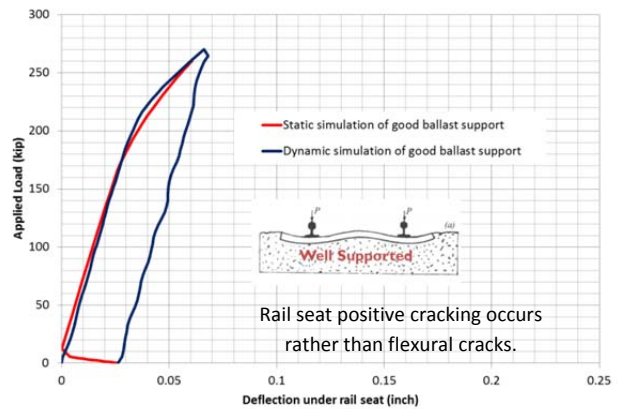
Figure 20 shows the measured load-deflection for each of the tested crossties. After the initial linear response around 0.05 inch mid-span deflection, flexural cracks develop. The peak load in each curve at around 0.4 inch mid-span deflection corresponds to sudden, catastrophic failure of the crosstie (i.e. shear failure or ultimate failure of the crosstie). The ultimate failure load is higher for the new crosstie, approximately 32.3 kips, as might be expected. Crossties S3 and S4 (which were the closest to the POD and most representative of crossties N1, S1, and S2 in terms of reduced cross-section) exhibited the lowest ultimate failure loads, crosstie S3 being the lowest – approximately 23.5 kips.

While testing demonstrated the crossties behavior under the extreme 3-point bending AREMA center negative test configuration, finite element (FE) analyses were conducted using one model representing a new crosstie and one model representing damaged crosstie S3 to predict the behavior of Metro-North concrete crossties under different load and support conditions. In this case, the damaged crosstie model is the same as the new crosstie model with 1 inch of concrete material removed from the tie bottom across the entire tie length – the exact geometry of the damaged crosstie was not used. Figure 21 shows the load-deflection behavior for 3 support conditions – namely, (1) an AREMA center negative supported crosstie, (2) a symmetric center-bound supported crosstie, and (3) a well-supported crosstie. Deflection on the horizontal axes is expressed as “deflection under rail seat” which is indicated by the blue arrow in the schematic in Figure 21(a). This is equivalent to the “mid-span deflection used in Figure 20. In Figures 21(a) and 21(b), the AREMA static simulations are compared to test results as an indicator of model validity. While the goal was to load the crossties to complete failure in the analyses, because the

ultimate failure of concrete crossties is often sudden and catastrophic, it is very difficult for a static simulation to capture the behavior near around the peak. The simulation curves agree reasonably well with the test curves, though they stop at lower deflections and slightly lower peak loads than the test curves. Simplified modeling of the concrete-reinforcement interface may explain the discrepancies.

Figure 21: Measured and predicted load-deflection behavior of Metro-North concrete crossties under different load and support conditions.

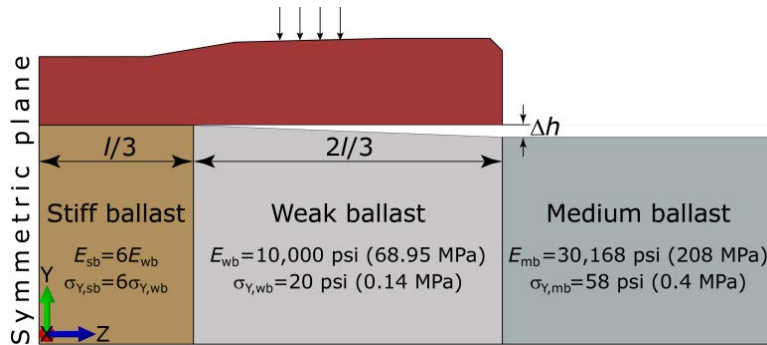
Figure 22 shows the model of deteriorated ballast support used in the analyses shown in Figures 21(c) and 21(d) above for representing the center-bound support condition found at derailment location. The gap at the interface between the ballast and crossties near the crosstie ends, Δh , are intended to represent the combination of missing/pulverized ballast and uneven wear on the crosstie bottom near the crosstie ends. A gap of 2 inches was used to represent these combined conditions.

Figure 22: Model of deteriorated ballast support representing center-bound support condition found at derailment location, cases Figure 21(c) and 21(d).

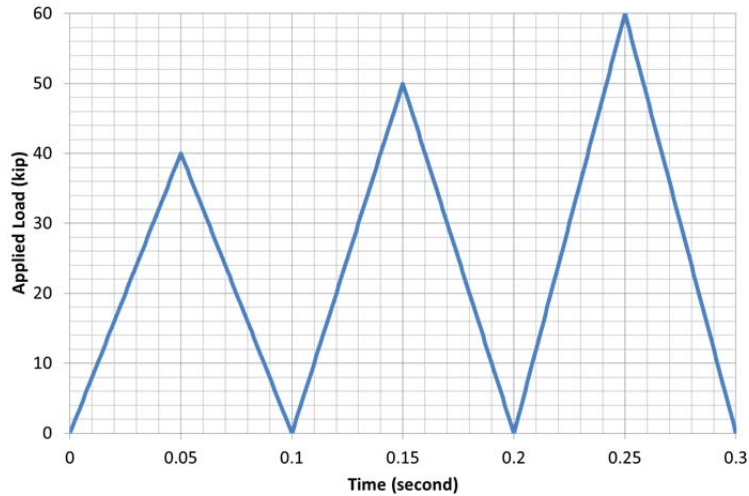
While the loads in the AREMA center negative support condition cases are applied statically, the cases involving the center-bound support conditions were conducted using both a statically applied load and a dynamically applied load to better represent the type of loading that may be experienced in the field. Figure 23 shows the time history of dynamic load applied the analysis above with the new crosstie and center-bound support condition, case Figure 21(c). A similar, but lower magnitude time history is applied in the analysis above with the damaged crosstie S3 and center-bound support condition, case Figure 21(d).

Figure 23: Time history of dynamic load applied the case with the new crosstie and center-bound support condition, case Figure 21(c).

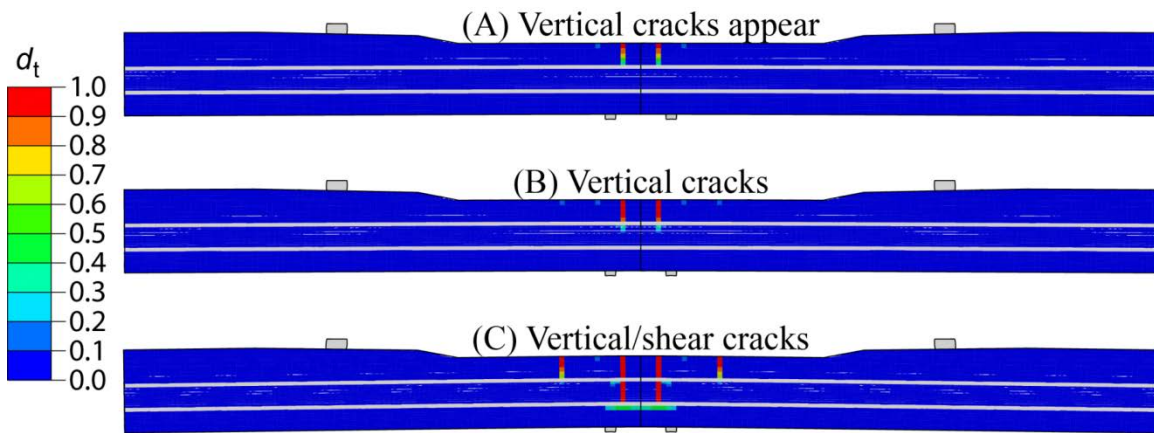
Figure 24 shows three stages of cracking in the static load analysis above with the new crosstie and the AREMA center negative test support condition, case Figure 21(a).

Figure 24: Three stages of cracking in the static load analysis with the new crosstie and the AREMA center negative test support condition, case Figure 21(a).

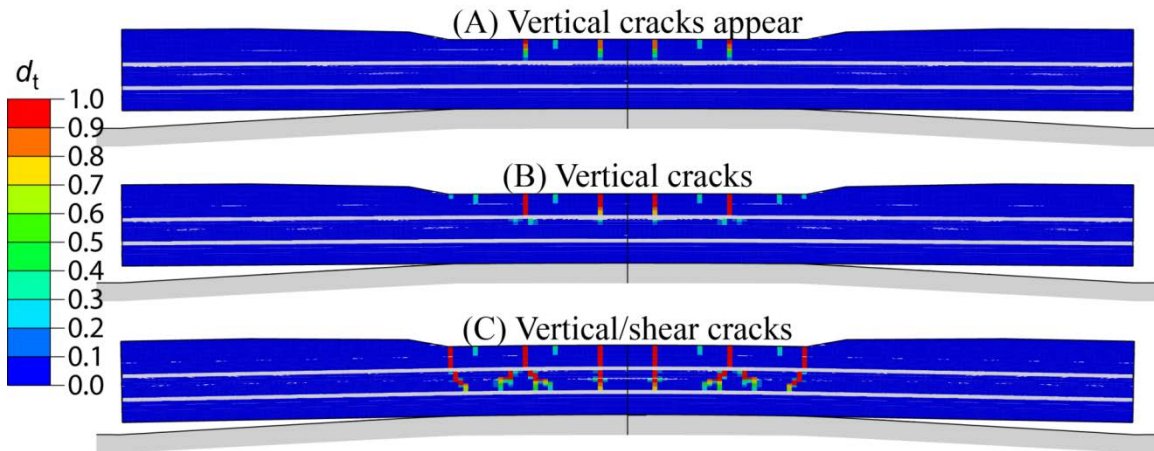
Figure 25 shows three stages of cracking in the static load analysis above with the new crosstie and the center-bound support condition, case Figure 21(c).

Figure 25: Three stages of cracking in the static load analysis with the new crosstie and the simulated center-bound support condition, case Figure 21(c).

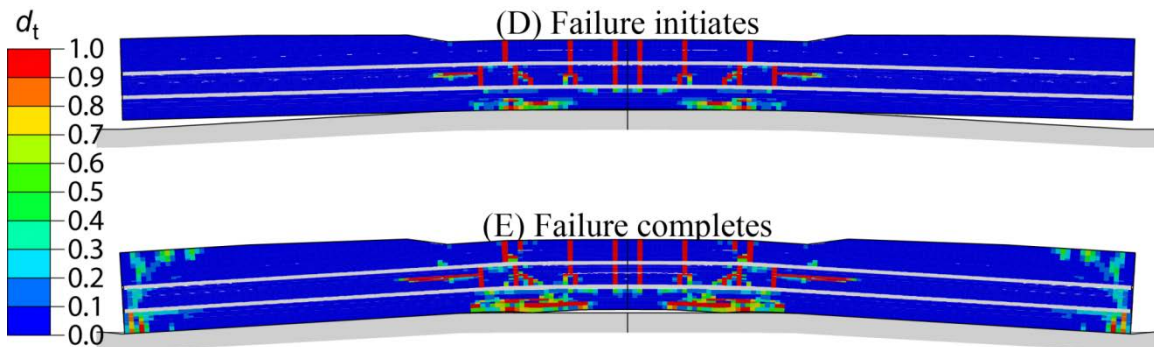
Figure 26 shows three stages of sudden catastrophic failure in the dynamic load analysis with the new crosstie and the simulated center-bound support, case Figure 21(c).

Figure 26: Stages of sudden catastrophic failure in the dynamic load analysis with the new crosstie and the simulated center-bound support, case Figure 21(c).

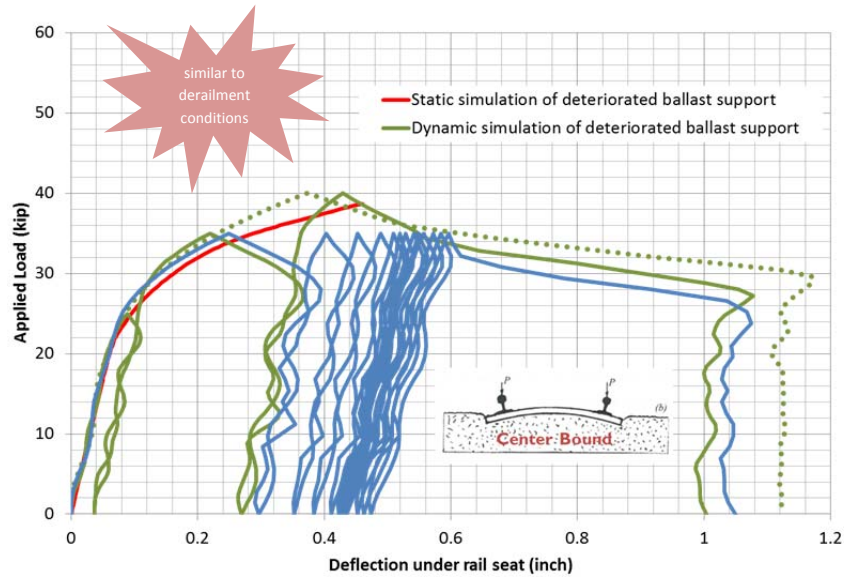
The FE analyses described above investigated the effects of loading and support conditions on ultimate tie failure. The results are meant to provide an estimate of failure loads under different conditions. Further on going work is being conducted to examine the effect of other ballast and loading assumptions on ultimate crosstie failure load. For example, Figure 27 shows results for the damaged crosstie S3 and the simulated center-bound support, same as case Figure 21(b), including cyclic 35 kip dynamic load case. Under these circumstances ultimate crosstie failure may happen at a lower load.

Figure 27: Load-deflection behavior for the damaged crosstie S3 and the simulated center-bound support, same as case Figure 21(b), including cyclic 35 kip dynamic load case.

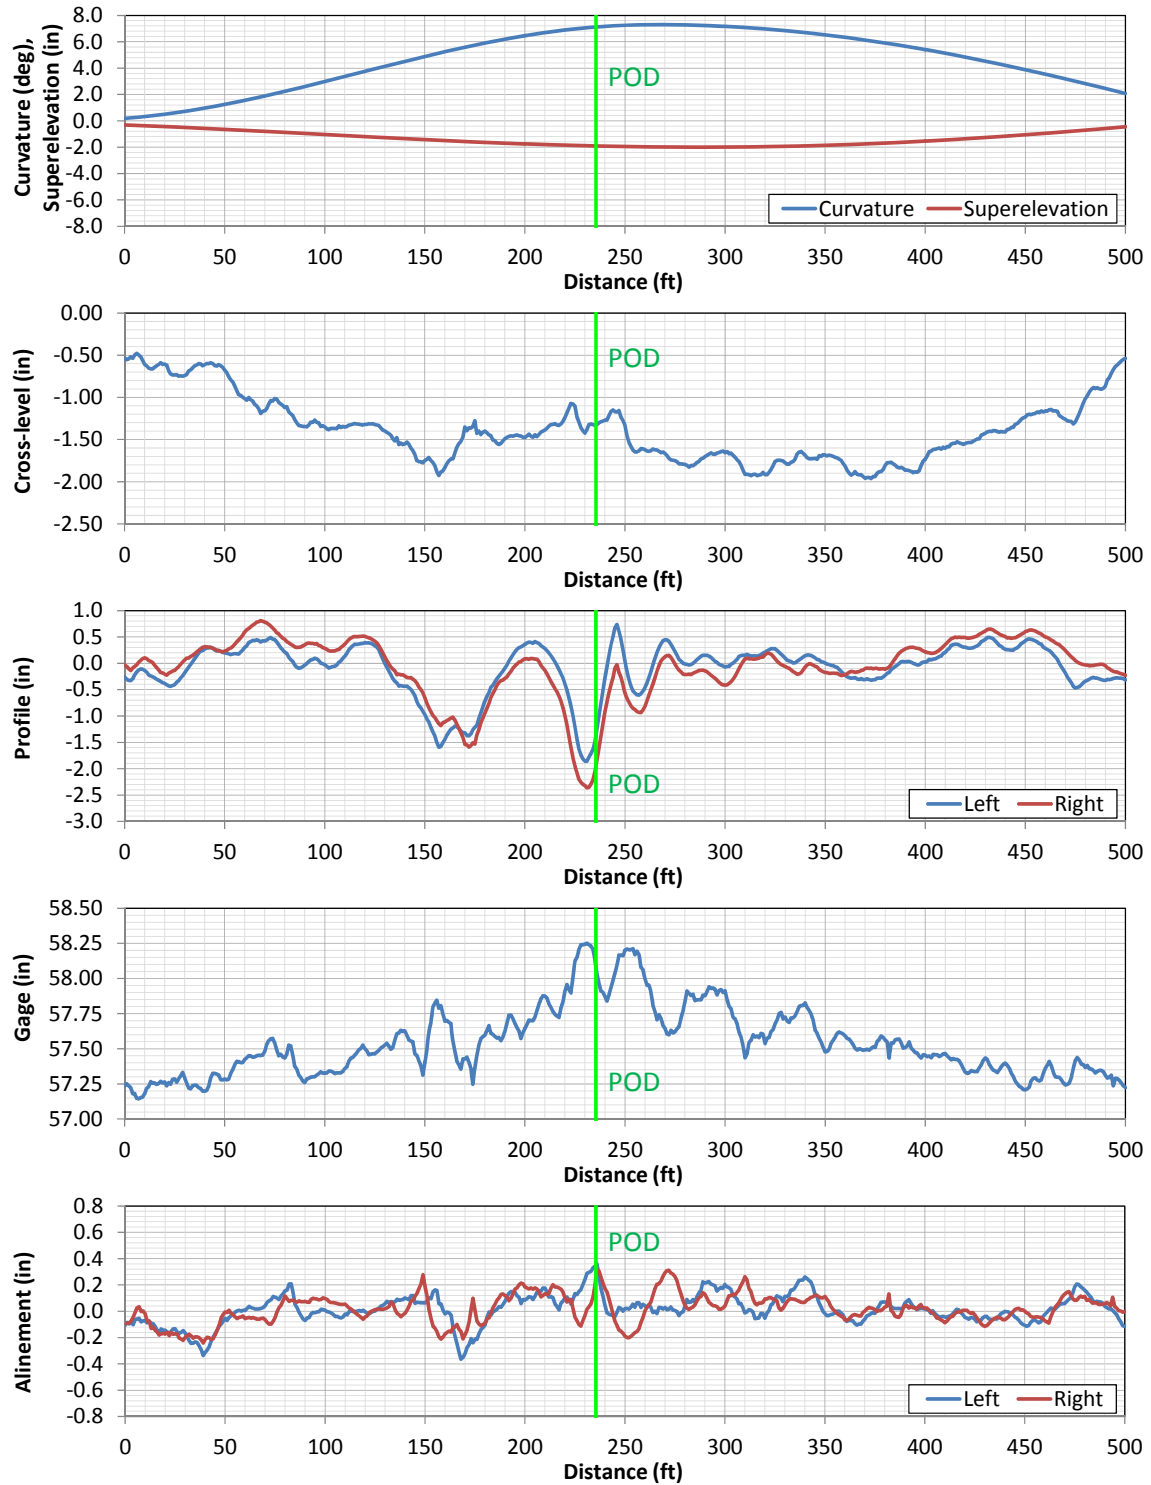
Figure A1 shows the measured track geometry used as input to the VTI simulations having the unloaded gage adjusted to 58.25 inches to reflect the movement of the rails under the insulator clips - a condition present at the time of the derailment (described in greater detail in the Track Condition section) and not necessarily at the time of the FRA track geometry surveys.

**Figure A1: Measured track geometry data used in simulation:
curvature, superelevation, crosslevel, profile, gage, and alinement.**

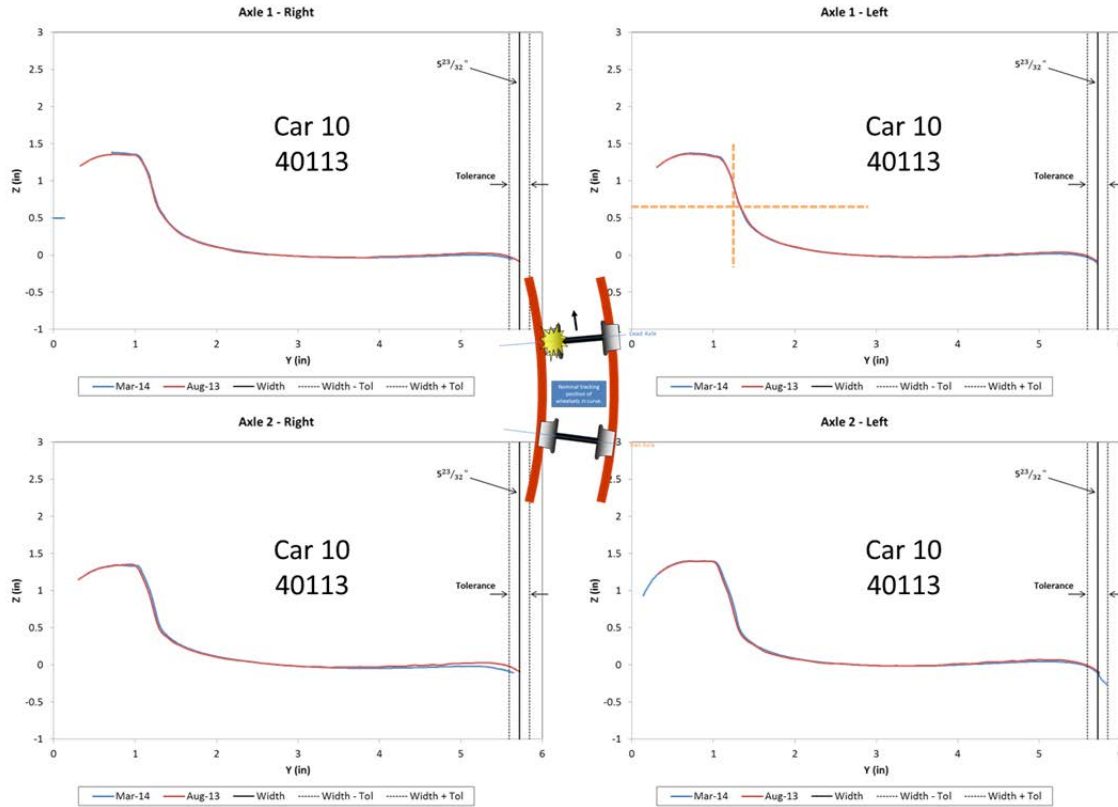
Figure B1: Wheel profiles on car 10, lead truck; left and right are when looking from the front of the car backwards.

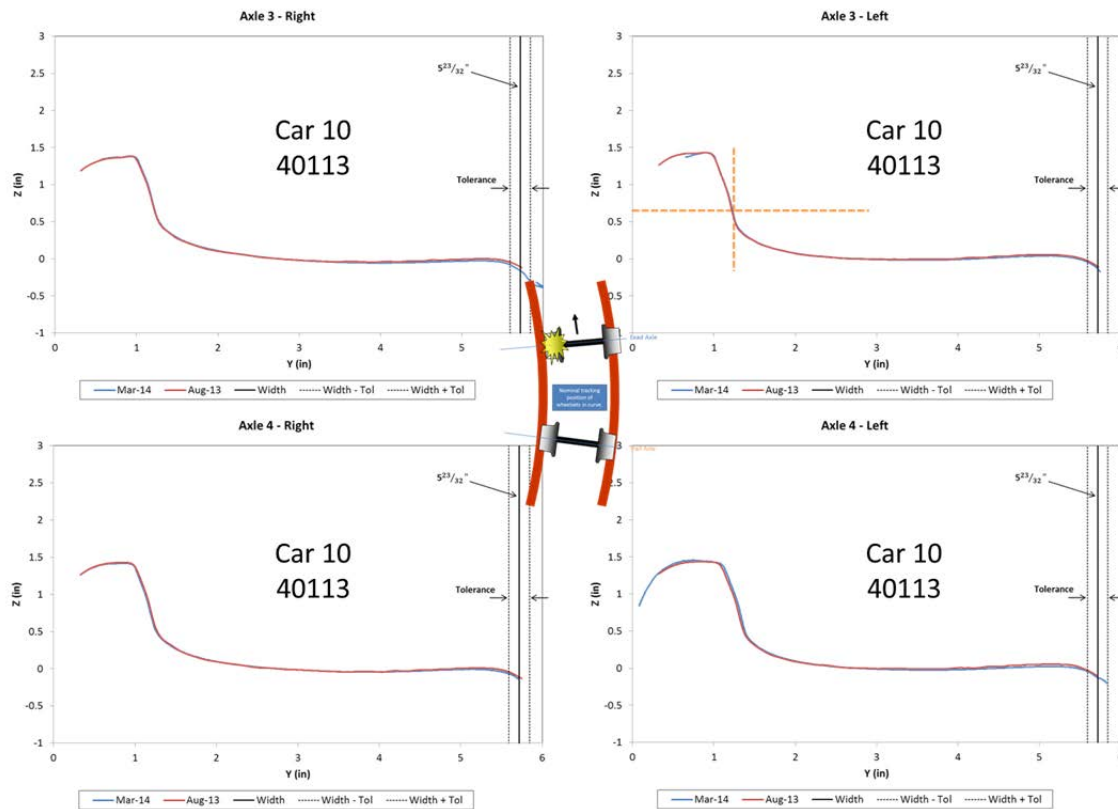
Figure B2: Wheel profiles on car 10, trail truck; left and right are when looking from the front of the car backwards.

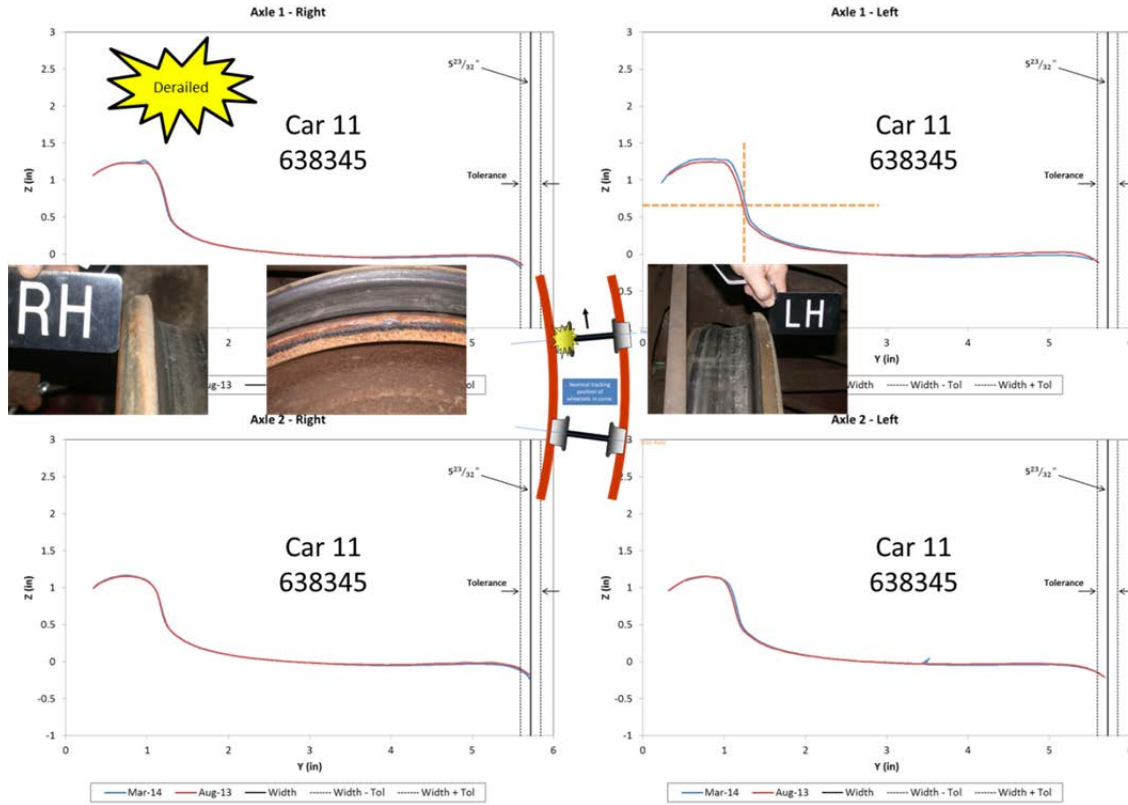
Figure B3: Wheel profiles on car 11, lead truck; left and right are when looking from the front of the car backwards.

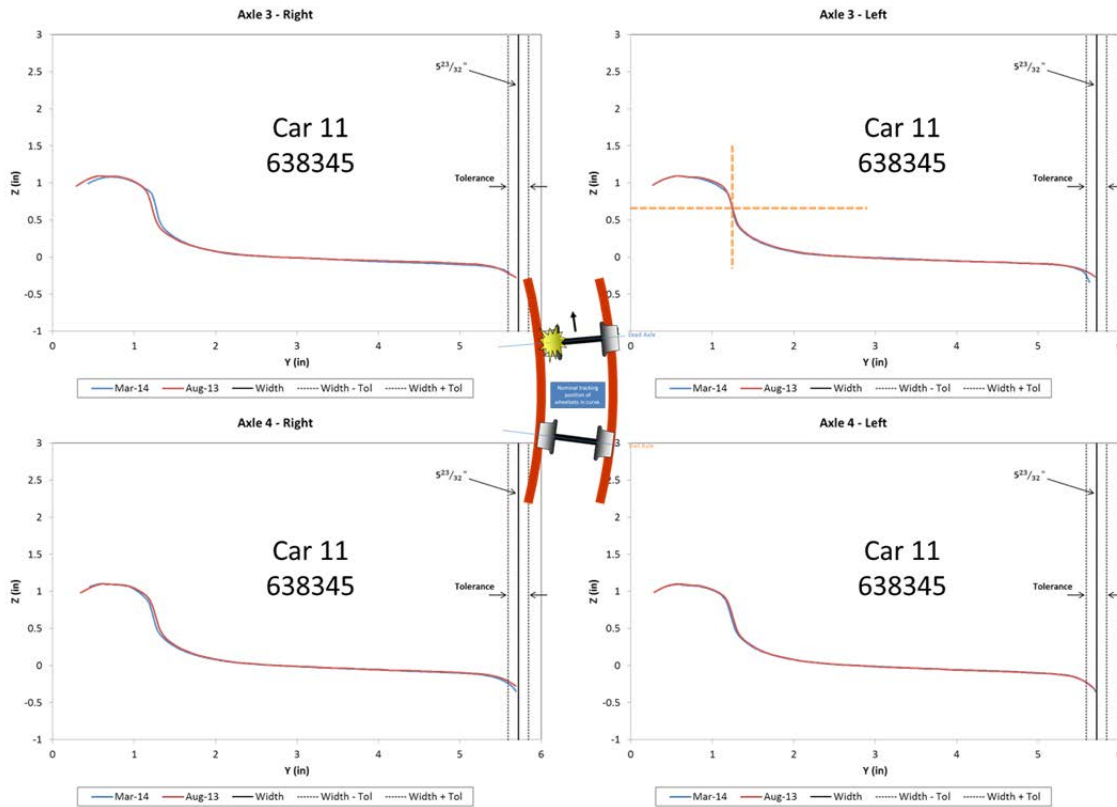
Figure B4: Wheel profiles on car 11, trail truck; left and right are when looking from the front of the car backwards.

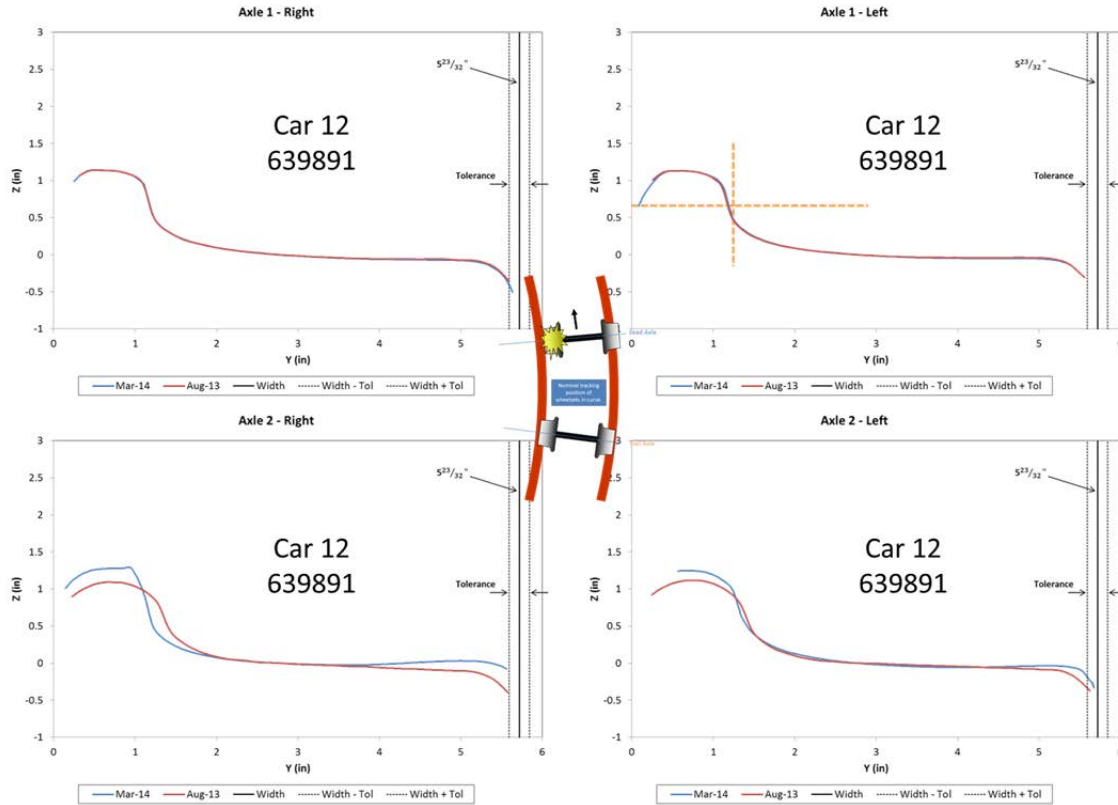
Figure B5: Wheel profiles on car 12, lead truck; left and right are when looking from the front of the car backwards.

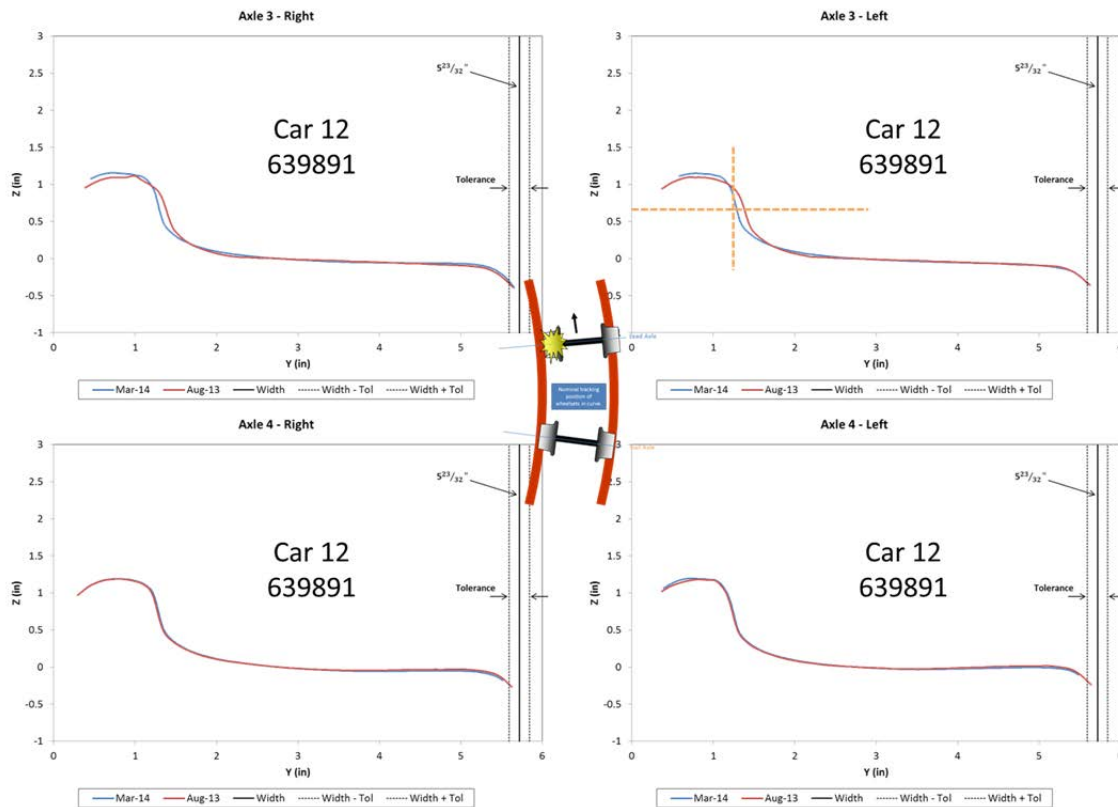
Figure B6: Wheel profiles on car 12, trail truck; left and right are when looking from the front of the car backwards.

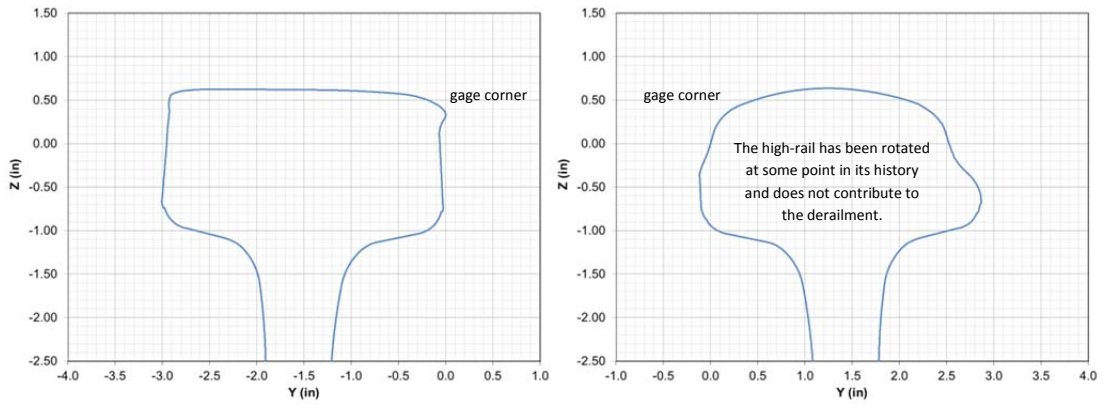
Figure B7: Rail profiles taken near POD (low-rail left, high-rail right).

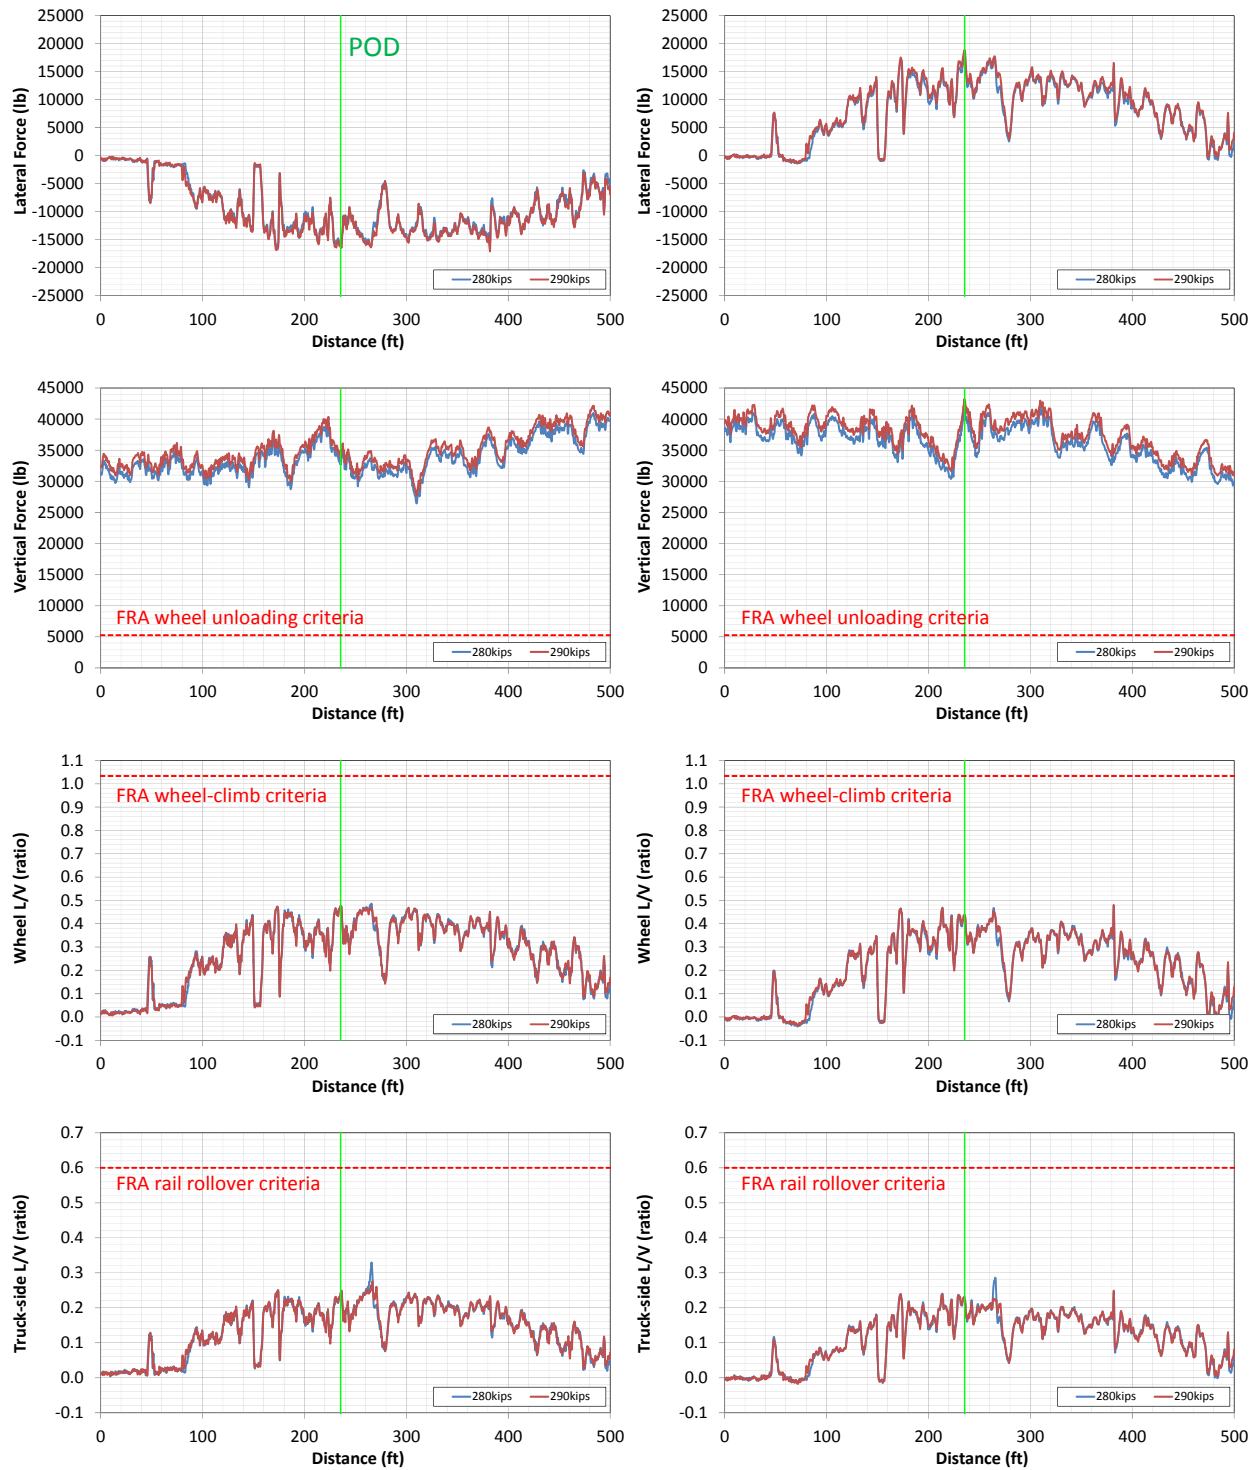
Figure C1: Axle 1 predicted wheel-rail forces in derailment curve, effect of carbody weight: comparison of baseline case car with weight of 280 kips and car weight of 290 kips, center of gravity of 93 inches.
